School District of Philadelphia

S102201; West Philadelphia Auto

Final
Site Assessment Report

February 2, 2017

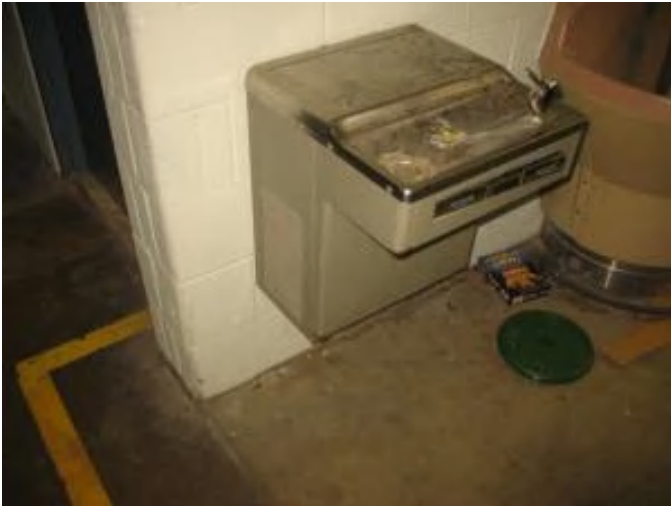
System: D2010 - Plumbing Fixtures

Location: Shop area

Distress: Damaged

Notes: Replace two (2) wall hung drinking fountains in the shop area. These units are beyond their service lives and are in poor condition.

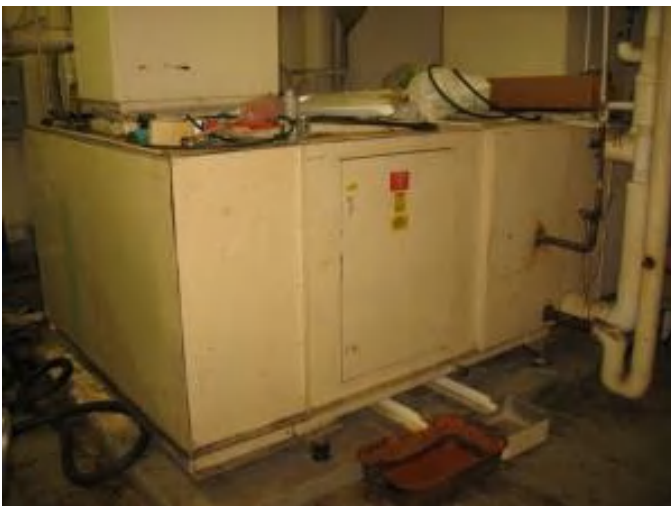
System: D3040 - Distribution Systems

Location: Second floor mechanical room

Distress: Beyond Service Life

- Replace the two (2) York AHUs, located in the second floor mechanical room, which are at the end of their service lives, and the two (2) 25 ton associated roof mounted condensing units in the next 1-3 years.

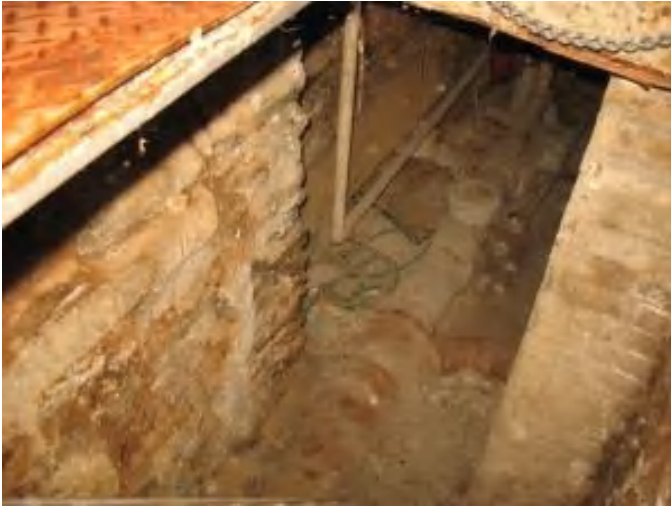
System: D2020 - Domestic Water Distribution

Location: Throughout building

Distress: Beyond Service Life

Correction: Replace domestic water piping (75 KSF)

Notes: Hire a qualified contractor to perform a detailed inspection of the domestic water piping, in use for an unknown amount of time, and replace any damaged piping.

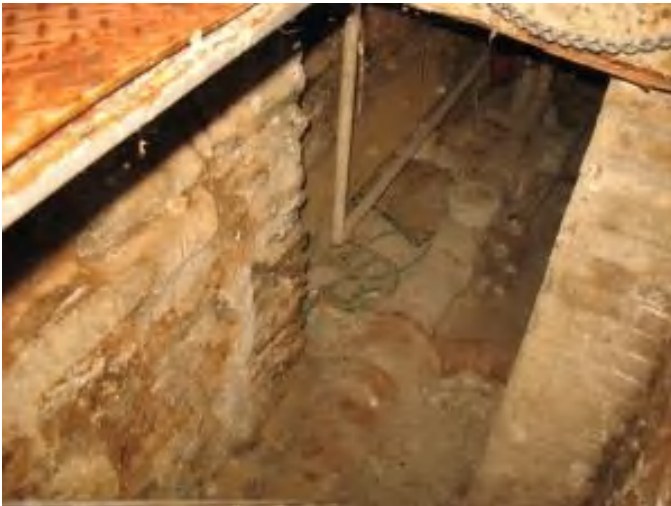
System: D2030 - Sanitary Waste

Location: Throughout building

Distress: Beyond Service Life

Notes: Hire a qualified contractor to perform a detailed examination of the sanitary waste piping using visual inspection and video cameras to locate and replace any damaged piping and to further quantify the extent of potential failures.

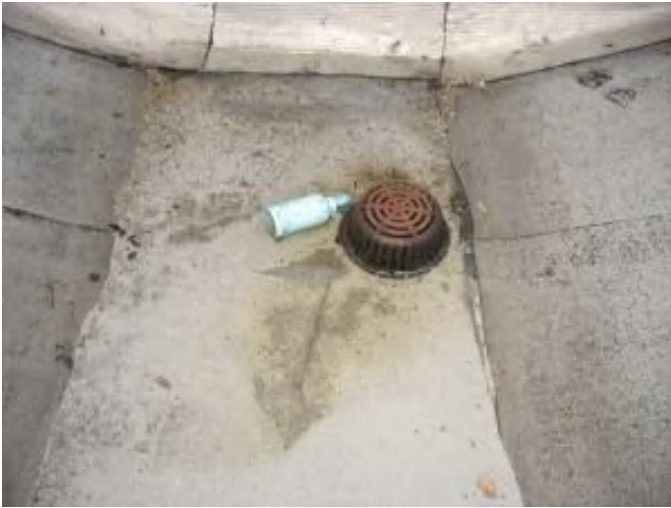
System: D2040 - Rain Water Drainage

Location: Throughout building

Distress: Beyond Service Life

Notes: Hire a qualified contractor to perform a detailed examination of the rain water drainage piping using visual inspection and video cameras to locate and replace any damaged piping and to further quantify the extent of potential failures.

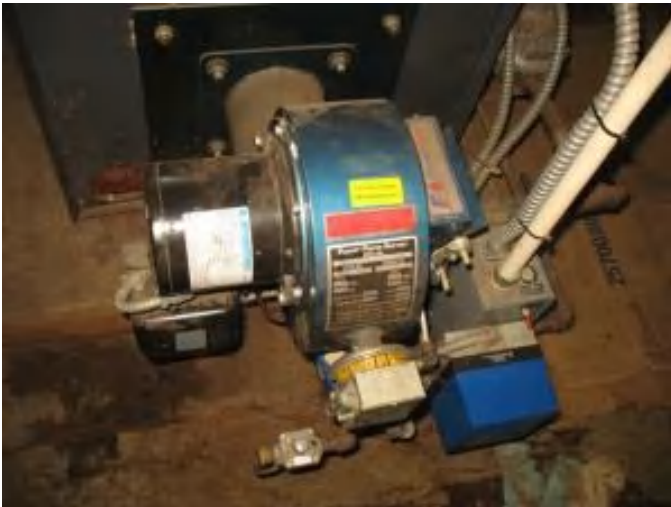
System: D3020 - Heat Generating Systems

Location: Second floor mechanical room

Distress: Beyond Service Life

Notes: Replace the one (1) 714MBH gas boiler burner, which is at the end of its service life, with a new more efficient burner within the next 2-4 years.

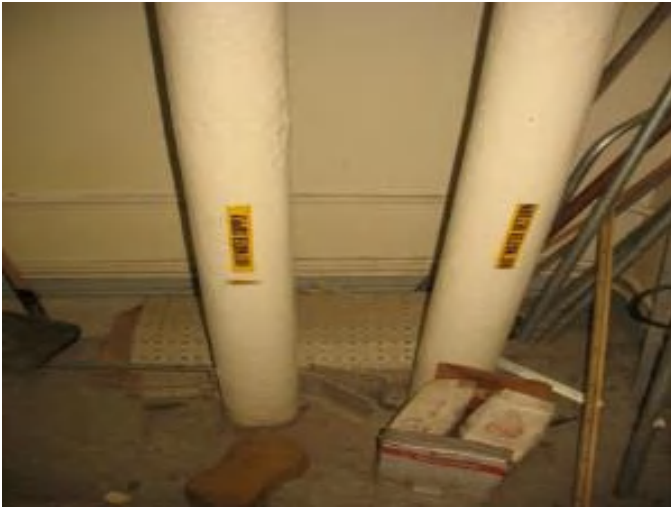
System: D3040 - Distribution Systems

Location: Throughout building

Distress: Beyond Service Life

Notes: Hire a qualified contractor to examine the building heating hot water piping, in service for an unknown amount of time, and perform additional testing to locate and replace any damaged piping and to further quantify the extent of potential failures.

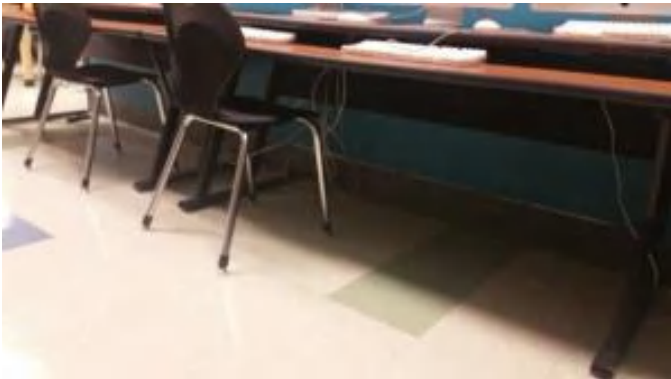
System: D5020 - Lighting and Branch Wiring

Location: throughout the building

Distress: Inadequate

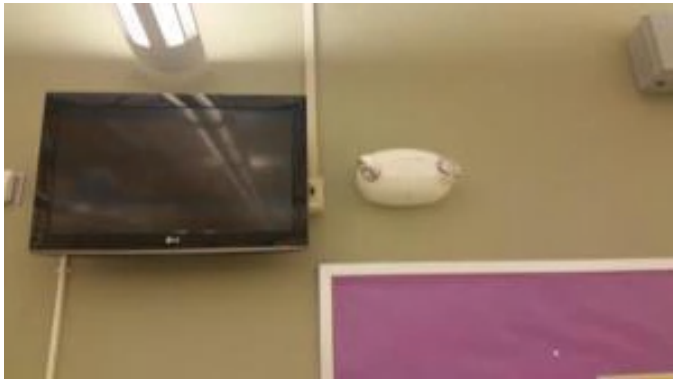
System: D5090 - Other Electrical Systems

Location: throughout the building

Distress: Beyond Service Life

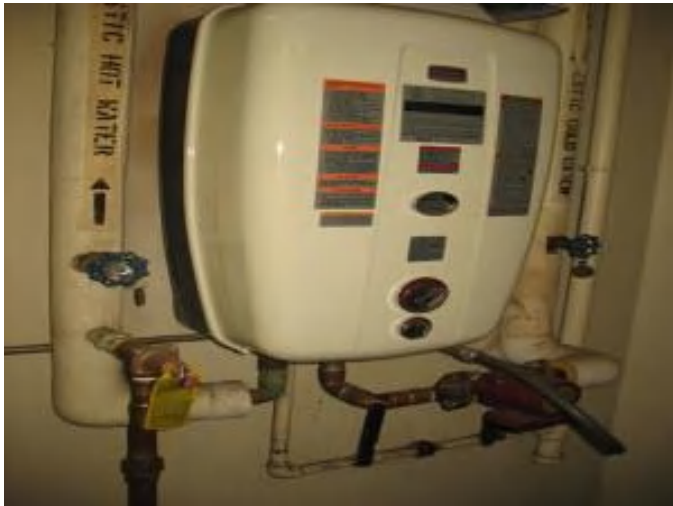
System: D2020 - Domestic Water Distribution

Location: Second floor mechanical room

Distress: Beyond Service Life

Notes: Replace the one (1) existing Paloma instant hot water heater, which is approaching the end of its service life, within the next 3-5 years.

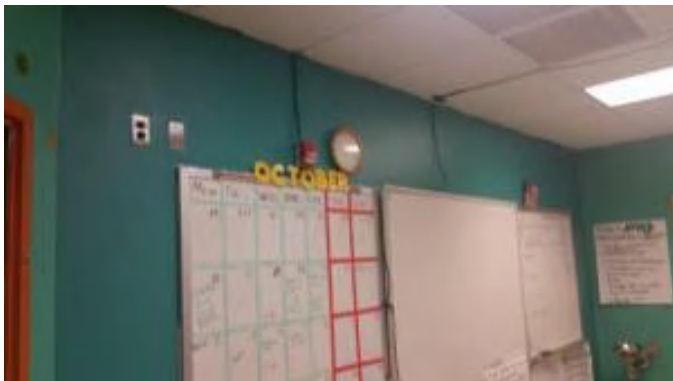
System: D5030 - Communications and Security

Location: throughout the building

Distress: Beyond Service Life

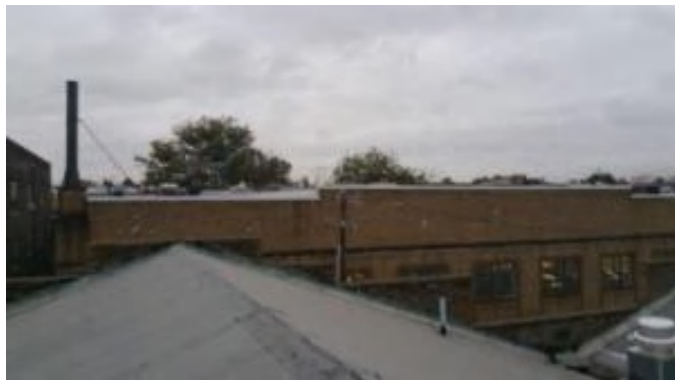
System: D5090 - Other Electrical Systems

Location: roof

Distress: Inadequate
