## Facility Condition Assessment Summary Report

### Wright School

School District of Philadelphia  
**S447001;Wright**  
Final  
**Site Assessment Report**

January 30, 2017

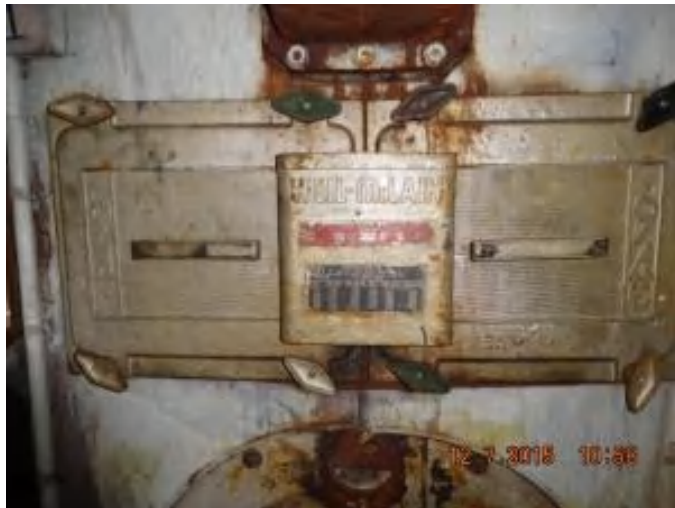
**Location:** mechanical room

The boilers were installed in 1970 should be replaced based on excessive service life. The unit ventilators and air handling units should be replaced based on age and condition and to provide code required outside air quantities. The distribution piping and pumps are in poor condition, have exceeded the service life and should be replaced. The chilled water system is within five years of normal service life and is recommended to be replaced as part of an HVAC renovation.

#### System: D3020 - Heat Generating Systems

**Distress:** Beyond Service Life

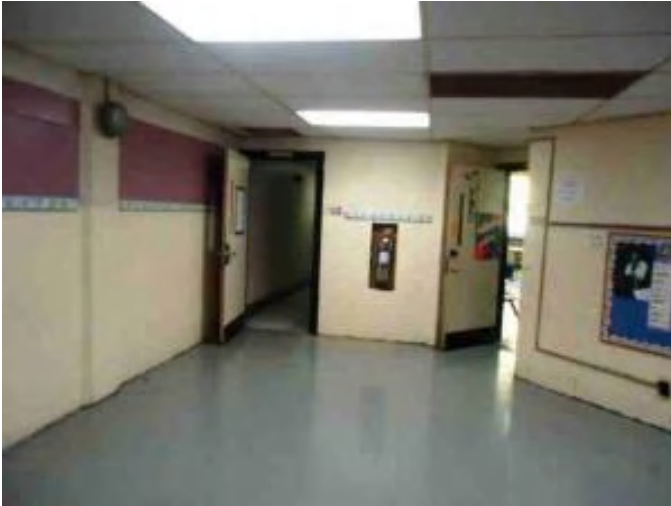
**Location:** Building Wide

faster than normal rate for this application. Numerous repairs to locksets and door hardware have advanced the deterioration of the doors. This deficiency provides a budgetary consideration to replace a portion of the interior doors and frames with consideration for the physically challenged.

**System: C1020 - Interior Doors**

**Distress:** Damaged

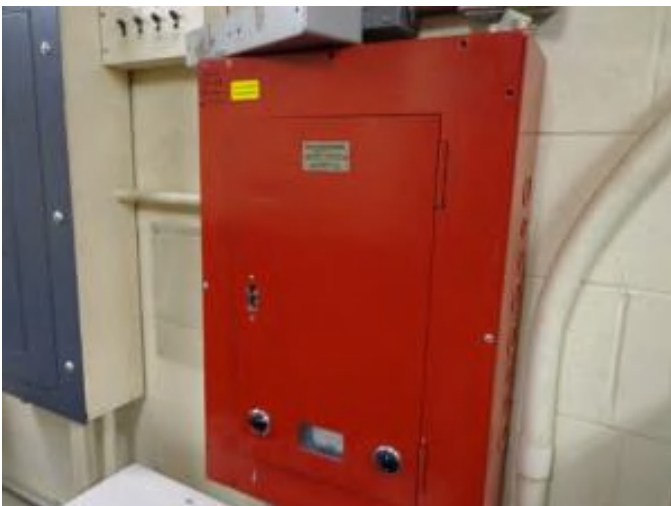
**Location:** Building wide

**System: D5030 - Communications and Security**

**Distress:** Life Safety / NFPA / PFD

**Notes:** Replace fire alarm system with an addressable type system meeting current NFPA Codes and ADA requirements.

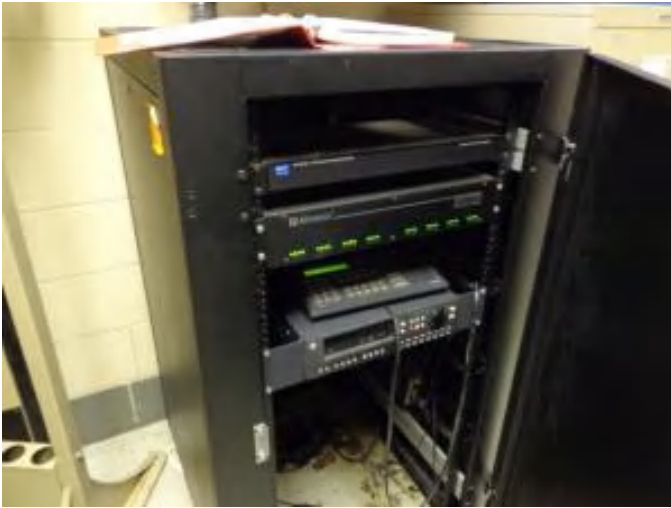
**Location:** Building wide

**System: D5030 - Communications and Security**

**Distress:** Security Issue

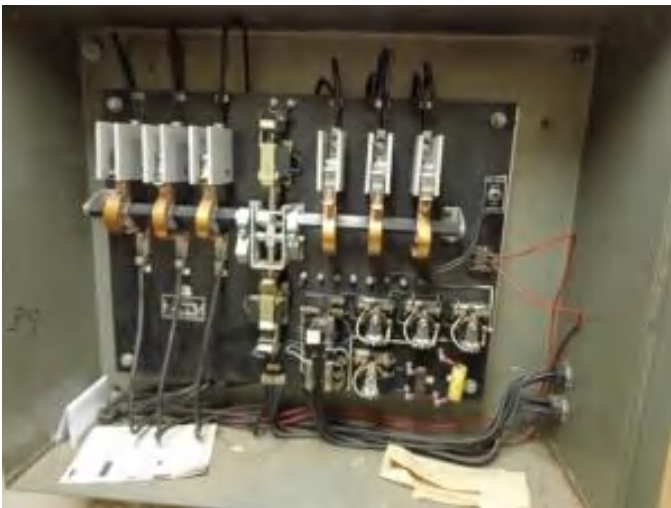
**Location:** Mechanical Room 104A

**System: D5090 - Other Electrical Systems**

**Distress:** Beyond Service Life

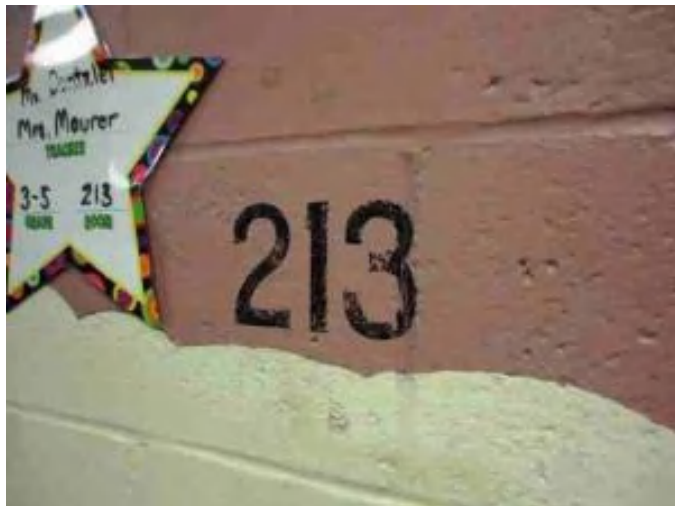
**Location:** Building Wide

**System: C1030 - Fittings**

**Distress:** Damaged

**Notes:** There is no directional signage and room signage is a custom design in places and scarce or painted with no consistency in others. Accessibility signage criteria have been established for the physically challenged. These include mounting heights, contrast and finish, raised and Braille characters and pictograms, and character proportions and heights. It is recommended that compliant signage be installed throughout the building.

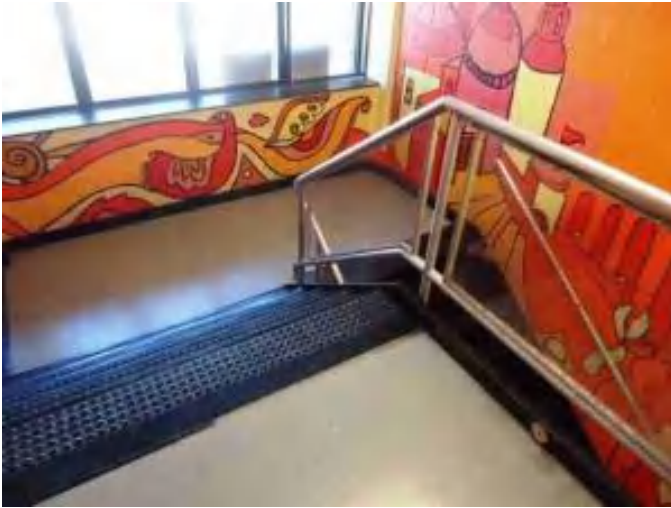
**Location:** Stairs

Current requirements for stairs indicate that they have graspable handrails on both sides, that the rails have a specific end geometry, and that the handrails continue horizontally at the landings. In addition, guardrails must prevent the passage of a 4 inch diameter sphere (6 inches in the triangle formed by the lower rail and tread/riser angle). Although the stairs are compliant with the code enforced at the time of construction until a major renovation occurs, they are deficient in handrail and guardrail design relative to current standards. Future efforts should include comprehensive stair railing removal and replacement upgrades.

**System: C2010 - Stair Construction**

**Distress:** Life Safety / NFPA / PFD

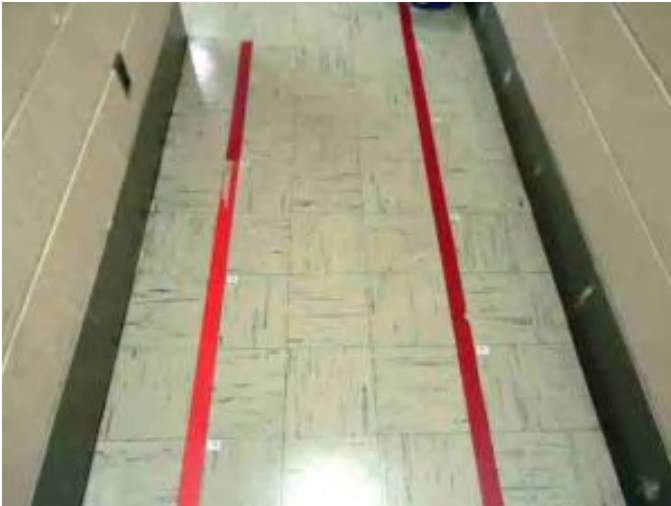
**Location:** Building Wide

**System: C3020413 - Vinyl Flooring**

**Distress:** Health Hazard / Risk

**Notes:** The floor finish for this school is a combination of 12x12 and 9x9 vinyl tile in the classrooms, gym and administrative area, wood stage floor finish with concrete stairs and some hallway sections. The vinyl tile finish is a 9 x 9 application and is suspect to contain asbestos. This finish is recommended for upgrade to a new 12 x 12 vinyl tile application. Suspected asbestos containing materials (ACM) are believed to be limited to the original vinyl floor tile and mastic. While currently sound and manageable in place, future renovation efforts should include provision to test and abate any and all ACM.

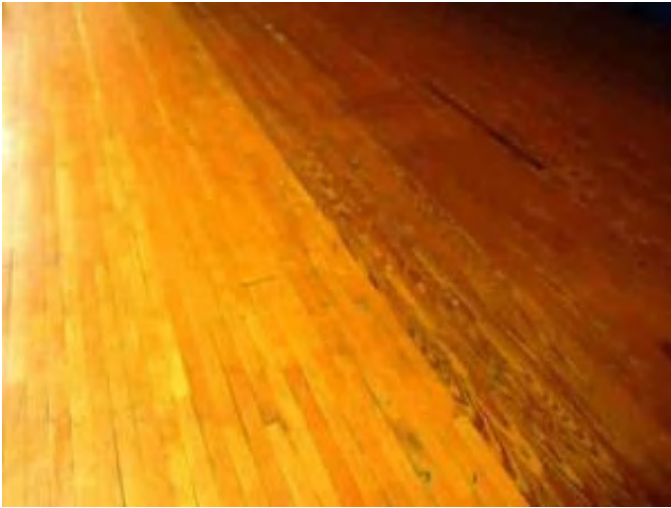
**Location:** Stage

The stage floor finish in the auditorium is a wood floor finish that appears to be from original construction. The system is showing signs of age such as the effects of sanding and refinishing with yearly cleaning and waxing with some repairs. The floor finish is in fair condition however, the finish is beyond its expected life cycle. It is recommended that the damaged wood floor finish be removed and replaced with an in kind finish.

**System: C3020414 - Wood Flooring**

**Distress:** Damaged

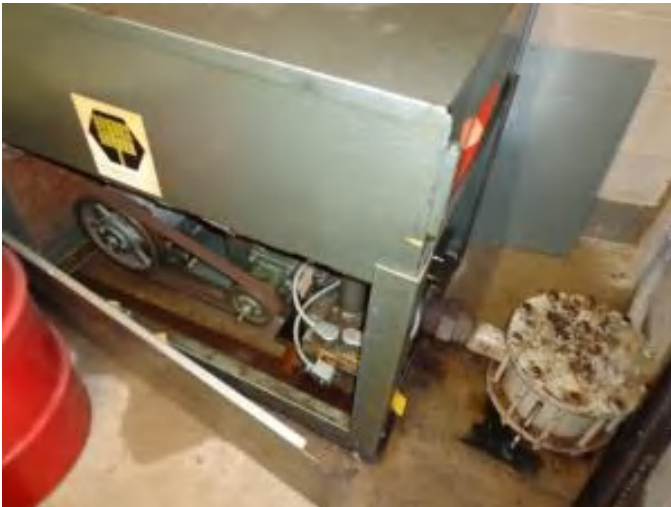
**Location:** Elevator machine room

**System: D1010 - Elevators and Lifts**

**Distress:** Beyond Service Life

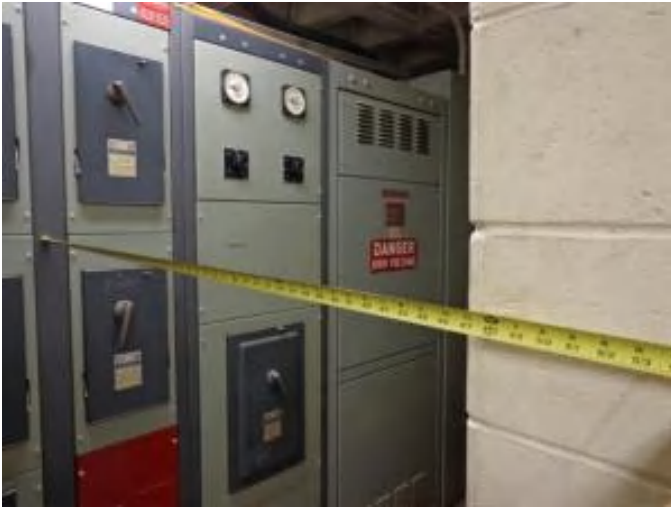
**Location:** Mechanical Room 104A

Room 104A has a total of 17 feeder circuit breakers to feed the fire pump and (14) 208/120V, 3 phase panelboards throughout the building. The installation does not meet the current minimum working space in front of the equipment and entrance to and egress from the working space, as required by NFPA 70, National Electrical Code Article 110. Since both substations have served their useful life, and since the dedicated equipment space required by code for the main entrance substation is not adequate, it is recommended that a single 1000 kVA, 13.2 kV-208/120V, 3 phase pad mount transformer be provided at the southeast corner of the building to supply a 3000A, 208/120V, 3 phase, 4 wire switchboard located in Mechanical Room 104A. All loads, including the chiller, would be fed from the 3000A switchboard. The substation for the chiller in the Mechanical Room 101 would be removed and replaced with a step-up 208V-480/277V transformer. Replace all 14 panelboards throughout the building, including their feeder conductors.

**System: D5010 - Electrical Service/Distribution**

**Distress:** Beyond Service Life

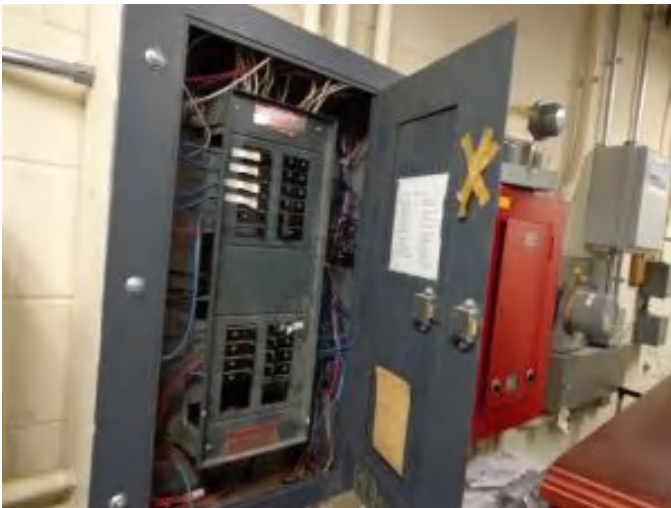
**Location:** Building wide

**System: D5010 - Electrical Service/Distribution**

**Distress:** Beyond Service Life

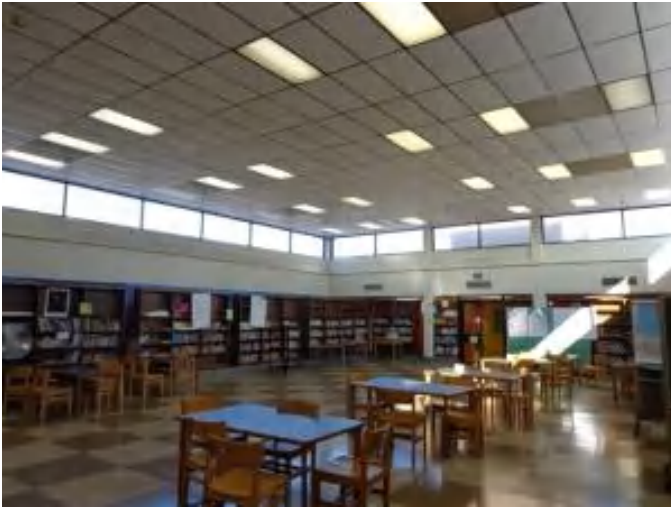
**Location:** Building wide

**System: D5020 - Lighting and Branch Wiring**

**Distress:** Beyond Service Life

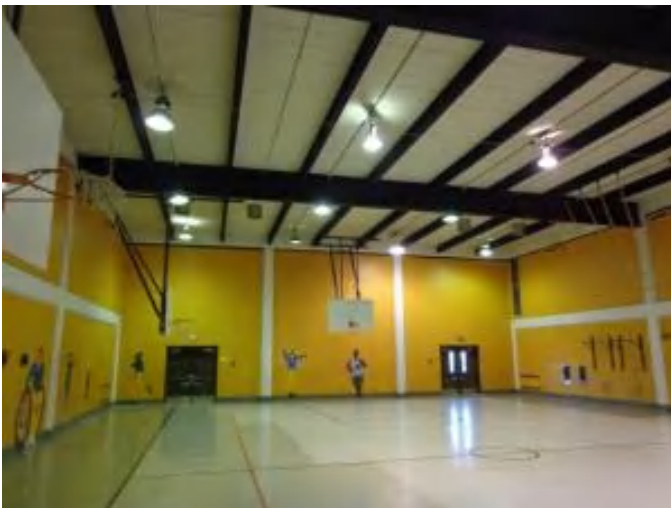
**Location:** Gymnasium

**System: D5020 - Lighting and Branch Wiring**

**Distress:** Beyond Service Life

**Notes:** Replace (20) metal halide industrial fixtures in the gymnasium with LED industrial fixtures. Replace incandescent lamps in eight (8) cylinder downlights that are used for emergency lighting with LED lamps.

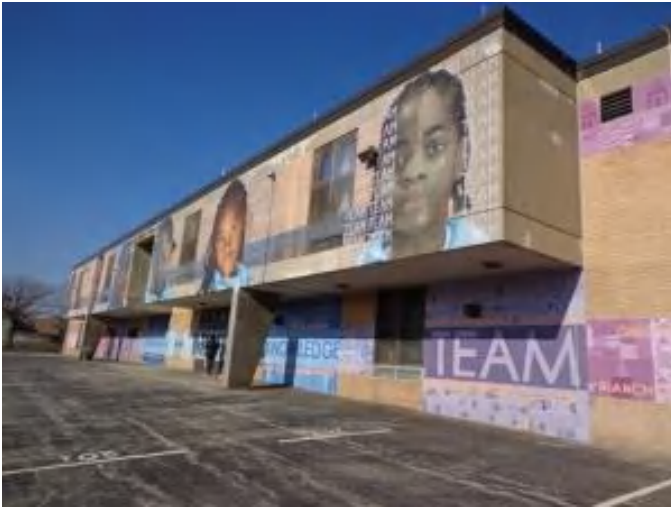
**Location:** Building exterior

**System: D5020 - Lighting and Branch Wiring**

**Distress:** Beyond Service Life

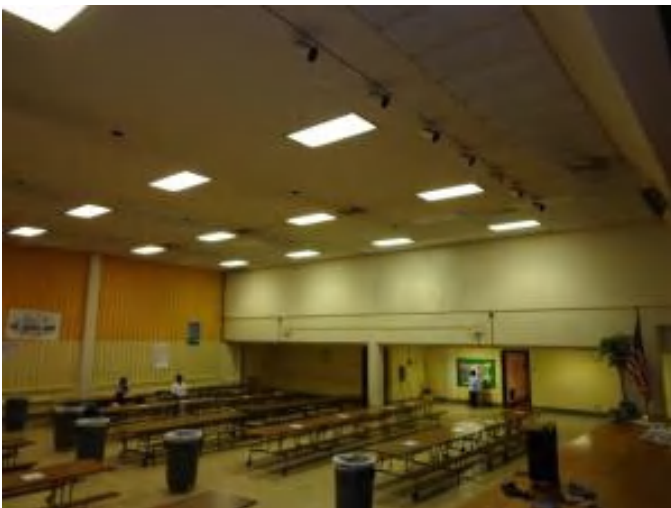
**Location:** Cafeteria/Auditorium

**System: D5020 - Lighting and Branch Wiring**

**Distress:** Beyond Service Life

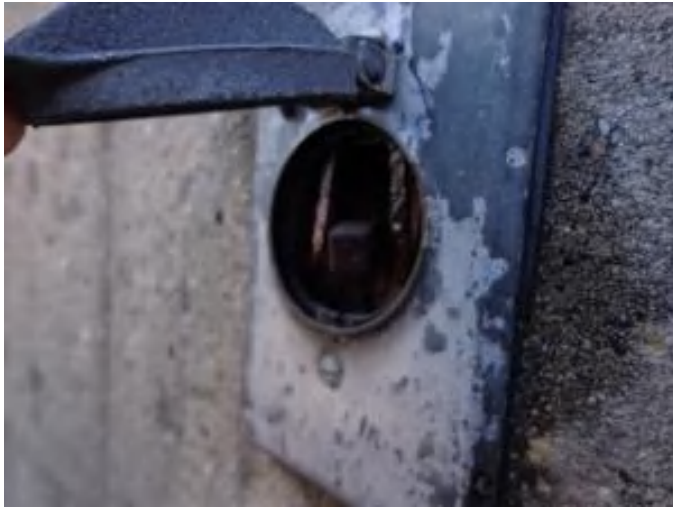
**Location:** Roof and Mech. Penthouses

**System: D5020 - Lighting and Branch Wiring**

**Distress:** Damaged

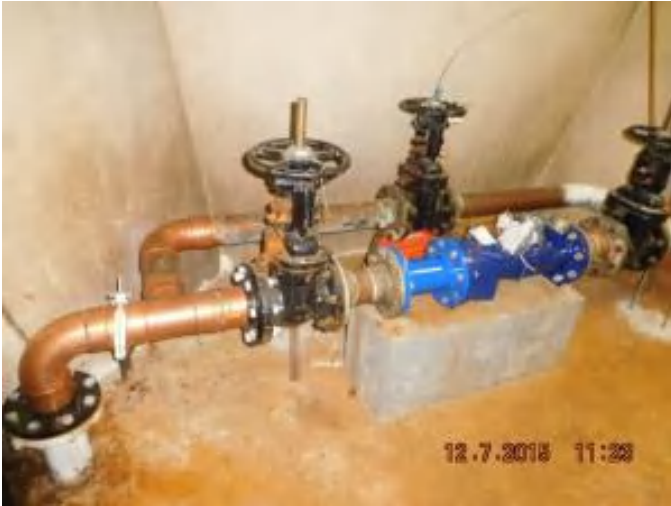
**Location:** entire building

The plumbing piping systems are from original 1970 installation. The supply piping has exceeded the service life and should be replaced. The cast iron piping should be inspected for damage and replaced or repaired as required. The water heaters should remain serviceable up to fifteen years. The fixtures appear to have been replaced during the past ten years and should have remaining life of twenty five years.

**System: D2020 - Domestic Water Distribution**

**Distress:** Beyond Service Life

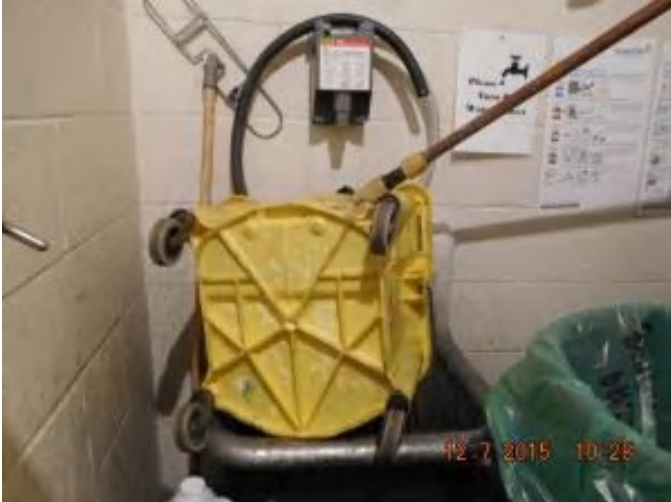
**Location:** entire building

**System: D2030 - Sanitary Waste**

**Distress:** Beyond Service Life

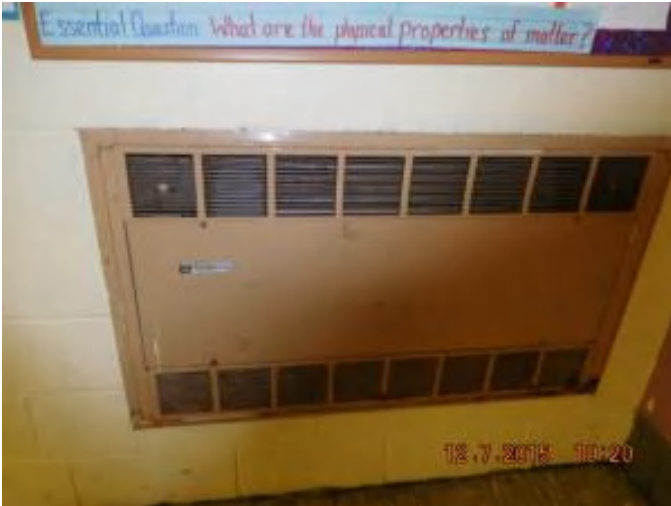
**Location:** classrooms

**System: D3040 - Distribution Systems**

**Distress:** Building / MEP Codes

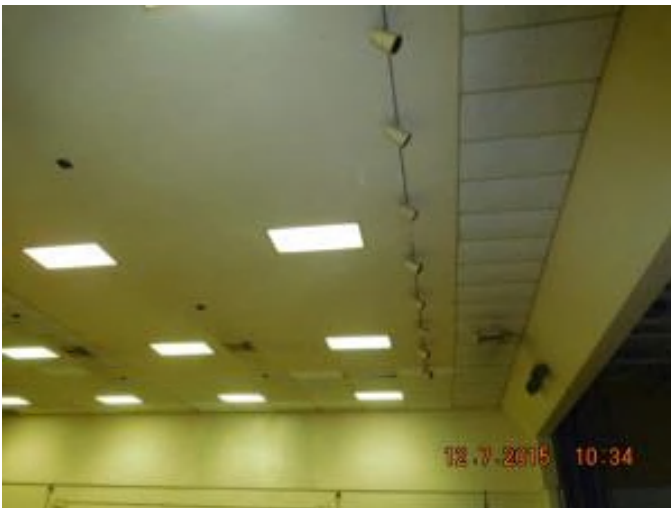
**Location:** penthouse, IMC

**System: D3040 - Distribution Systems**

**Distress:** Building / MEP Codes

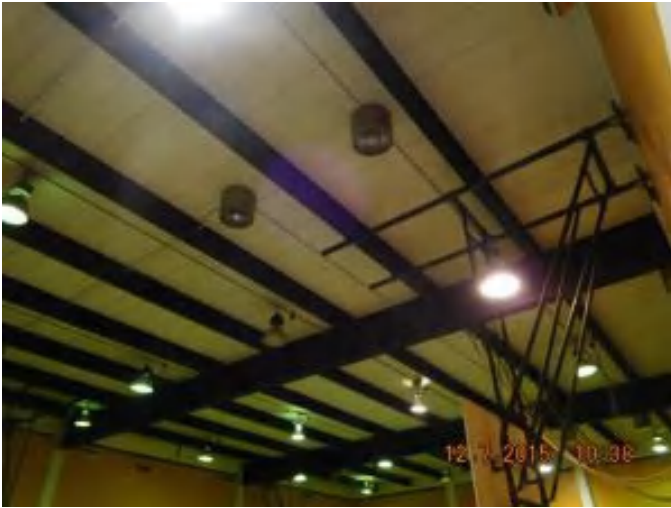
**Location:** penthouse, gymnasium

**System: D3040 - Distribution Systems**

**Distress:** Building / MEP Codes

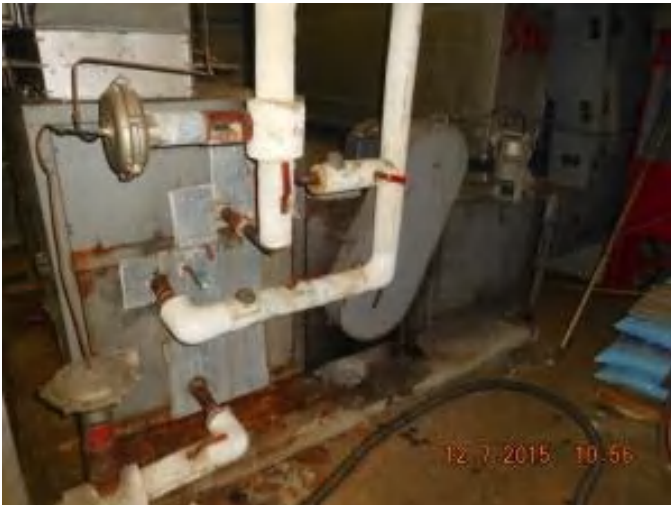
**Location:** first floor, mechanical room

**System: D3040 - Distribution Systems**

**Distress:** Building / MEP Codes

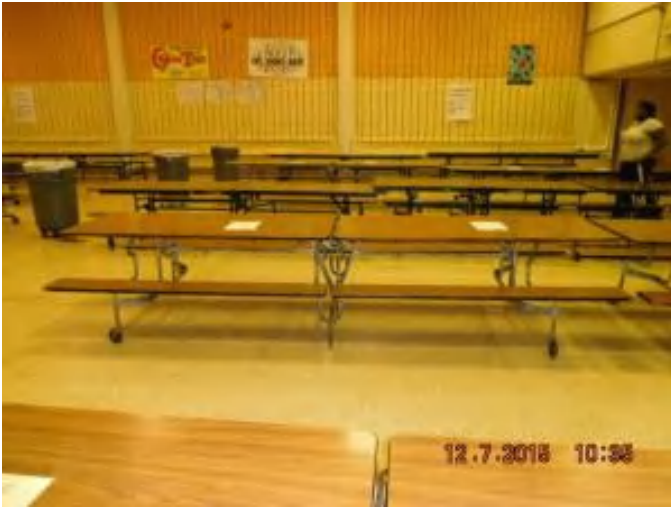
**Location:** penthouse, cafeteria/auditorium

**System: D3040 - Distribution Systems**

**Distress:** Building / MEP Codes

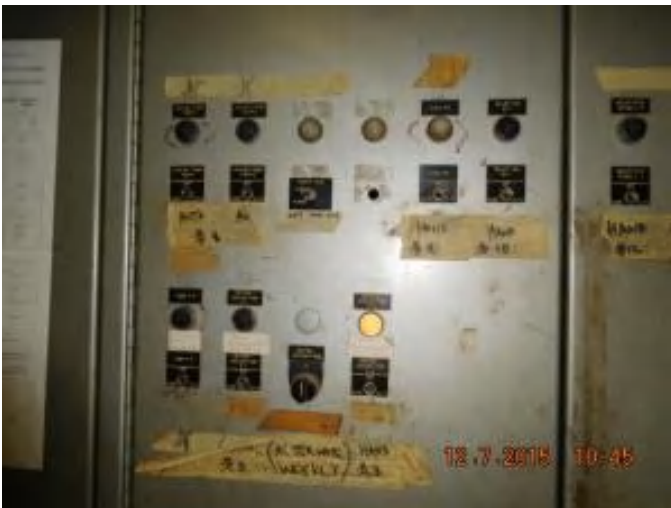
**Location:** entire building

**System: D3060 - Controls & Instrumentation**

**Distress:** Inadequate

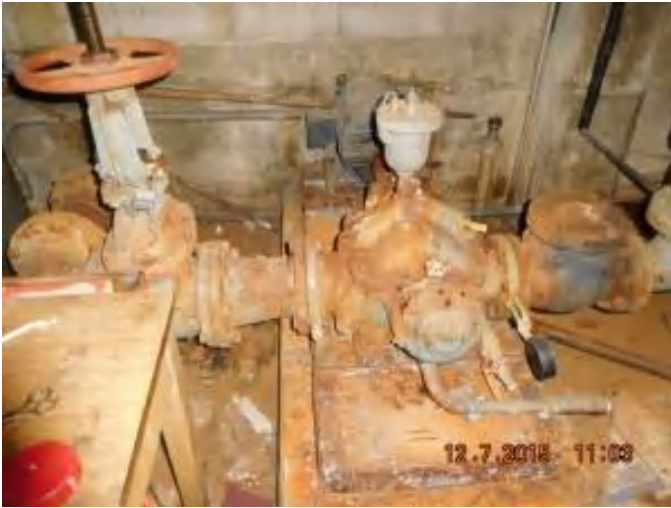
**Location:** entire building

**FIRE PROTECTION-** There is a four inch fire service line into the mechanical room and an old fifteen hp fire pump and controller that are in poor condition. The only sprinklers are two rows of closely spaced heads at the glass walls of the IMC to create a water curtain.

**System: D4010 - Sprinklers**

**Distress:** Life Safety / NFPA / PFD

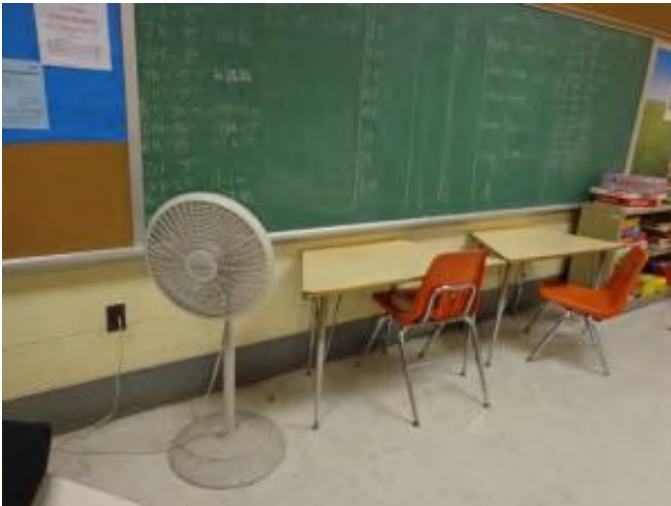
**Location:** Classrooms

**System: D5020 - Lighting and Branch Wiring**

**Distress:** Inadequate

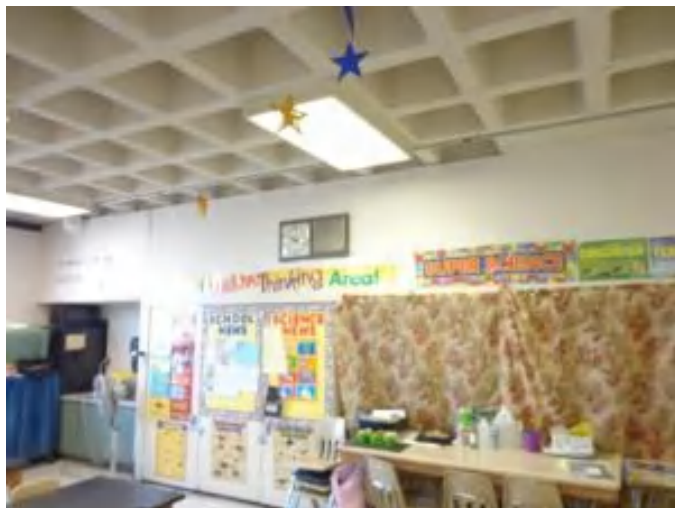
**Location:** Building wide

**System: D5030 - Communications and Security**

**Distress:** Damaged

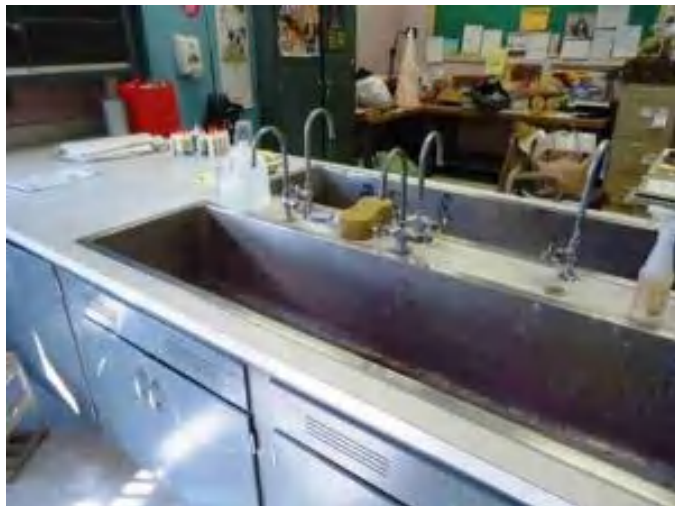
**Location:** Science Lab

The science labs appear to be original applications installed during construction. The installation consist of an instruction demonstration desk with sink. Wall mounted storage cabinets and cabinets with sinks for student use. The system is showing signs of age and lack of maintenance such as broken sink fixtures missing cabinet doors and damaged shelves. This deficiency provides a budgetary consideration for the universal upgrade of the science teaching labs to include new counter tops, sink, cabinets, shelves and fixtures required to support a conducive level of education.

**System: C1010 - Partitions**

**Distress:** Damaged

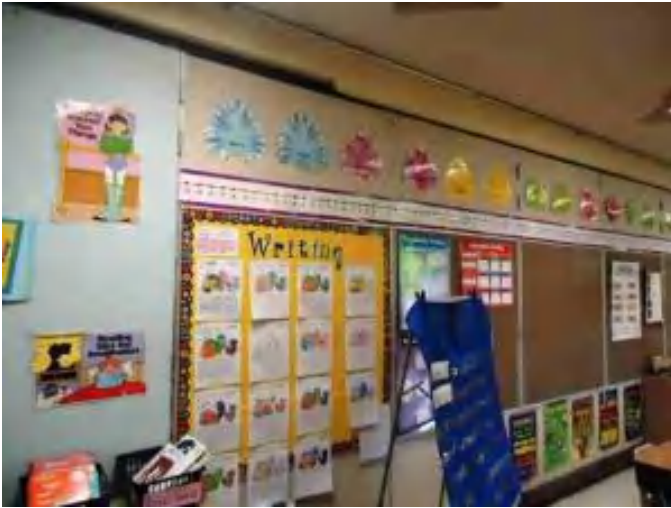
**Location:** Classrooms

There are several movable partitions that remain in classrooms. These wall systems are no longer used and in most cases cannot be used due to damage or wall modifications to support classroom needs. This deficiency provides a budgetary consideration to remove and replace the wall systems with universal removal of the existing movable partitions and upgrades to a permeate wall systems.

**System: C1010 - Partitions**

**Distress:** Damaged

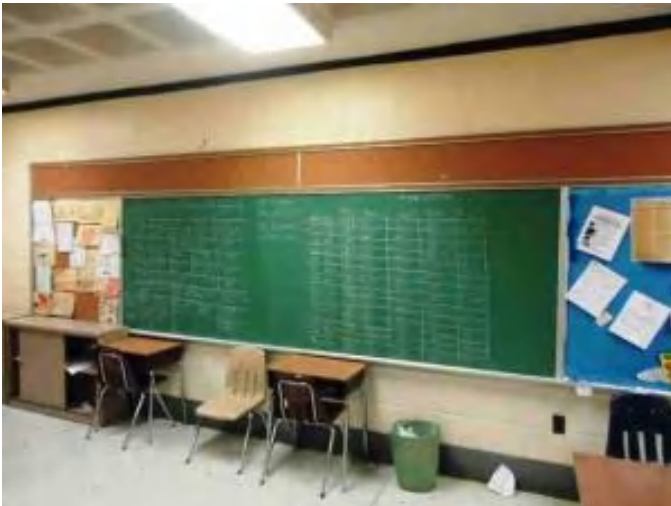
**Location:** Classrooms

**System: C1030 - Fittings**

**Distress:** Damaged

**Notes:** Some of the classroom chalk boards are original to the buildings construction. This system is damaged and beyond its expected life, universal upgrades are warranted. Remove and upgrade damaged chalk boards to new marker board systems.

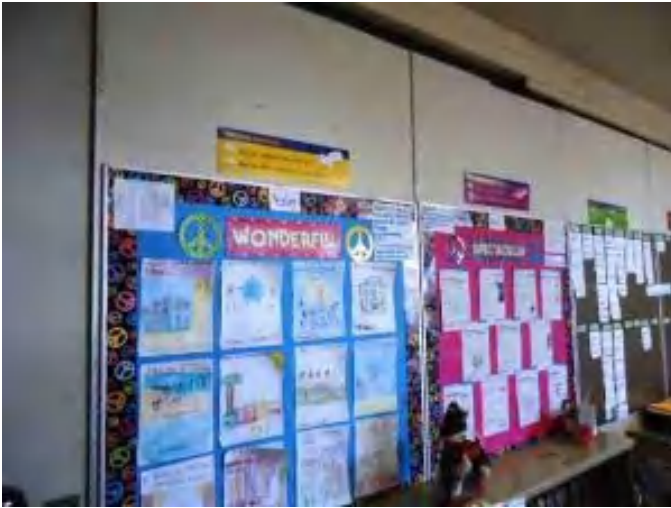
**Location:** Building Wide

There are several tack boards in the hallways for student displays. The systems are damaged and beyond the expected service life for this application. Remove and replace tack boards is recommended.

**System: C1030 - Fittings**

**Distress:** Damaged

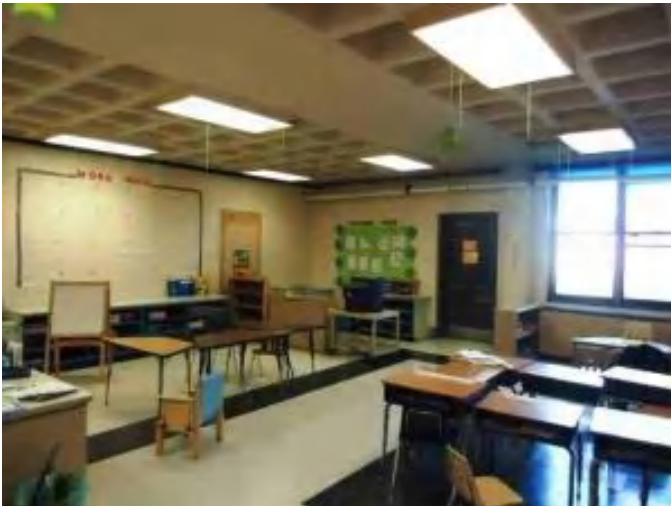
**Location:** Building WIDE

The ceiling finish is a mix of 12 x 12 ceiling grid, painted and 2 x 4 Acoustical tile finish. Ceilings have been repaired in several areas and is in good condition considering the age of the application and the current condition of the school. The ceiling finish is expected to require upgrades to support the recommended efforts in this report prior to re-opening. This deficiency provides a budgetary consideration for removal and replacement of the current ceiling finish to a new acoustical tile finish. Considering the recommended mechanical and electrical upgrades this effort should be completed as part of an overall renewal program for the school.

**System: C3030 - Ceiling Finishes**

**Distress:** Damaged

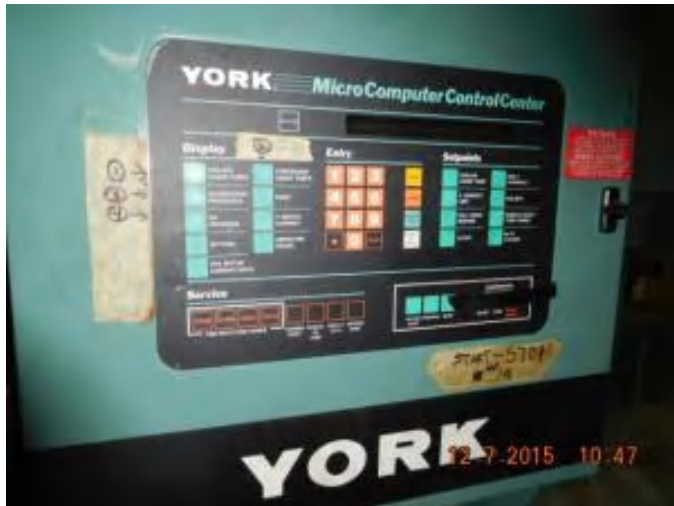
**Location:** roof, mechanical room

**System: D3030 - Cooling Generating Systems**

**Distress:** Beyond Service Life

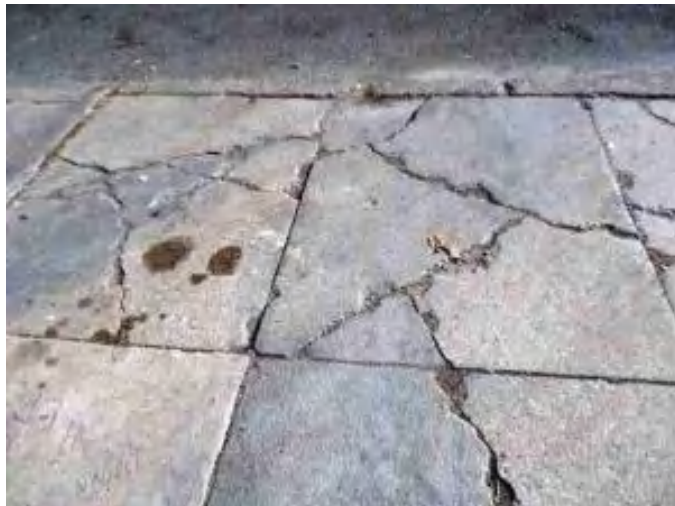
**Location:** Site

#### System: G2030 - Pedestrian Paving

**Distress:** Damaged

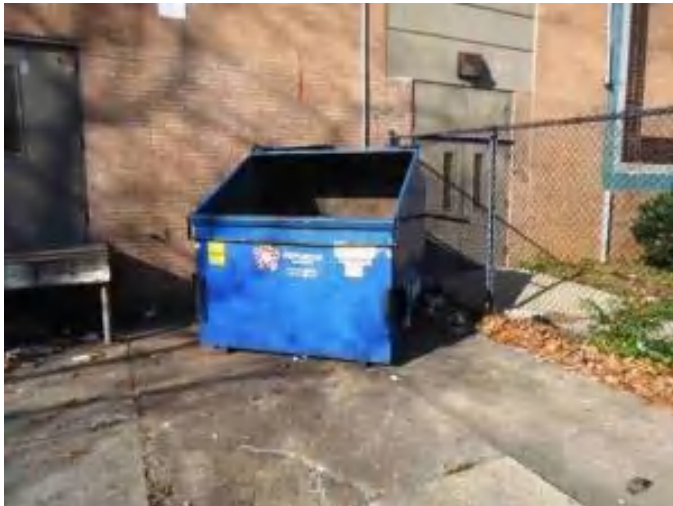
**Location:** Site

**System: G2040 - Site Development**

**Distress:** Health Hazard / Risk
