## Facility Condition Assessment Summary Report

### Ziegler School

School District of Philadelphia  
**S746001;Ziegler**  
Final  
**Site Assessment Report**  
January 31, 2017

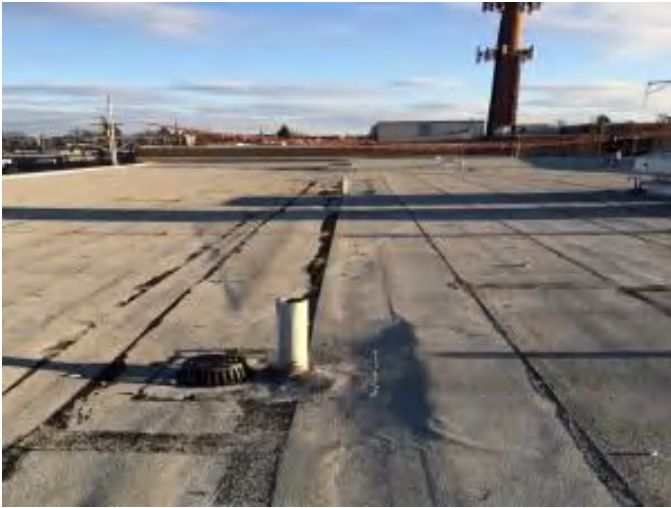
#### System: B3010105 - Built-Up

**Location:** old building - roof

**Distress:** Beyond Service Life

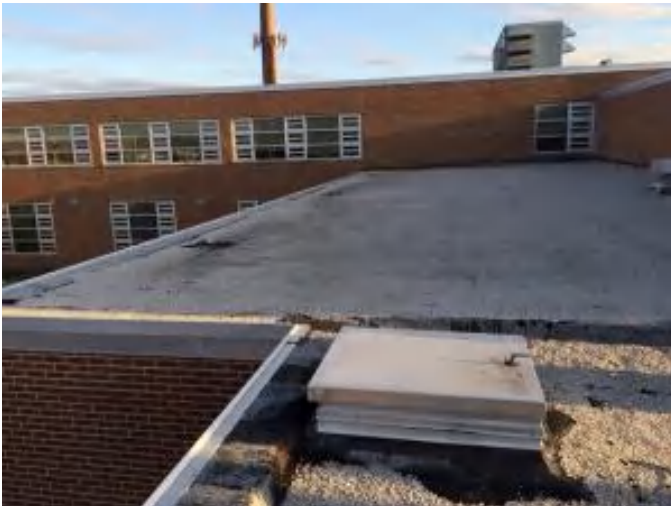
#### System: B3020 - Roof Openings

**Location:** new building - roof

**Distress:** Building / MEP Codes

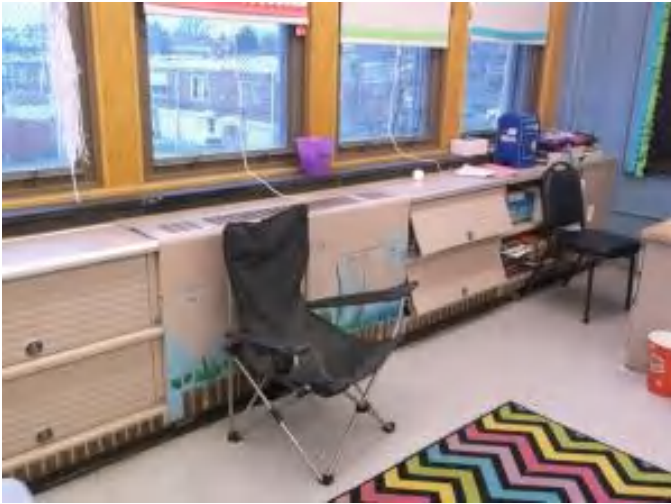
**System: D3040 - Distribution Systems**

**Location:** Old Building Classrooms

**Distress:** Health Hazard / Risk

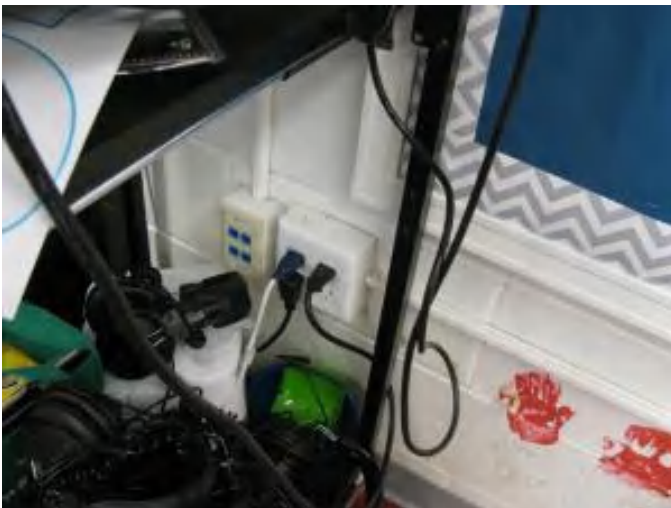
**System: D5020 - Lighting and Branch Wiring**

**Location:** Kindergarten classrooms

**Distress:** Health Hazard / Risk

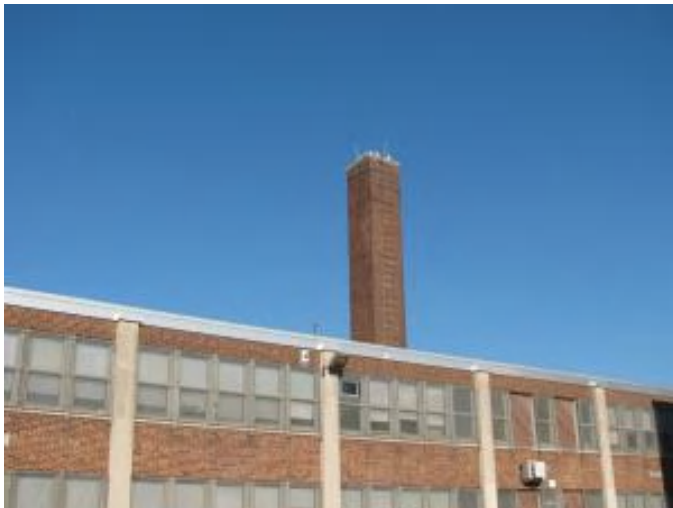
**System: D5090 - Other Electrical Systems**

**Location:** Roof

**Distress:** Life Safety / NFPA / PFD

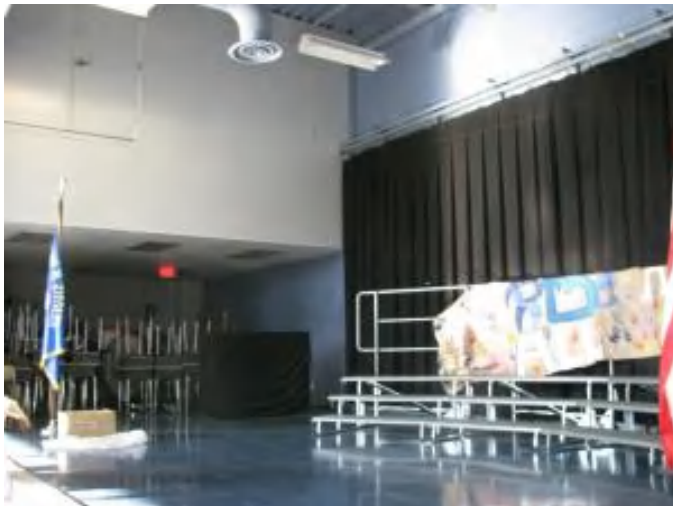
**System: E1020 - Institutional Equipment**

**Location:** Multipurpose Room

**Distress:** Inadequate

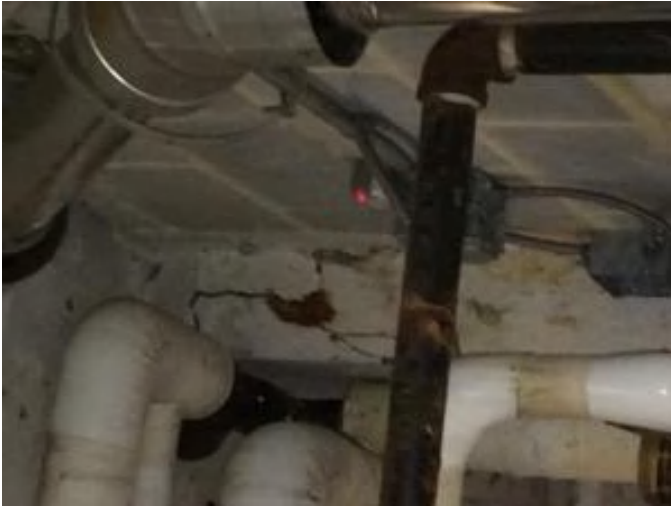
**System: B1010 - Floor Construction**

**Location:** old building - basement

**Distress:** Failing

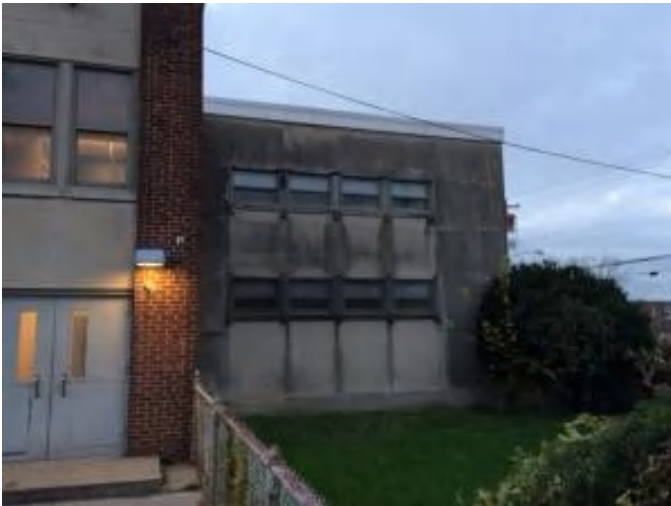
**System: B2010 - Exterior Walls**

**Location:** old building - exterior plaster wall

**Distress:** Failing

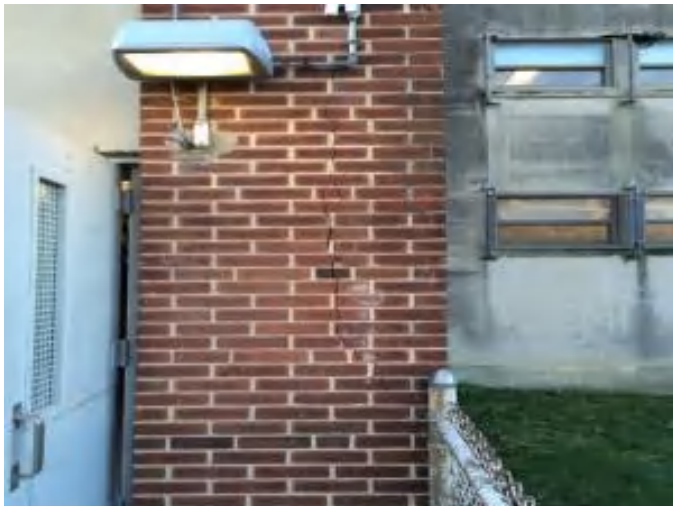
**System: B2010 - Exterior Walls**

**Location:** old building - brick walls

**Distress:** Damaged

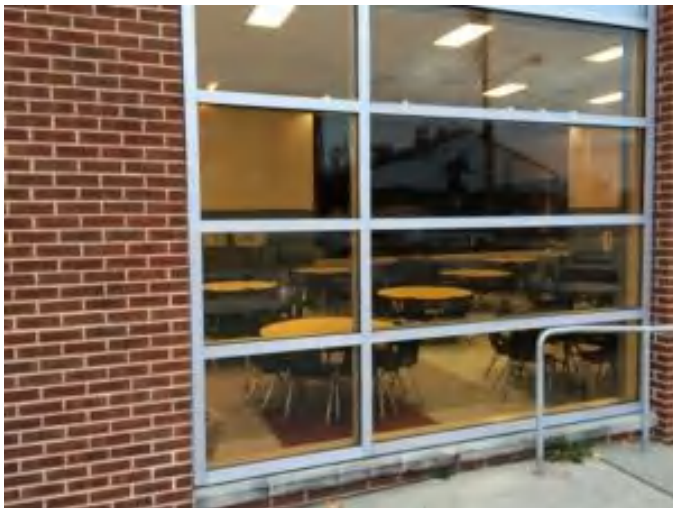
**System: B2010 - Exterior Walls**

**Location:** brick walls

**Distress:** Appearance

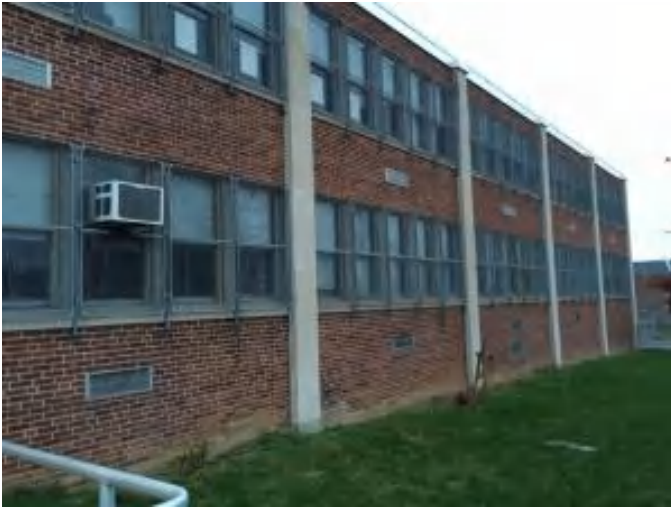
**System: B2010 - Exterior Walls**

**Location:** old building - lintels

**Distress:** Failing

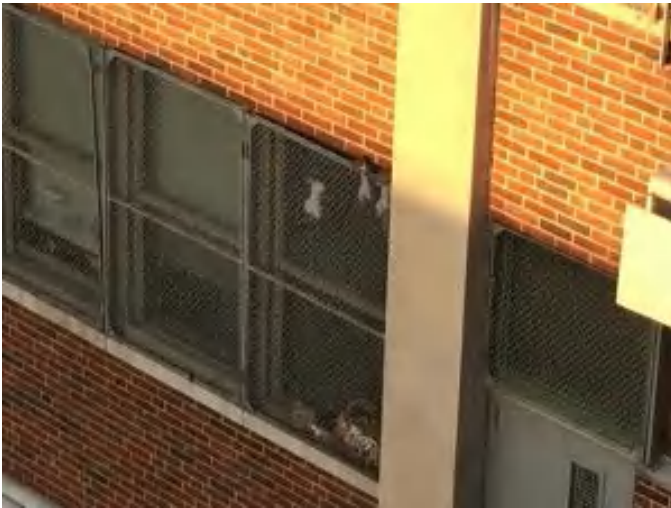
**System: B2020 - Exterior Windows**

**Location:** old building - windows

**Distress:** Beyond Service Life

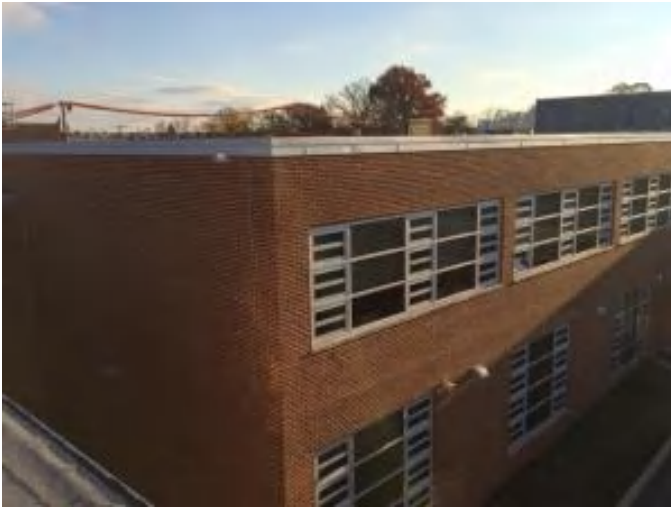
**System: B2020 - Exterior Windows**

**Location:** new building - windows facing playground

**Distress:** Security Issue

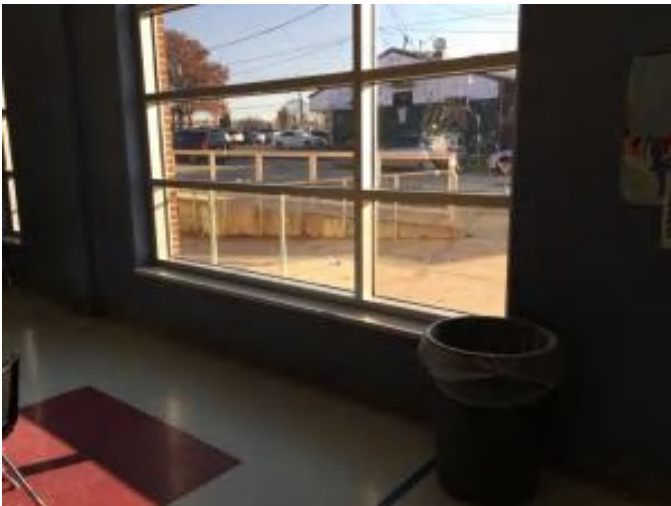
**System: B2020 - Exterior Windows**

**Location:** new building - cafetorium window

**Distress:** Damaged

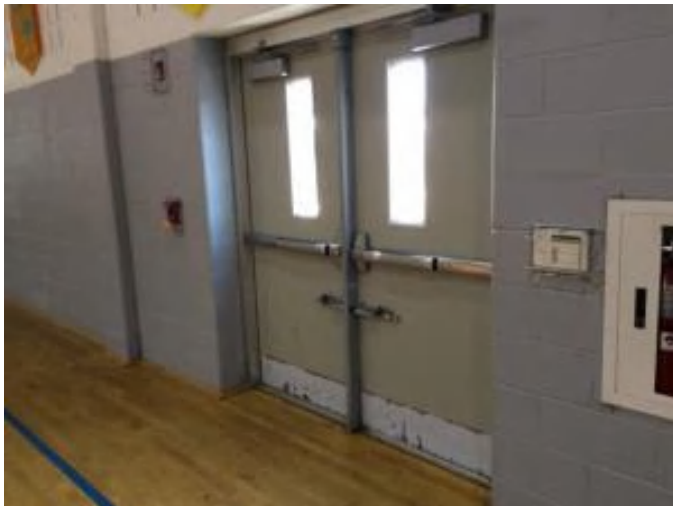
**System: B2030 - Exterior Doors**

**Location:** exterior doors

**Distress:** Failing

Repaint all exterior metal doors and metal frames; replace all weatherstripping (18 3x7)

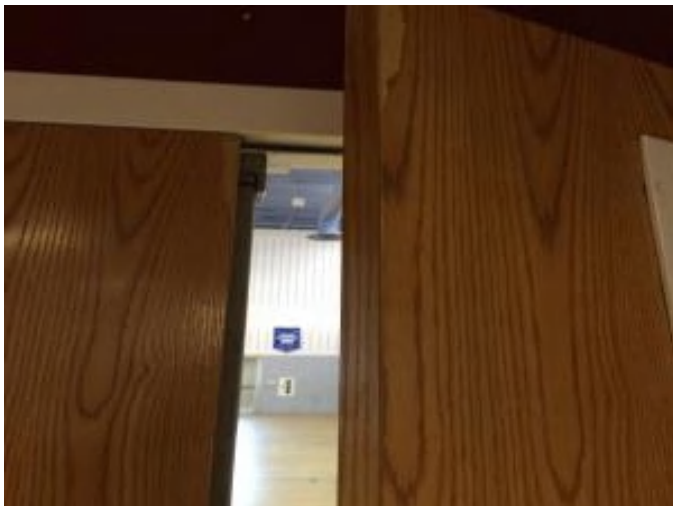
**System: C1020 - Interior Doors**

**Location:** new building - gym doors

**Distress:** Damaged

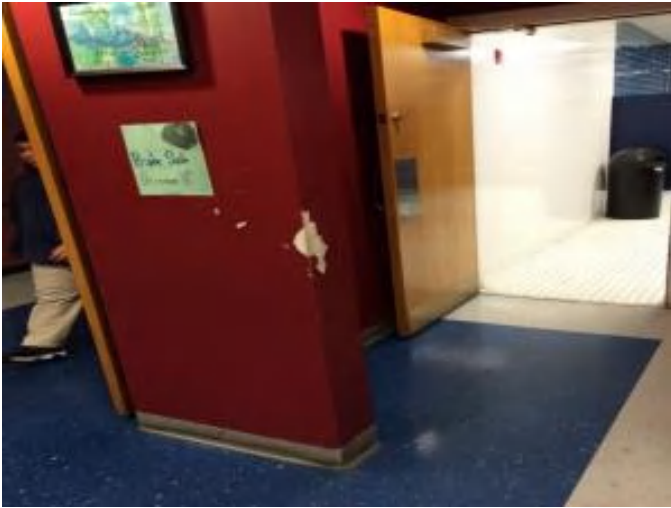
**System: C3010230 - Paint & Covering**

**Location:** new building walls

**Distress:** Damaged

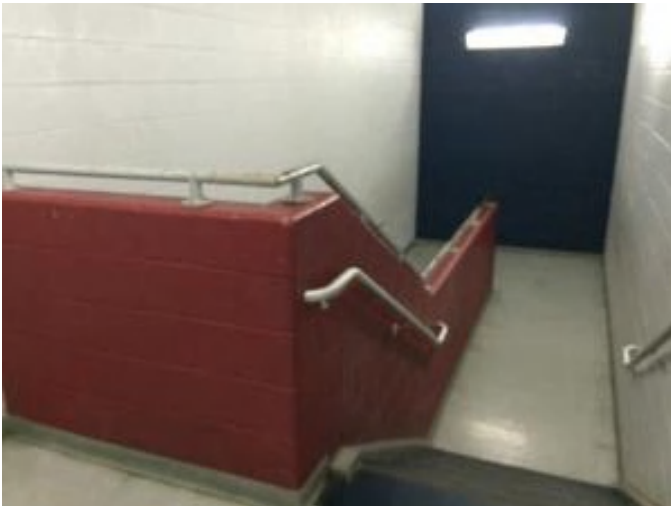
**System: C3020413 - Vinyl Flooring**

**Location:** floors

**Distress:** Damaged

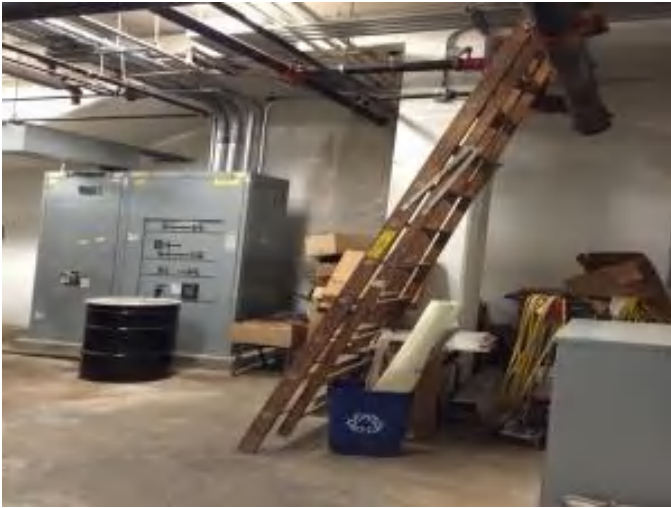
**System: C3020415 - Concrete Floor Finishes**

**Location:** old building - basement

**Distress:** Appearance

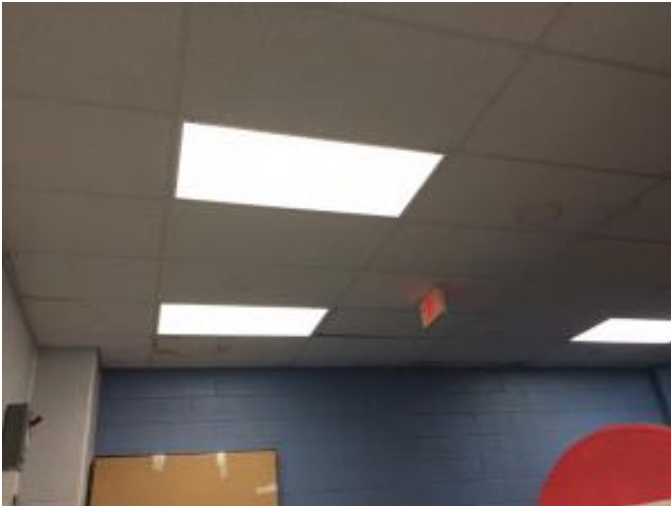
**System: C3030 - Ceiling Finishes**

**Location:** new building - ceilings

**Distress:** Damaged

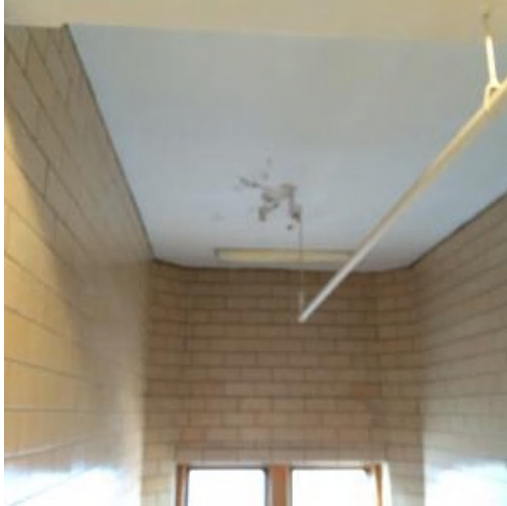
**System: C3030 - Ceiling Finishes**

**Location:** old building - ceilings

**Distress:** Failing

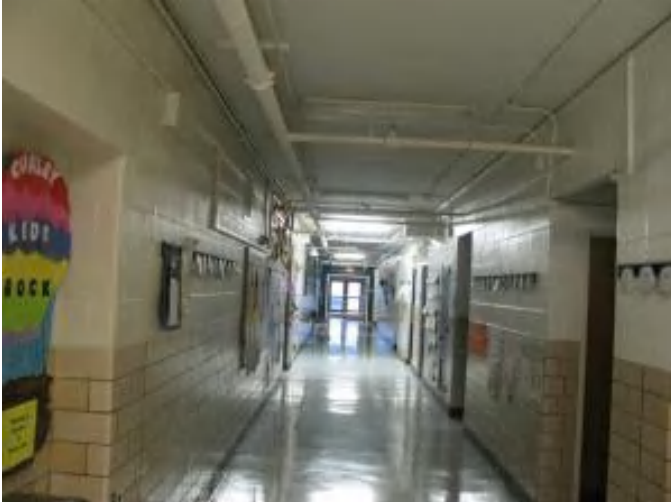
**System: D3040 - Distribution Systems**

**Location:** Corridors

**Distress:** Life Safety / NFPA / PFD

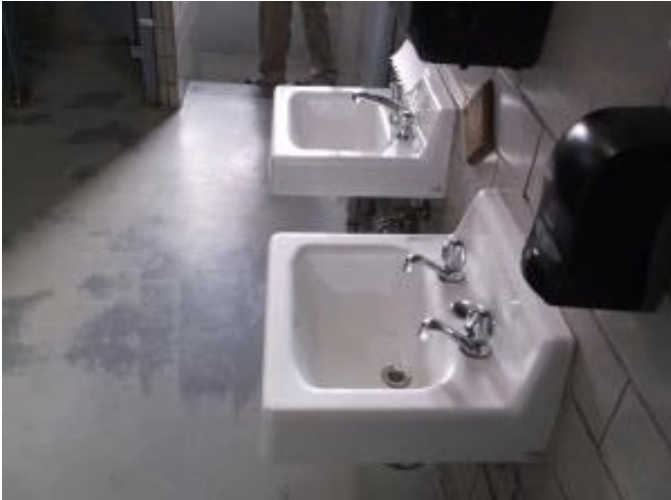
**System: D2010 - Plumbing Fixtures**

**Location:** Restrooms - Old Building

**Distress:** Beyond Service Life

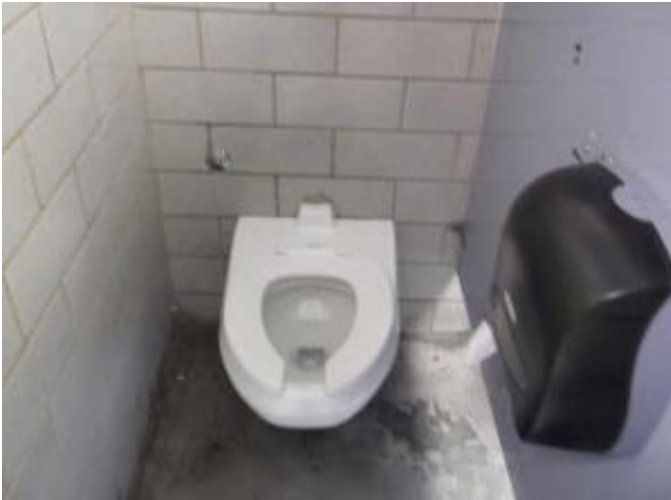
**System: D2010 - Plumbing Fixtures**

**Location:** Restrooms - Old Building

**Distress:** Beyond Service Life

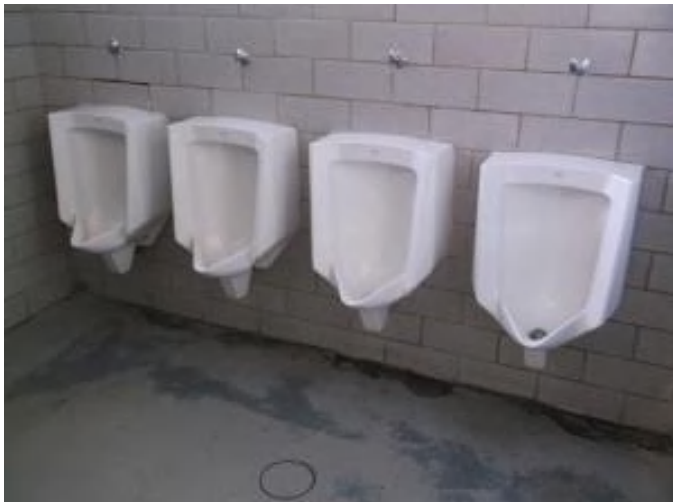
**System: D2010 - Plumbing Fixtures**

**Location:** Restrooms - Old Building

**Distress:** Beyond Service Life

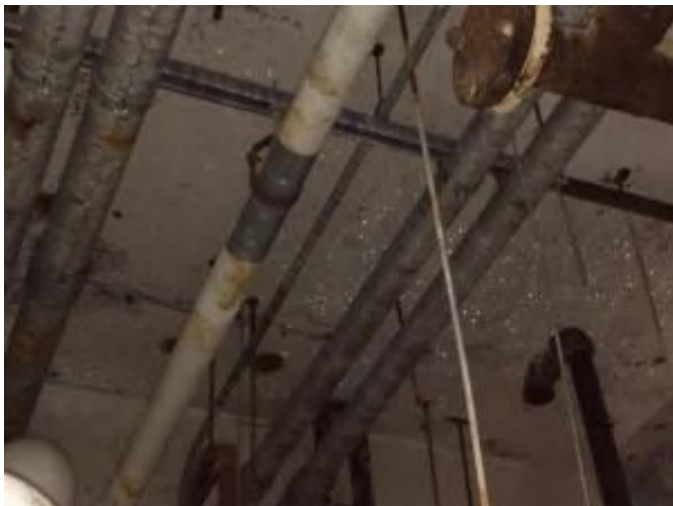
**System: D2020 - Domestic Water Distribution**

**Location:** Old Building

**Distress:** Beyond Service Life

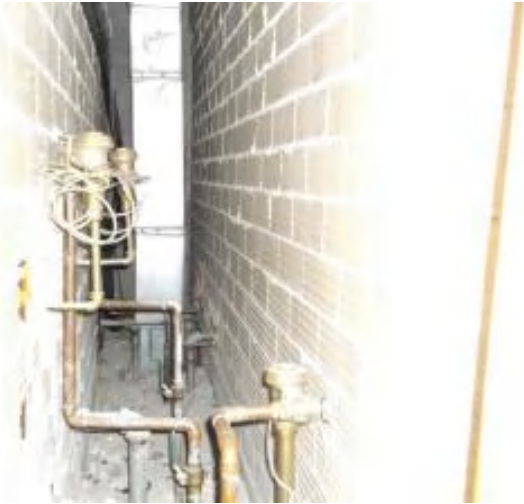
**System: D2030 - Sanitary Waste**

**Location:** Old Building

**Distress:** Beyond Service Life

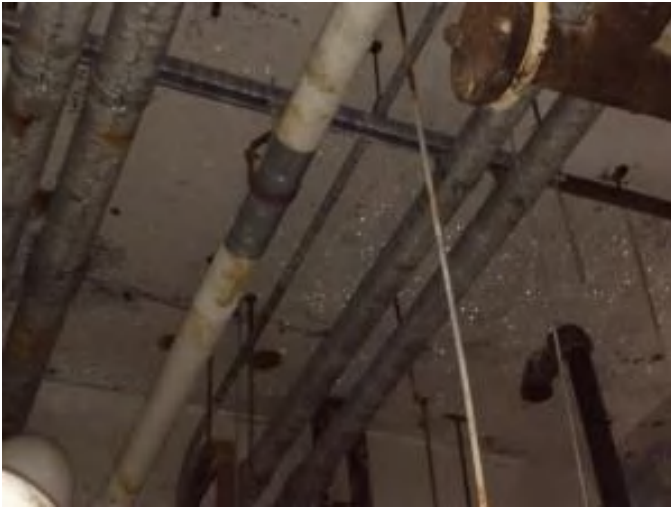
**System: D2040 - Rain Water Drainage**

**Location:** Old Building

**Distress:** Beyond Service Life

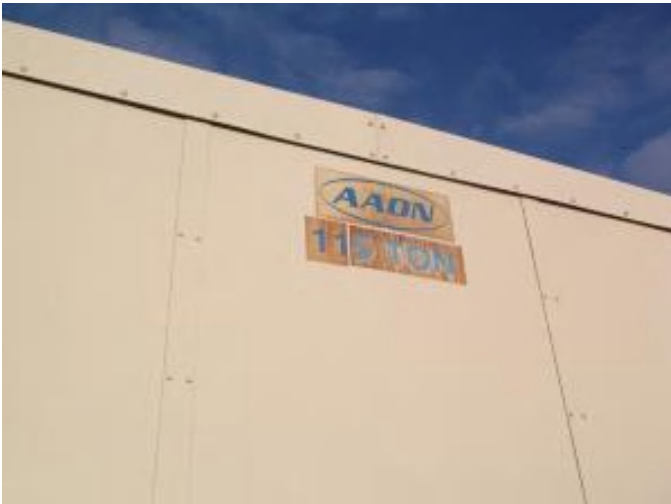
**System: D3030 - Cooling Generating Systems**

**Location:** Old Building

**Distress:** Inadequate

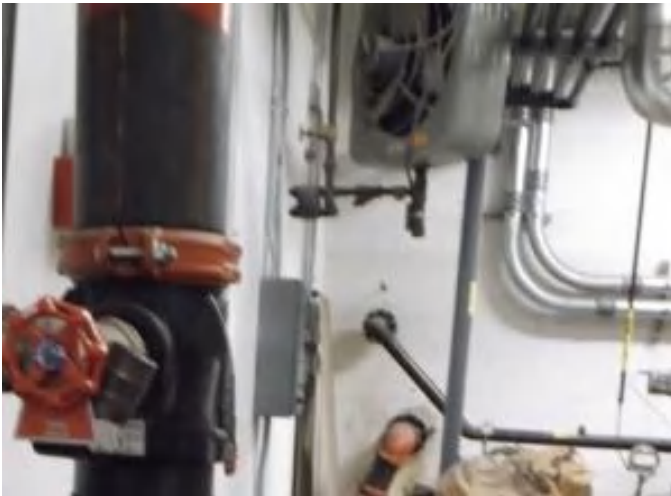
**System: D3040 - Distribution Systems**

**Location:** Old Building

**Distress:** Beyond Service Life

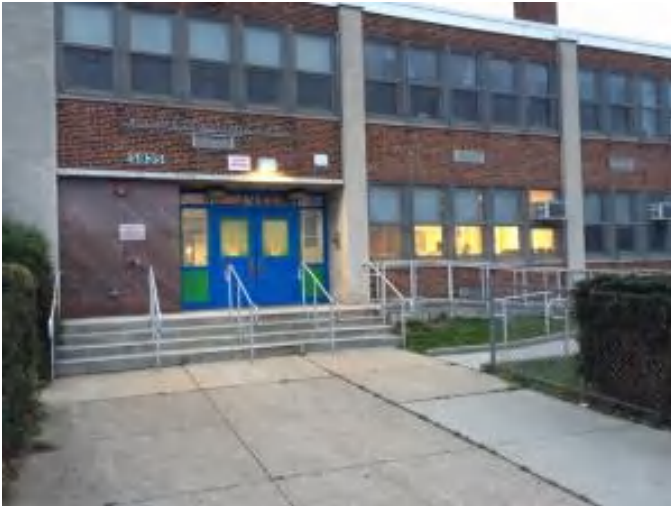
#### System: G2030 - Pedestrian Paving

**Location:** sidewalks

**Distress:** Damaged

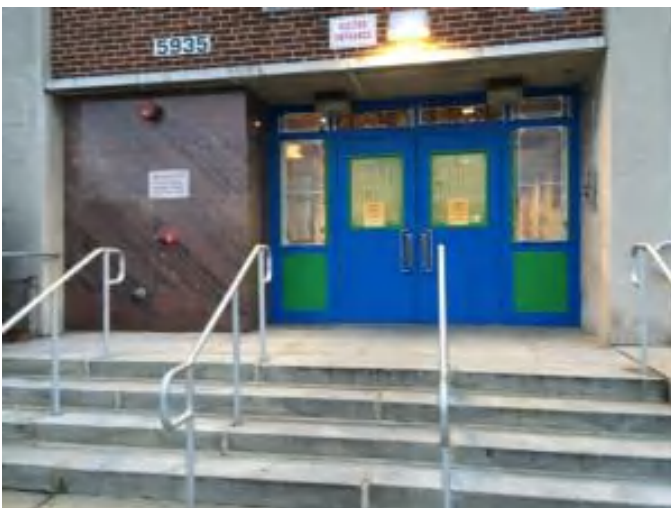
#### System: G2030 - Pedestrian Paving

**Location:** front stairs

**Distress:** Failing

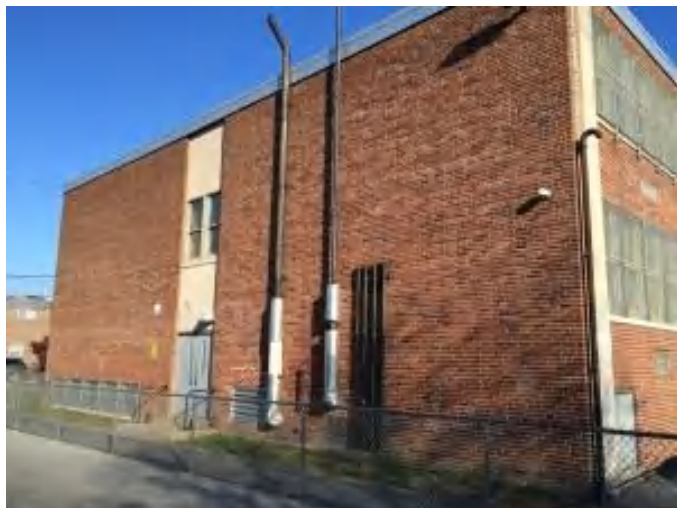
**System: G2040 - Site Development**

**Location:** site fence

**Distress:** Failing
