Ethan Allen Elementary School

6329 Battersby, Philadelphia, PA 19149

Scope Determination Report For New Addition & Major Renovation

January 08, 2017

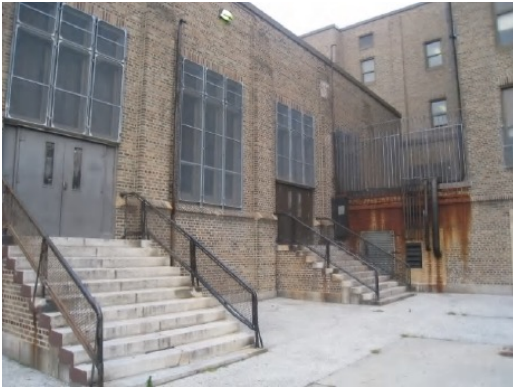
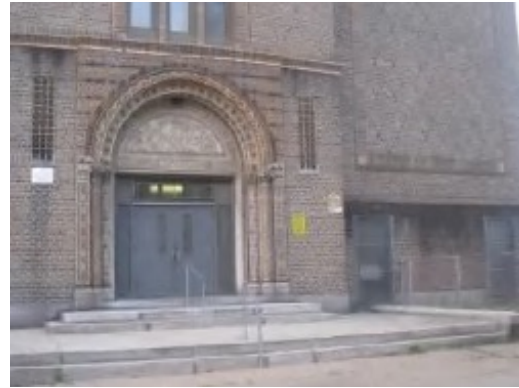
Exterior Doors

- 1) Replace all exterior steel doors, frames and hardware to be ADA compliant
- 2) Remove rust from steel security bars @ fire exit stairs and repaint.

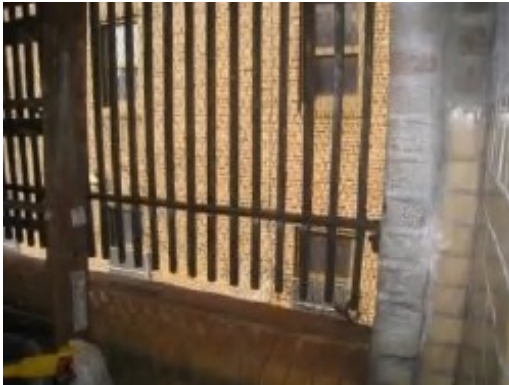
Steel Security Bars & Stair Tower

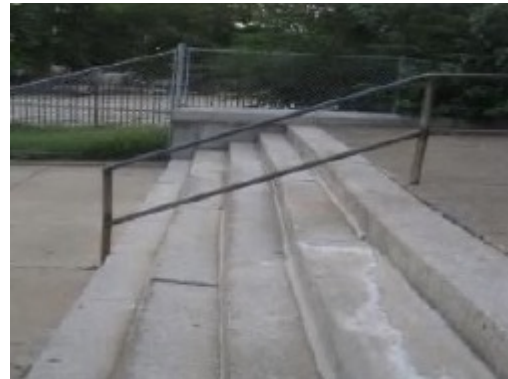
Stone Treads & Risers

- 7) Remove and replace cracked and broken 8" concrete curb at front, (Approx. 80 l.f.)
- 8) Regrout all joints between limestone block tread/risers at exterior stairs (60 risers @ 10ft average length)

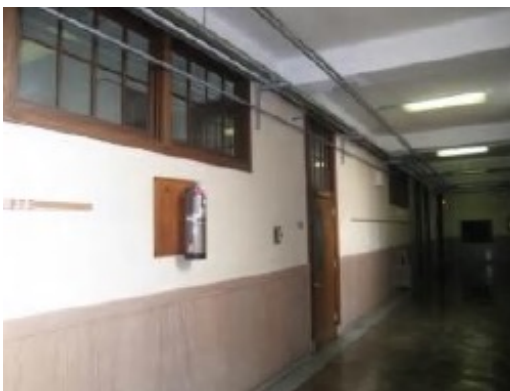
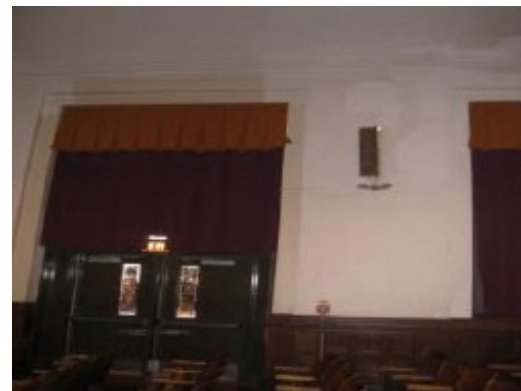
Damaged Plaster Walls & Ceilings

- 1) Patch, repair and paint damages and cracks in plaster walls at bathroom ceilings and auditorium walls and ceilings throughout. (Approx. 1800 s.f.)

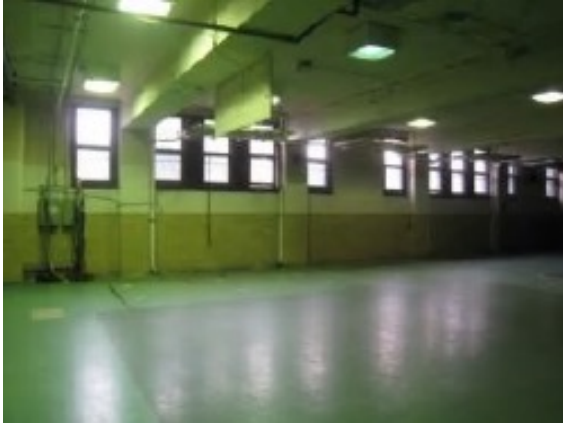
Cafeteria /Gym

The cafeteria has ample size to seat the capacity of students. A double serving line needs to be installed along the north side of the cafeteria. Currently, the serving line is set up in the kitchen, where there is only one exit.

- 1) Install (2) new ADA compliant concrete ramps at cafeteria both sides (28'x5' ramp, 5'-6"x5'-6" landing).
- 2) Remove basketball hoops and hardware and patch, repair and paint damages.
- 3) Remove existing VAT & VCT flooring in cafeteria. Grind existing concrete floor and polish.
- 4) Paint walls above brick wainscot & ceilings (Approx. 4000 s.f.). Scrape loose paint on ceilings, (Approx. 80 SF) patch and repair.
- 5) Install hand washing sink.
- 6) Replace water fountain with new ada fountain.
- 7) Serving line equipment shall consist as the following:
 - a. (2) Milk Cabinets
 - b. (2) Hot Food Serving Counters
 - c. (4) Cold Food Serving Counters

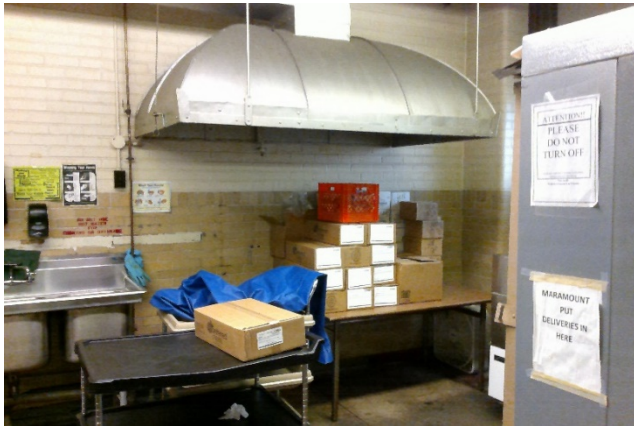
The existing kitchen currently performs as a limited service kitchen. There is no Ansul system, ventilation system or air conditioning system. There are existing exhaust hoods that are not operable. Provide a full service kitchen with dry and wet storage and an office space.

Kitchen Existing Exhaust

- 1) Remove existing exhaust hoods (2). Existing duct to remain.
- 2) Remove existing 3 compartment sink to be relocated. Cut and cap drain lines for reuse as required.

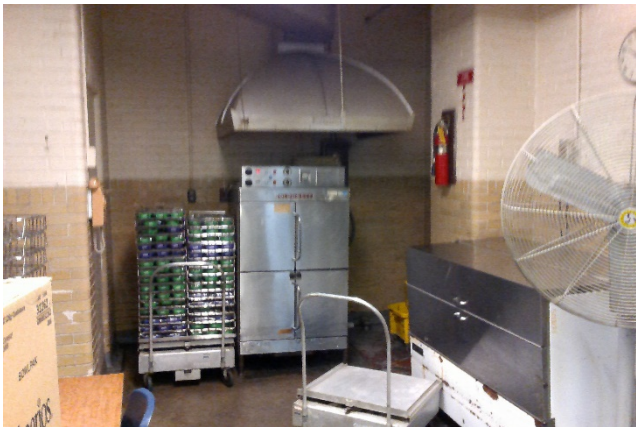
Kitchen Existing Exhaust & Convection Oven

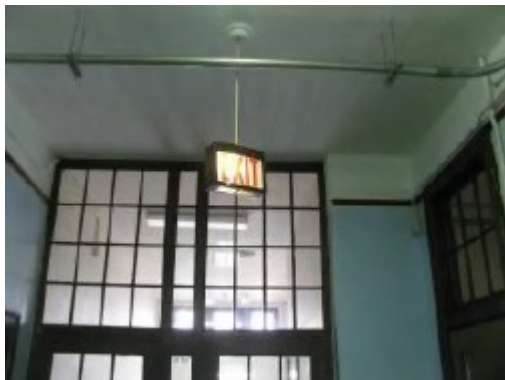
The existing building interior lighting system has mostly T12 fluorescent lights. The gym and cafeteria have high intensity discharge lights. The exterior lighting is a mixture of LED's and HID's. The exit signs are incandescent type.

Exit Signs

- 1) Replace all incandescent exit signs with white thermoplastic LED exit signs and connect to generator source.
- 2) Replace lighting fixtures with new LED lighting fixtures throughout the existing building and provide occupancy sensors in classrooms and offices to comply with energy code. Provide timeclock for hallways, stairs, and exterior lights. Provide generator power to sufficient number of lights in egress path to provide illumination as required by code.
- 3) Replace the exterior HID's with LED's equipped with integral photocells.
- 4) Provide new LED's in new addition with dimmer controls in classrooms.

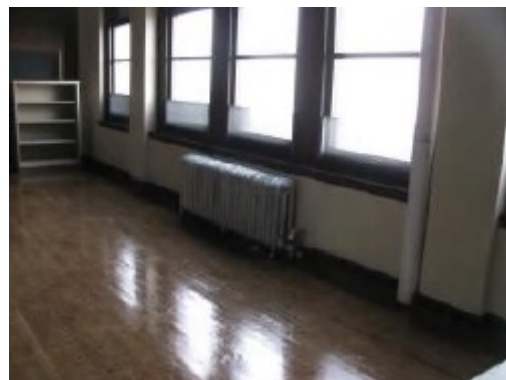
Insufficient Classroom Receptacles & Data

The existing classrooms only have 2 CAT5E jacks in a single gang box. Wireless access points were installed in classrooms.

- 4) Modernize classroom with sufficient power receptacles per school district classroom minimum receptacle layout.

- 1) Provide telecommunication upgrades including CAT 6 connections in existing classrooms based on school district classroom minimum layout.
- 2) Provide 3 CAT6 connections at each new workstation.
- 3) Construction documents and specifications shall adhere to school IT design guideline and specifications.
- 4) The contractor shall be responsible for installation of conduits, cables, patch panels, racks and including all terminations and labeling.
- 5) The design consultant shall provide floor plans, riser and specifications.
- 6) Classroom phones connections to stay.
