Richmond Elementary School

Addition and Major Renovation

Scope Determination Report

April 16, 2017

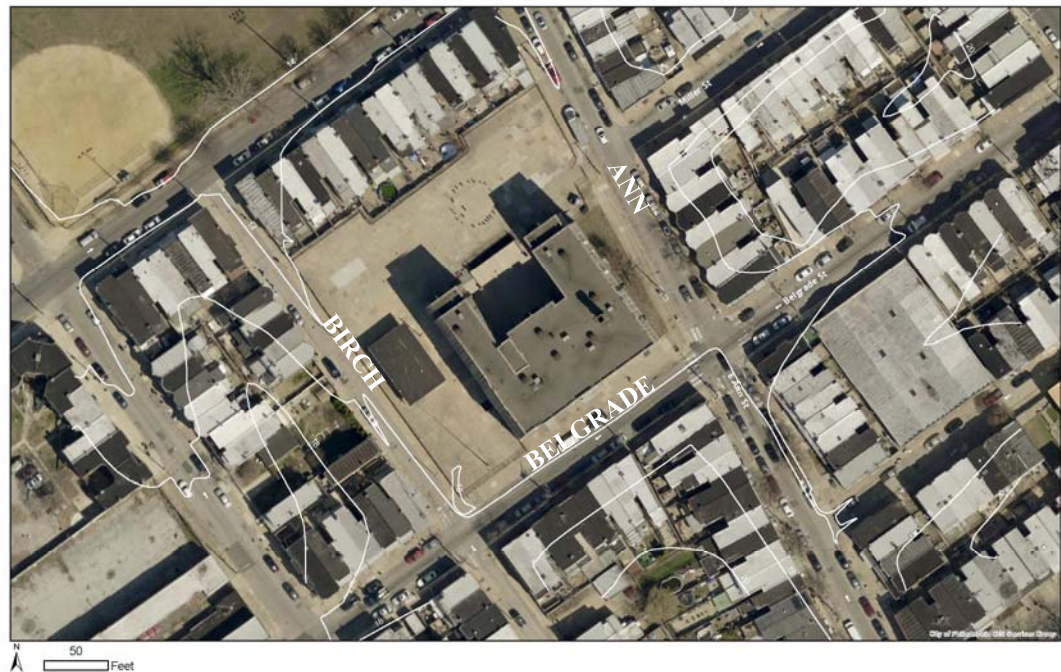
The site is currently concrete and contains the main school building footprint along with one modular building along the western edge of the building. The modular building contains one classroom and appears to be on concrete piers. There is one active utility pole located between the modular building and the main school building. Concrete appears to be in good condition throughout with cracking and spalling in select squares. Dumpsters are located along E. Ann Street. Perimeter fence is ornamental and approximately 4' in height along Birch and E. Ann Streets, terminating at the main building and completely enclosing the yard. The fence contains 3 gates (one at each street, Birch, Belgrade, and Ann), each in good condition, operable, and lockable. The rear fence borders adjacent row-home backyards and is approximately 6' in height, comprised of chainlink, and mounted on a low concrete cheek wall. The chainlink fence in the rear yard, while not aesthetically pleasing, appears to be in good condition. The low concrete wall contains paintings by the students. The rear yard appears to be used most frequently for recess and is located to the north of the main school building.

The scope of work includes demolition of the existing modular building and construction of the new addition to house 6 classrooms and a cafeteria. In order to avoid triggering stormwater management regulations with the construction of the addition the total site disturbance, including removal of modular building, construction of addition, and site disturbance due to construction activities, should be limited to less than 15,000 sf. Assumptions for the site scope include, at a minimum, the following items:

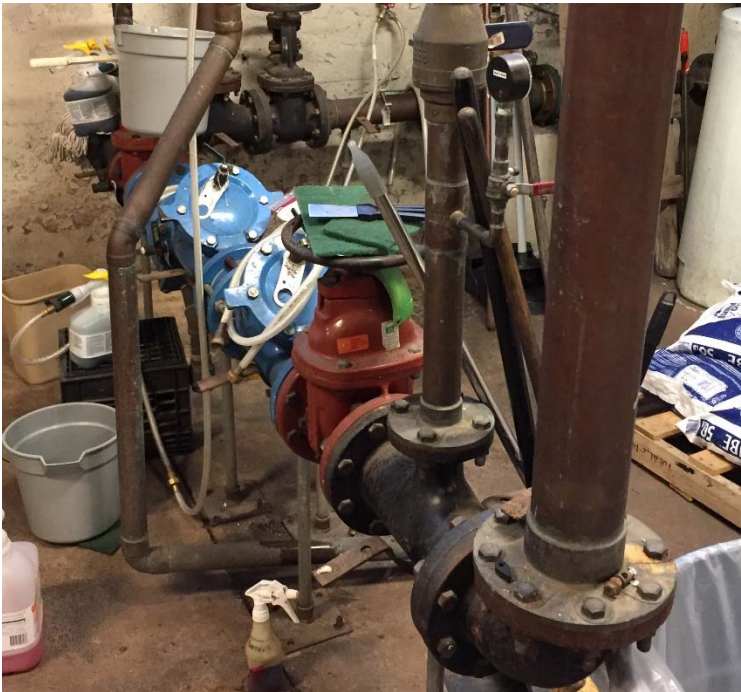
- a. Backflow preventers: Watts 909 simplex installation condition good
- b. Recommendation: No action

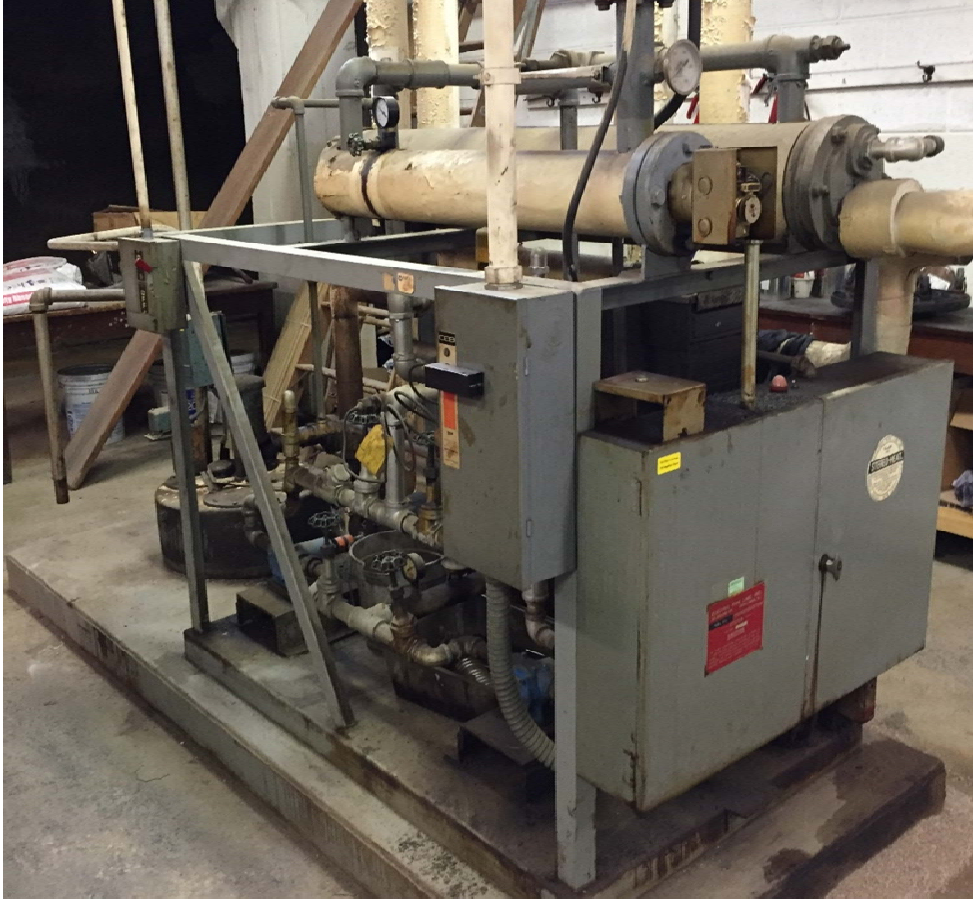
- a. Fuel oil pump set: Unit is original to oil conversion. System is operational with no evidence of leakage.
- b. Fuel oil tank: Tank is indoor, single wall, 8,000 gallon unit. No evidence of leakage.
- c. Recommendation: No action required at this time. During boiler replacement provide 5k/g UST and new pump set.

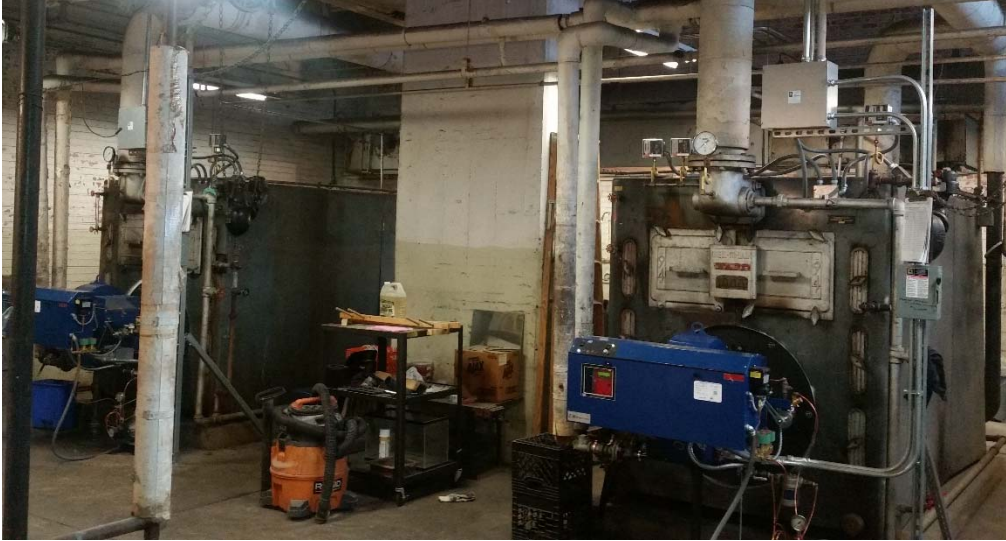
- a. Boilers: Existing boilers are operational and have been re-burnered within the past five years.
- b. Recommendations: No action required at this time. Replace with dual fuel units during plant replacement

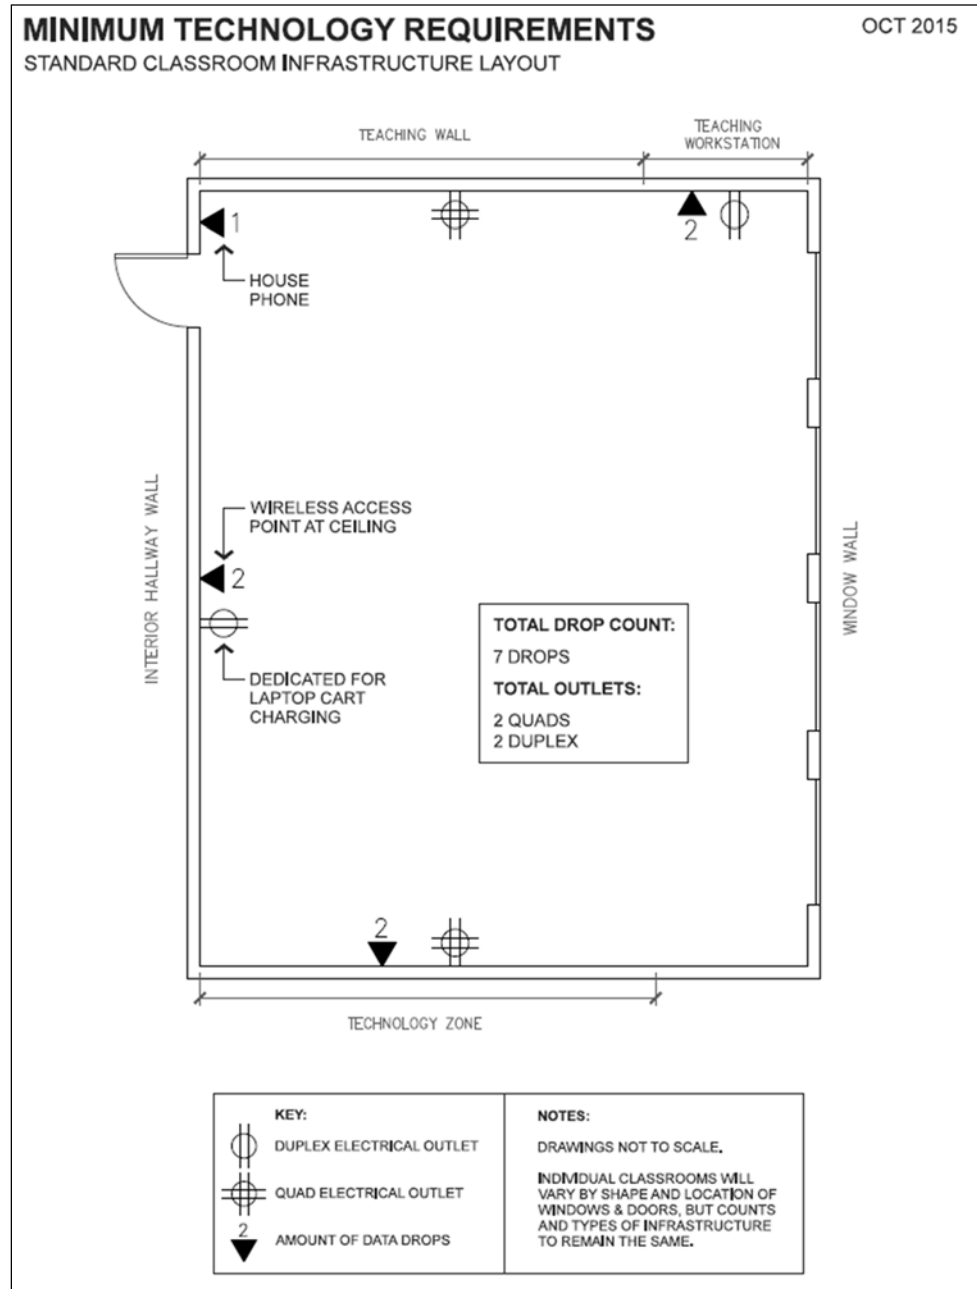
- a. The existing quantity of power receptacles and data receptacles is not sufficient.

- a. Provide additional power and data receptacles. The optimum solution would be to meet Minimum School District technology requirement, specifically at classrooms in the Addition (see image below). Provide as many receptacles as possible in the existing classrooms where electric loads and service size allows it.
