School District of Philadelphia

# **S820001;Allen, Ethan**

## **Site Assessment Report**

January 31, 2017

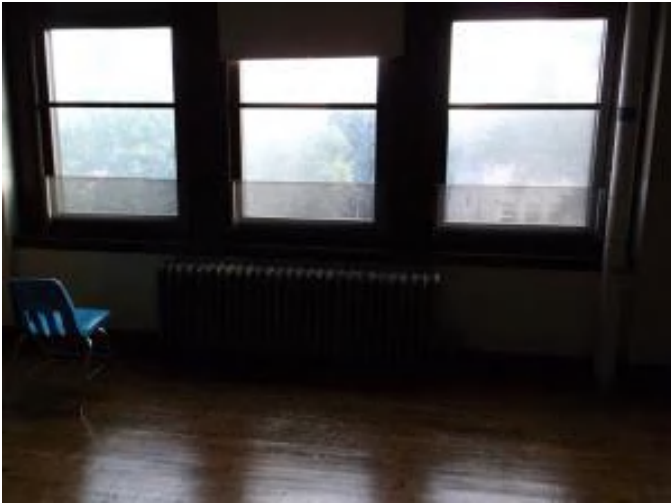
**System: D3040 - Distribution Systems**

**Location:** Throughout the building

**Distress:** Beyond Service Life

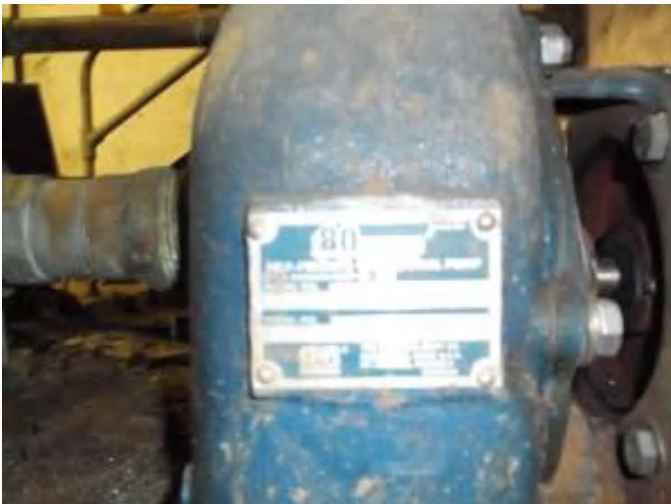
**System: D3040 - Distribution Systems**

**Location:** Throughout the building

**Distress:** Beyond Service Life

**Notes:** Conduct a steam trap survey to identify and replace failed traps passing live steam into the condensate piping system.

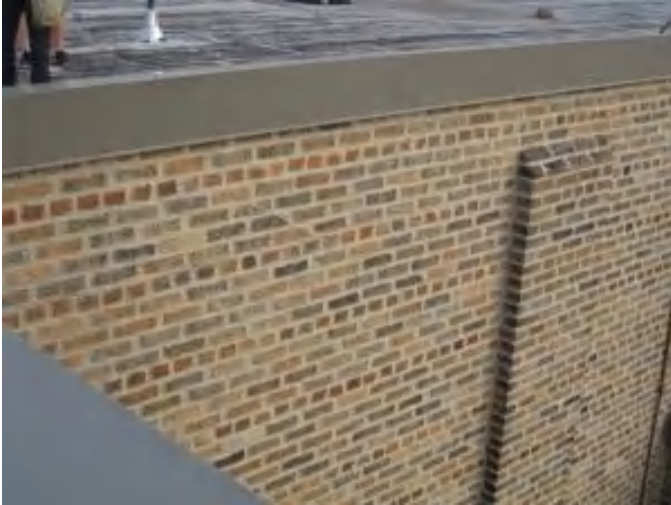
**System: B2010 - Exterior Walls**

**Location:** all exterior basement windows and some upper walls

**Distress:** Building Envelope Integrity

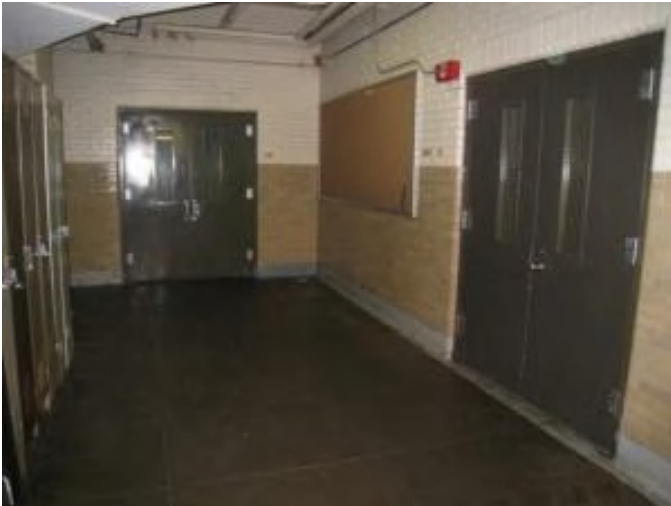
**System: C1020 - Interior Doors**

**Location:** basement doors

**Distress:** Beyond Service Life

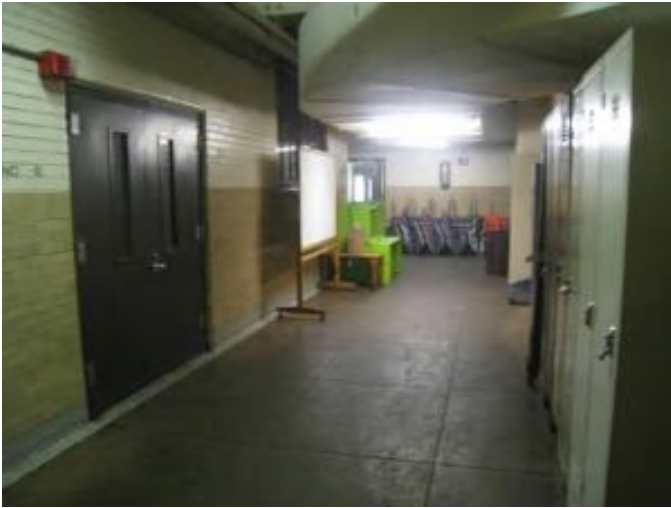
**System: C3020415 - Concrete Floor Finishes**

**Location:** basement mech rooms and all stairs

**Distress:** Appearance

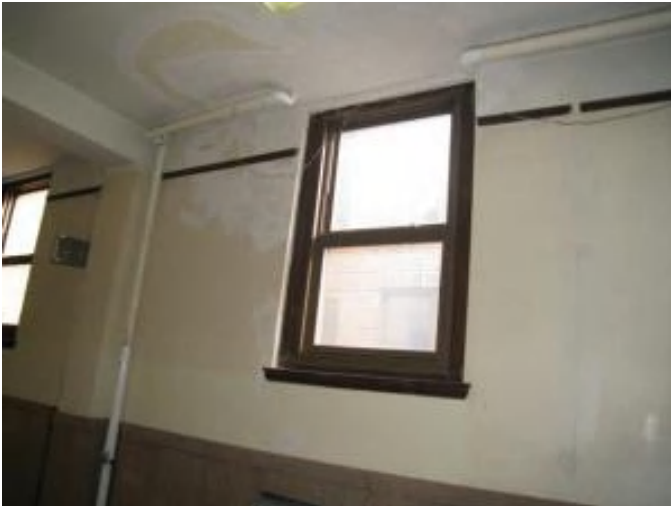
**System: C3030 - Ceiling Finishes**

**Location:** ceilings

**Distress:** Damaged

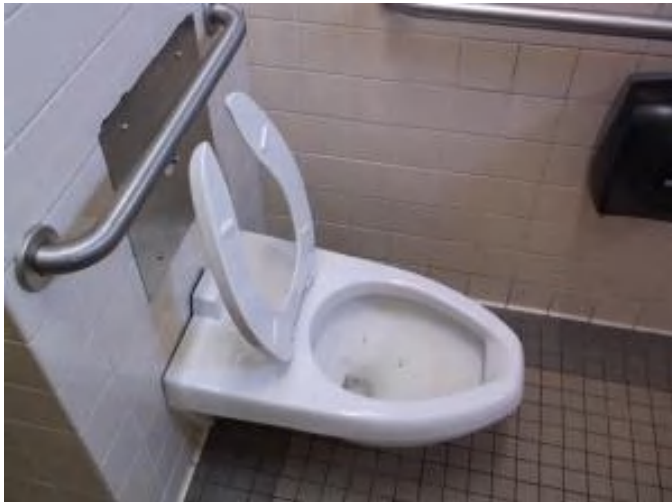
**System: D2010 - Plumbing Fixtures**

**Location:** Throughout the building

**Distress:** Beyond Service Life

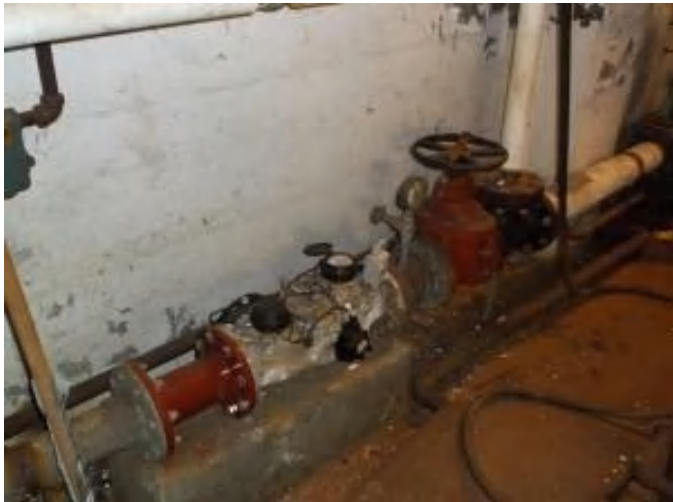
**System: D2020 - Domestic Water Distribution**

**Location:** Throughout the building

**Distress:** Beyond Service Life

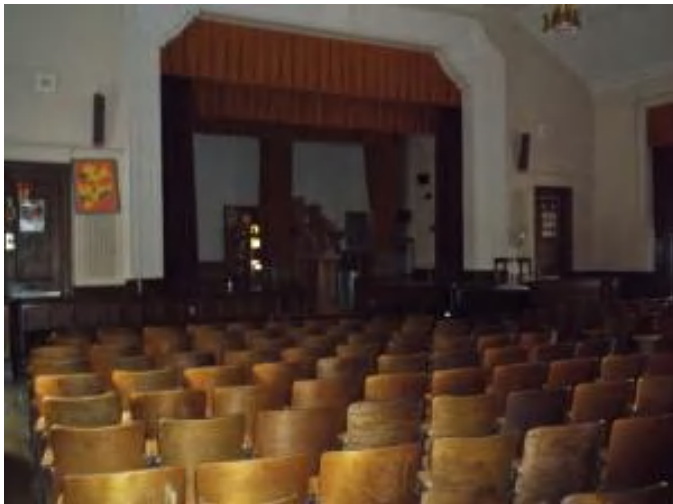
**System: D3040 - Distribution Systems**

**Location:** Auditorium

**Distress:** Beyond Service Life

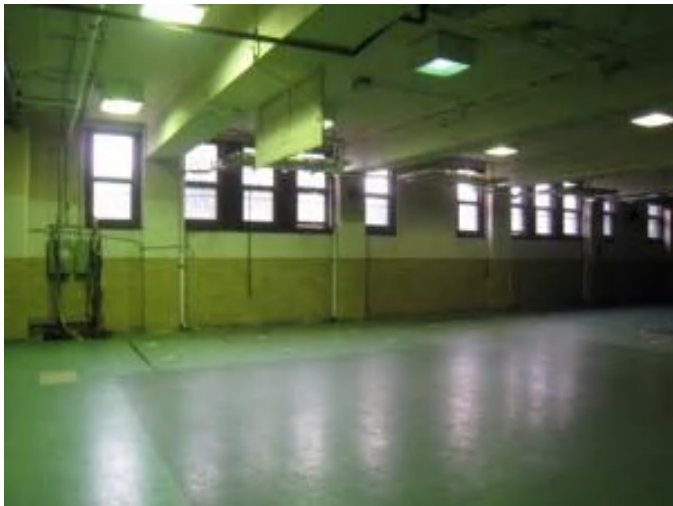
**System: D3040 - Distribution Systems**

**Location:** Gym

**Distress:** Beyond Service Life

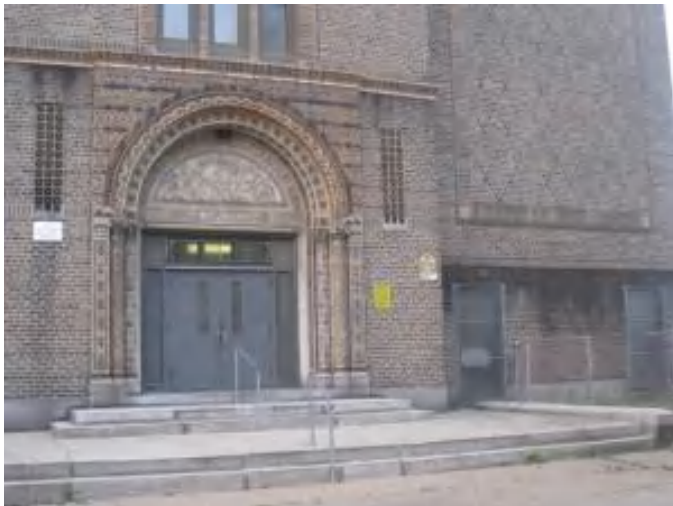
#### **System: G2030 - Pedestrian Paving**

**Location:** front door

**Distress:** Accessibility
