Facility Condition Assessment Summary Report

Swenson High School

School District of Philadelphia
S809001;Swenson
Final
Site Assessment Report
February 2, 2017

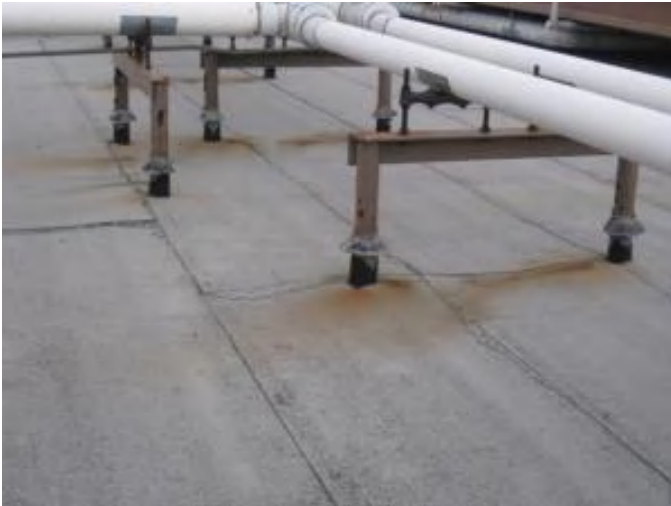
System: B3010105 - Built-Up

Location: roof

Distress: Damaged

Notes: Repair bubbles in roof membrane (50 major bubbles @ 10sf each area + small bubbles = 1000sf)

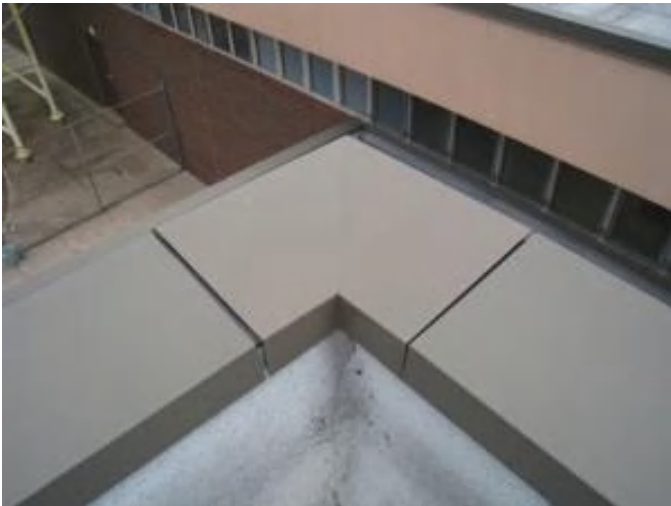
System: B3010105 - Built-Up

Location: roof

Distress: Failing

Notes: Repair separating coping (12 pieces 100ft)

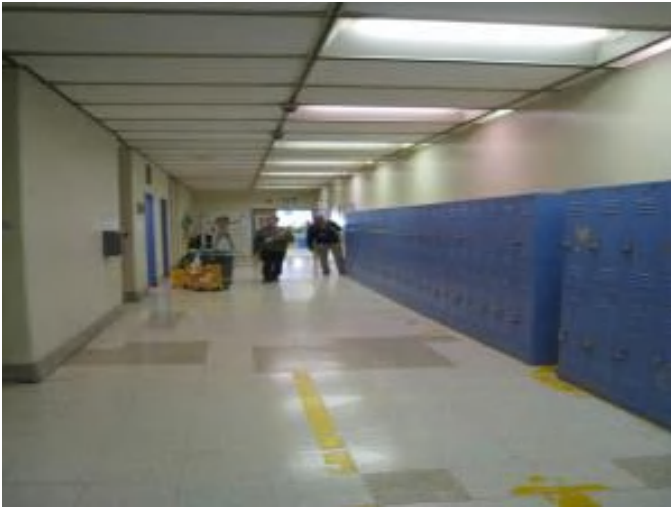
System: C1010 - Partitions

Location: 2nd floor

Distress: Building / MEP Codes

Notes: Replace second floor gypsum board corridor partitions with full height 1 hour fire rated gypsum board partitions (40,000sf)

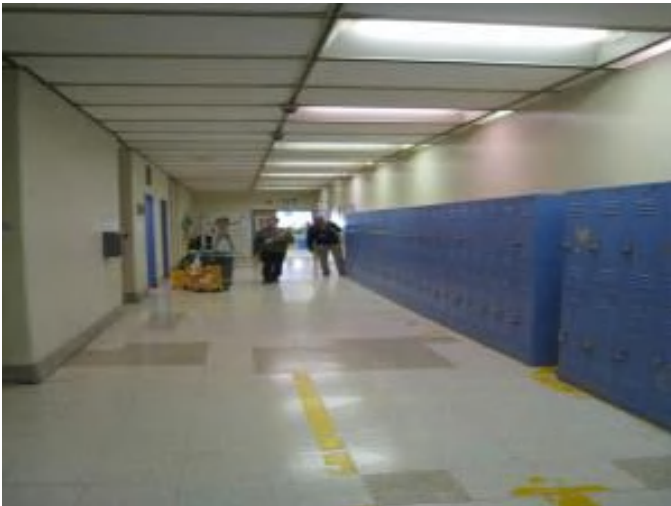
System: C1010 - Partitions

Location: 2nd floor corridor at Rm 216

Distress: Building / MEP Codes

Notes: Provide new fire rated gypsum board corridor to eliminate 65 ft dead end corridor at Classroom 216 (1500sf)

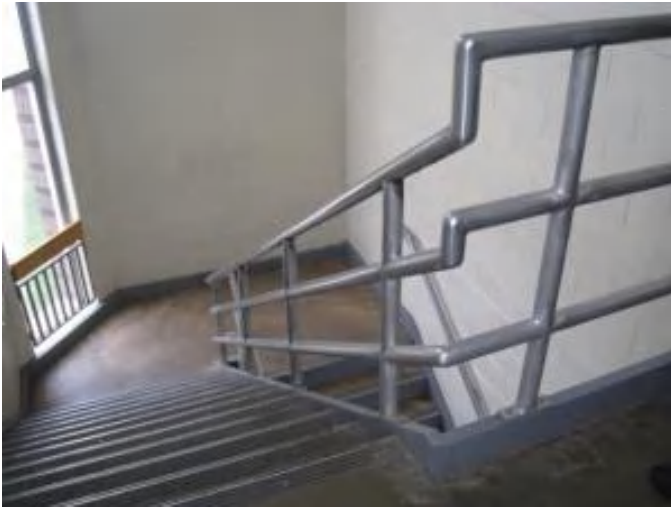
System: C2010 - Stair Construction

Location: stairs

Distress: Building / MEP Codes

Notes: New code compliant handrails, 4" spaced balusters, and guards on stairways (6 stairways) x 25ft handrail+guard = 150ft;. 25ft handrail on walls = 150ft, and 8ft guard at top of each stairway = 50ft.

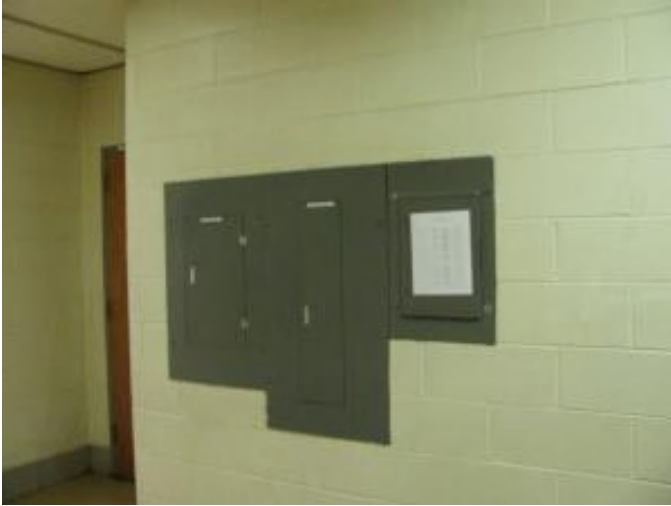
System: D5010 - Electrical Service/Distribution

Location: Entire Building

Distress: Beyond Service Life

Notes: Replace the entire distribution system with new panels and new wiring/conduits. Provide arc flash label on the electrical equipment. Estimated 20 panel boards.

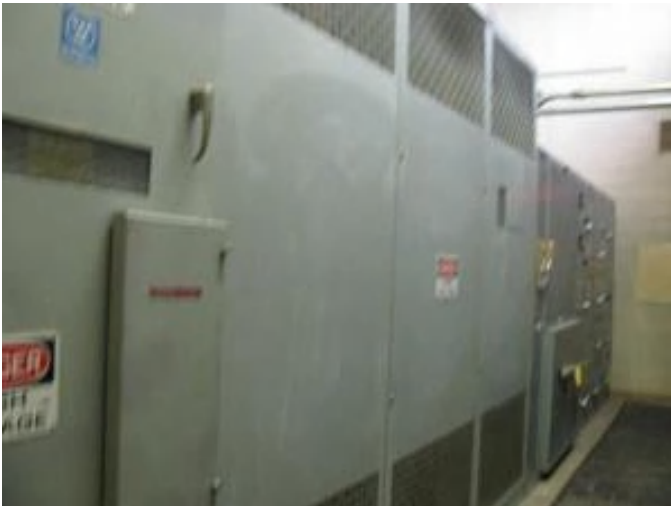
System: D5010 - Electrical Service/Distribution

Location: Main Electrical Room

Distress: Beyond Service Life

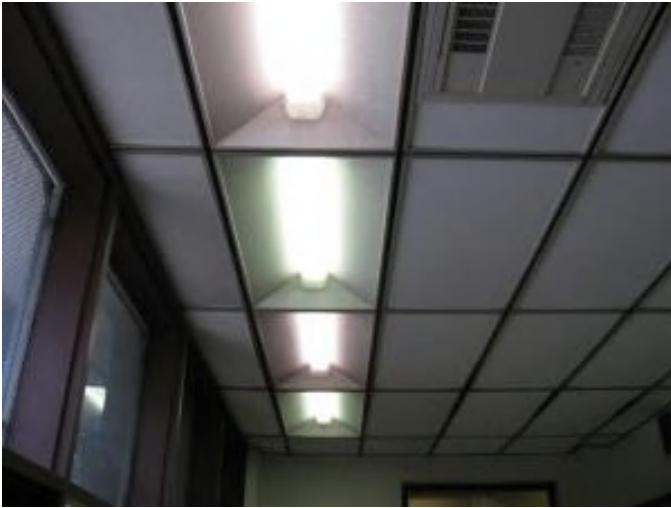
System: D5020 - Lighting and Branch Wiring

Location: Entire Building

Distress: Beyond Service Life

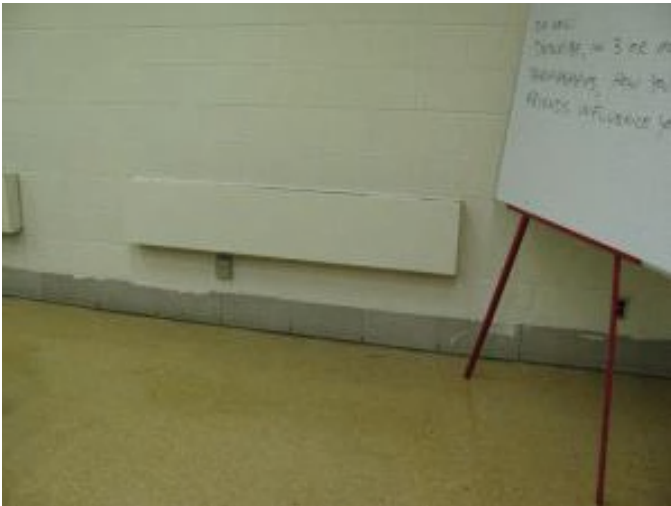
System: D5020 - Lighting and Branch Wiring

Location: Entire Building

Distress: Inadequate

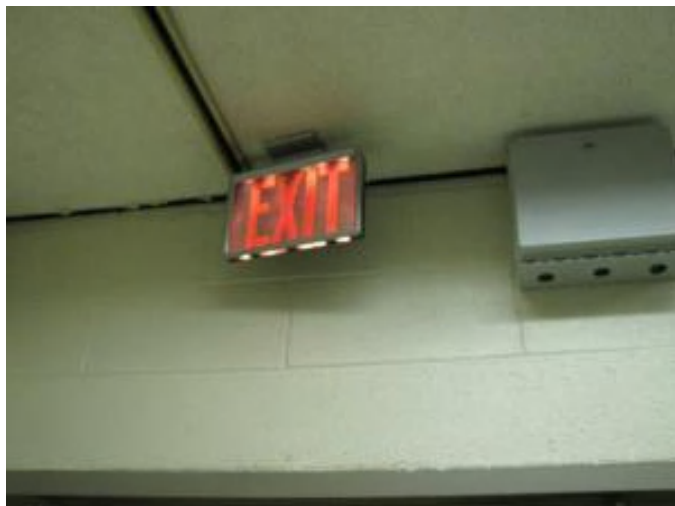
System: D5020 - Lighting and Branch Wiring

Location: Entire Building

Distress: Damaged

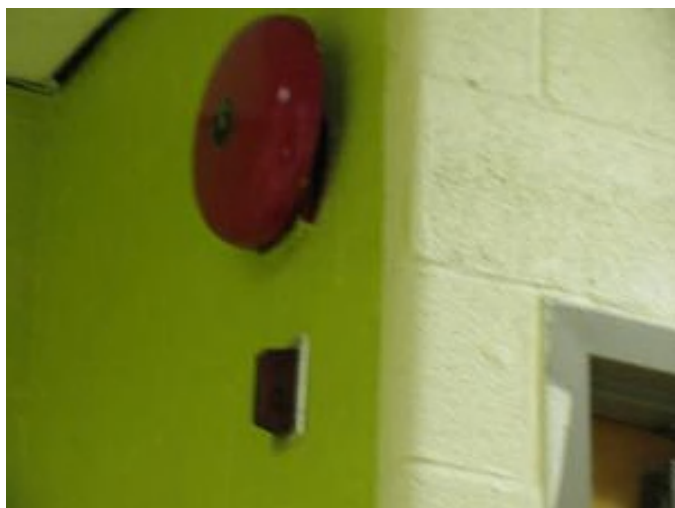
System: D5030 - Communications and Security

Location: Entire Building

Distress: Beyond Service Life

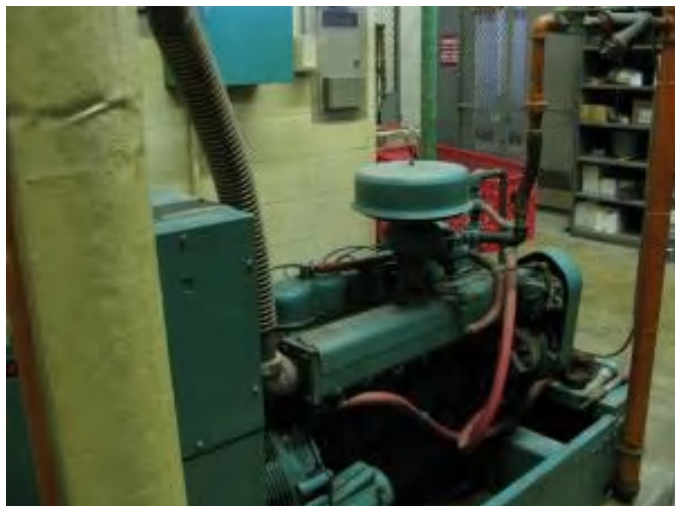
System: D5090 - Other Electrical Systems

Location: Basement

Distress: Life Safety / NFPA / PFD

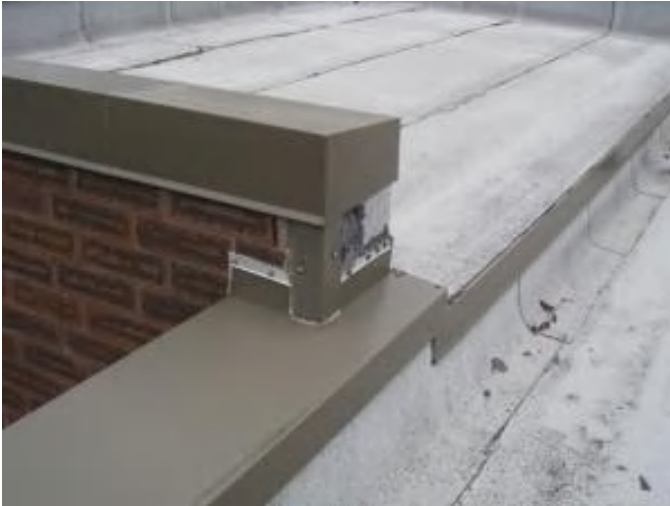
System: B2010 - Exterior Walls

Location: exterior

Distress: Failing

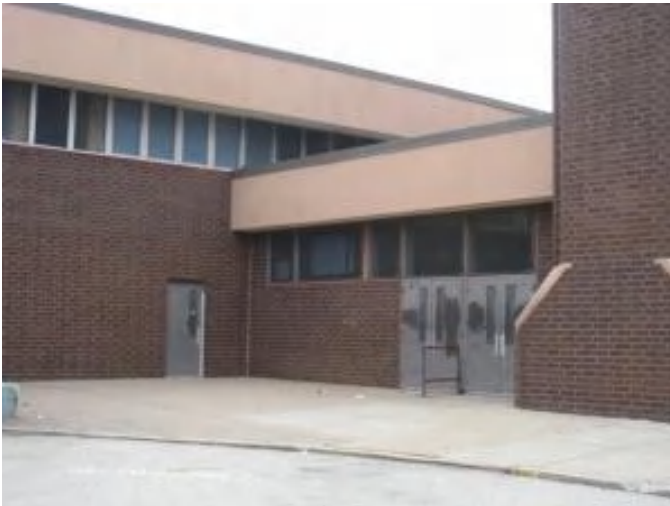
System: B2020 - Exterior Windows

Location: exeterior walls

Distress: Failing

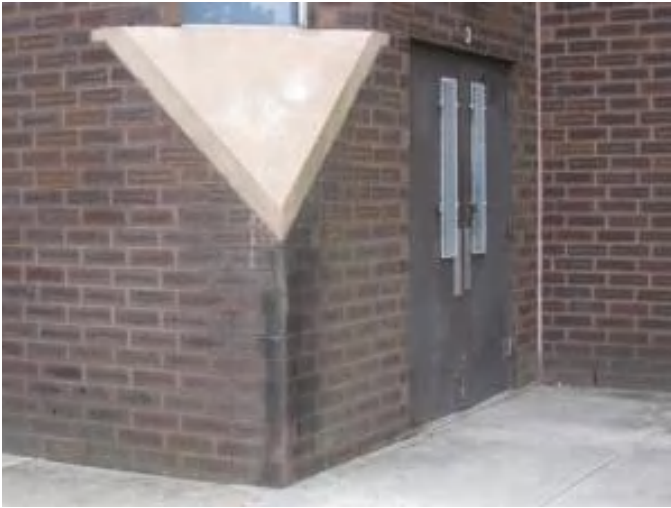
System: B2030 - Exterior Doors

Location: exterior walls

Distress: Beyond Service Life

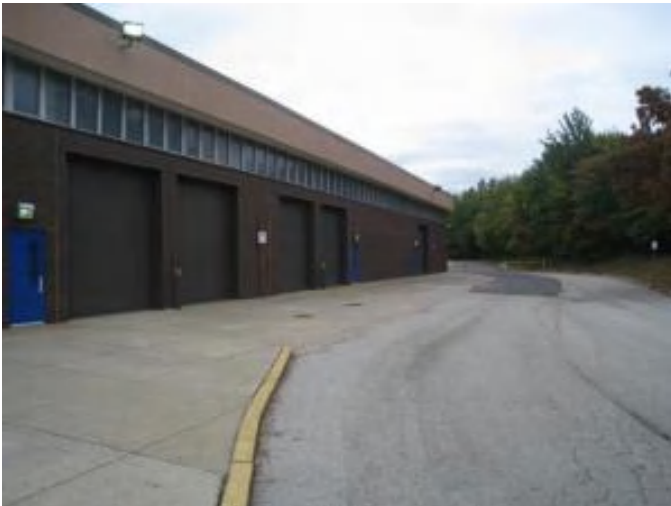
System: B2030 - Exterior Doors

Location: automobile, carpentry, masonry shop exter walls

Distress: Damaged

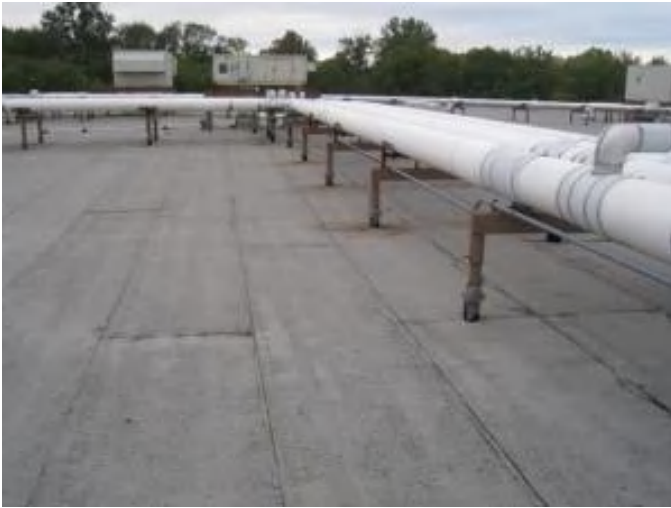
System: B3010105 - Built-Up

Location: roof

Distress: Failing

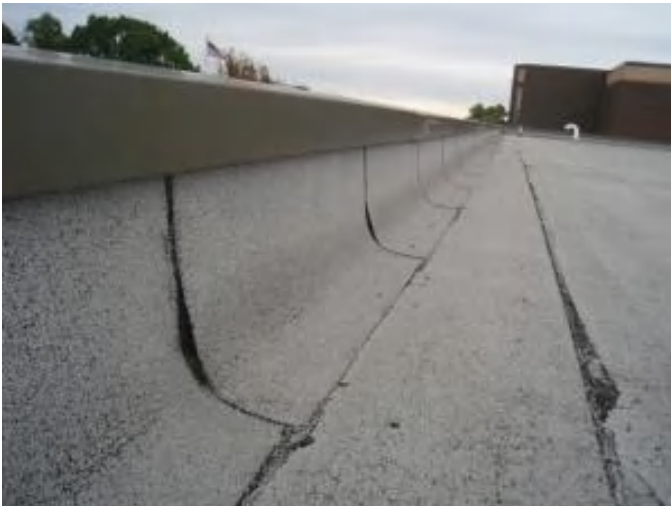
System: B3010105 - Built-Up

Location: roof

Distress: Failing

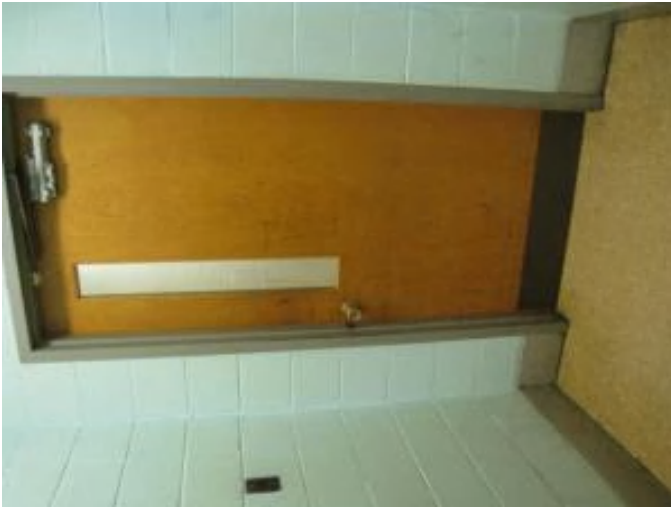
System: C1020 - Interior Doors

Location: corridors

Distress: Building / MEP Codes

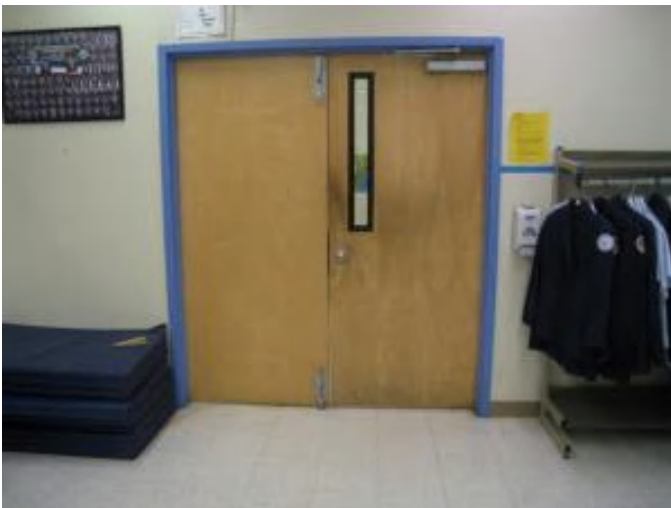
System: C1020 - Interior Doors

Location: interior room doors

Distress: Appearance

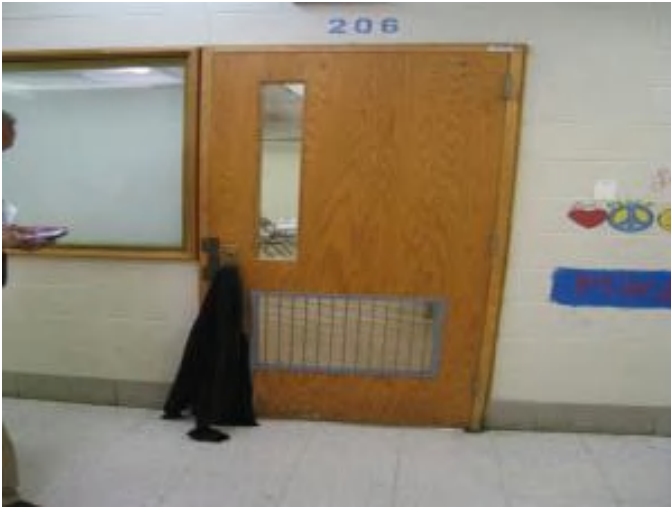
System: C1020 - Interior Doors

Location: corridor classroom and public spaces

Distress: Security Issue

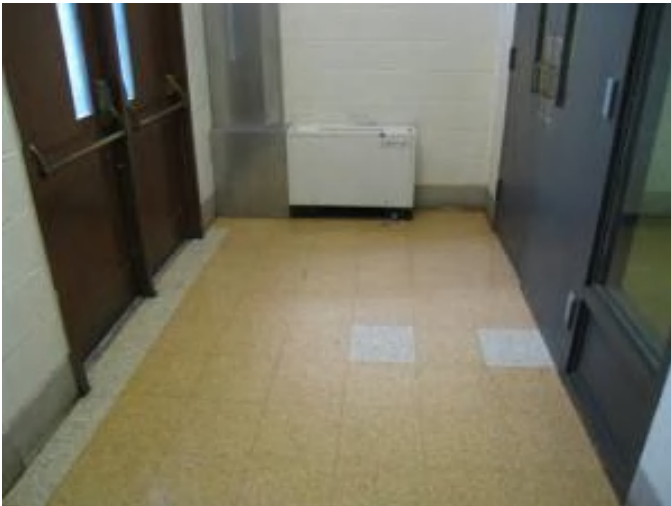
System: C1020 - Interior Doors

Location: mech room, stair doors

Distress: Appearance

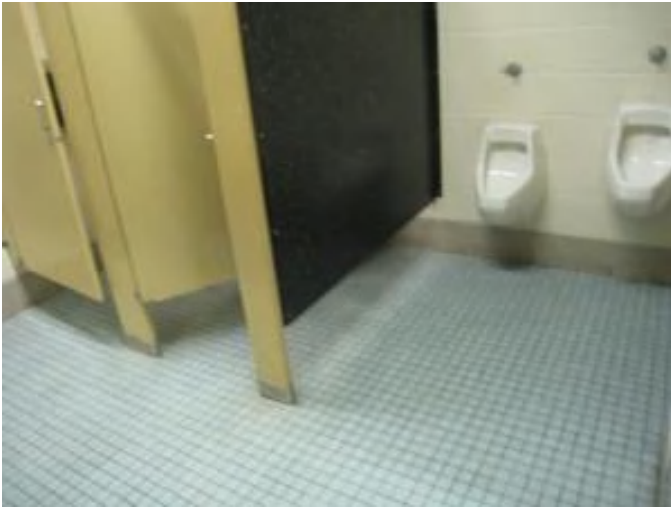
System: C1030 - Fittings

Location: toilet rooms

Distress: Damaged

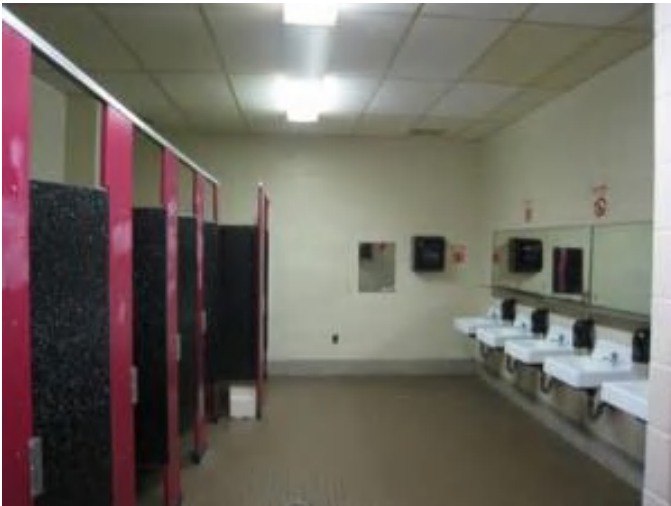
System: C1030 - Fittings

Location: toilet rooms

Distress: Damaged

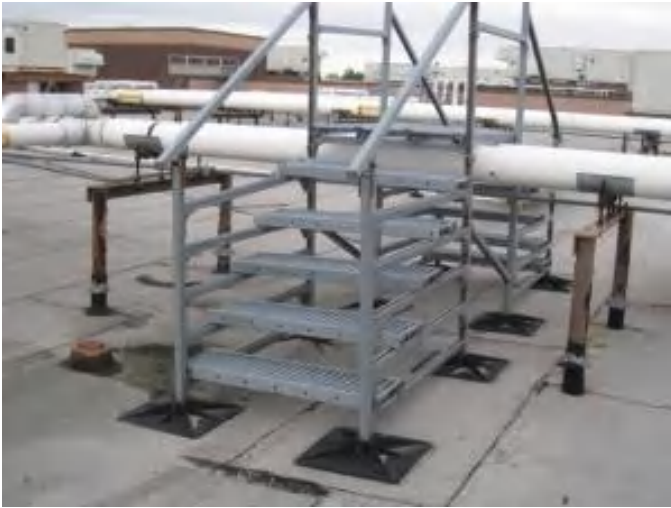
System: C3010230 - Paint & Covering

Location: roof top equipment (supports)

Distress: Damaged

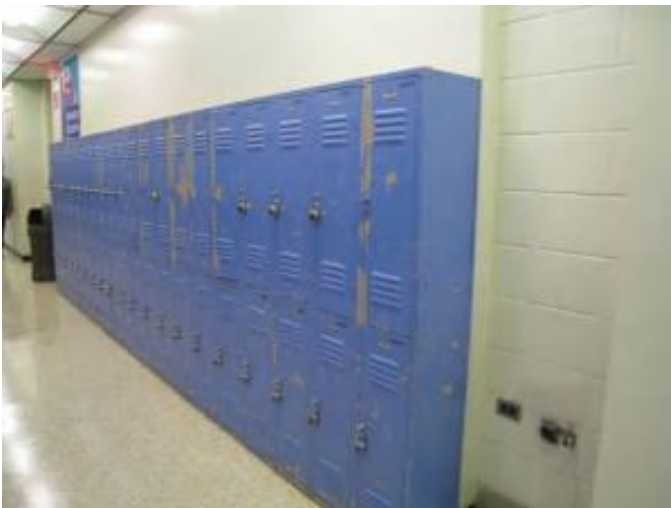
System: C3010230 - Paint & Covering

Location: corridors

Distress: Appearance

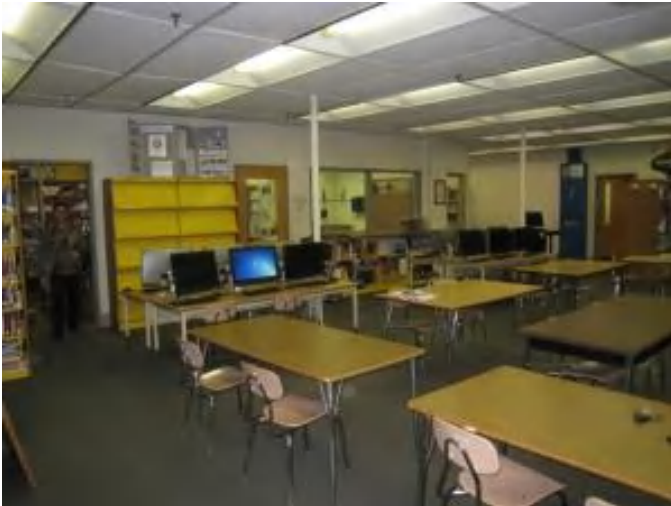
System: C3020411 - Carpet

Location: culinary arts and offices

Distress: Beyond Service Life

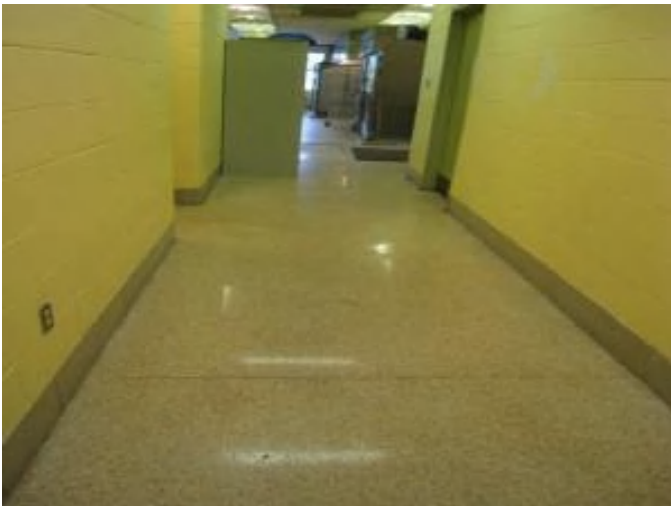
System: C3020412 - Terrazzo & Tile

Location: culinary kitchen areas

Distress: Damaged

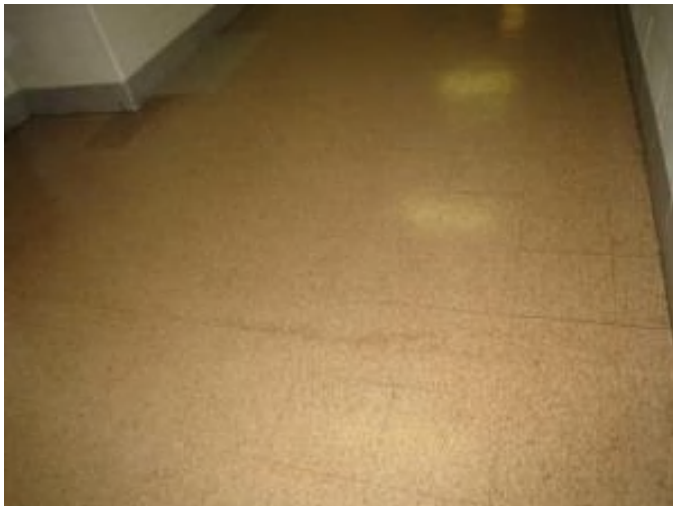
System: C3020413 - Vinyl Flooring

Location: interiors

Distress: Beyond Service Life

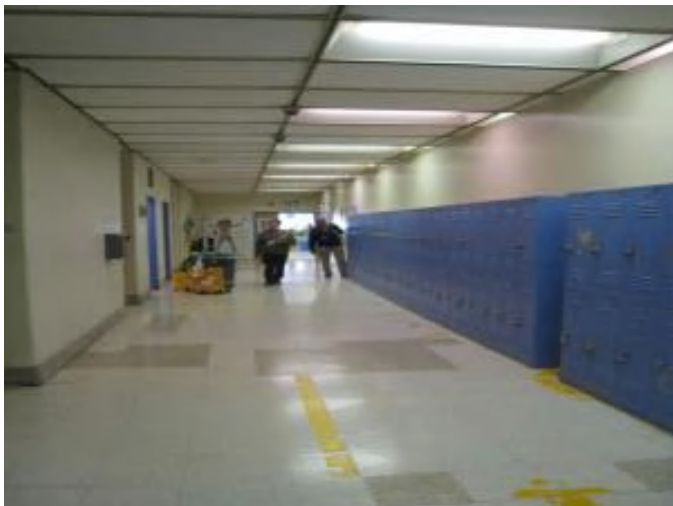
System: C3020415 - Concrete Floor Finishes

Location: upper (2nd) floor

Distress: Damaged

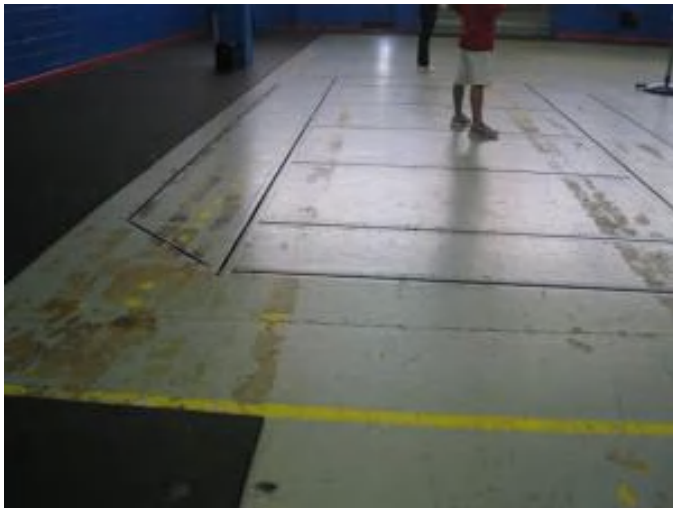
System: C3020415 - Concrete Floor Finishes

Location: automotive shop and gym

Distress: Damaged

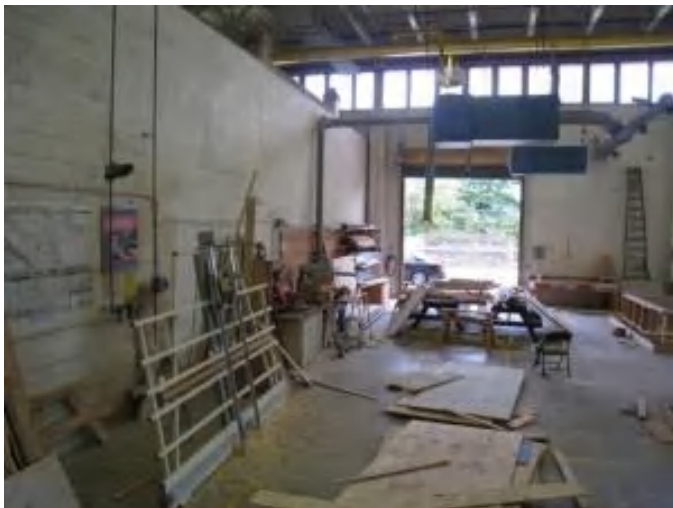
System: C3020415 - Concrete Floor Finishes

Location: stairways, masonry shop, carpentry, and general maintenance area

Distress: Appearance

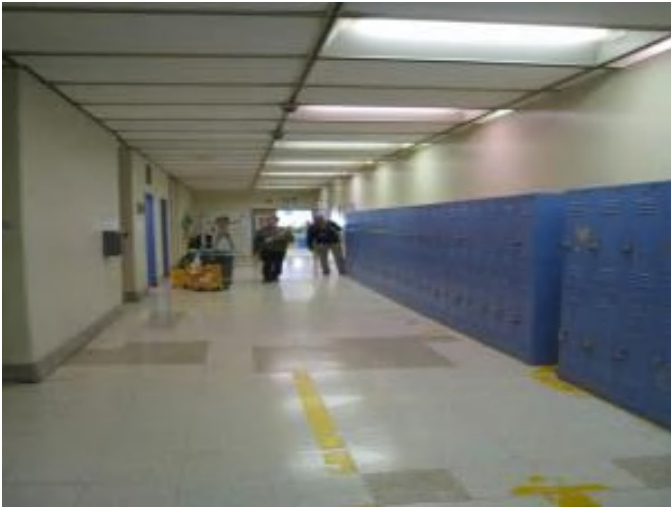
System: C3030 - Ceiling Finishes

Location: 1st and 2nd floor ceilings

Distress: Beyond Service Life

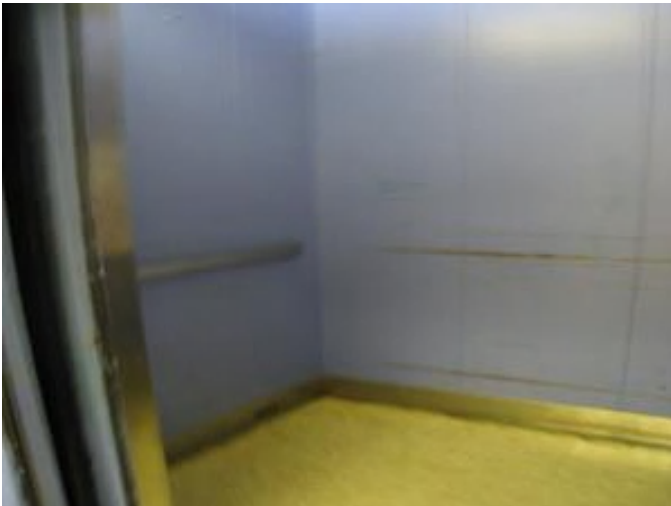
System: D1010 - Elevators and Lifts

Location: elevator

Distress: Building / MEP Codes

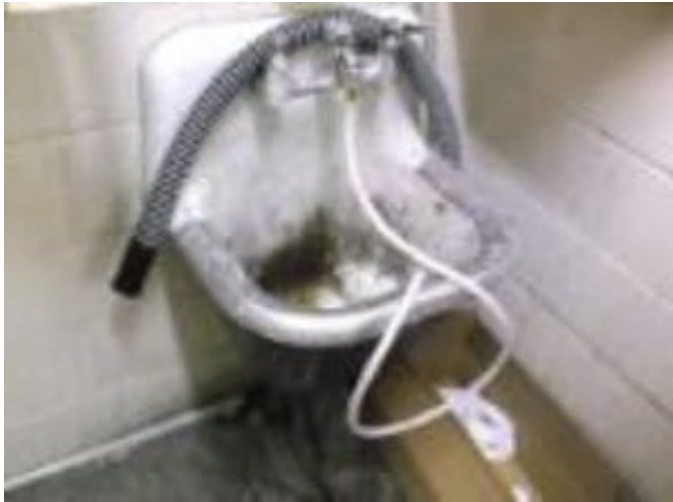
System: D2010 - Plumbing Fixtures

Location: Throughout Building

Distress: Beyond Service Life

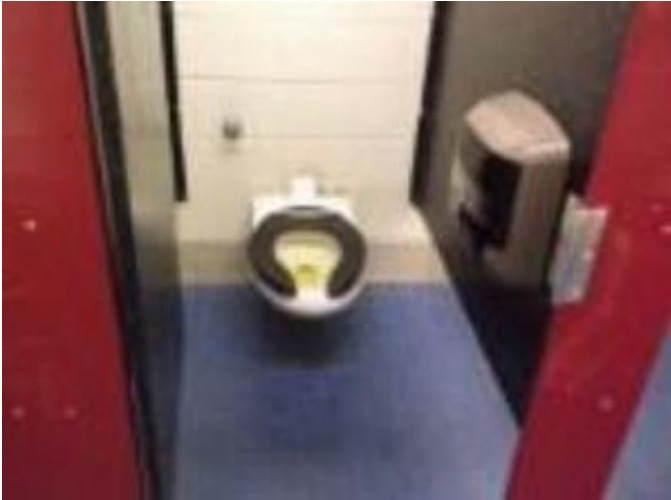
System: D2010 - Plumbing Fixtures

Location: Throughout Building

Distress: Beyond Service Life

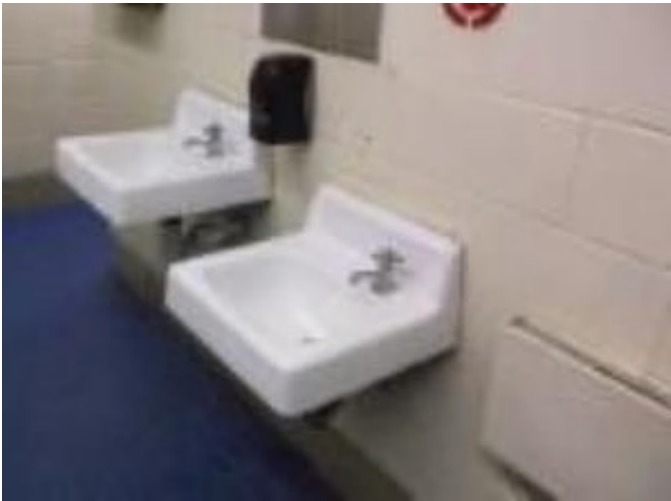
System: D2010 - Plumbing Fixtures

Location: Throughout Building

Distress: Beyond Service Life

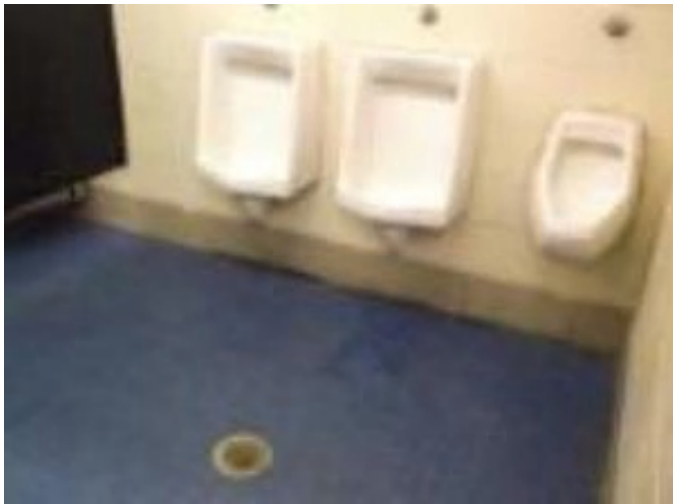
System: D2010 - Plumbing Fixtures

Location: Throughout Building

Distress: Beyond Service Life

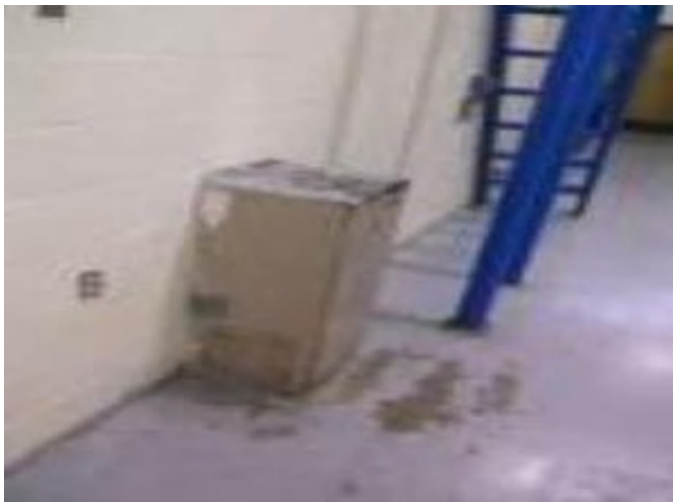
System: D2010 - Plumbing Fixtures

Location: Throughout Building

Distress: Accessibility

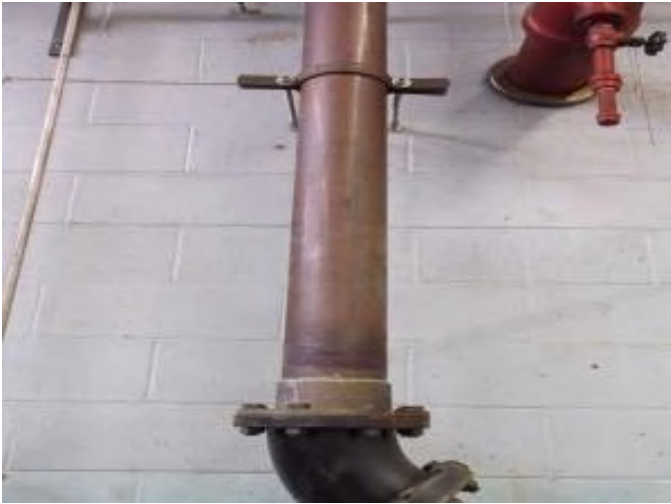
System: D2020 - Domestic Water Distribution

Location: Throughout Building

Distress: Beyond Service Life

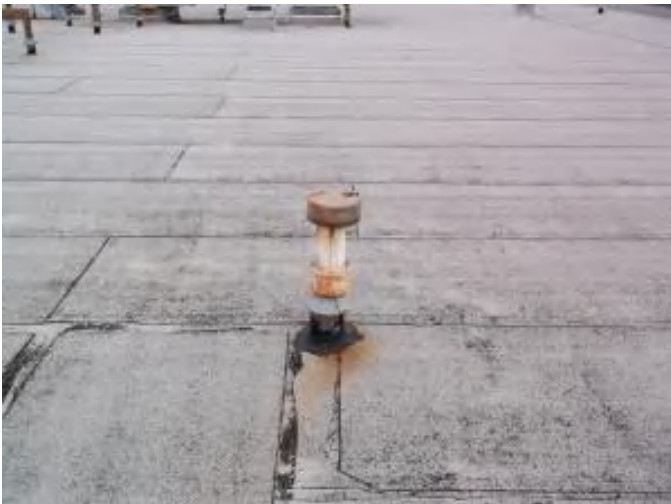
System: D2030 - Sanitary Waste

Location: Throughout Building

Distress: Beyond Service Life

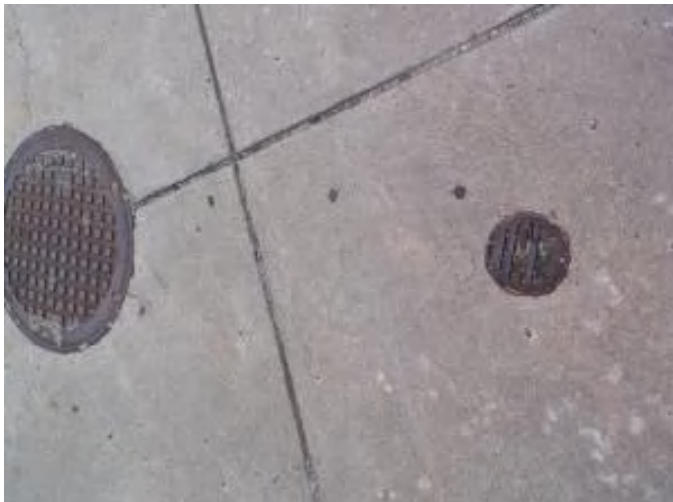
System: D3020 - Heat Generating Systems

Location: Site

Distress: Beyond Service Life

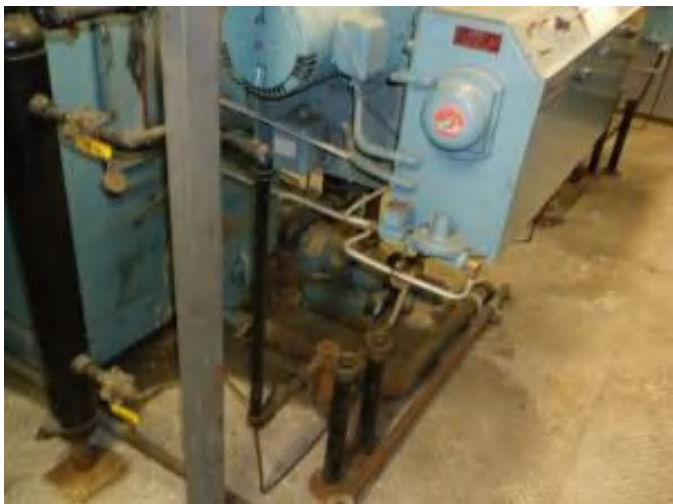
System: D3020 - Heat Generating Systems

Location: Penthouse

Distress: Beyond Service Life

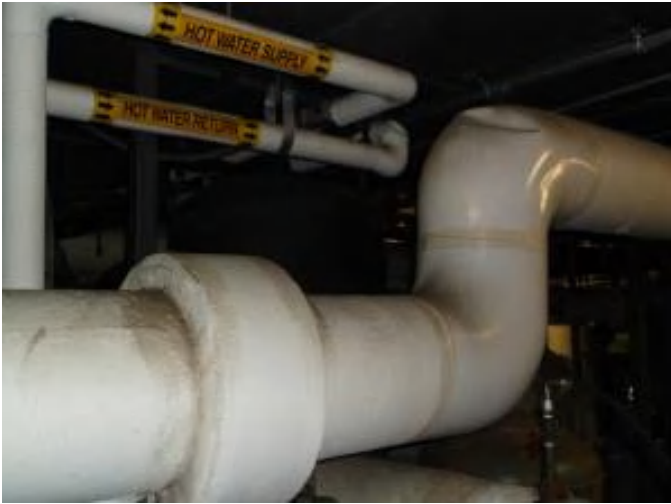
System: D3040 - Distribution Systems

Location: Throughout Building

Distress: Beyond Service Life

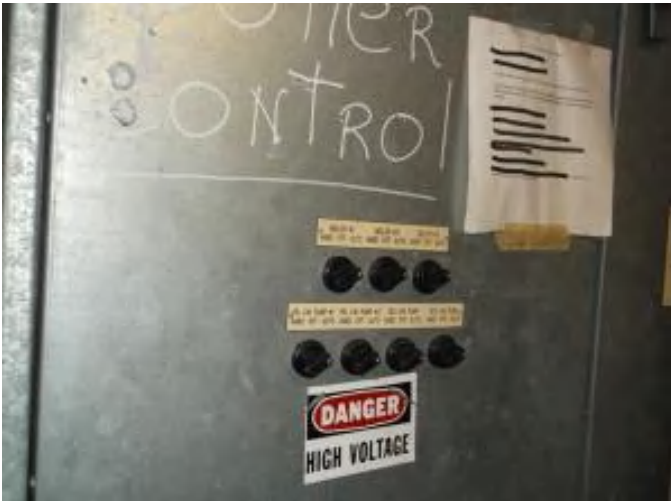
System: D3060 - Controls & Instrumentation

Location: Throughout Building

Distress: Energy Efficiency

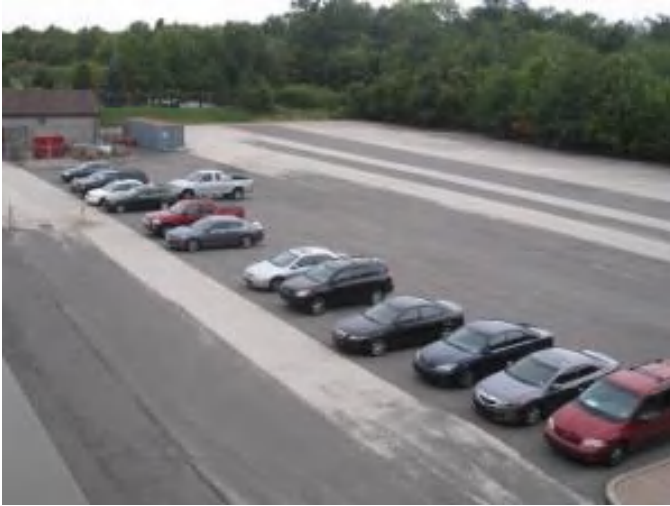
System: G2020 - Parking Lots

Location: rear parking lot

Distress: Failing

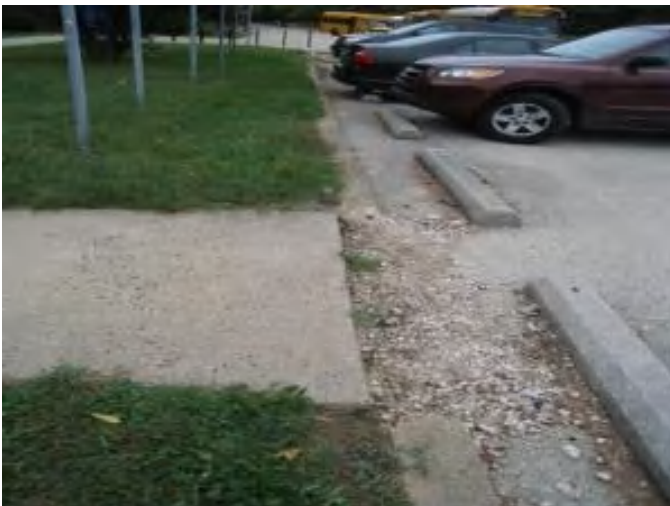
System: G2020 - Parking Lots

Location: curbs at front entrance and side roadways

Distress: Damaged

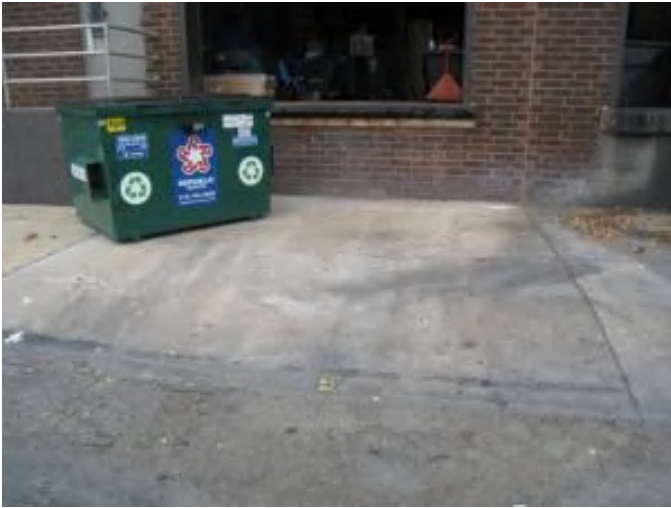
System: G2030 - Pedestrian Paving

Location: dumpster pad

Distress: Damaged

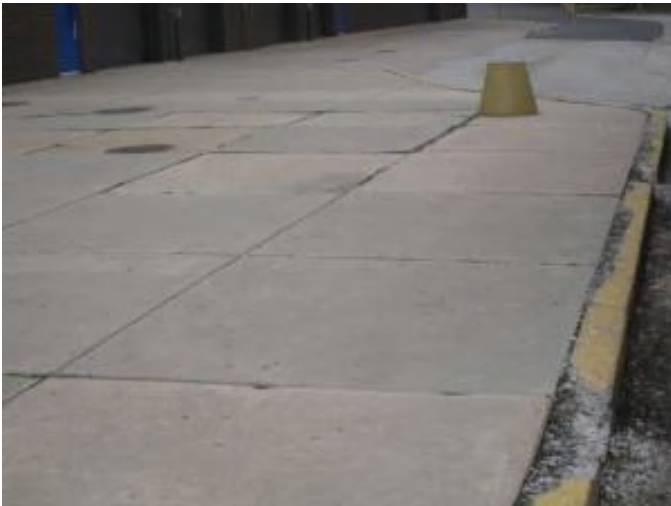
System: G2030 - Pedestrian Paving

Location: front sidewalk

Distress: Damaged

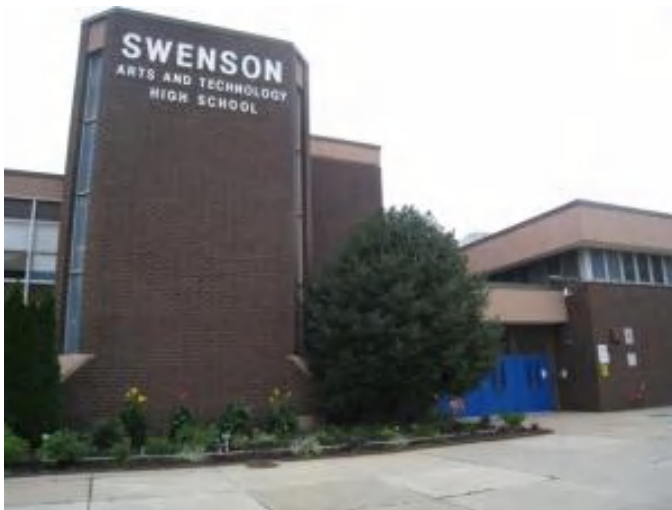
System: G2040 - Site Development

Location: front drop off area

Distress: Damaged

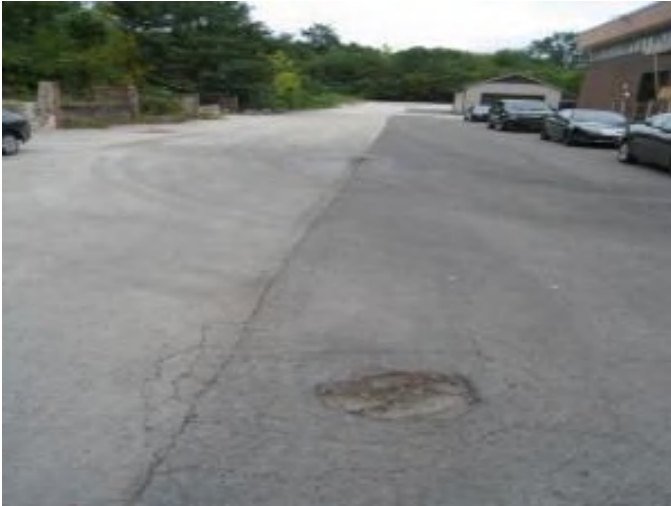
System: G2020 - Parking Lots

Location: front parking lot

Distress: Failing

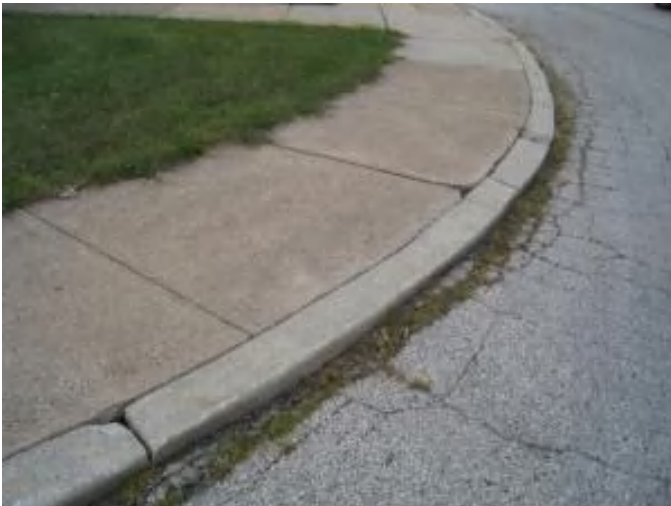
System: G2020 - Parking Lots

Location: left side roadway

Distress: Failing
