## Facility Condition Assessment Summary Report

### Randolph School

**School District of Philadelphia**  
**S609001;Randolph**  
**Final**  
**Site Assessment Report**  
**January 30, 2017**

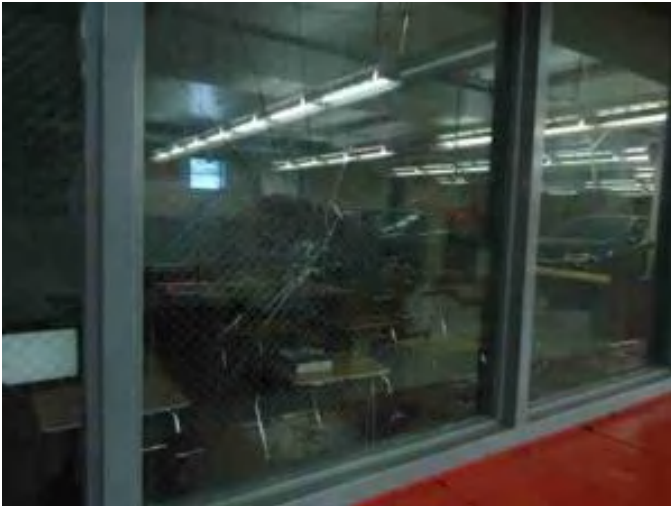
**Location:** Shop

The interior safety glass that separates the classroom from the shop area is damaged. As indicated in the photo several sections are damaged and one is broken creating a safety issue. This deficiency provides a budgetary consideration for the removal and replacement of the shop safety glass to the classroom.

**Distress:** Damaged

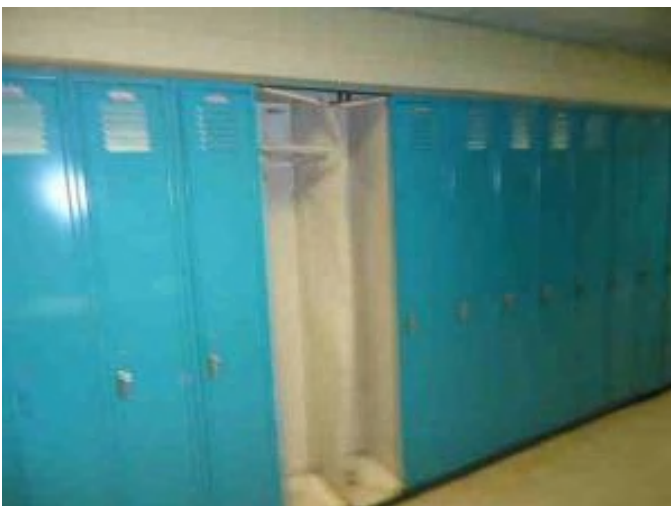
**Location:** Shops

**Distress:** Damaged

**Notes:** The shop locker room locker system is beyond its expected life, several of the lockers are damaged and some of the doors are missing. The locker system is recommended for removal and replacement with a new system. Budgetary consideration for a portion of the lockers to be designed with the needs of the physically challenged in mind is included in this effort.

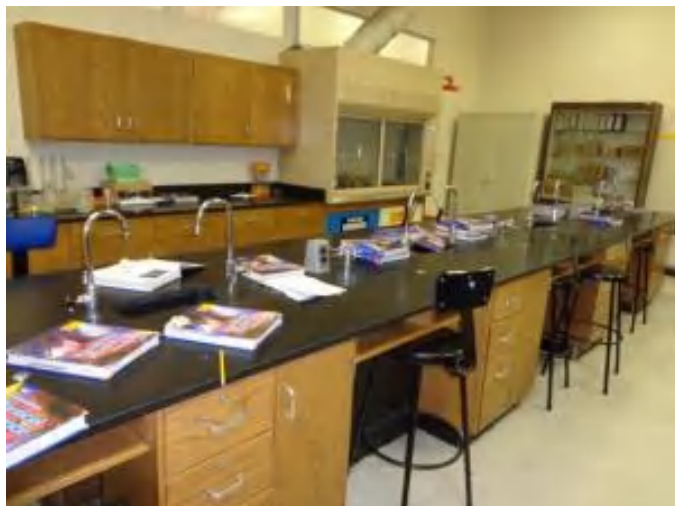
**Location:** Science Lab 75

**Distress:** Life Safety / NFPA / PFD

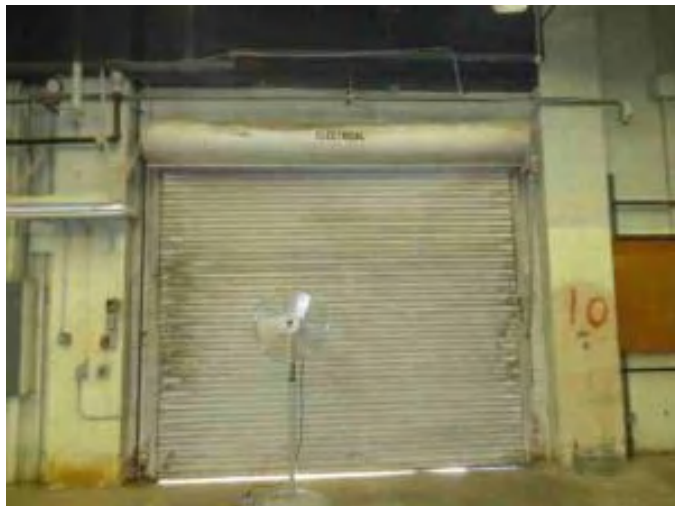
**Location:** Shop

The exterior doors are metal applications with metal frames. The exterior door system for this school is a very high traffic system. Most of the doors are in good condition however, the shop doors on the East face of the school are aging at a faster rate than expected based on traffic and condition. The Eastern exterior door system and service doors are recommended for upgrade. The new doors are expected to retain their dimensions and profiles, but that incorporate updated energy-efficient features.

**Distress:** Damaged

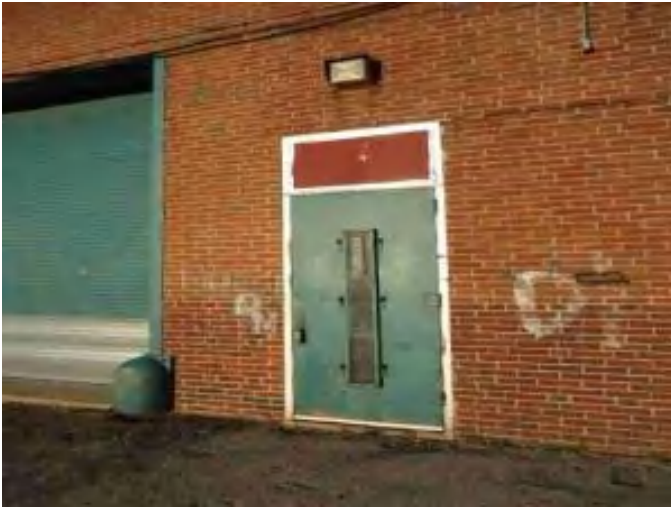
**Location:** Exterior Elevation

This school has several roll up door systems that appear to be original to the construction of the school. As indicated in the photos several doors have been repaired from damage. During the time of the inspection several door no longer functioned properly. This system is a very high traffic system and represents the only access for the educational needs of the school. This door system is recommended to be removed and replaced with a modern overhead door system with safety and security considerations.

**Distress:** Damaged

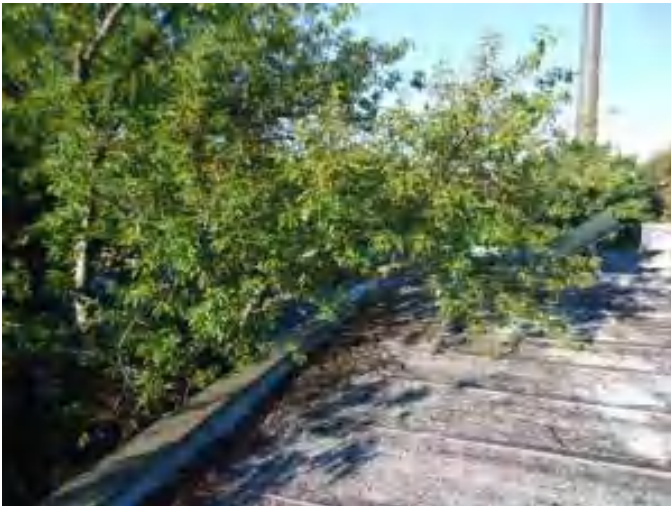
**Location:** Roof

The existing built up roofing system has clear signs of ponding and there reportedly has been an increase of roofing maintenance. As indicated in the photos, most of the roof surface material no longer exists and there are sections of landscaping growth that is affecting the integrity of this built up roof. This deficiency provides a budgetary consideration for a complete roof replacement. Care should be taken to ensure that tree growth does not affect the newly installed roofing system. In the short term the trees should be cut away from the roof.

**Distress:** Damaged

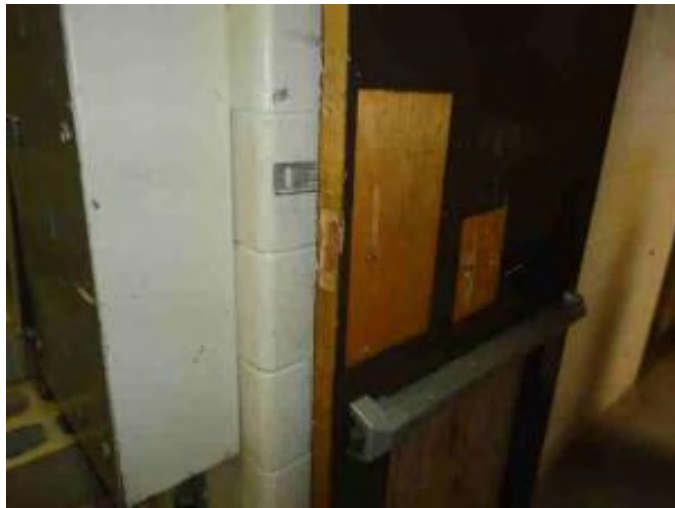
**Location:** Building Wide

Interior doors are typically wood in metal frames with wired glass glazing. Other interior doors include hollow metal in hollow metal frames at hallway breaks and exit ways, access doors. Doors are generally in fair condition and are a mix of ADA compliant and non-complaint doors with both non-rated and fire rated. Several of the shop doors are aging at a faster than normal rate for this application. Numerous repairs to locksets and door hardware have advanced the deterioration of the doors. This deficiency provides a budgetary consideration to replace a portion of the interior doors and frames with consideration for the physically challenged.

**Distress:** Damaged

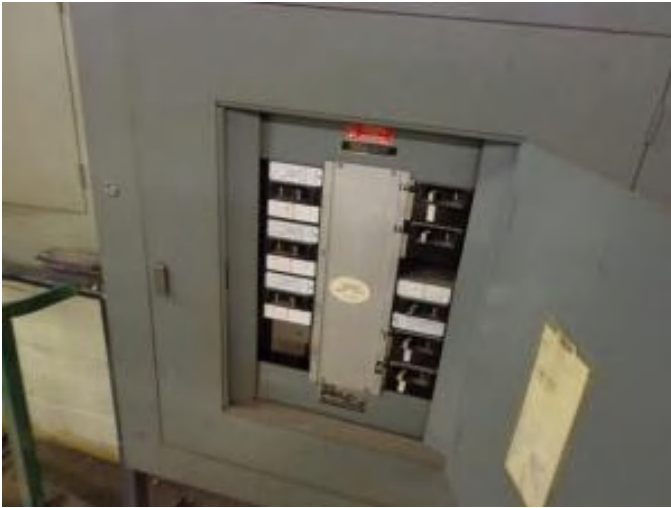
**Location:** Building wide

There are several distribution panelboards, step-down transformers and panelboards that are located throughout the building in the various vocational departments. Except for two panelboards in the kitchen, all distribution equipment is manufactured by Federal Pacific Electric and is obsolete and needs to be replaced.

**Distress:** Beyond Service Life

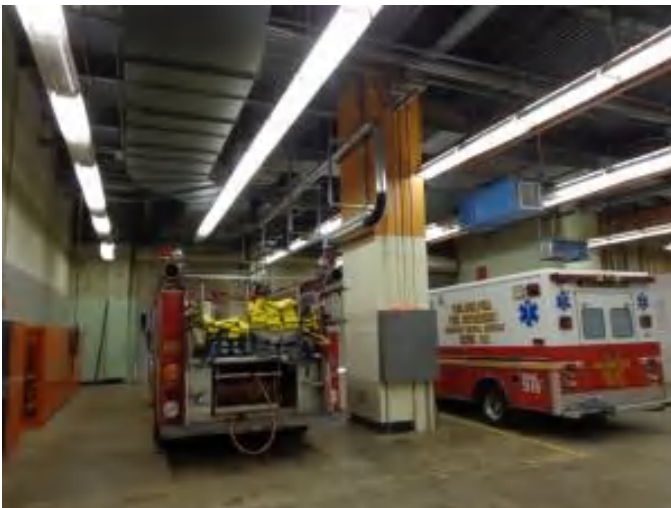
**Location:** Building wide

Except for the lighting fixtures in the Boiler Room and dental labs, all lighting fixtures need to be replaced with fixtures using T8 or T5 lamps.

**Distress:** Beyond Service Life

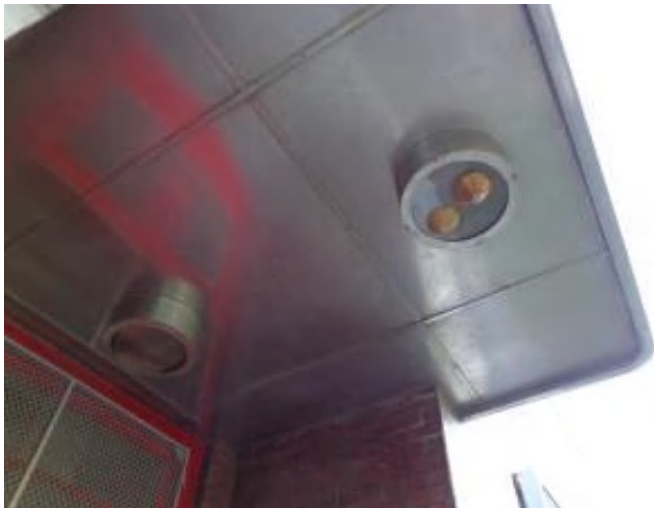
**Location:** Exterior exit discharges

**Distress:** Beyond Service Life

- Replace ten (10) exterior HID floodlighting fixtures on the building exterior with LED type floodlighting fixtures.

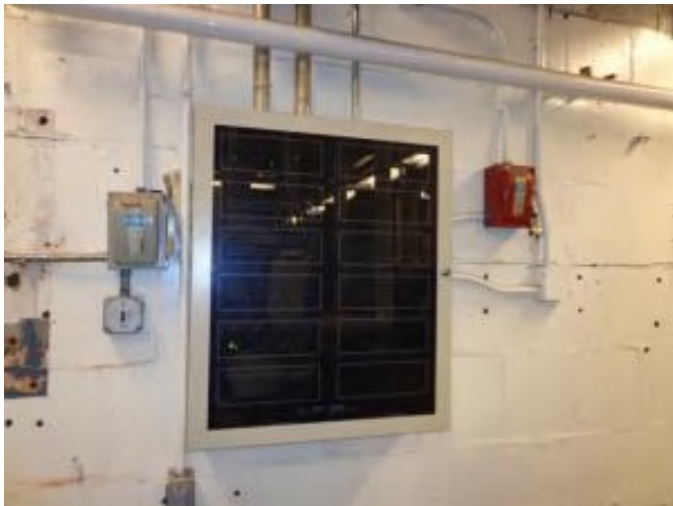
**Location:** Building wide

**Distress:** Life Safety / NFPA / PFD

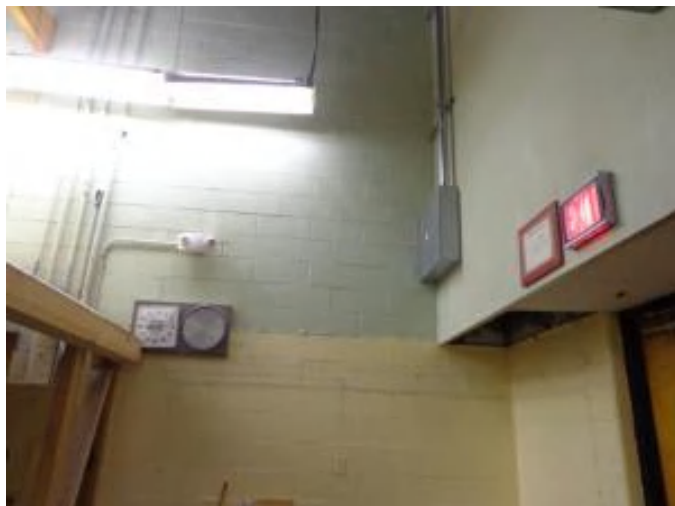
**Location:** Shop areas

**Distress:** Life Safety / NFPA / PFD

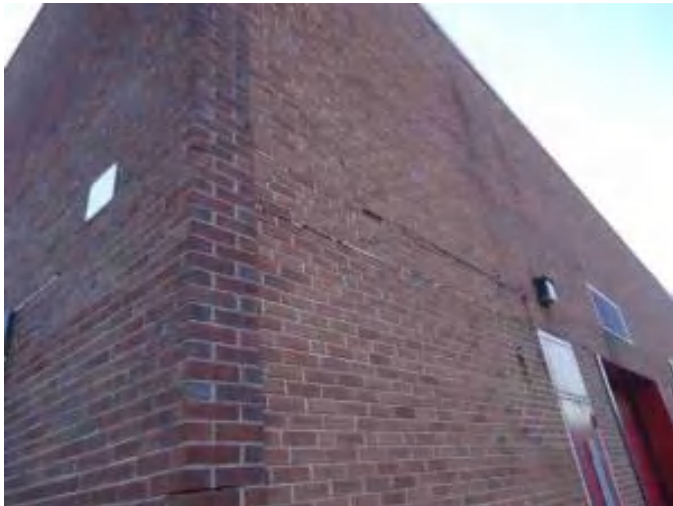
**Location:** Exterior Elevation

The exterior brick surfaces are generally in fair to good condition for their age. In some locations, such as the exterior finish facing Henry Ave. Sections of bricks have cracked or spalled and should be replaced. The repointing of deteriorated mortar joints is also recommended, using mortar of a similar color and consistency as the original. Following the detailed examination of the brick and repair of mortar construction joints, the entire building should be pressure washed to remove stains and embedded pollutants. If moisture is found to be penetrating the masonry facade, the application of a spray sealant to the suspected exterior masonry surface is recommended.

**Distress:** Damaged

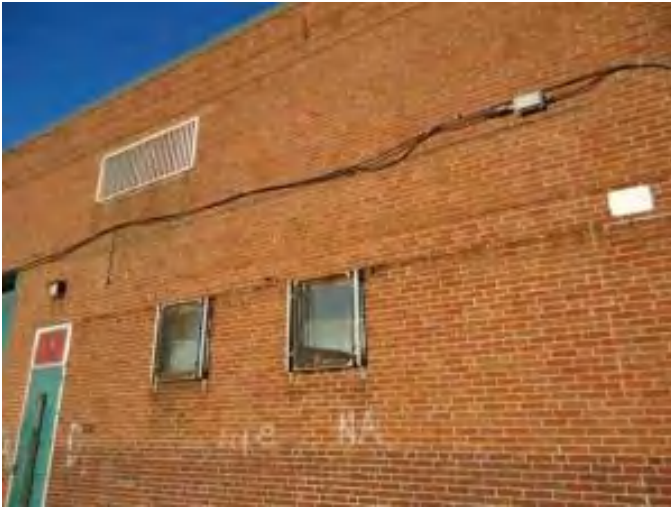
**Location:** Exterior Elevation

The exterior windows are the original industrial metal framed single pane applications. Some of the windows are operable while others no longer function. The exterior windows have exceeded the expected life cycle for this type of application. It is recommended that the exterior window system be replaced with units that retain their dimensions and profiles, but that incorporate updated energy-efficient features.

**Distress:** Damaged

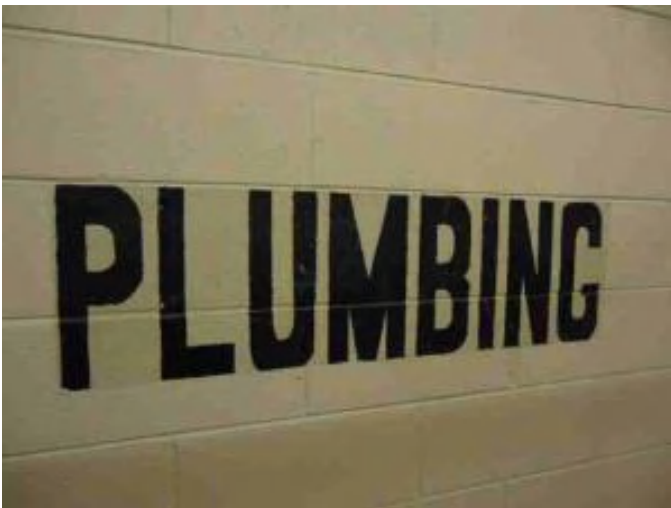
**Location:** Building Wide

**Distress:** Damaged

**Notes:** There is no directional signage and room signage is a custom design in places and scarce or painted with no consistency in others. Accessibility signage criteria have been established for the physically challenged. These include mounting heights, contrast and finish, raised and Braille characters and pictograms, and character proportions and heights. It is recommended that compliant signage be installed throughout the building.

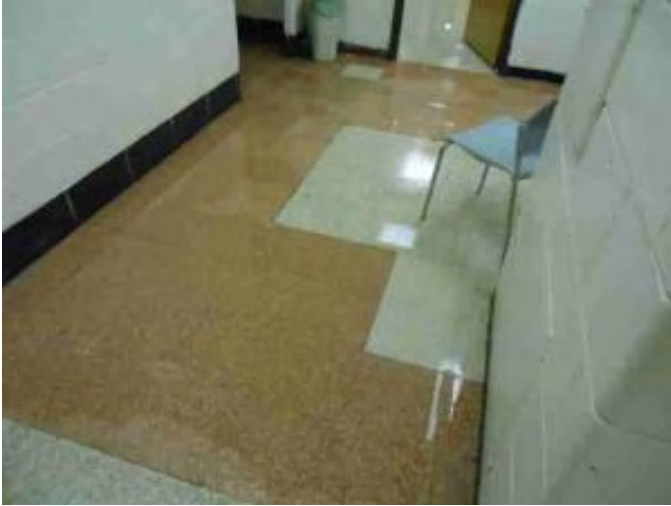
**Location:** Building Wide

The vinyl floor finish in most of this school is in very good condition and appears to have part of an isolated upgrade. Some of the flooring is damaged from water leaks and industrial wear. This deficiency provides a budgetary consideration for partial removal and replacement of the damaged vinyl tile.

**Distress:** Damaged

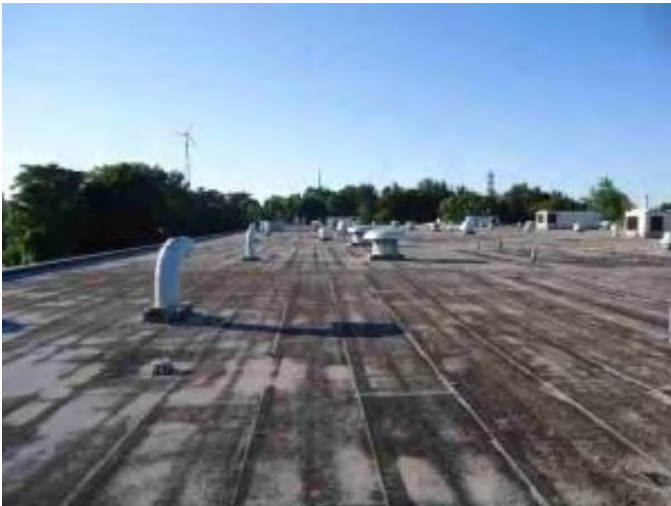
**Location:** roof, mechanical room

**Distress:** Inadequate

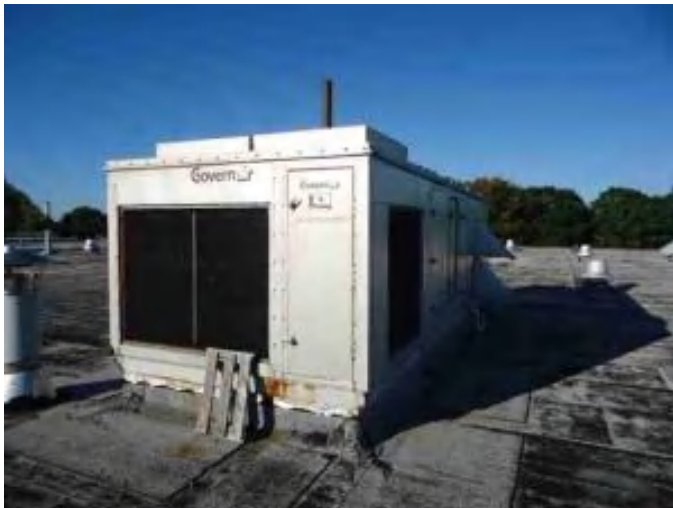
**Location:** classrooms/offices

**Distress:** Energy Efficiency

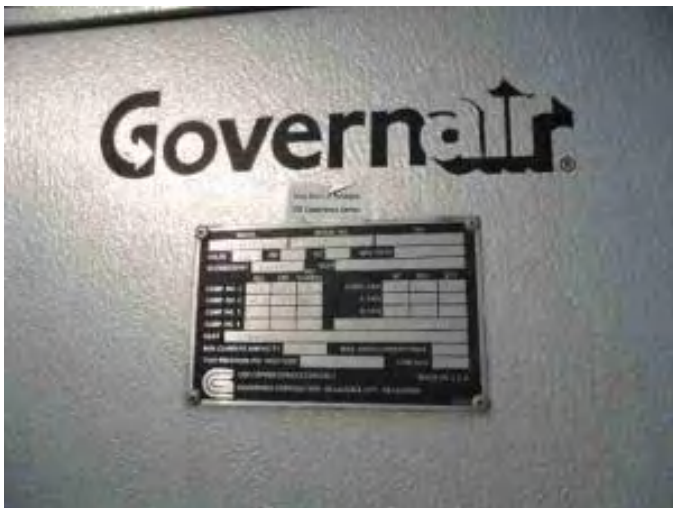
**Location:** classrooms/offices

**Distress:** Energy Efficiency

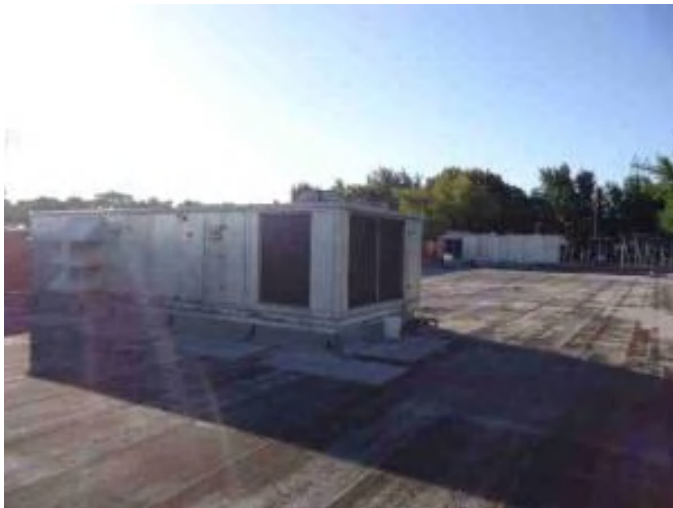
**Location:** classrooms/offices

**Distress:** Energy Efficiency

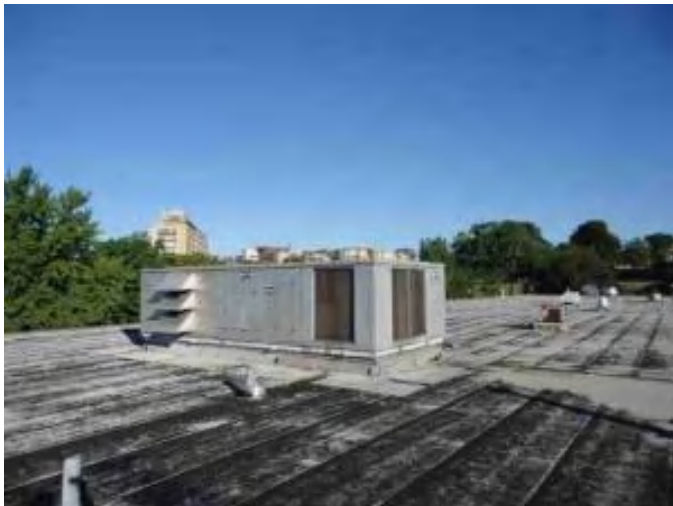
**Location:** classrooms/offices

**Distress:** Energy Efficiency

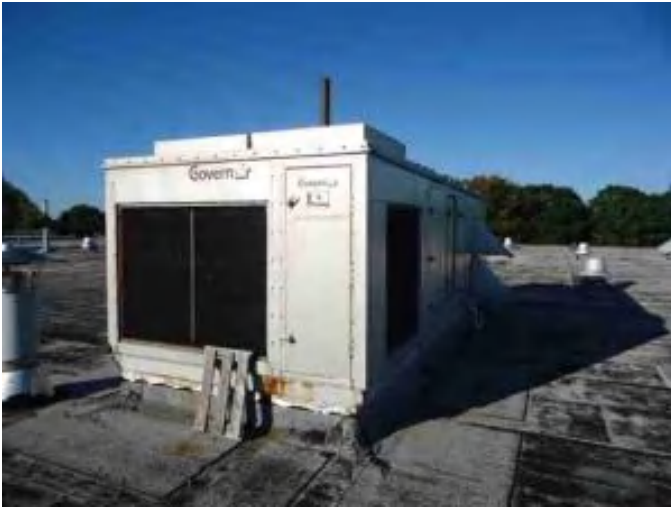
**Location:** classrooms/offices

**Distress:** Energy Efficiency

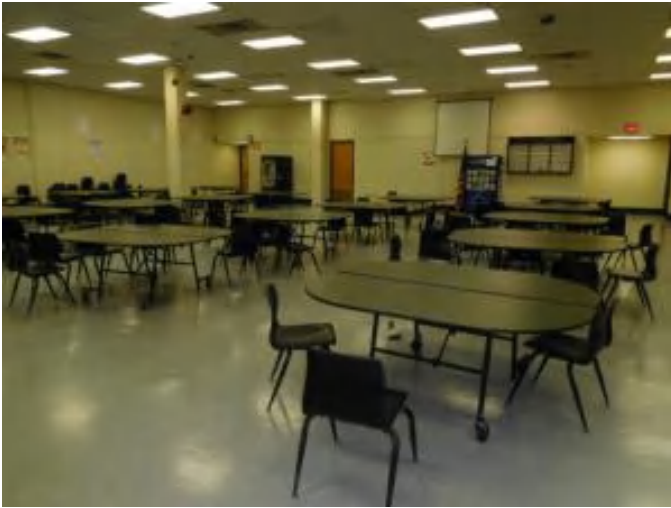
**Location:** cafeteria

**Distress:** Building / MEP Codes

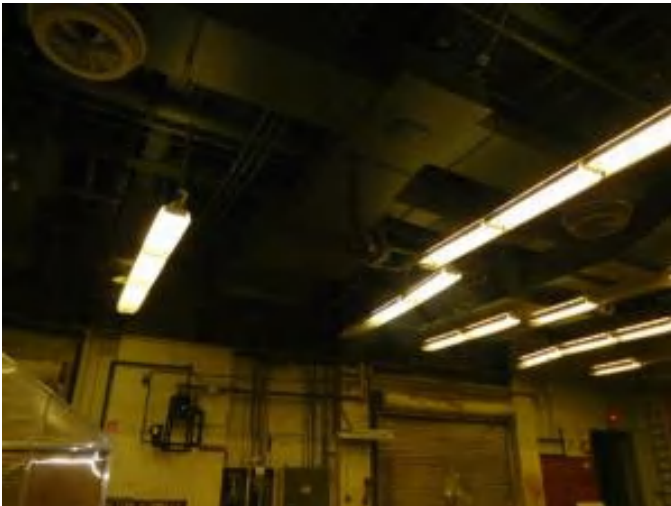
**Location:** shop areas

**Distress:** Damaged

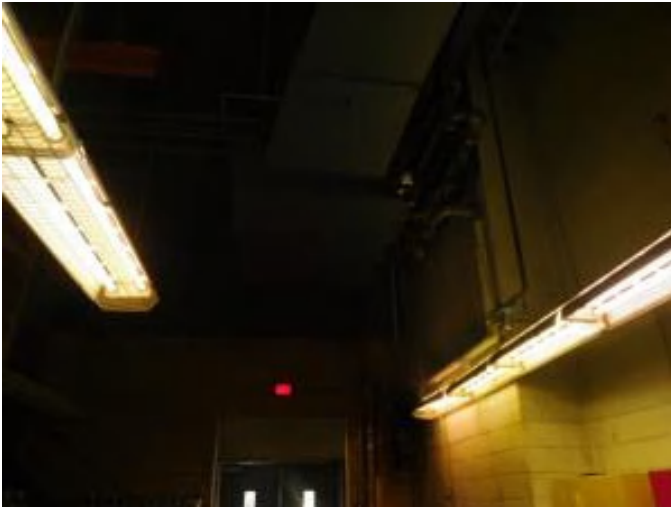
**Location:** shop areas

**Distress:** Damaged

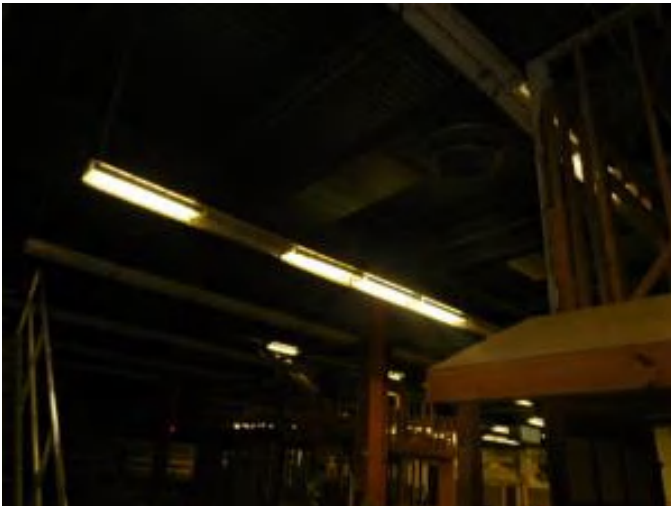
**Location:** shop areas

**Distress:** Damaged

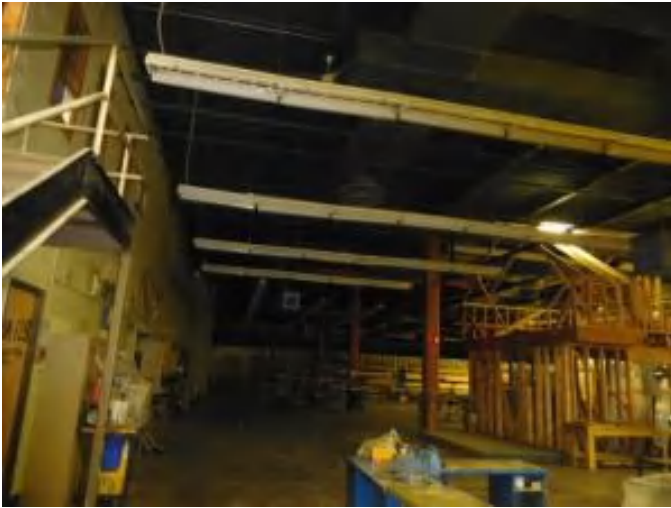
**Location:** shop areas

**Distress:** Damaged

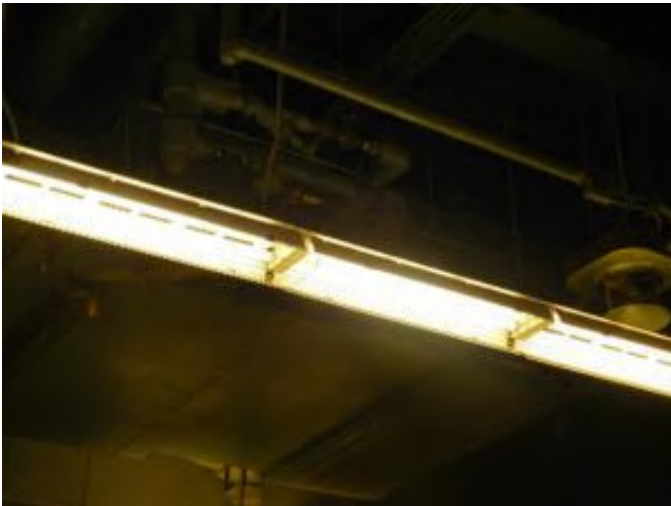
**Location:** shop areas

**Distress:** Damaged

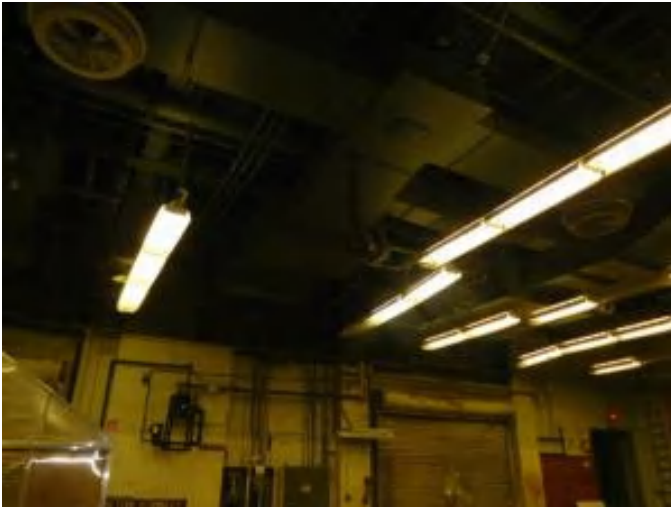
**Location:** shop areas

**Distress:** Damaged

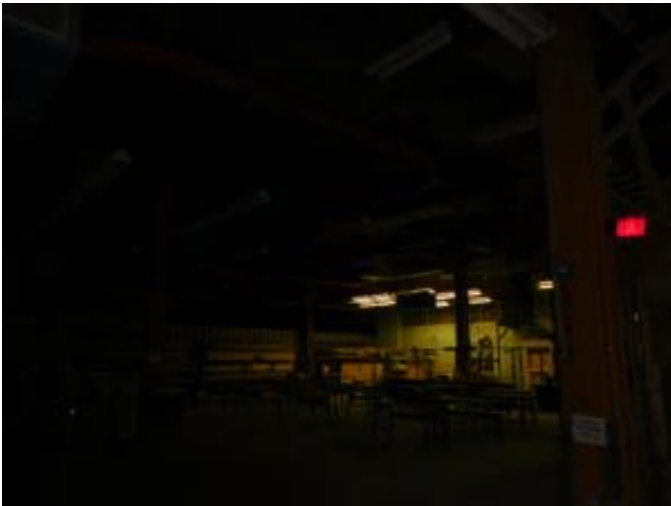
**Location:** shop areas

**Distress:** Damaged

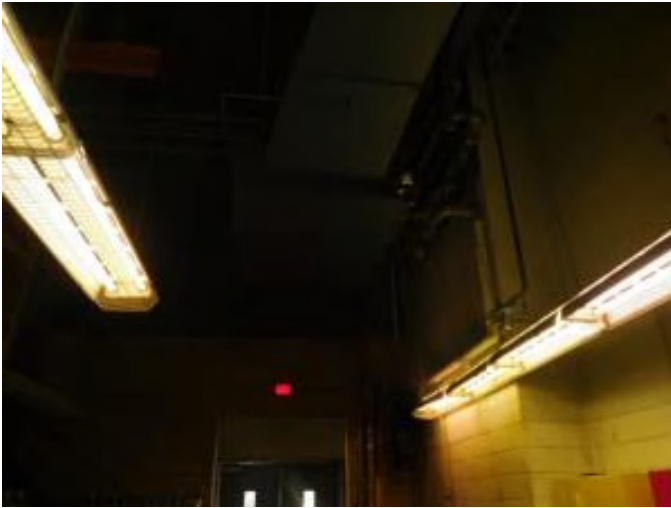
**Location:** shop areas

**Distress:** Damaged

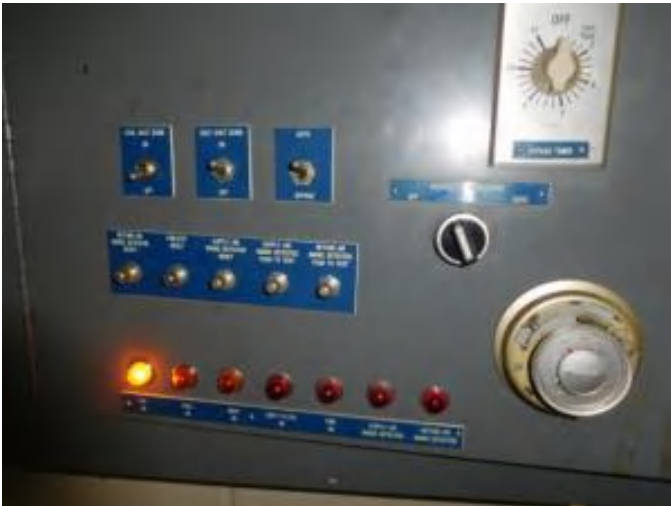
**Location:** entire building

**Distress:** Inadequate

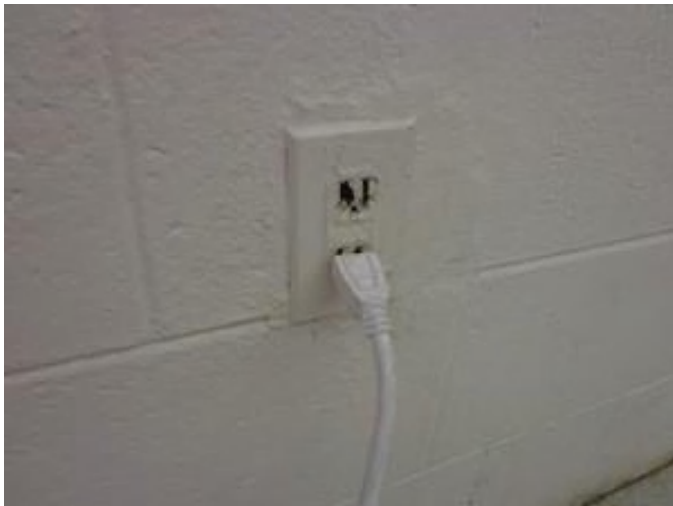
**Location:** Building wide

**Distress:** Failing

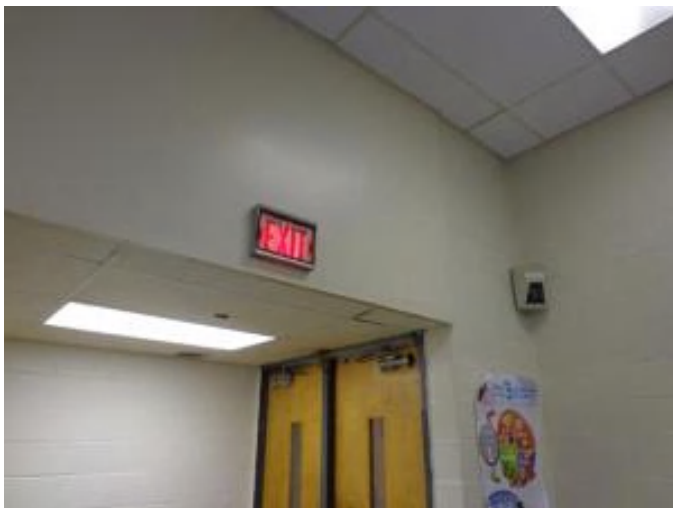
**Location:** Building wide

**Distress:** Security Issue

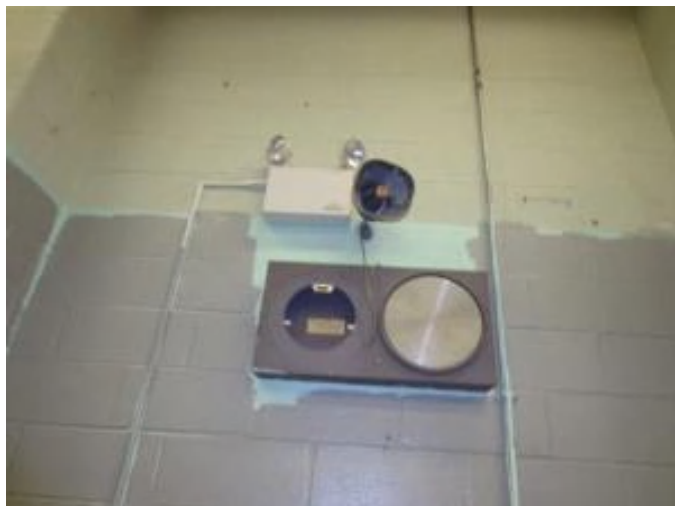
**Location:** Building wide

**Distress:** Failing

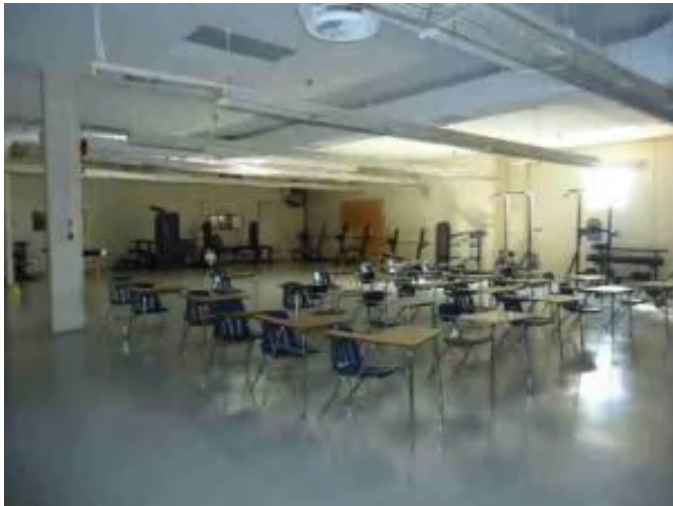
**Location:** Building Wide

The ceiling finish is a mix of painted, exposed and 2 x 4 Acoustical tile finish. Ceilings have been repaired in several areas and are in good condition considering the age of the application and the current condition of the school. The ceiling finish is expected to require upgrades to support the recommended efforts in this report prior to re-opening. This deficiency provides a budgetary consideration for removal and replacement of the current ceiling finish to a new acoustical tile finish. Considering the recommended mechanical and electrical upgrades this effort should be completed as part of an overall renewal program for the school.

**Distress:** Damaged

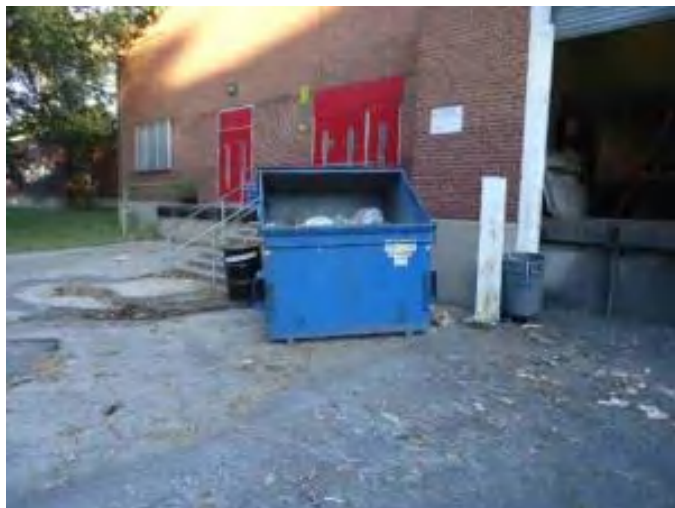
**Location:** Loading Dock

**Distress:** Health Hazard / Risk

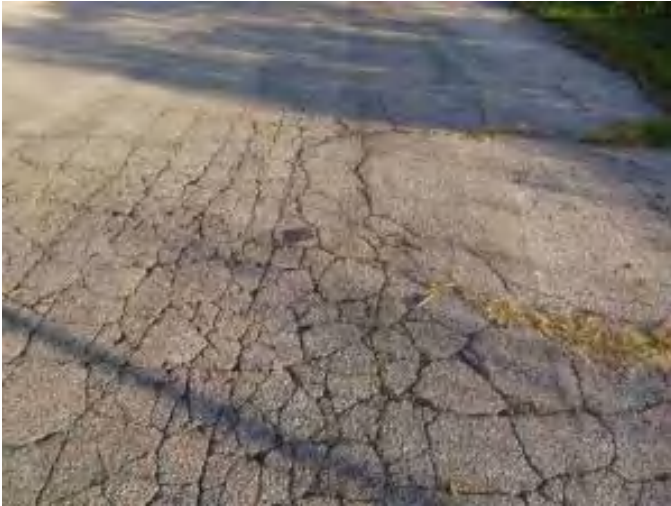
**Location:** Site

**Distress:** Damaged

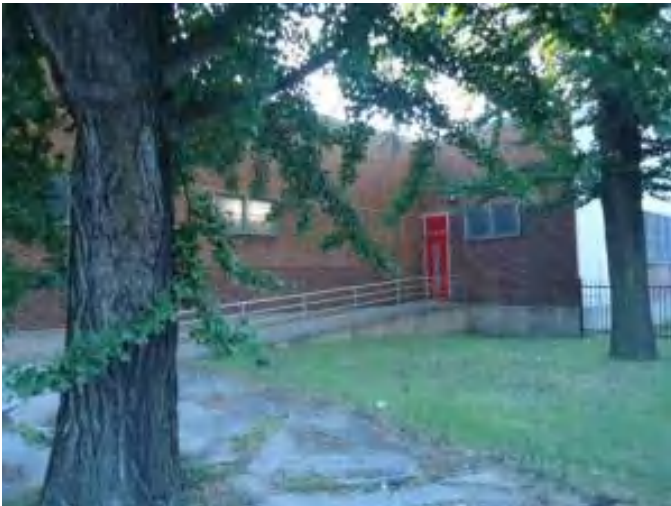
**Location:** ADA Entrance

**Distress:** Damaged

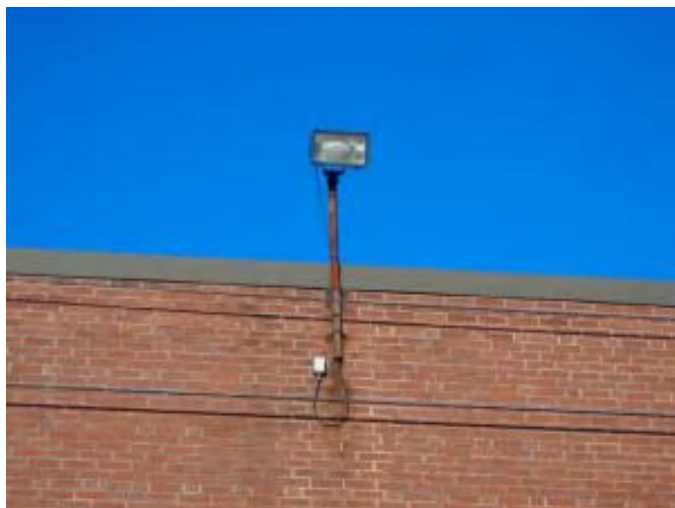
**Location:** Site lighting

**Distress:** Beyond Service Life
