## **Andrew Hamilton School**

5640 Spruce Street, Philadelphia, PA 19139

### **Scope Determination Report: Major Renovation**

May 11, 2018

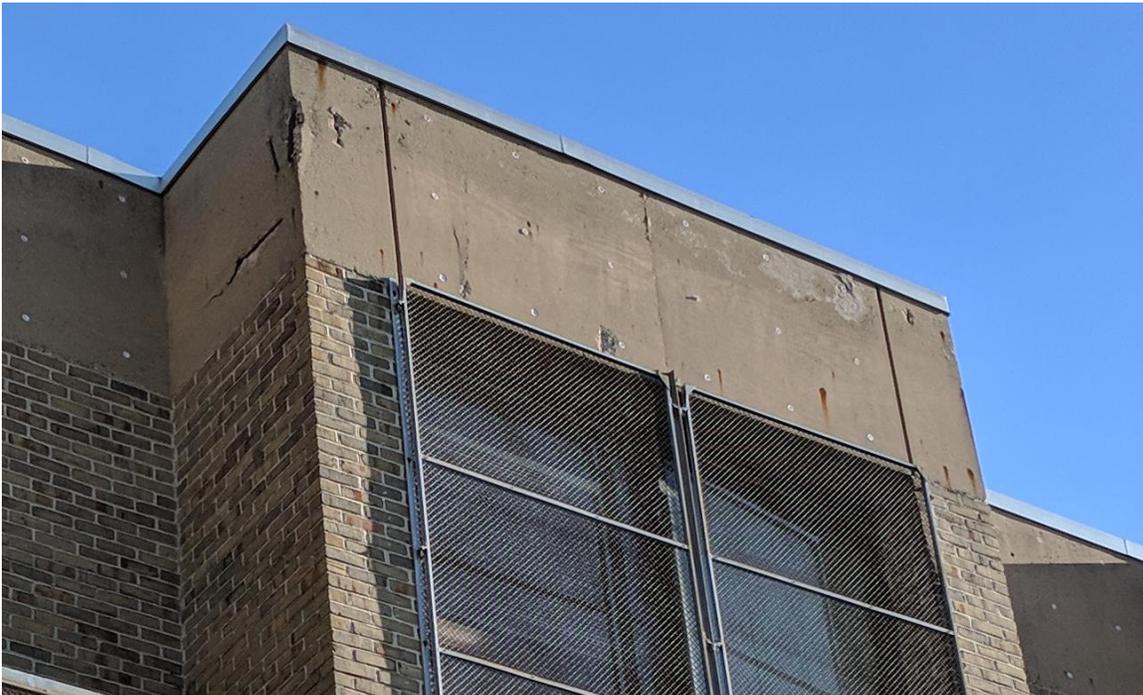
**Photograph 1: Exposed reinforcement**

Minor deteriorations of exposed architectural concrete framing are observed around the building. Deteriorations include spalled concrete surfaces and exposed steel reinforcement.

Several factors may have contributed to the observed concrete deteriorations. One apparent factor is insufficient concrete cover over reinforcements. Locations of exposed reinforcements show that there is not enough concrete cover, especially for concrete permanently exposed to weather. Another factor may be the change in the pH level of concrete due to carbonation. As concrete loses its alkalinity due to carbonation, an environment more conducive to corrosion is created within reinforced concrete.

The following photograph exhibits the typical deterioration of exposed concrete framing.

1. Remove loose or cracked material from architectural exposed concrete framing surfaces.
2. Unspalled concrete surfaces showing leached rust shall be chipped to expose steel reinforcement to be repaired.
3. At locations of spalled concrete:
  - a. Saw cut edges and remove concrete to a depth at least  $\frac{3}{4}$ " beyond existing reinforcement. Overall depth of removal may be 3" to 4".
  - b. Clean rust from exposed, corroded reinforcement. Weld additional reinforcement if existing reinforcement shows significant section loss.
  - c. Apply a bonding agent to exposed reinforcement and concrete surfaces to be patched.

- d. Patch the spalled areas with cementitious patching material. Patched surfaces shall match the adjacent existing surfaces.

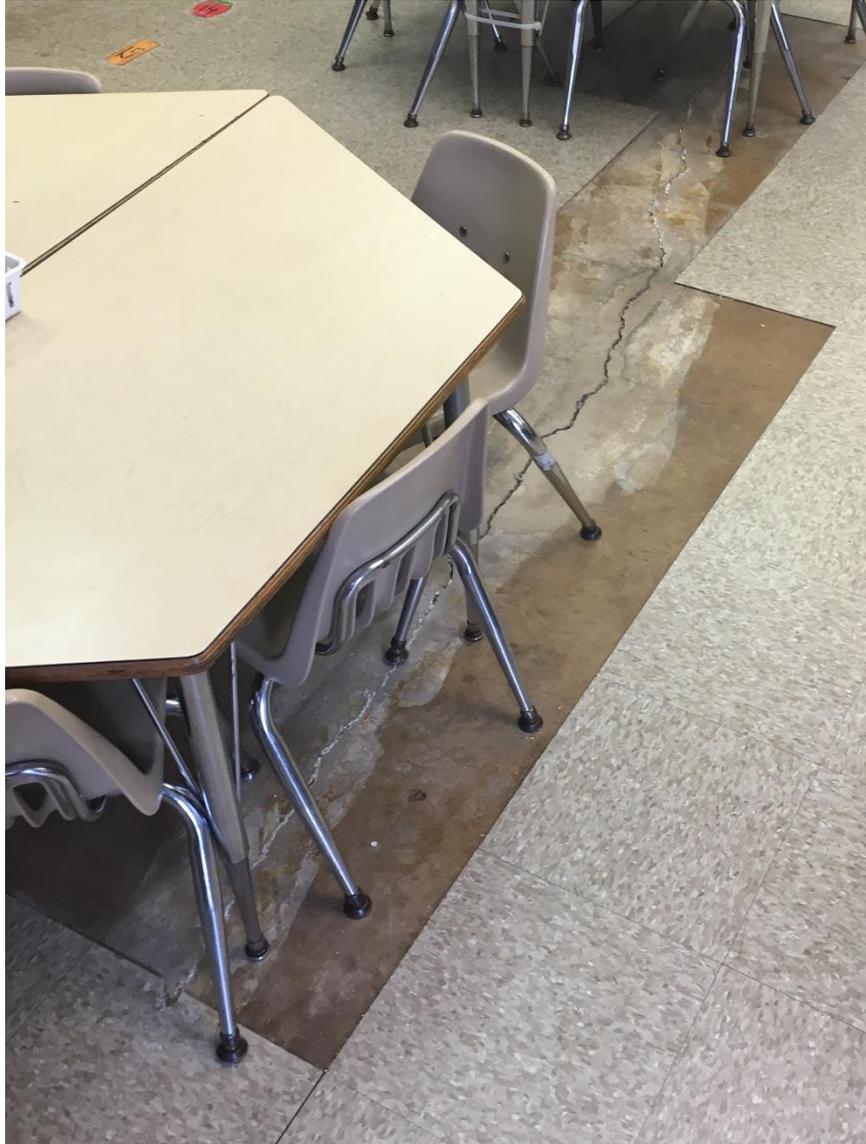
**Photograph 2: Cracked concrete slab**

**Cracked slab in Rm. 130**

A crack exists under existing flooring in Rm. 130. Original design drawings dated 1968 show that the floor slab is a 4" thick slab-on-grade reinforced with welded wire fabric.

1. Clean the cracked concrete surface and remove dirt, adhesive, etc.
2. Repair the cracks by injecting high strength epoxy adhesive such as Sikadur according to manufacturer's instructions.
3. Smooth the top surface of cracks to match existing slab.
