Facility Condition Assessment Summary Report

Hamilton School

School District of Philadelphia
S129001;Hamilton
Final
Site Assessment Report
January 30, 2017

Facility Assessment
October 2015

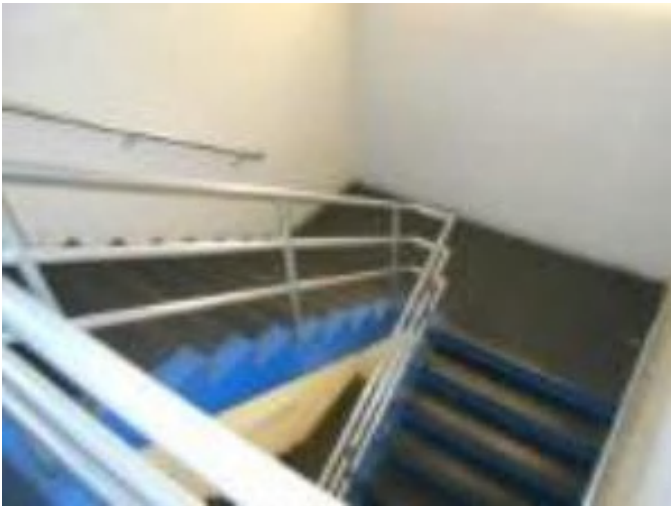
Location: Stairways

System: C2010 - Stair Construction

Distress: Accessibility

Notes: Replace handrails in exit stairwells and at the main entry

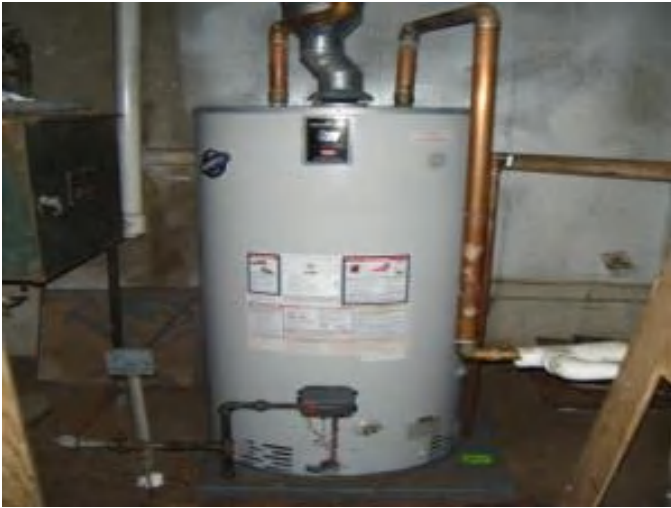
Location: Boiler Room

System: D2020 - Domestic Water Distribution

Distress: Building / MEP Codes

Notes: Provide an expansion tank for the 75 gallon vertical tank type, gas-fired domestic water heater.

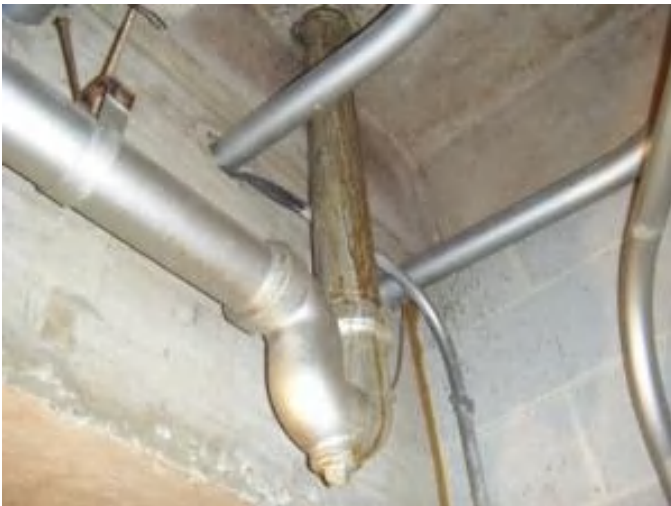
Location: Throughout Building

The original sanitary and storm drain piping is galvanized steel with threaded fittings. Roof drain leaders run through the building and connect to an underground storm sewer system on the site. The Principal reported leaks at fittings have caused water damage leading

to mold problems. However, these piping systems have been in service for nearly 50 years and will require more frequent attention from the maintenance staff as time passes. The District should hire a qualified contractor to examine the sanitary waste and storm drain piping using video cameras to locate and replace any damaged piping and to further quantify the extent of potential failures.

System: D2030 - Sanitary Waste

Distress: Failing

Notes: Hire a qualified contractor to perform a detailed examination of the sanitary waste piping using visual inspection and video cameras to locate and replace any damaged piping and to further quantify the extent of potential failures. The Principal reported leaks at fittings have caused water damage leading to mold problems.

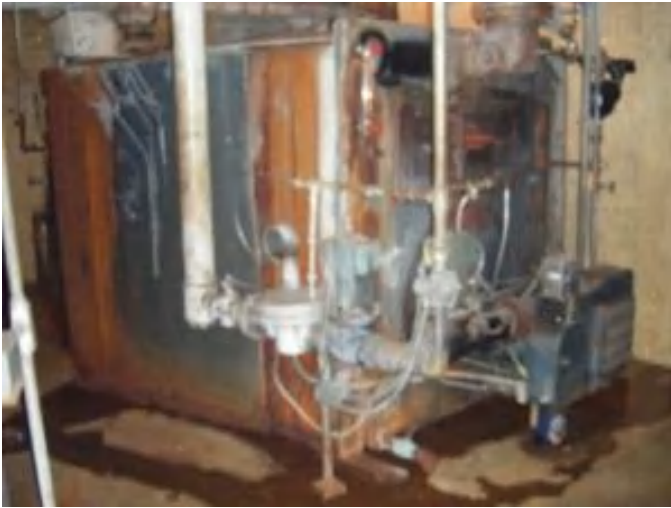
Location: Boiler Room

Low pressure steam is generated at 15 lbs/sq. in. or less by two 120 HP Weil McLain cast iron sectional boilers installed in 1968. Each boiler is equipped with its original power burner designed to operate on natural gas. Combustion air makeup is supplied by louvers equipped with motorized dampers. The gas train serving each boiler appears to have code required venting of the regulators and dual solenoid valves with venting of the chamber between. Cast iron sectional boilers have an anticipated service life of 35 years or more; these units have been in service nearly 50 years. The District should budget to replace these boilers as they appear in poor condition.

System: D3020 - Heat Generating Systems

Distress: Failing

Notes: Replace the two 120 HP Weil McLain cast iron sectional boilers installed in service since 1968. The District should budget to replace these boilers as they appear in poor condition.

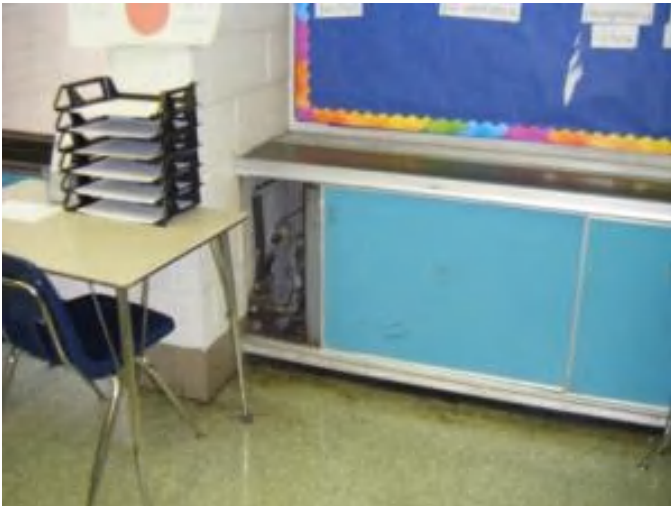
Location: Throughout Building

System: D3040 - Distribution Systems

Distress: Health Hazard / Risk

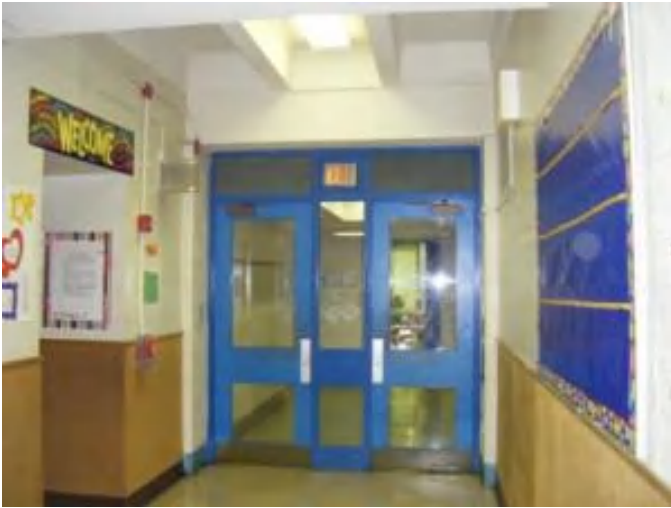
Location: Corridors

System: D3040 - Distribution Systems

Distress: Inadequate

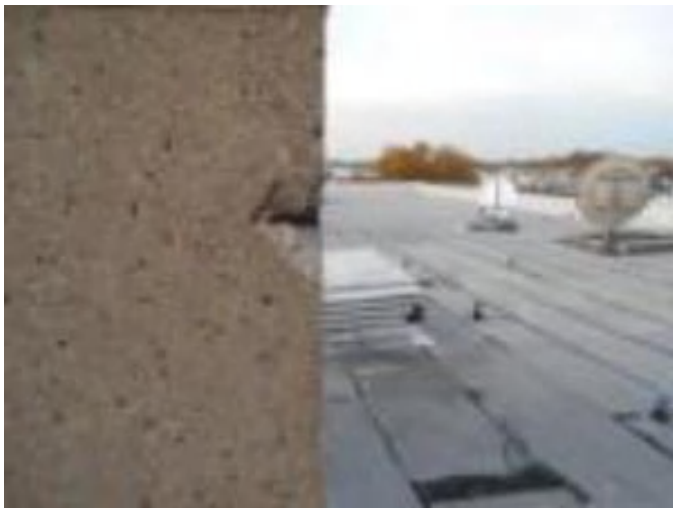
Location: Exterior walls

System: B2010 - Exterior Walls

Distress: Building Envelope Integrity

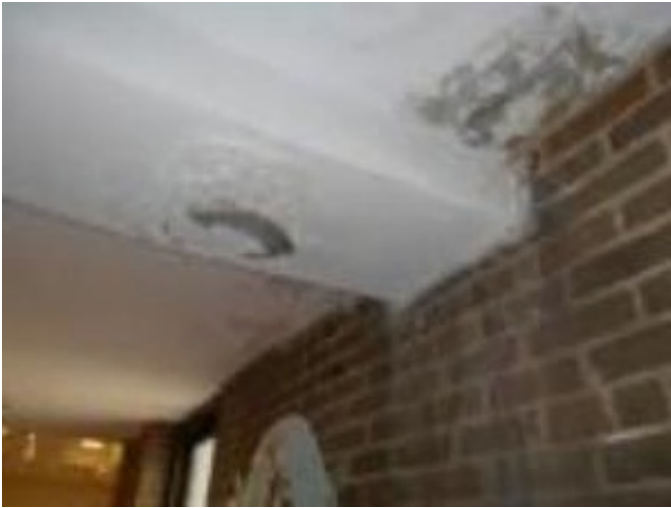
Location: Exterior Soffits

System: B2010 - Exterior Walls

Distress: Appearance

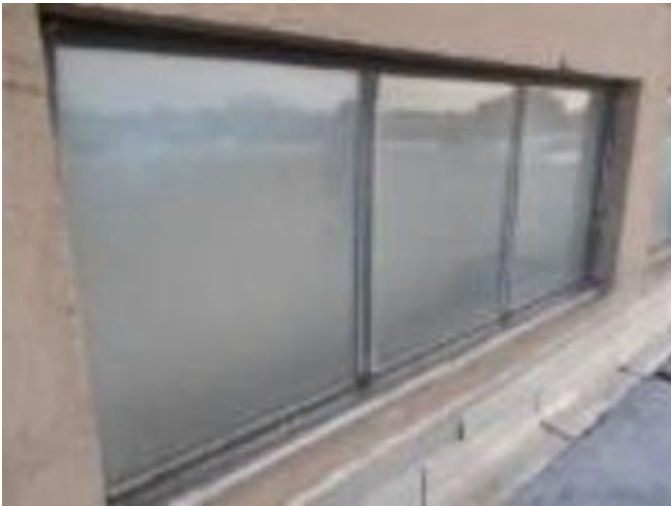
Location: Exterior walls

System: B2020 - Exterior Windows

Distress: Beyond Service Life

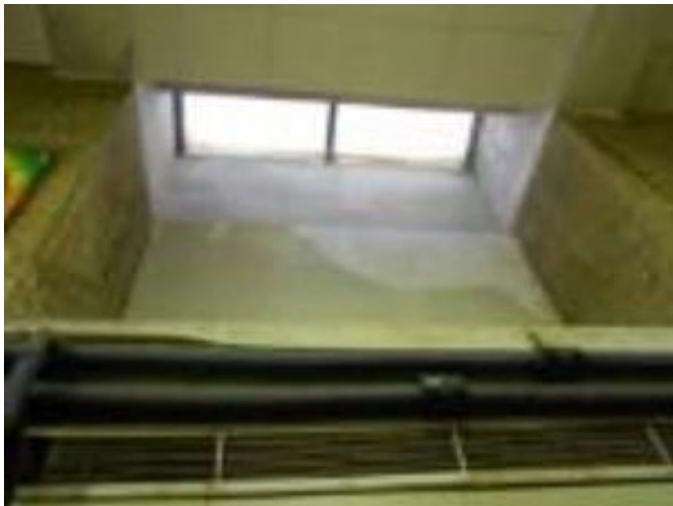
Location: Cafe

System: B2020 - Exterior Windows

Distress: Damaged

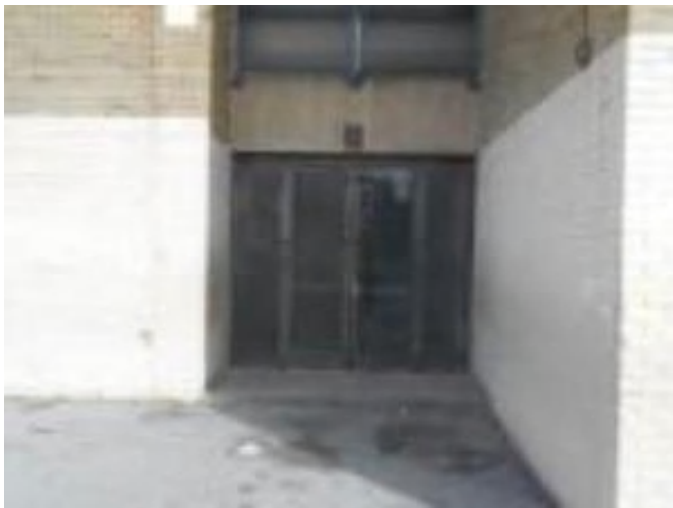
Location: Exterior doors

System: B2030 - Exterior Doors

Distress: Beyond Service Life

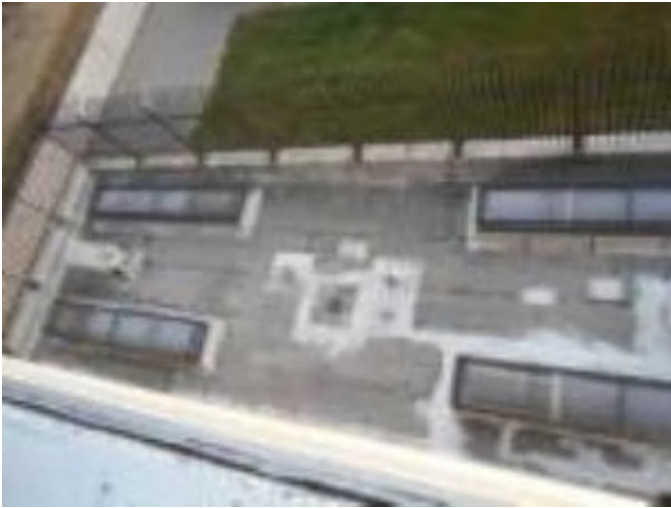
Location: Roof

System: B3020 - Roof Openings

Distress: Beyond Service Life

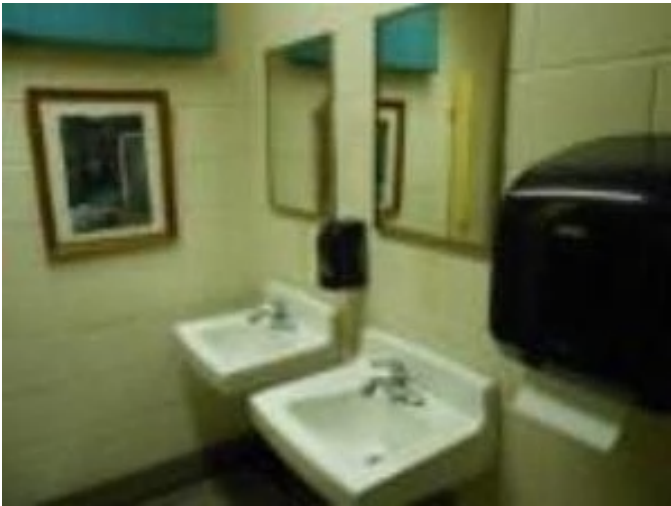
Location: Throughout the building

System: C1010 - Partitions

Distress: Accessibility

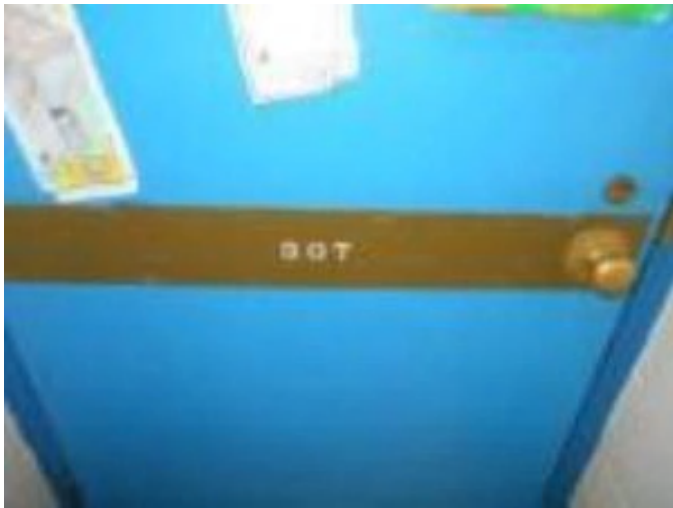
Location: Throughout the building

System: C1020 - Interior Doors

Distress: Beyond Service Life

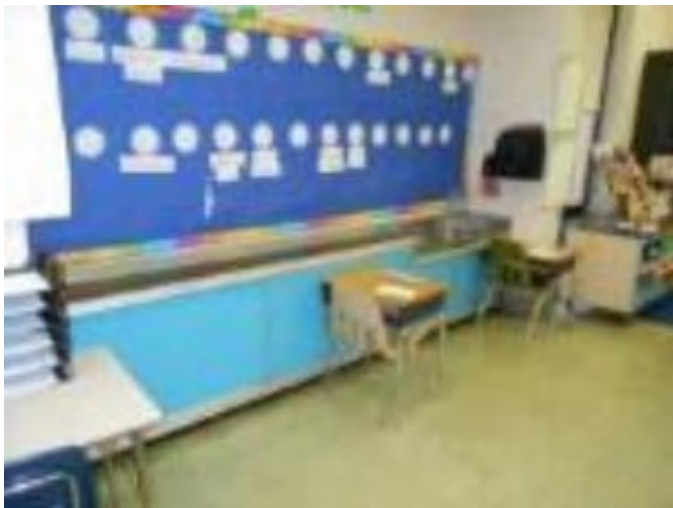
Location: Classrooms

System: C1030 - Fittings

Distress: Inadequate

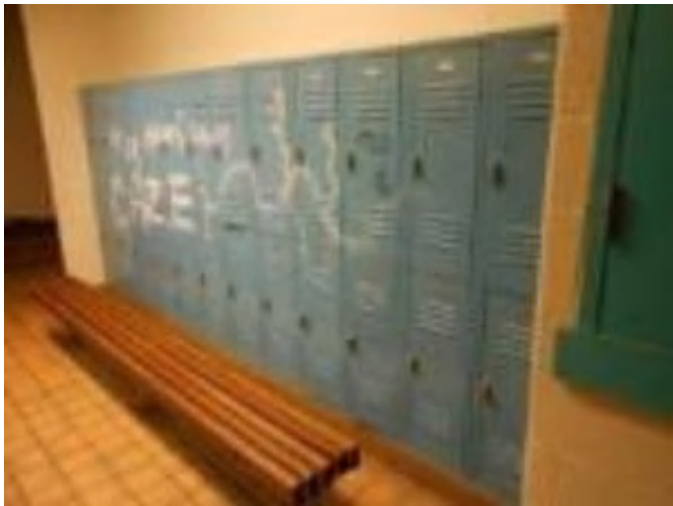
Location: Locker rooms and staff areas

System: C1030 - Fittings

Distress: Beyond Service Life

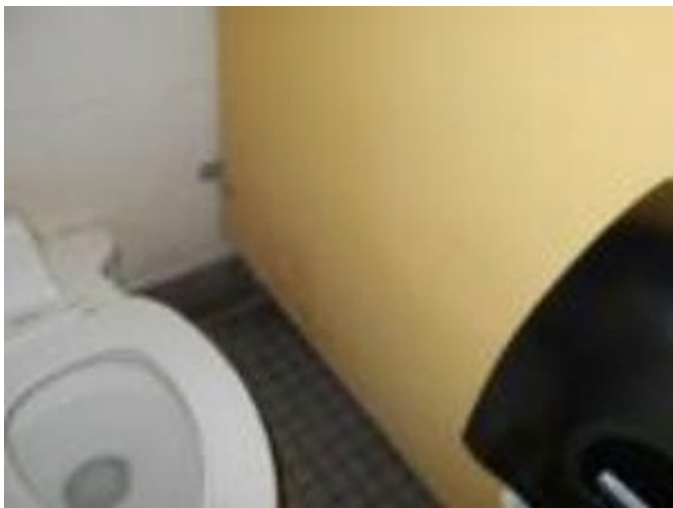
Location: Restrooms

System: C1030 - Fittings

Distress: Damaged

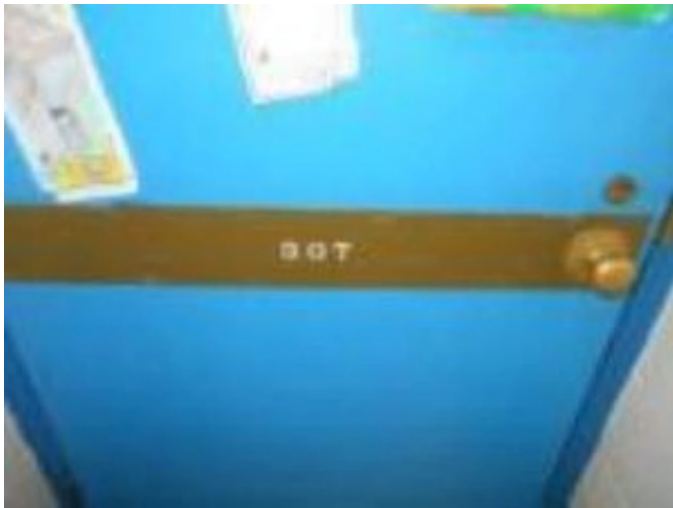
Location: Throughout the building

System: C1030 - Fittings

Distress: Inadequate

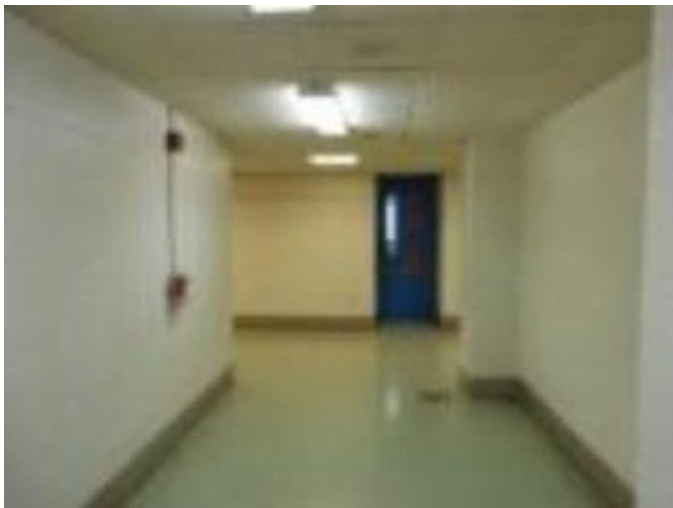
Location: Throughout the building

System: C3010230 - Paint & Covering

Distress: Appearance

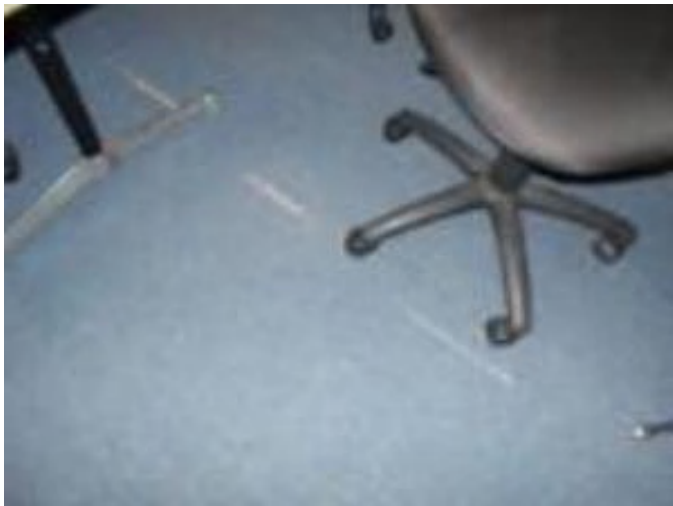
Location: Administrative

System: C3020411 - Carpet

Distress: Damaged

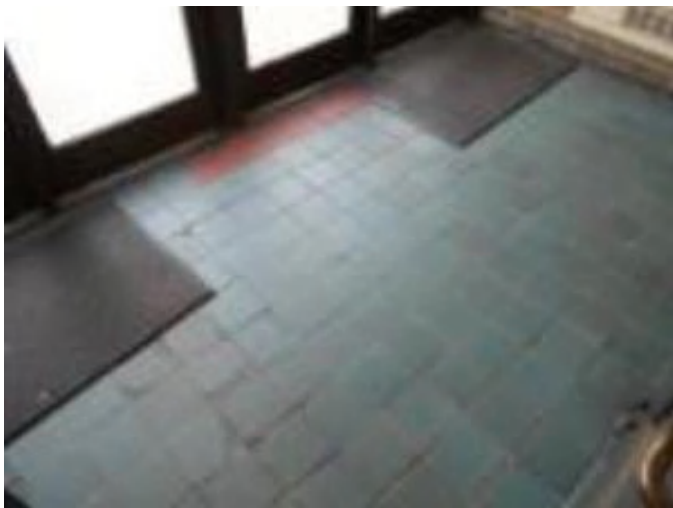
Location: Lobby

System: C3020412 - Terrazzo & Tile

Distress: Beyond Service Life

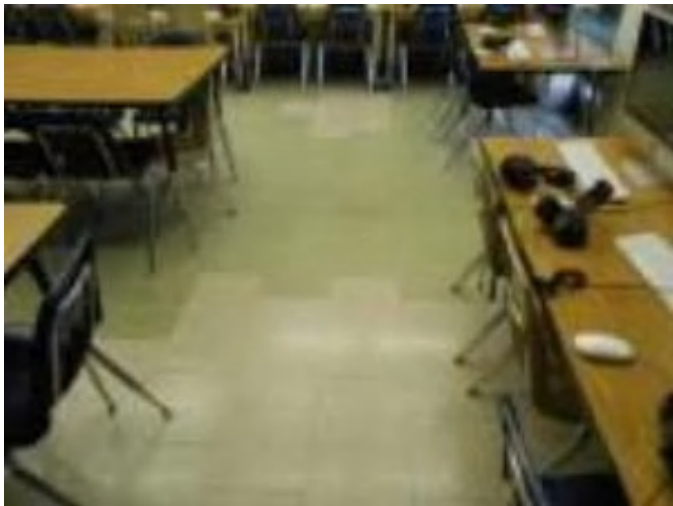
Location: Throughout the building

System: C3020413 - Vinyl Flooring

Distress: Beyond Service Life

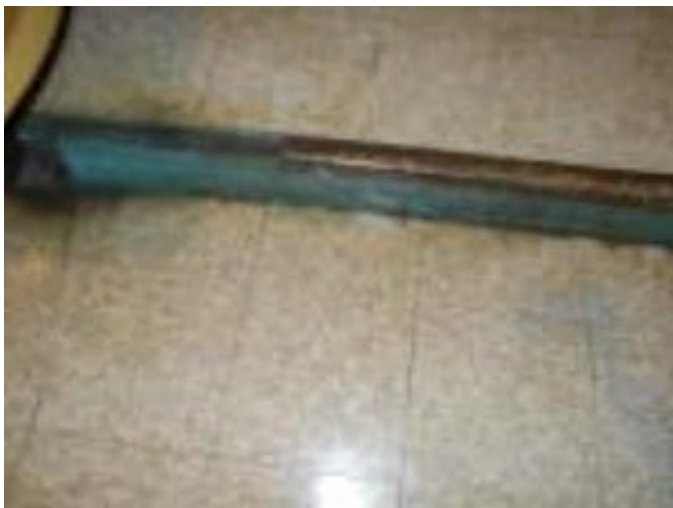
Location: Auditorium

System: C3020413 - Vinyl Flooring

Distress: Beyond Service Life

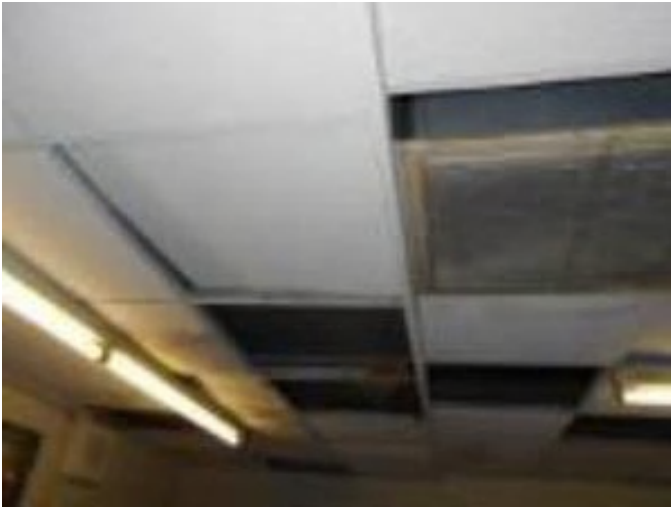
Location: Ceilings

System: C3030 - Ceiling Finishes

Distress: Appearance

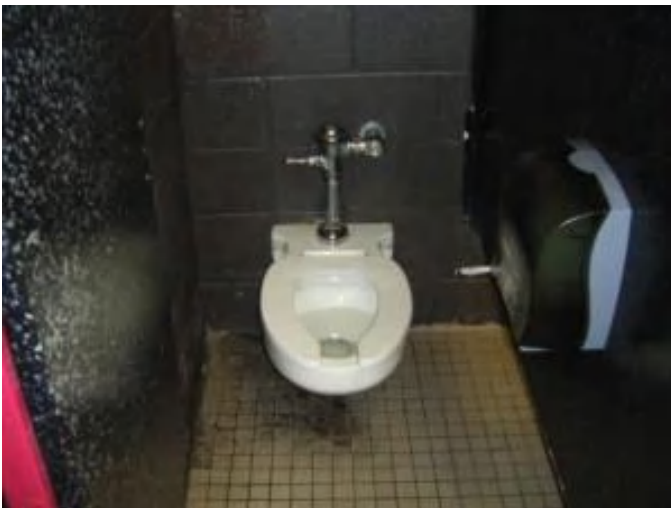
Location: Restrooms

System: D2010 - Plumbing Fixtures

Distress: Beyond Service Life

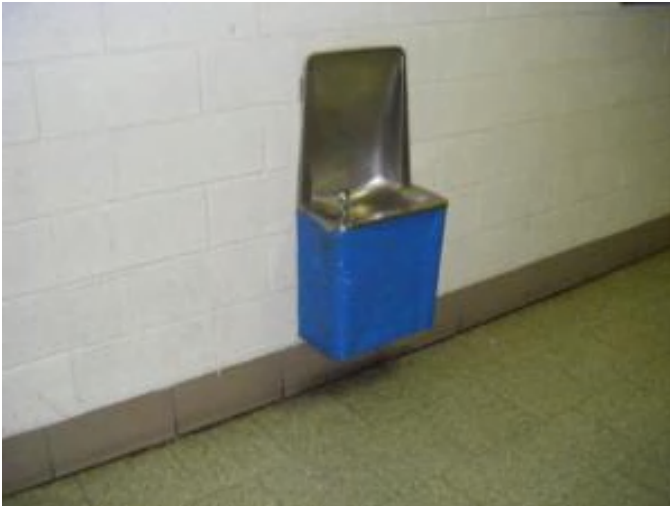
Location: Corridors

Drinking fountains (2 per floor) in the corridors of the Ground and 1st Floors are the original wall hung with integral refrigerated coolers. They are well beyond their service life and should be replaced; most are NOT accessible type.

System: D2010 - Plumbing Fixtures

Distress: Accessibility

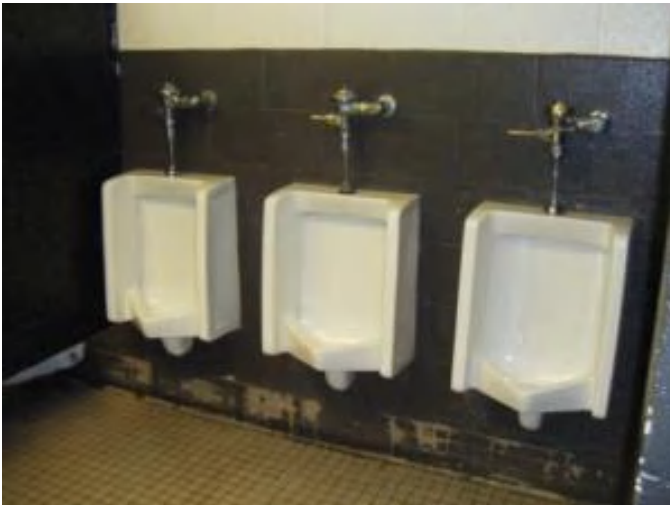
Location: Restrooms

System: D2010 - Plumbing Fixtures

Distress: Beyond Service Life

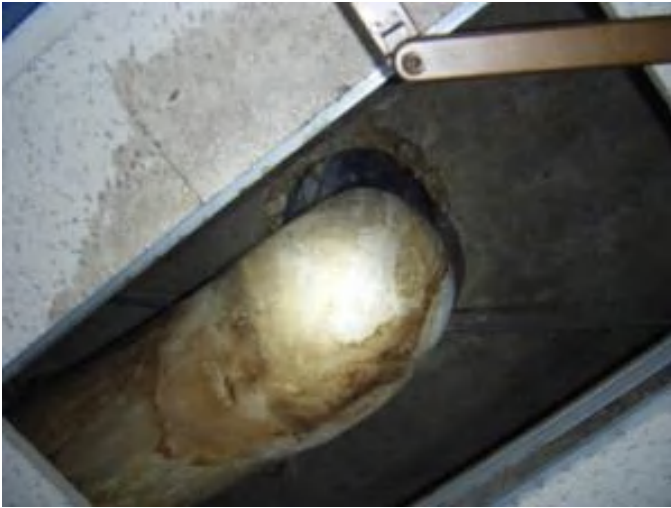
Location: Throughout Building

System: D2040 - Rain Water Drainage

Distress: Failing

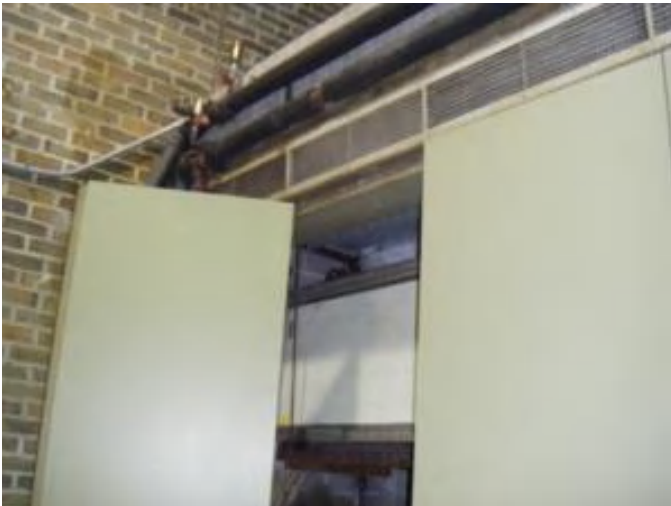
Location: Gymnasium

System: D3040 - Distribution Systems

Distress: Damaged

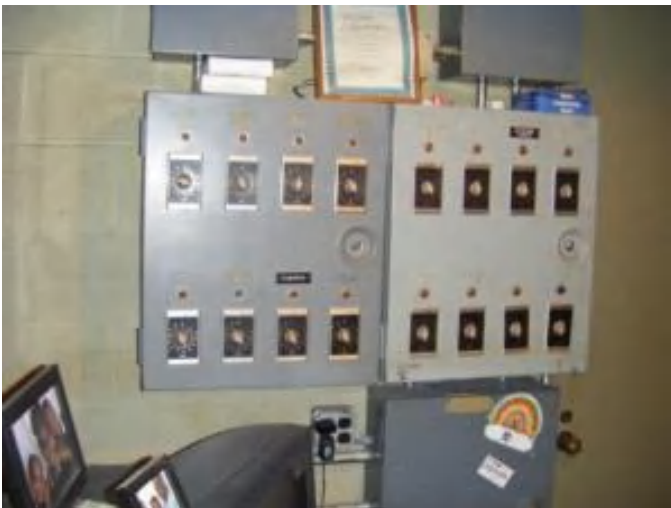
Location: Throughout Building

boiler room. The maintenance staff reports a failure of the compressor blow down mechanism had allowed the system to be contaminated with oil, moisture and dirt in the pneumatic copper tubing causing the small rubber gaskets and tubing connections at devices to become brittle and fail prematurely. The pneumatic systems are beyond their service life and require too much attention from the maintenance staff. The original control valves, dampers and pneumatic actuators are over 35 years old and should be rebuilt or replaced. These controls should be converted to DDC.

System: D3060 - Controls & Instrumentation

Distress: Failing

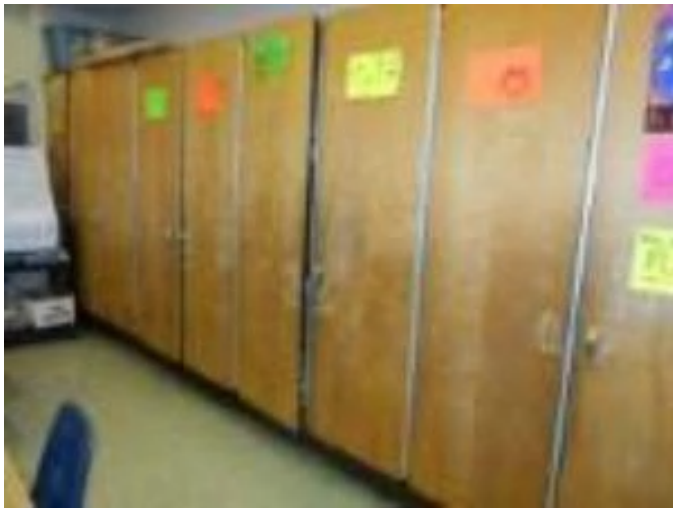
Location: Classrooms

System: E1020 - Institutional Equipment

Distress: Damaged

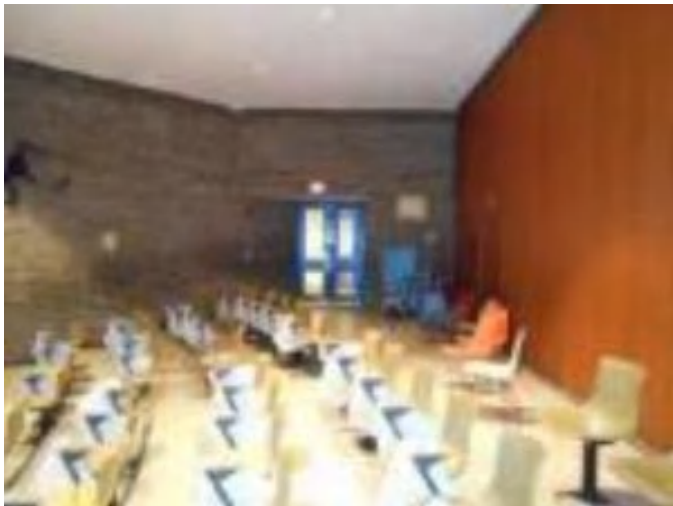
Location: Auditorium

System: E2010 - Fixed Furnishings

Distress: Beyond Service Life

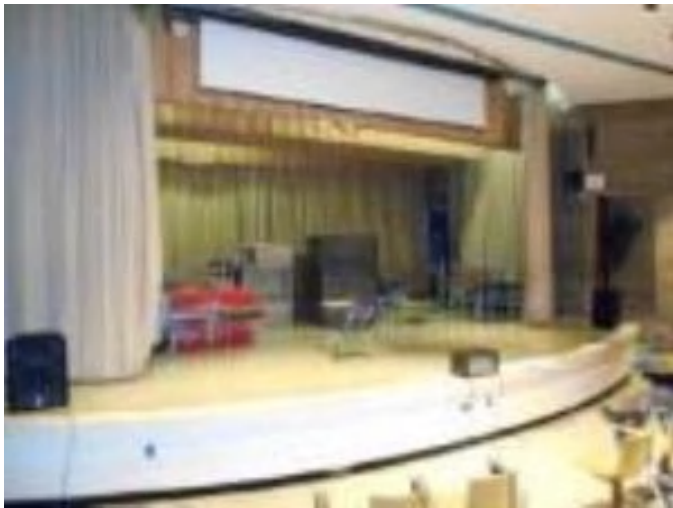
Location: Auditorium

System: E2010 - Fixed Furnishings

Distress: Beyond Service Life

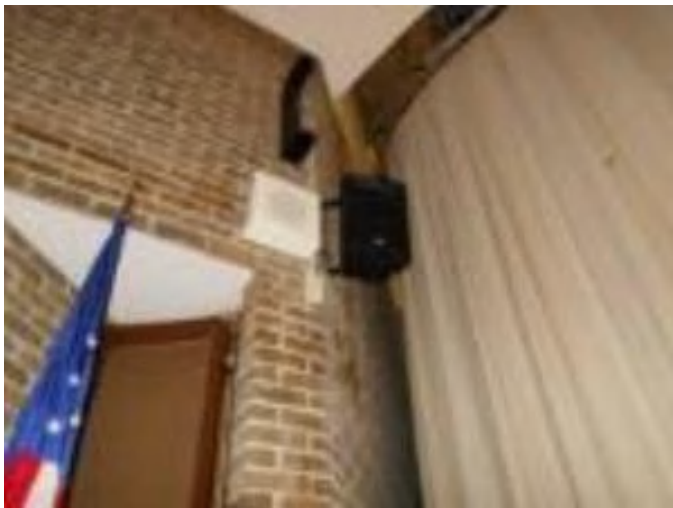
Location: Auditorium

System: E2010 - Fixed Furnishings

Distress: Beyond Service Life

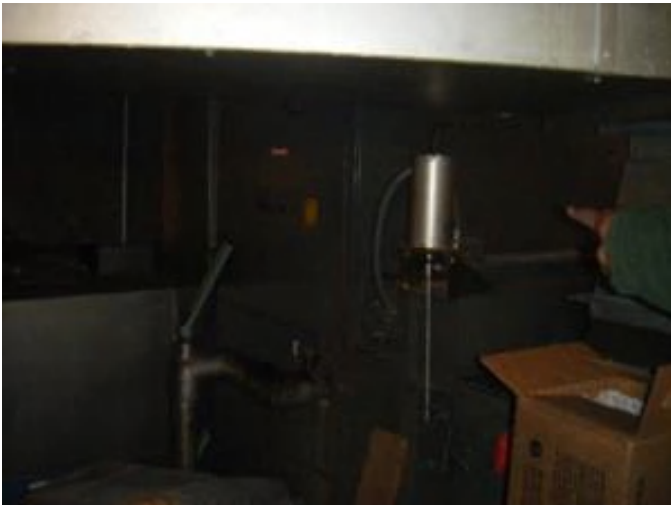
Location: Main Offices

System: D3040 - Distribution Systems

Distress: OSHA

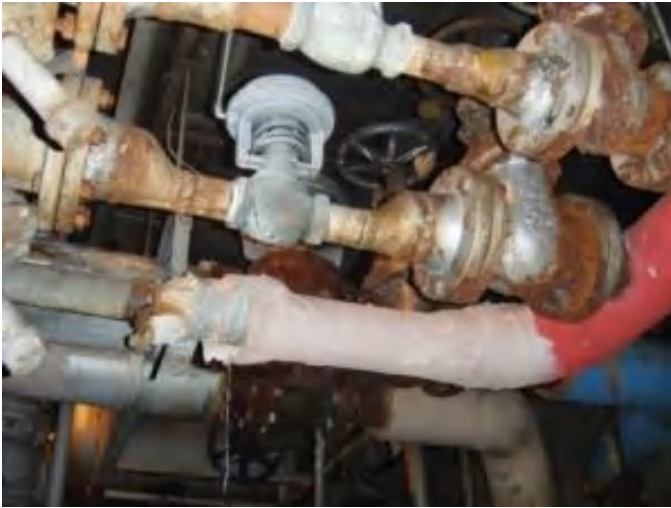
Location: Throughout Building

System: D3040 - Distribution Systems

Distress: Beyond Service Life

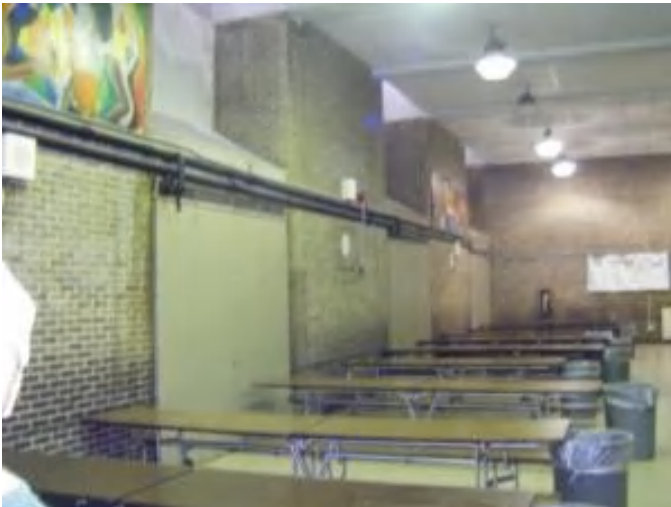
Location: Cafeteria

System: D3040 - Distribution Systems

Distress: Damaged

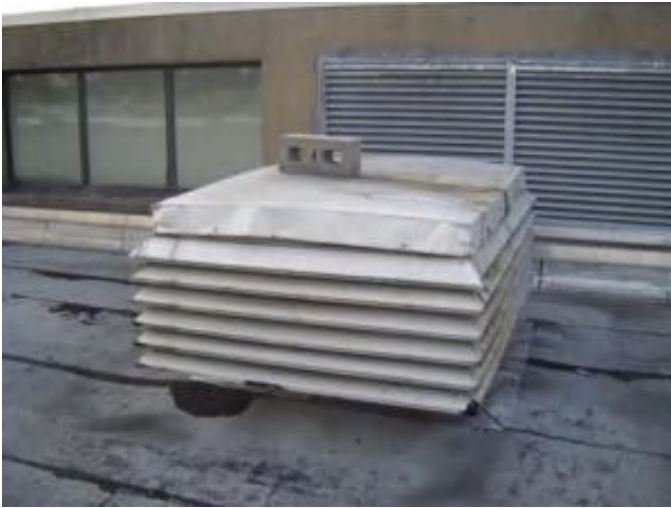
Location: Roof

System: D3040 - Distribution Systems

Distress: Damaged

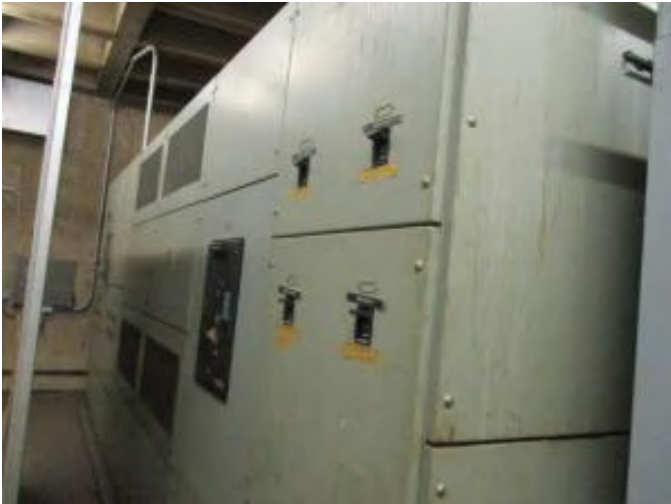
Location: Basement

System: D5010 - Electrical Service/Distribution

Distress: Beyond Service Life

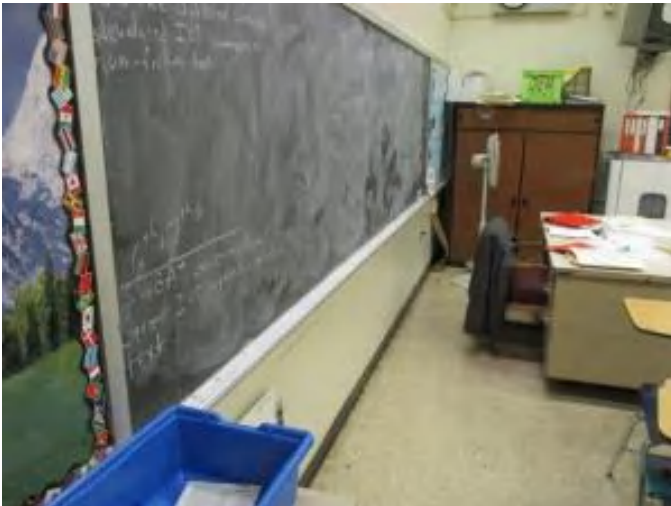
Location: Entire Building

System: D5020 - Lighting and Branch Wiring

Distress: Inadequate

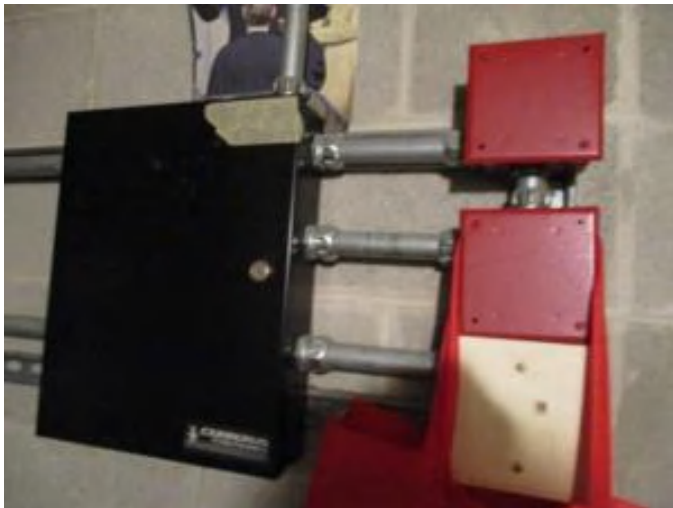
Location: Entire Building

System: D5030 - Communications and Security

Distress: Life Safety / NFPA / PFD

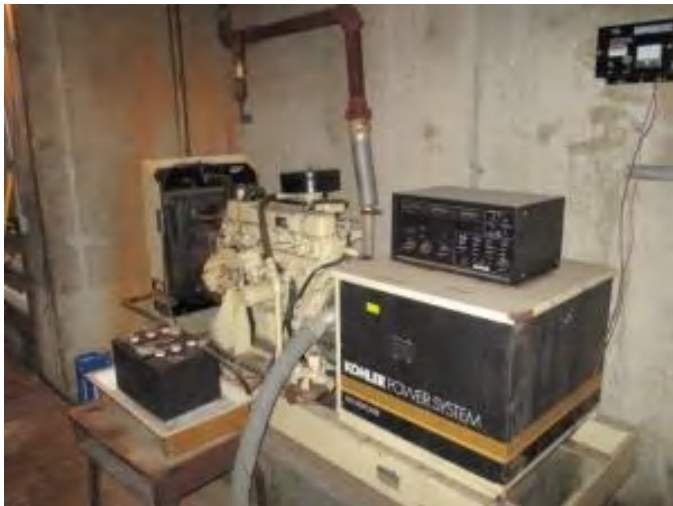
Location: Outdoor

System: D5090 - Other Electrical Systems

Distress: Inadequate

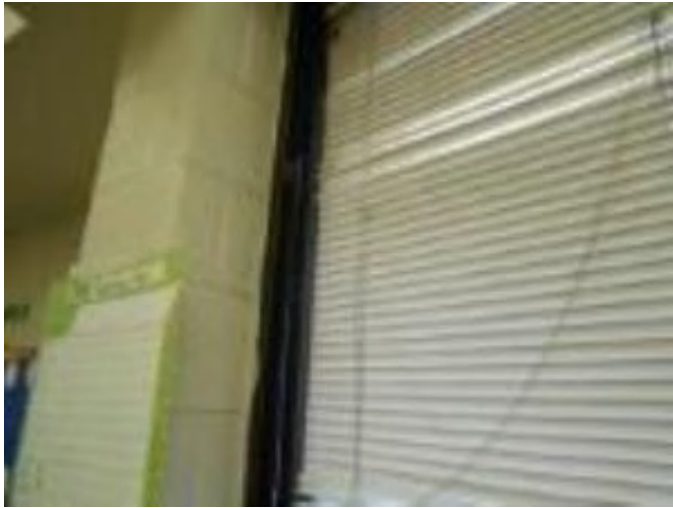
Location: Exterior windows

System: E2010 - Fixed Furnishings

Distress: Damaged

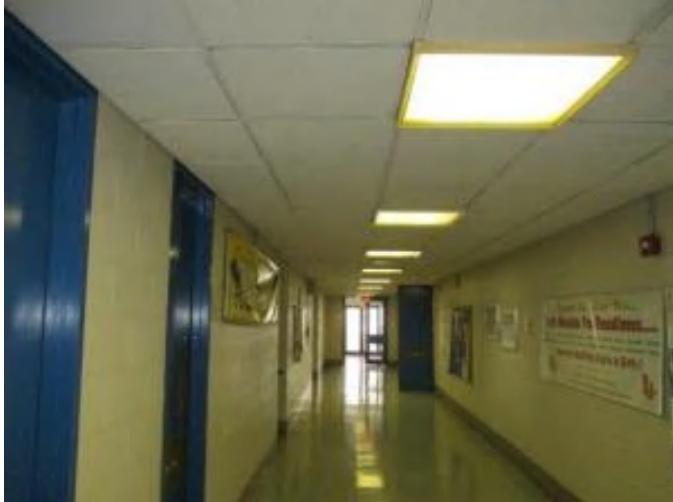
Location: Entire Building

System: D5030 - Communications and Security

Distress: Security Issue

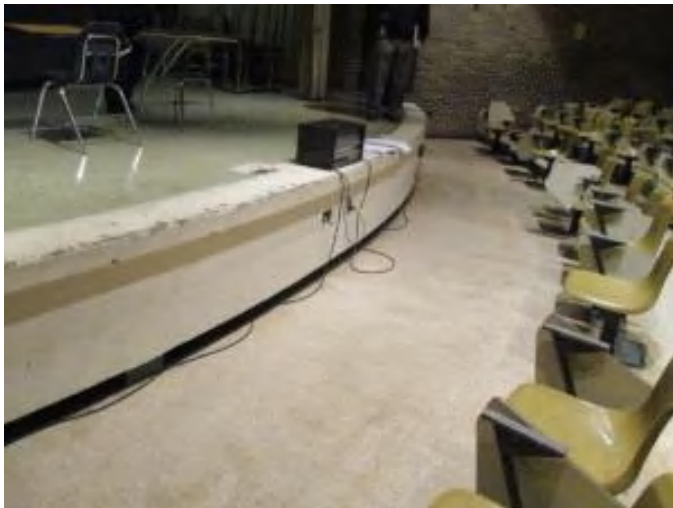
Location: Auditorium

System: D5030 - Communications and Security

Distress: Inadequate

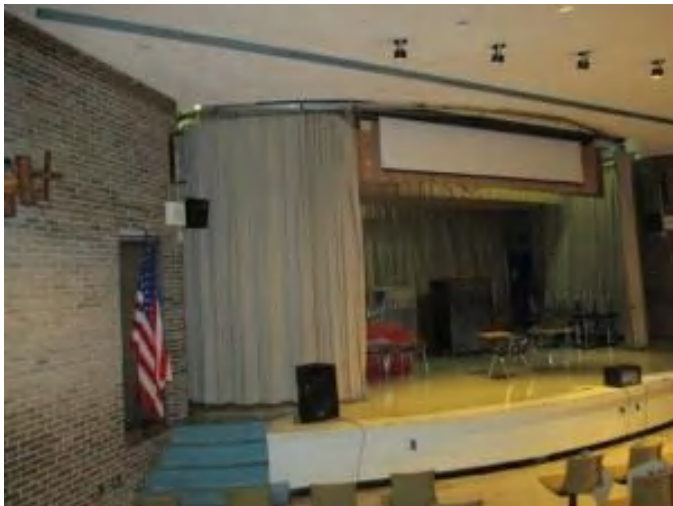
Location: Auditorium

System: E1020 - Institutional Equipment

Distress: Obsolete

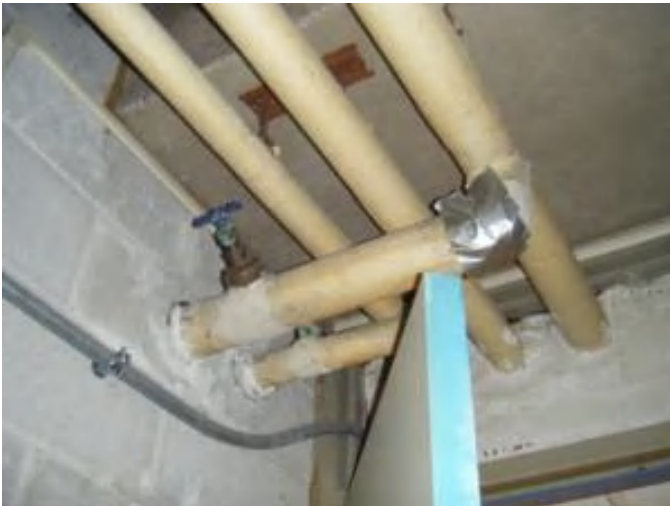
Location: Throughout Building

System: D2020 - Domestic Water Distribution

Distress: Beyond Service Life

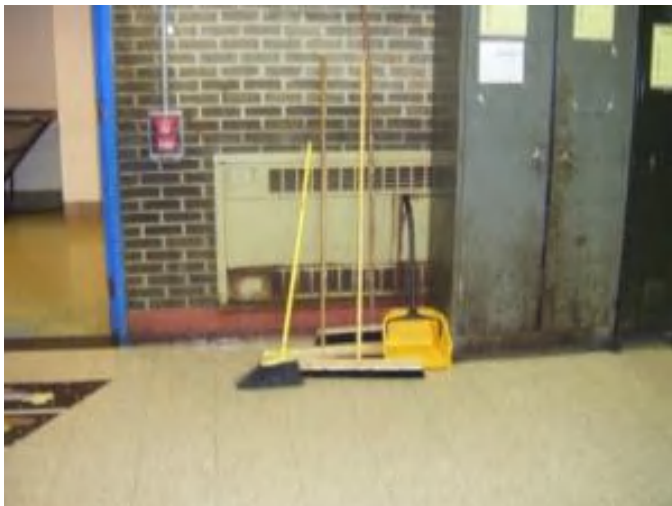
Location: Throughout Building

System: D3040 - Distribution Systems

Distress: Damaged

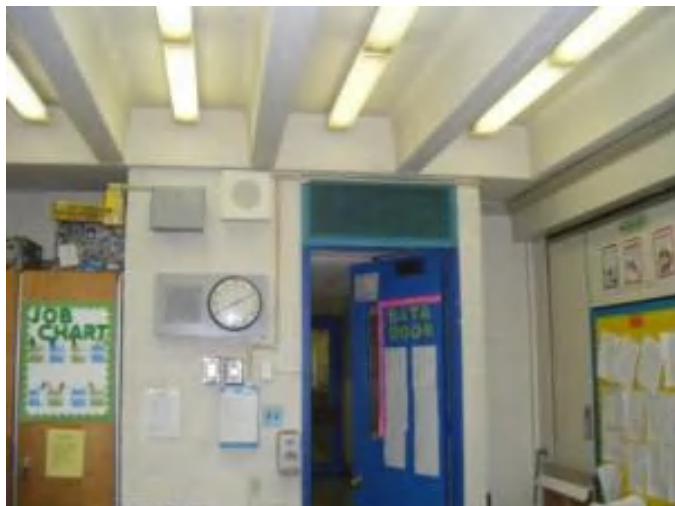
Location: Throughout Building

System: D4010 - Sprinklers

Distress: Inadequate

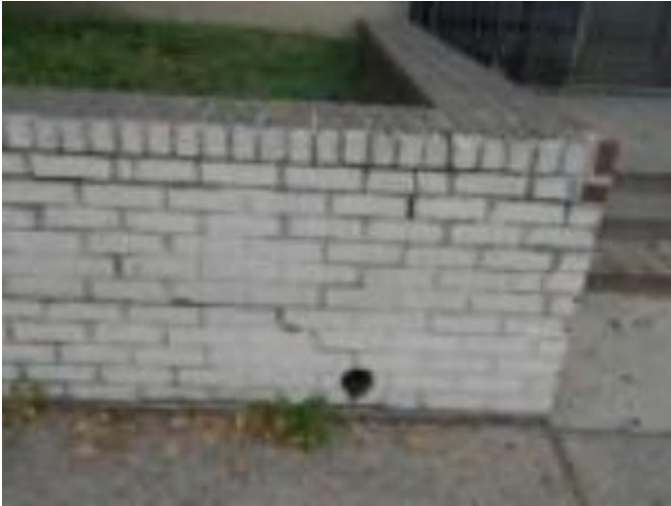
Location: Site retaining walls

Retaining walls are typically brick faced. Some are painted. A mural decorates the low retaining wall south of the main entrance facing Spruce St. Retaining walls are in fair condition with some cracking noted. Low brick site walls, some with brick columns with picket fencing to 6' are located around the playground and at the north end of the parking lot. Chain link fence is located atop the retaining wall at the west side of the parking lot and is in good condition. Picket fencing with outward curving spikes surround exterior mechanical equipment. Other site features include bollards, bicycle racks and a flagpole. Site signage is inadequate.

System: G2040 - Site Development

Distress: Failing

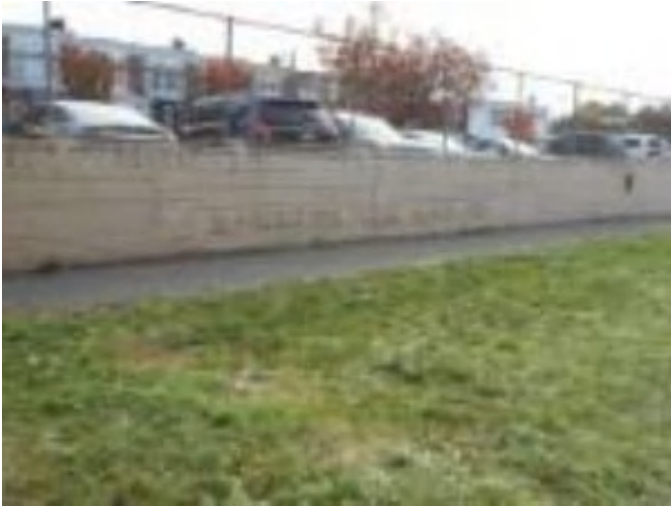
Location: Steps

System: G2040 - Site Development

Distress: Beyond Service Life

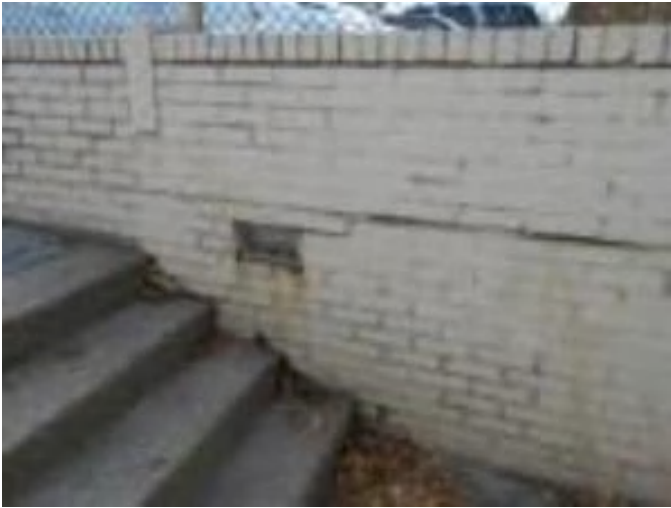
Location: Site Steps

System: G2040 - Site Development

Distress: Failing

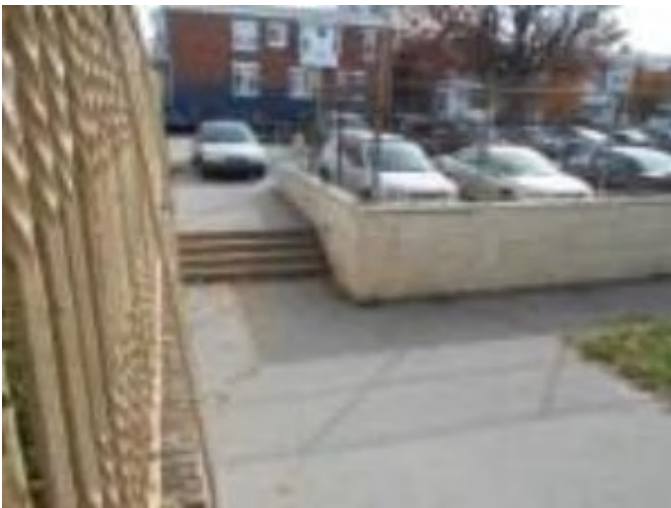
Location: Entrance

System: G2040 - Site Development

Distress: Inadequate

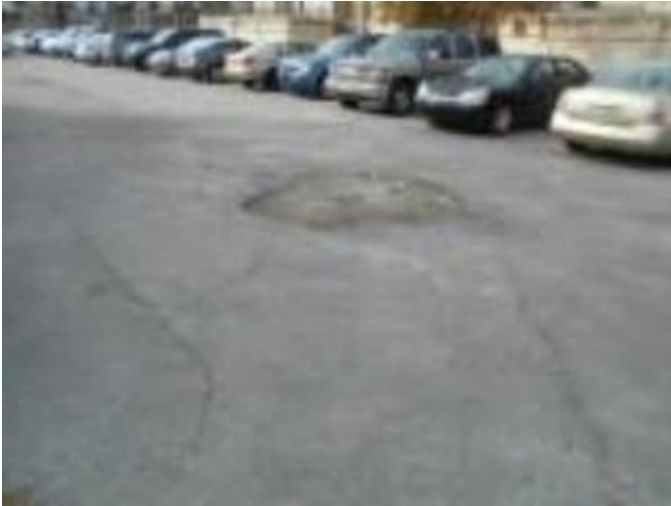
Location: Parking lot

System: G2020 - Parking Lots

Distress: Failing

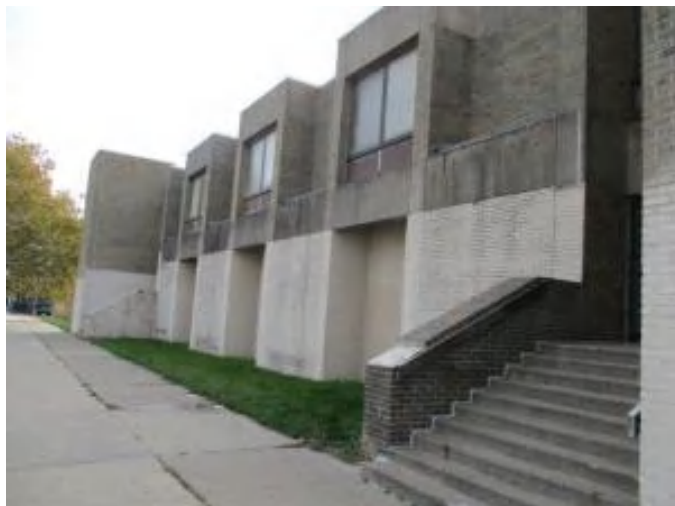
Location: Outdoor

System: G4030 - Site Communications & Security

Distress: Security Issue

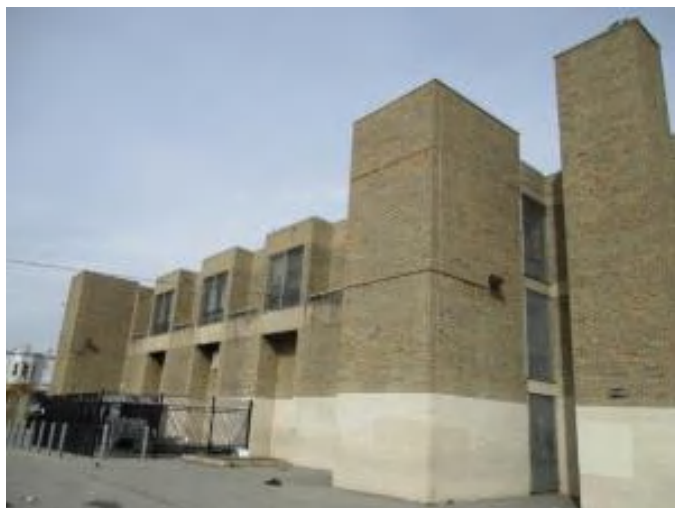
Location: Building Perimeter

System: G4030 - Site Communications & Security

Distress: Inadequate
