Anne Frank Elementary School

Addition and Major Renovation Scope Determination Report

October 10, 2018

School District of Philadelphia
Office of Capital Programs
440 N. Broad Street, 3rd Floor
Philadelphia, PA 19130

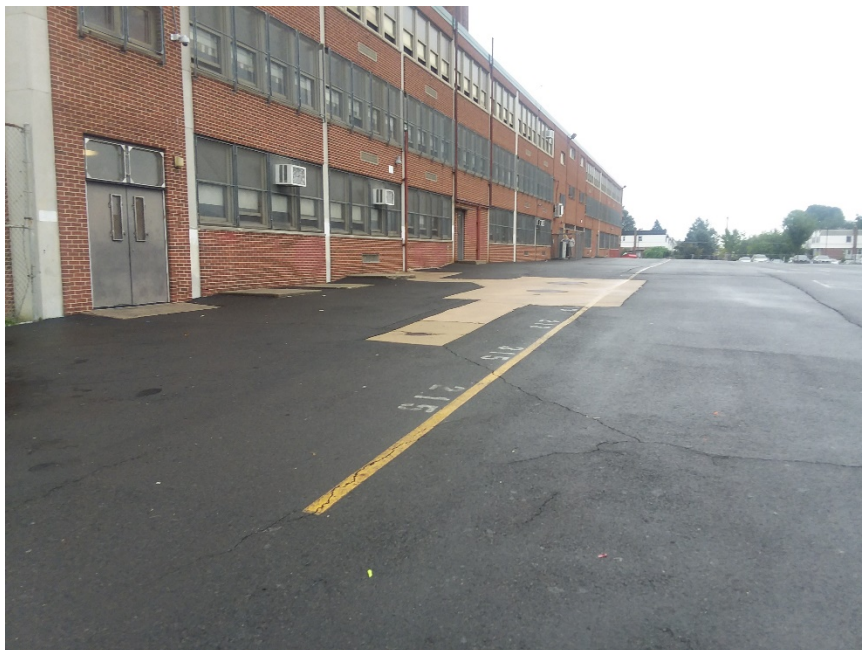
View looking east showing underground storage tanks.

- a. Excavation, earthwork and grading for new foundation of addition
- b. New foundation for addition(s)
- c. Utility connections and new lines to/from street
- d. Utility connections from ex. building to new addition
- e. Relocation or removal of underground storage tanks

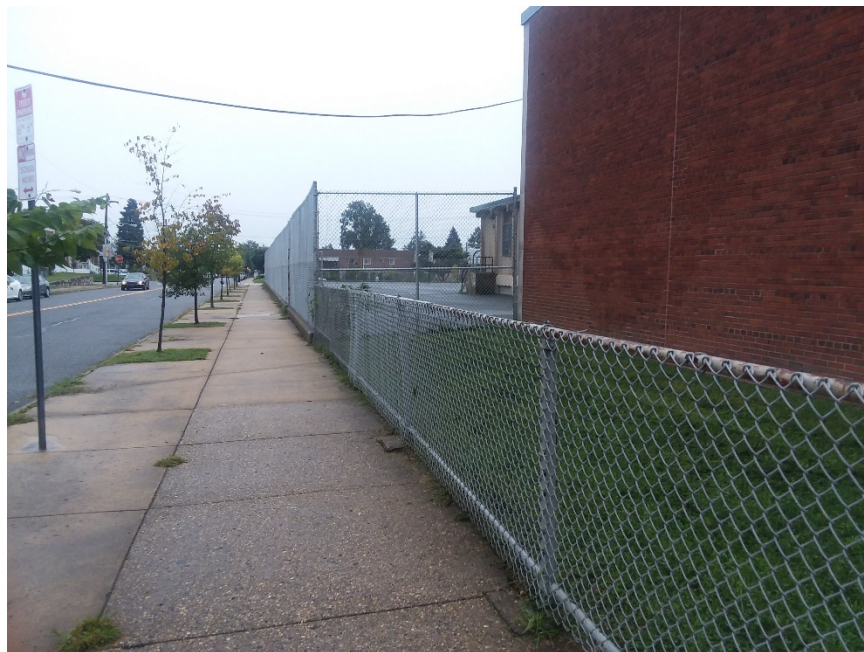
View of existing fence along Bowler Street.

- a. Perimeter fencing upgrades may include partial or full replacement or modification of existing. Select repairs may be required for concrete fence base wall.
- b. New dumpster fence enclosure per SDP standards

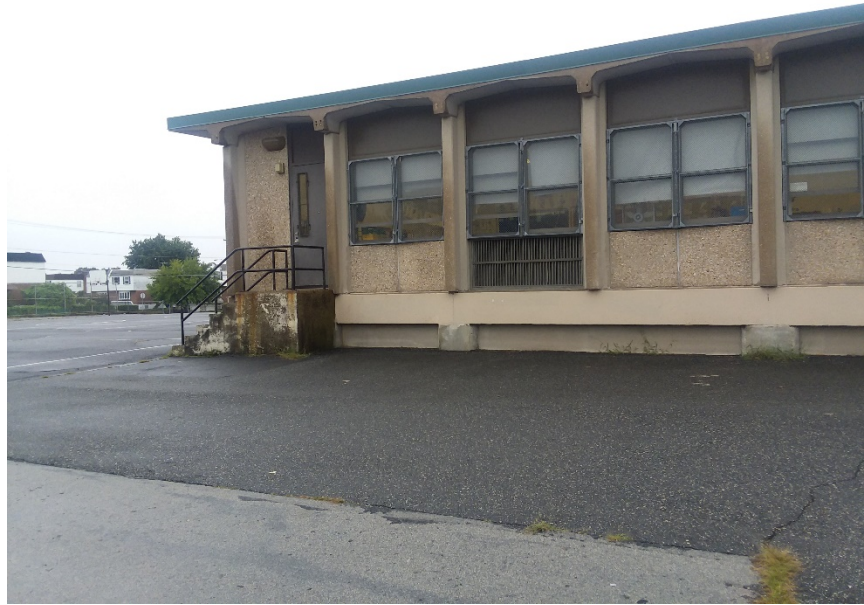
View of existing modular building.

- a. Demolish modular building and associated concrete foundation.
- b. Disconnect and cap active utilities feeding the modular building including power.
- c. E&S measures must be provided in compliance with Philadelphia Water Department's regulations.

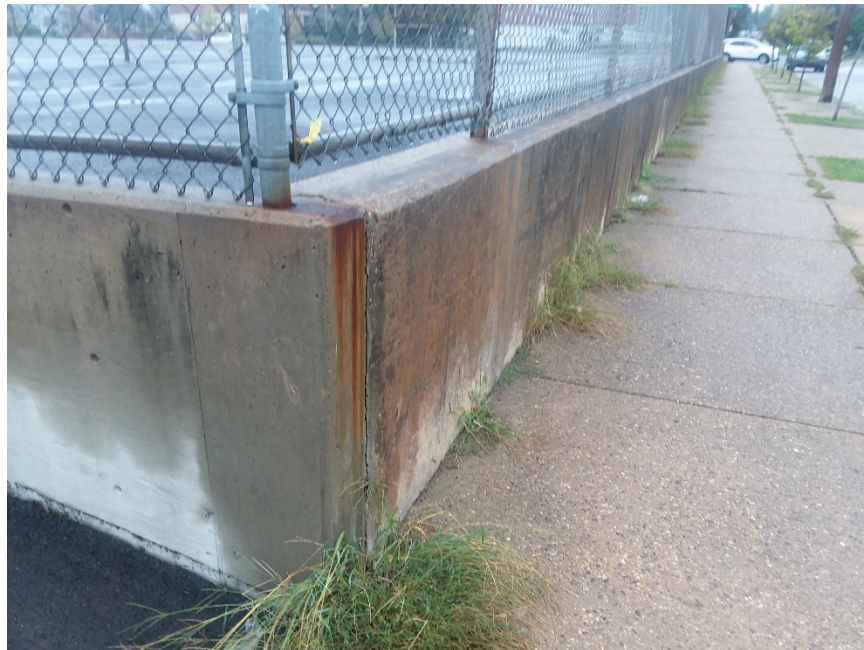
View of existing fence wall along Clark Street.

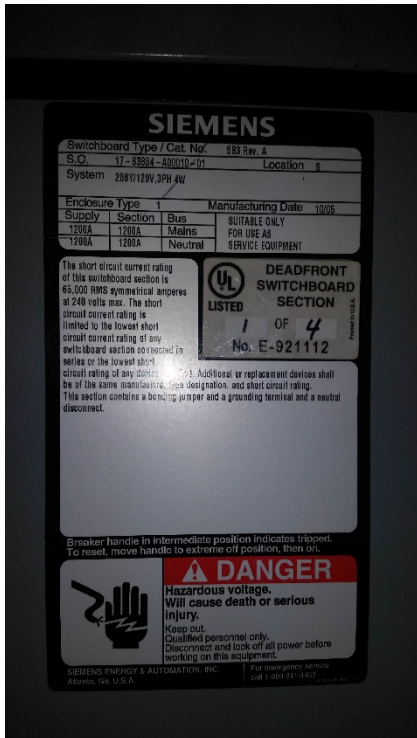
Main Switchboard Nameplate

The existing electric service is rated at 1200A, 208V/120V, 3 phase and 4 wire. According to PECO energy bills, the peak demand in the past one year was 137.6KW. The main switchboard is in good condition and has spaces that can accommodate new loads.

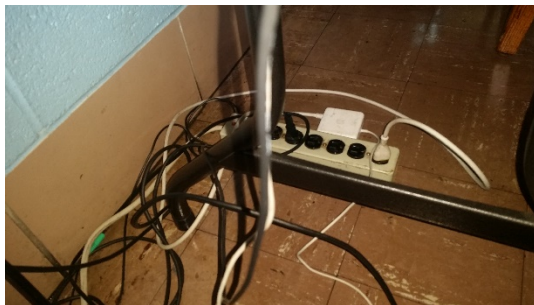
Insufficient Power Receptacles

2. Provide new receptacle and lighting panels as needed to modernize the existing classrooms per SDP ideal classroom device layout.
3. Modernize classroom with sufficient power receptacles per school district classroom minimum receptacle layout.
4. Retrofit or replace antiquated electrical panels that can no longer be maintained due to lack of parts and components.
5. Provide electrical connections to architectural and mechanical modifications in this report.
6. The design consultant shall provide detailed survey, floor plans, riser and specifications.
7. The design consultant shall commission a licensed electrician to open switchboard and panels to ensure that the final electrical design is feasible while reusing the existing equipment, devices and circuiting.

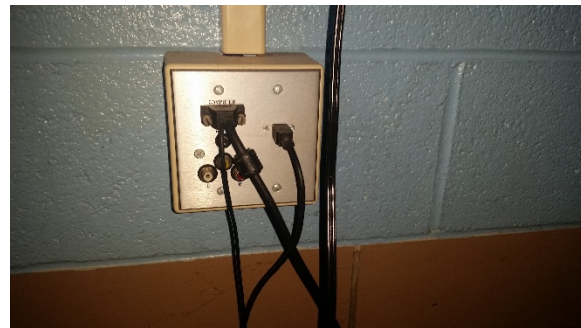
Antiquated AV receptacles

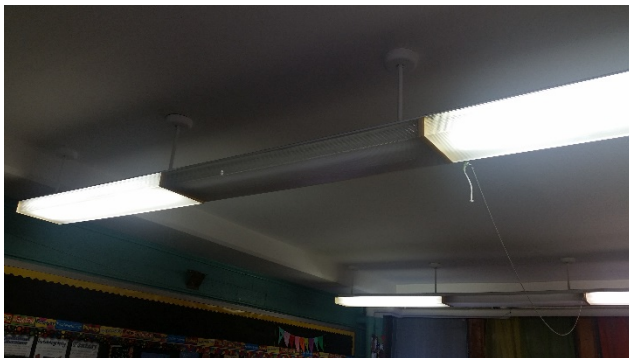
Typical Classroom Lighting

The existing building interior lighting system is mostly fluorescent lights. The exterior lighting system is high intensity discharge type. The exit signs are incandescent or compact fluorescent type.

1. Replace all incandescent exit signs with white thermoplastic LED exit signs and connect to generator source.
2. Replace lighting fixtures with new LED lighting fixtures throughout the existing building and provide lighting controls to comply with Philadelphia energy code. Provide generator power to sufficient number of lights in egress path to provide illumination as required by code.
3. Replace the exterior HID's with LED's equipped with integral photocells.
4. Provide new LED's in new addition with dimmer controls in classrooms. Each classroom shall have minimum 2 lighting control zones. One zone of dimming control over the Interactive Panel Board and rest of the classroom on the second zone of dimming control.
5. The design consultant shall provide detailed survey, floor plans, riser and specifications.

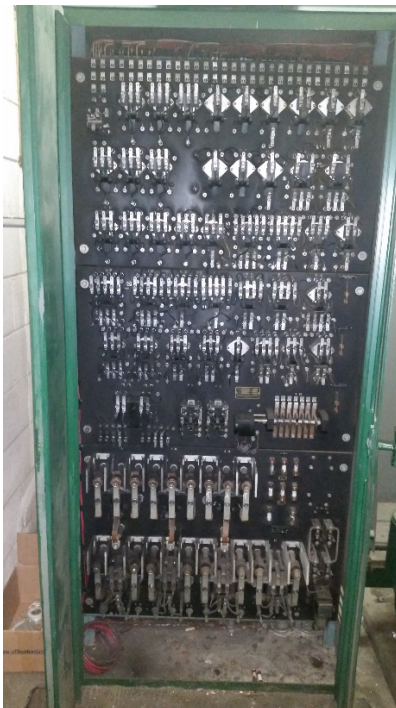
Elevator Control Panel

The existing passenger elevator is antiquated.
