Facility Condition Assessment Summary Report

Vare at Washington Elementary School

S273001; Washington ES

Site Assessment Report

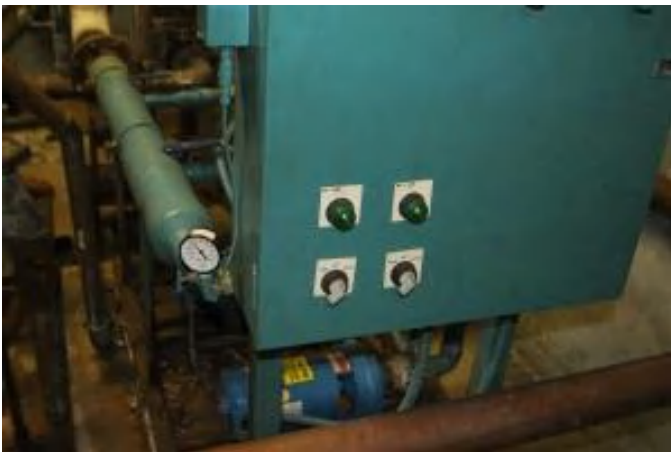
System: D2020 - Domestic Water Distribution

Location: Mechanical room

Distress: Energy Efficiency

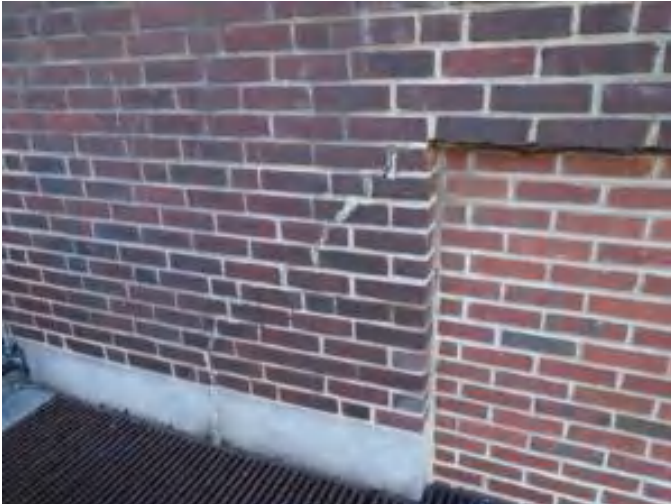
System: B2010 - Exterior Walls

Location: Lower windows

Distress: Building Envelope Integrity

Notes: Replace and repair failing window lintels and surrounding masonry

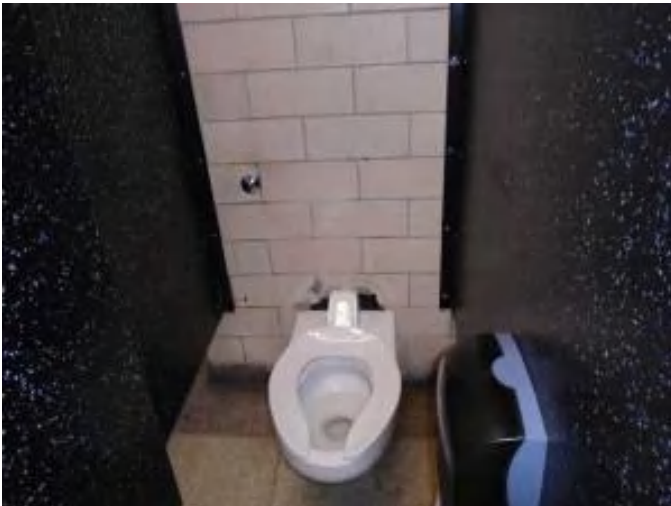
System: C1030 - Fittings

Location: Toilets

Distress: Accessibility

Notes: Provide new toilet partitions and toilet accessories including grab bars for accessibility

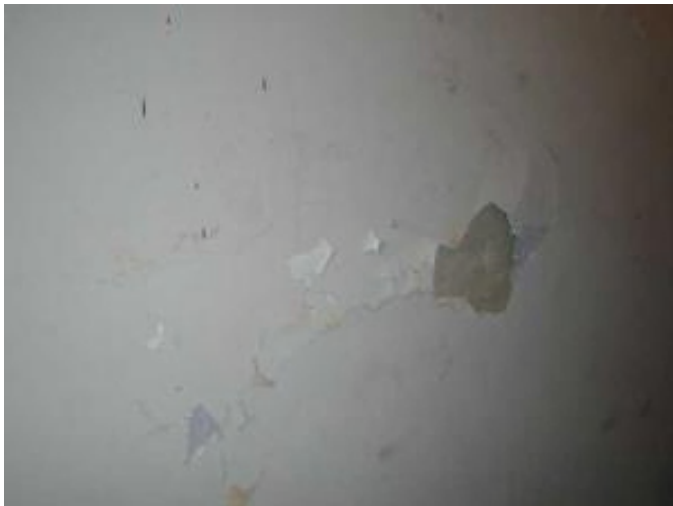
System: C3010230 - Paint & Covering

Location: Various

Distress: Damaged

Notes: Repair and repaint interior walls (5% of painted wall surface)

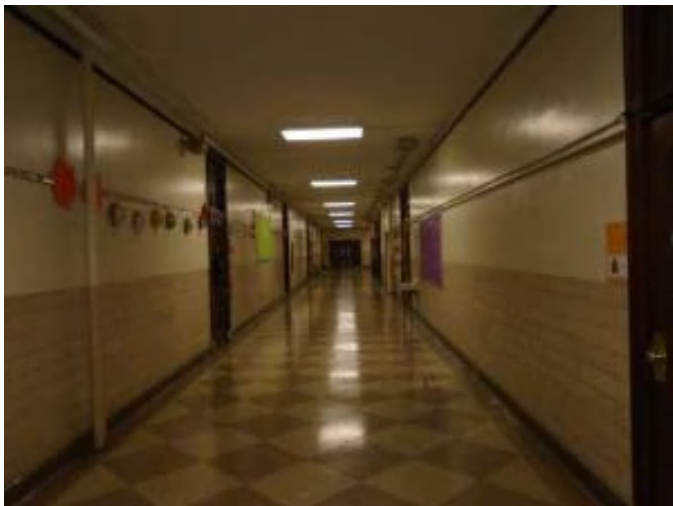
System: C3030 - Ceiling Finishes

Location: Corridors

Distress: Appearance

Notes: Install suspended acoustic tile ceiling system in corridors for appearance

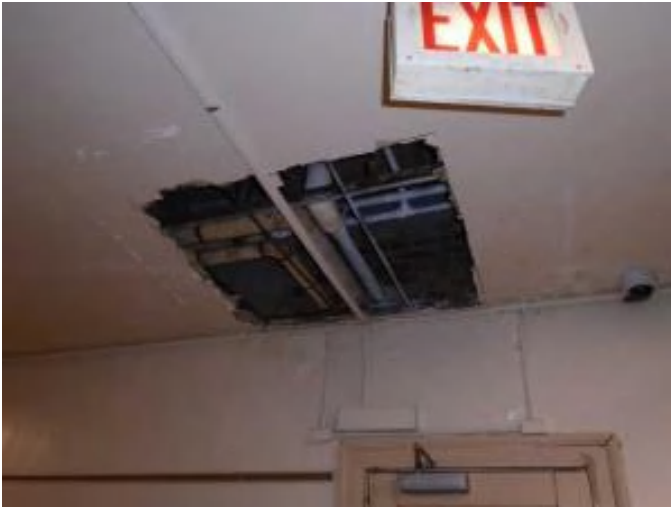
System: C3030 - Ceiling Finishes

Location: Various

Distress: Damaged

Notes: Repair and repaint interior ceiling (10% of painted ceiling surface)

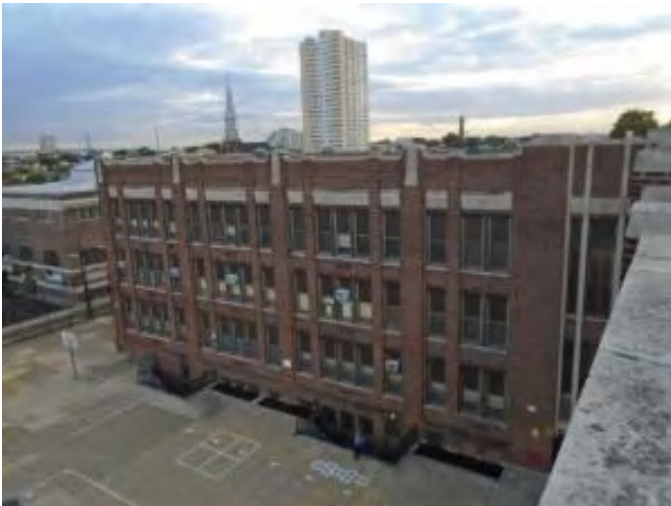
System: D1010 - Elevators and Lifts

Location: TBD

Distress: Accessibility

Notes: Install elevator for accessibility (location TBD)

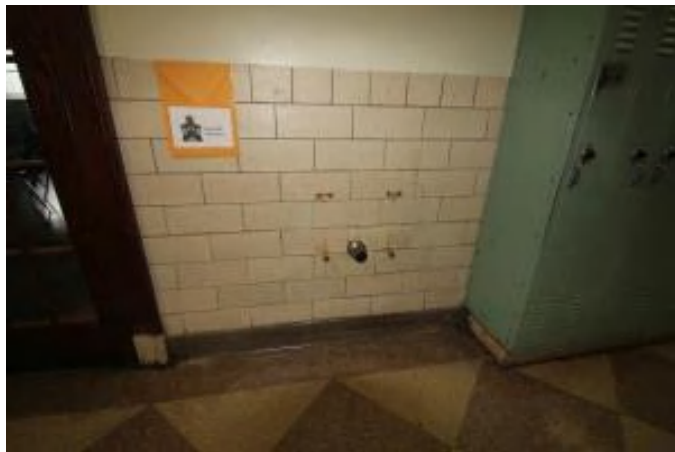
System: D2010 - Plumbing Fixtures

Location: Corridors

Distress: Accessibility

Notes: Replace drinking fountains with accessible ones with chillers

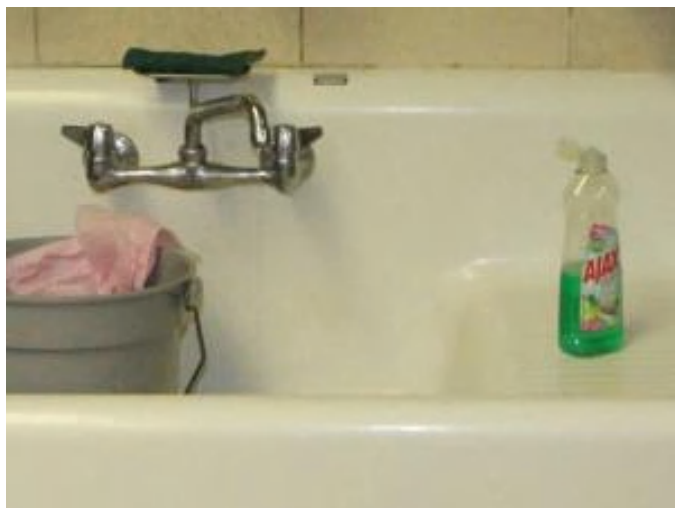
System: D2010 - Plumbing Fixtures

Location: Kitchen, classrooms

Distress: Failing

Correction: Replace lavatory faucet

Notes: Replace head start, kitchen, and science room faucets due to leaks and other operational failures

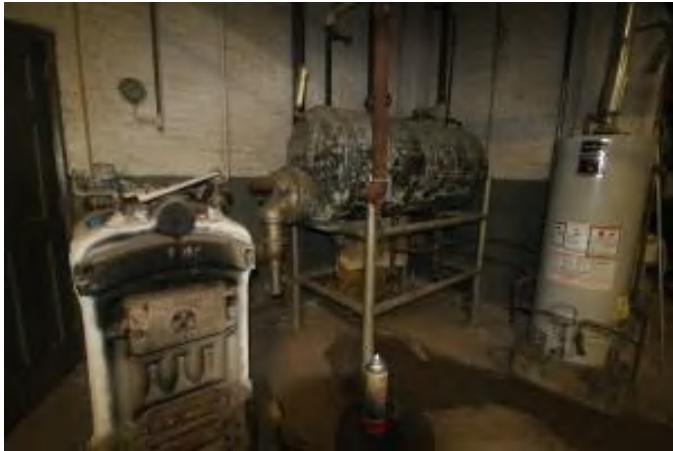
System: D2020 - Domestic Water Distribution

Location: Boiler room

Distress: Energy Efficiency

Notes: Insulate domestic hot water storage tank to conserve energy

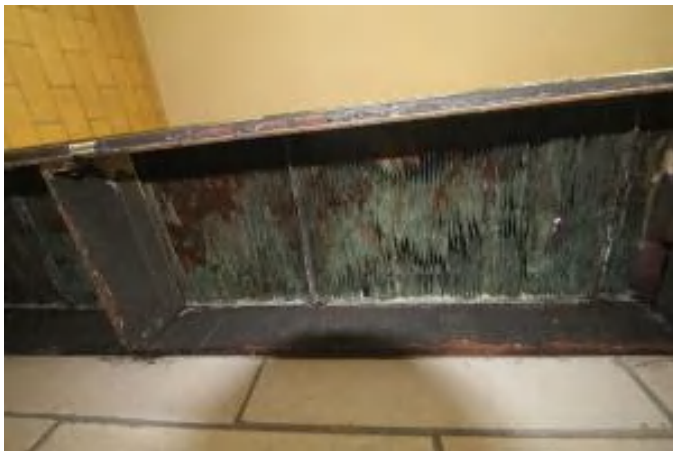
System: D3040 - Distribution Systems

Location: Classrooms, gym

Distress: Beyond Service Life

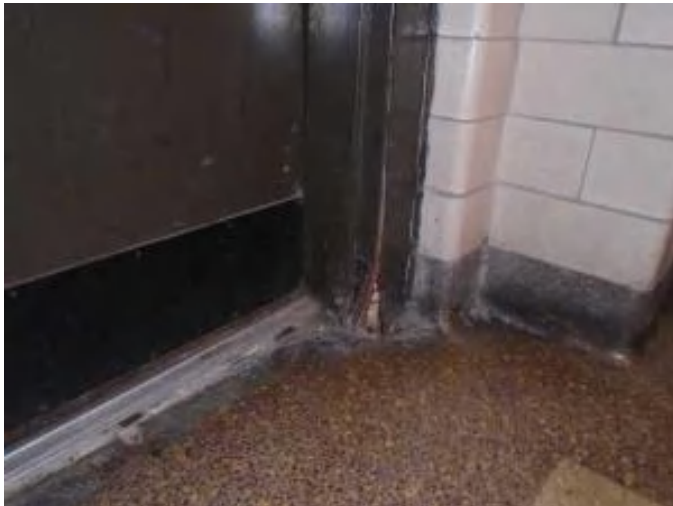
System: B2030 - Exterior Doors

Location: Ext. doors

Distress: Failing

Notes: Replace exterior doors – rusted failing

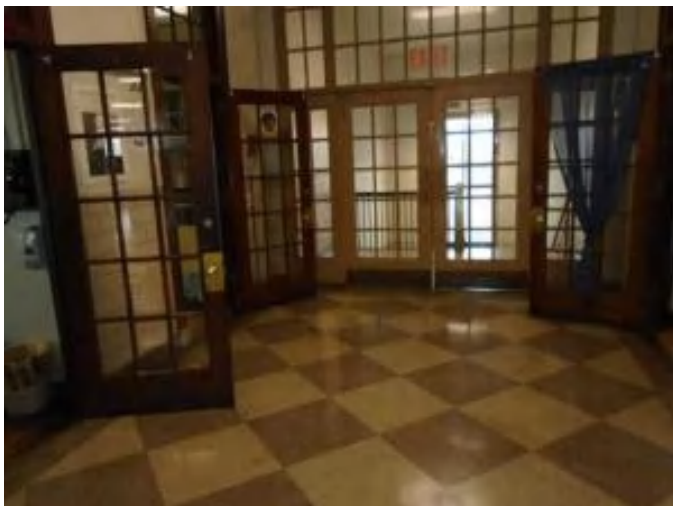
System: C1020 - Interior Doors

Location: Throughout

Distress: Accessibility

Notes: Provide ADA lever handle lock/latchsets on interior doors

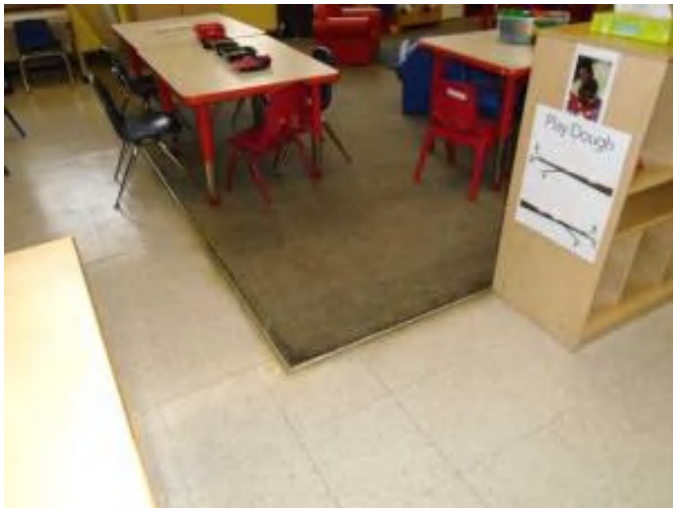
System: C3020411 - Carpet

Location: Kindergarten

Distress: Beyond Service Life

Notes: Replace carpet – beyond service life

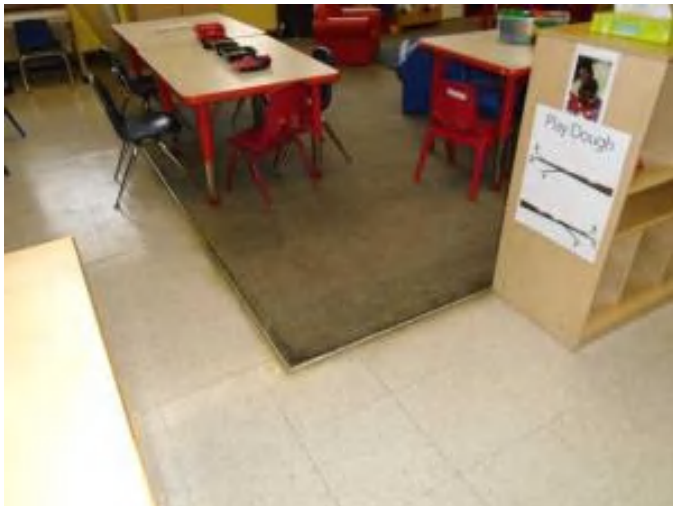
System: C3020413 - Vinyl Flooring

Location: Various

Distress: Beyond Service Life

Notes: Replace VCT flooring – damaged failing (30% of vinyl floor area)

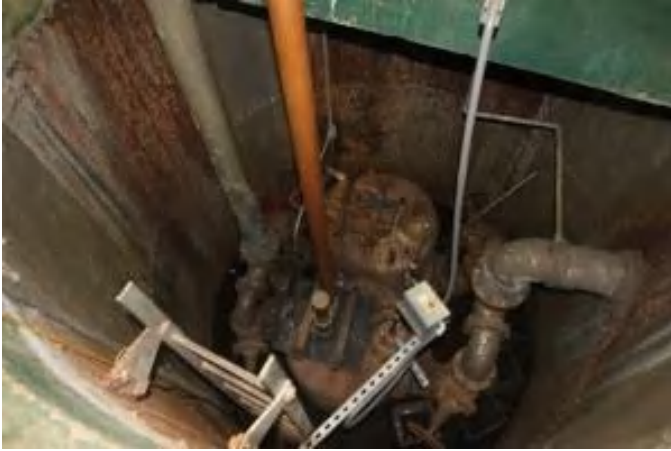
System: D2030 - Sanitary Waste

Sanitary drain piping is both hub and spigot cast iron and threaded galvanized steel. Several sink drains were observed to flow poorly. Some areas of cast iron pipe are very rusty. There were no visible recent repairs. The sanitary drain pipes should be inspected in greater detail and repaired or replaced as needed. There is a sewage ejector in a sump in the basement boiler room. It has 2 collection tanks and one tank is missing the level sensor. The sewage ejector system should be replaced during the drain pipe repairs. Sanitary drainage exits the building in the south side mechanical room in a 6 inch line next to the original air handler.

Location: Entire building

Distress: Failing

Notes: Inspect and repair or replace sanitary drain pipe as needed due to age, operation, and appearance including sewage ejector replacement

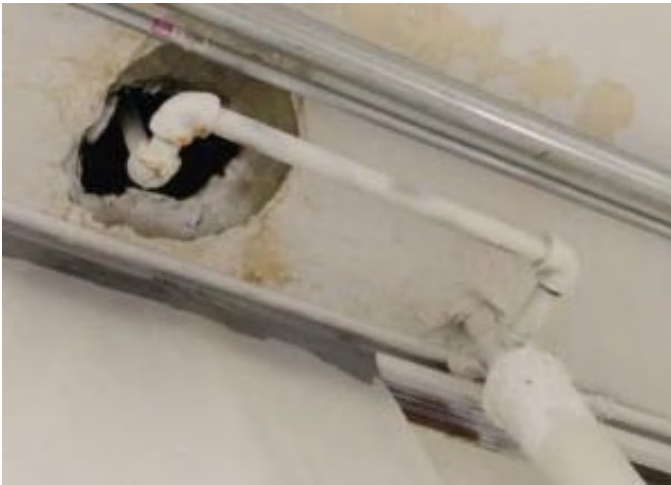
System: D3040 - Distribution Systems

Location: Entire building

Distress: Beyond Service Life

Notes: Inspect and repair steam and condensate pipes due to age

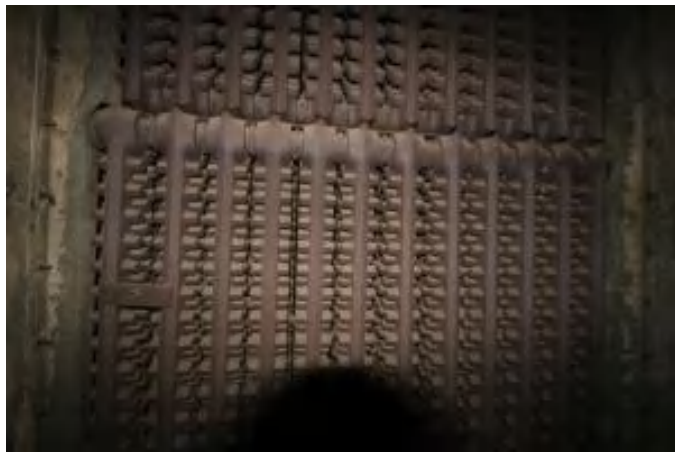
System: D3040 - Distribution Systems

Location: Mechanical room

Distress: Obsolete

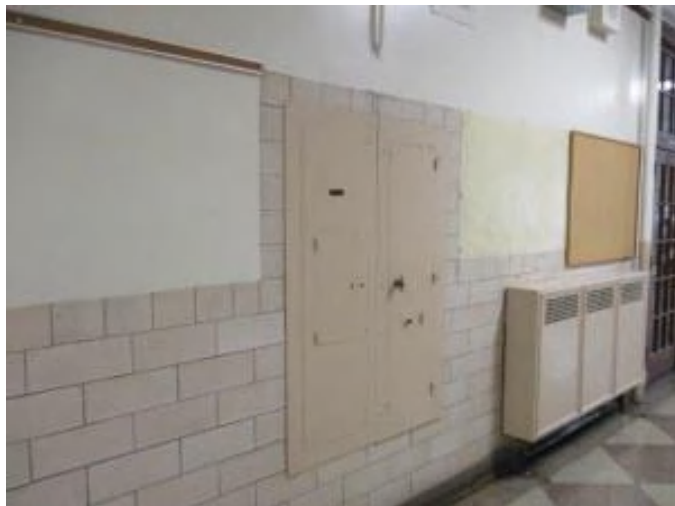
System: D5010 - Electrical Service/Distribution

Location: Entire Building

Distress: Beyond Service Life

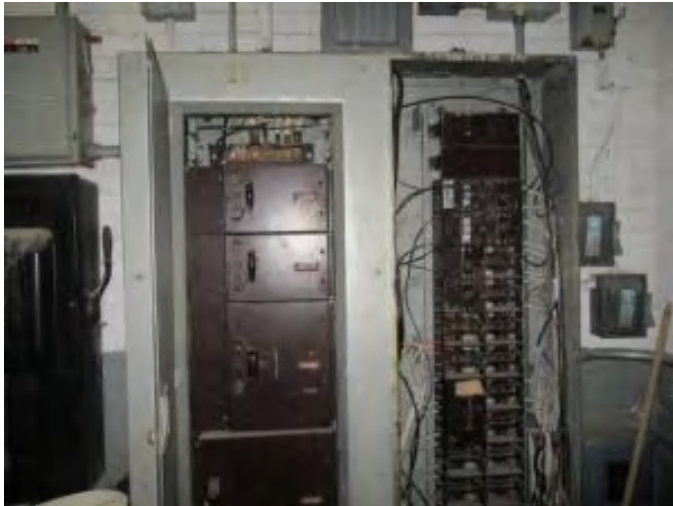
System: D5010 - Electrical Service/Distribution

Location: Basement

Distress: Obsolete

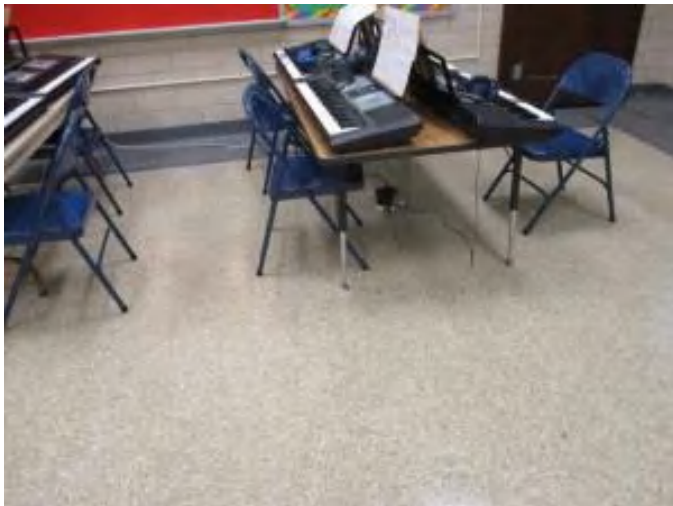
System: D5020 - Lighting and Branch Wiring

Location: Entire Building

Distress: Inadequate

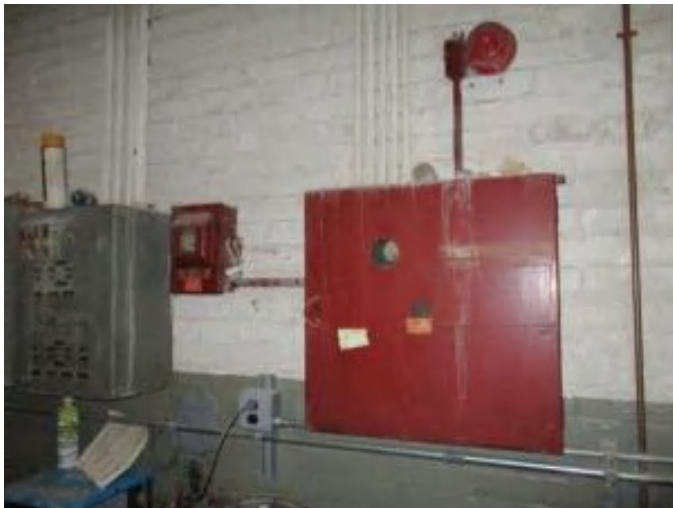
System: D5030 - Communications and Security

Location: Entire Building

Distress: Health Hazard / Risk

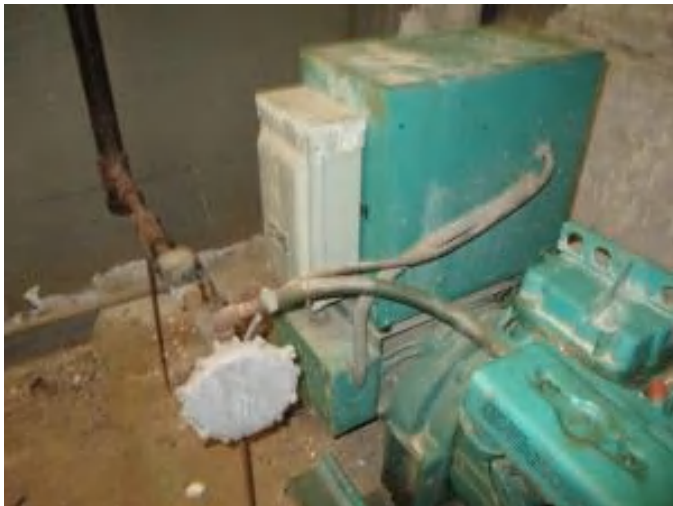
System: D5090 - Other Electrical Systems

Location: Outdoor

Distress: Beyond Service Life

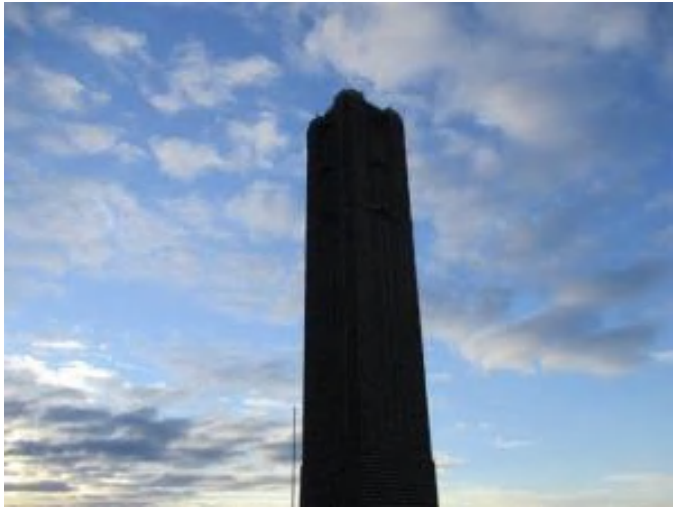
System: D5090 - Other Electrical Systems

Location: Roof

Distress: Building / MEP Codes

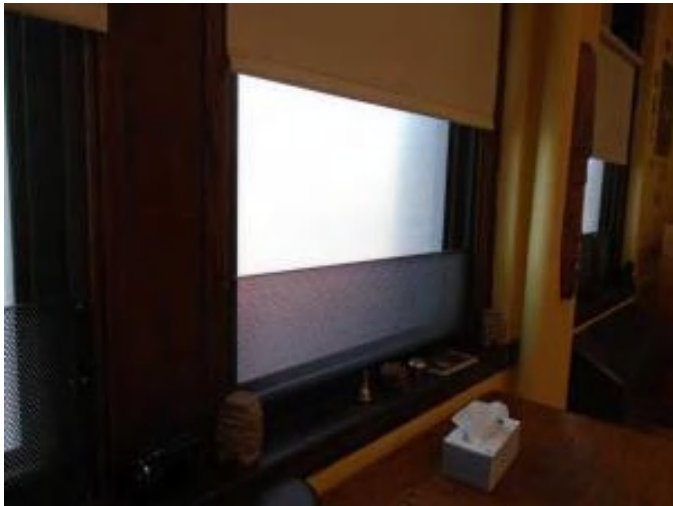
System: B2020 - Exterior Windows

Location: Ext. windows

Distress: Energy Efficiency

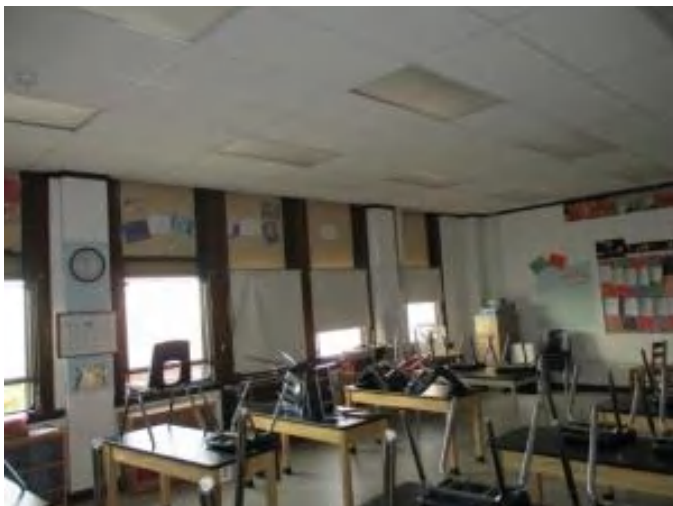
System: D5020 - Lighting and Branch Wiring

Location: Entire Building

Distress: Obsolete

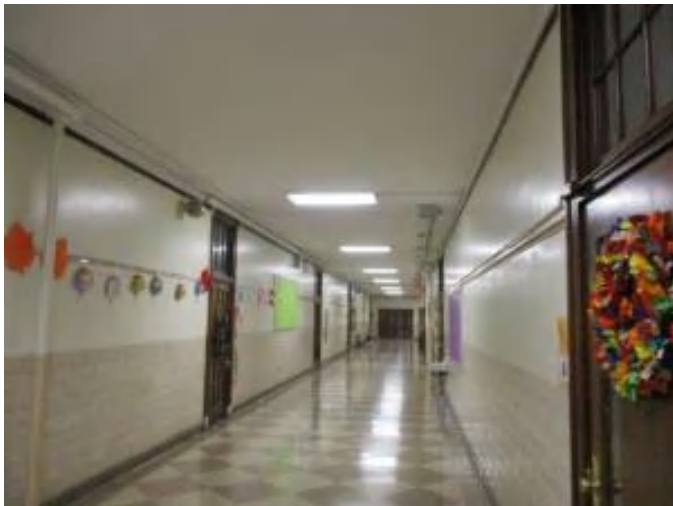
System: D5030 - Communications and Security

Location: Entire Building
Distress: Security Issue
Category: 1 - Health & Safety
Priority: 4 - Response Time (4-5 yrs)
Correction: Add/Replace Video Surveillance System
Qty: 1.00
Unit of Measure: Ea.
Estimate: \$120,669.80
Assessor Name: System
Date Created: 12/28/2015

Notes: Add surveillance CCTV cameras for a complete coverage of the school building interior. Approximate 30

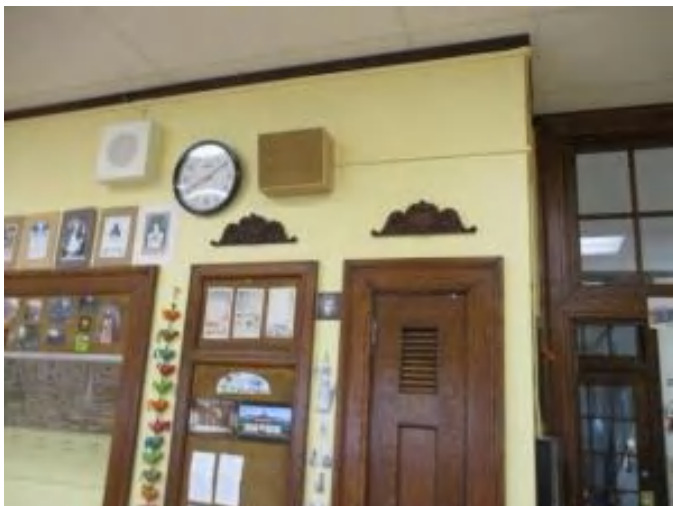
System: D5030 - Communications and Security

Location: Entire Building
Distress: Obsolete
Category: 3 - Operations / Maint.
Priority: 4 - Response Time (4-5 yrs)
Correction: Add/Replace Clock System or Components
Qty: 50.00
Unit of Measure: Ea.
Estimate: \$112,560.22
Assessor Name: System
Date Created: 12/28/2015

Notes: Provide a clock system with wireless, battery operated clocks. Approximate 50 clocks.

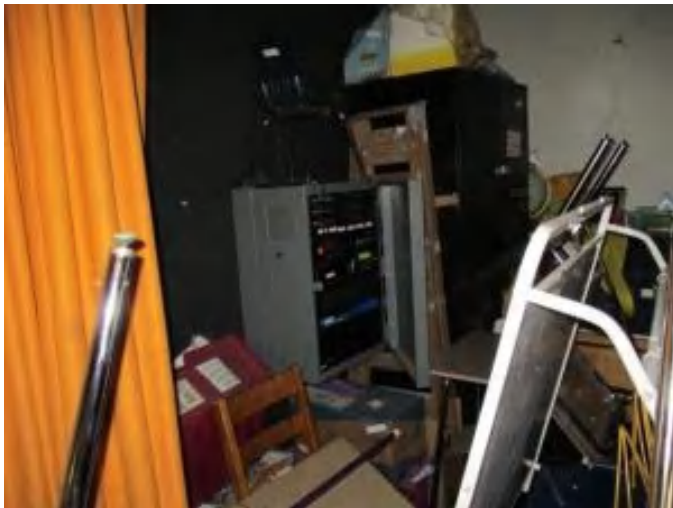
System: D5030 - Communications and Security

Location: Auditorium

Distress: Damaged

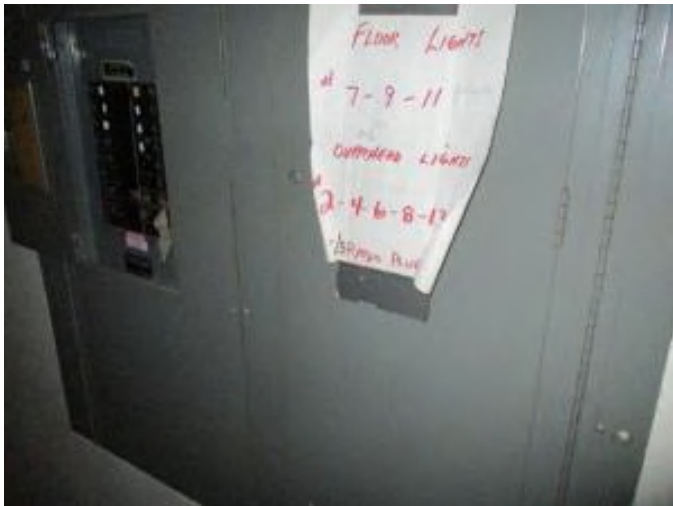
System: E1020 - Institutional Equipment

Location: Auditorium

Distress: Inadequate

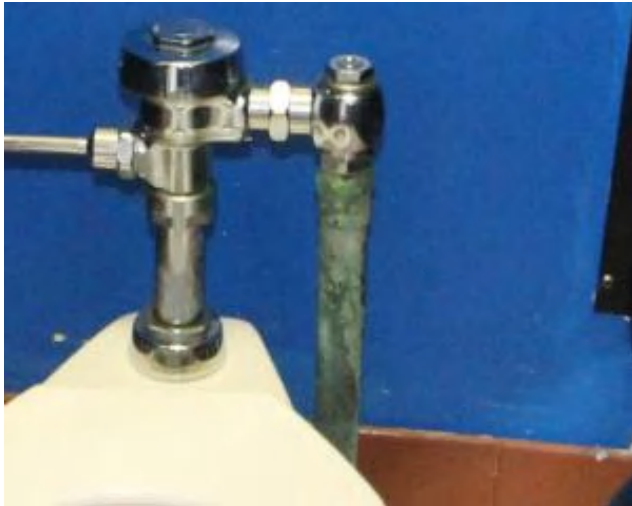
System: D2020 - Domestic Water Distribution

Location: Entire building

Distress: Beyond Service Life

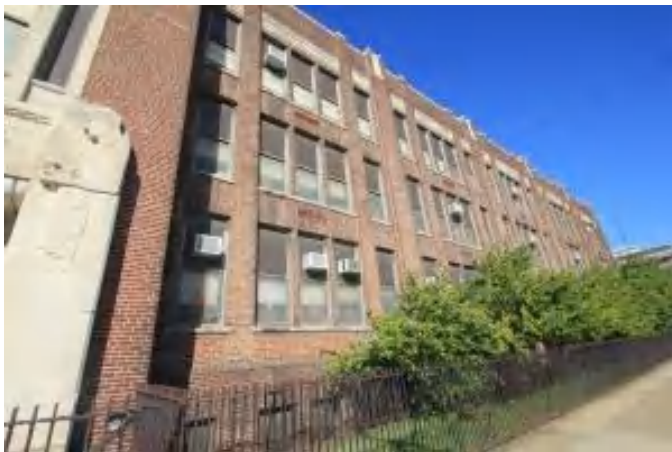
System: D3030 - Cooling Generating Systems

The building has no central cooling generating equipment. There are 19 window unit air conditioners and 1 mini split system which provide about 40 tons of cooling capacity to offices, etc. A chiller system with 170 ton capacity should be installed to provide cooling to the entire building.

Location: Entire building

Distress: Inadequate

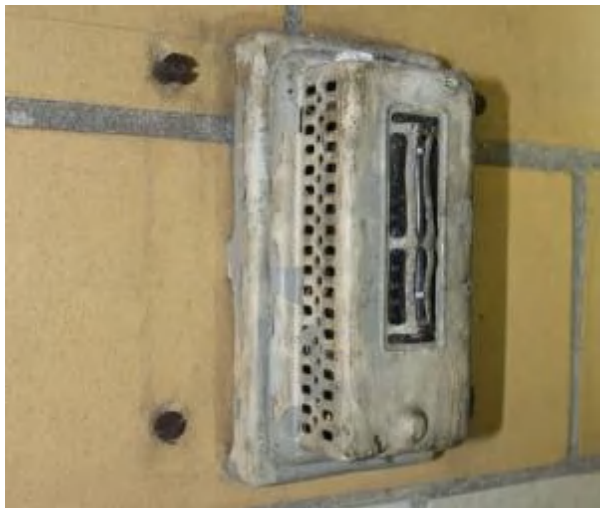
System: D3060 - Controls & Instrumentation

Building HVAC controls were pneumatic, but became inoperable year ago. Classrooms and gyms have wall mounted thermostats to control unit vents. The controls are obsolete and should be replaced with a DDC to control new HVAC equipment. There are two air compressors in the building. A single pump with tank and cooler is installed and operational in the boiler room. There is also a duplex pump with tank stored in the coal room not installed.

Location: Entire building

Distress: Obsolete

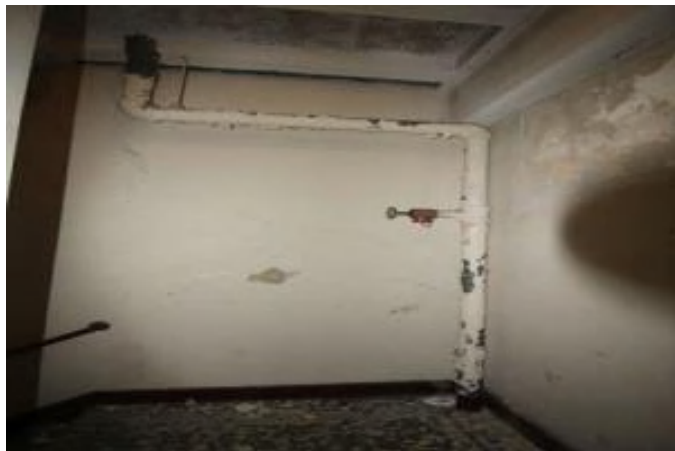
System: D4010 - Sprinklers

Location: Entire building

Distress: Life Safety / NFPA / PFD

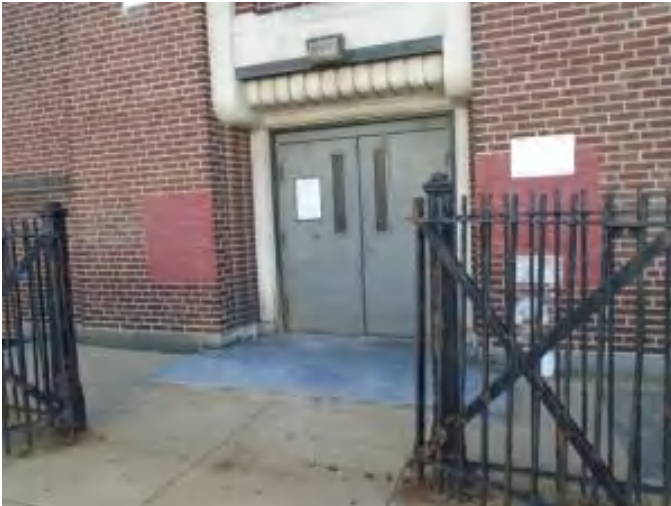
System: G2030 - Pedestrian Paving

Location: Entrance

Distress: Accessibility

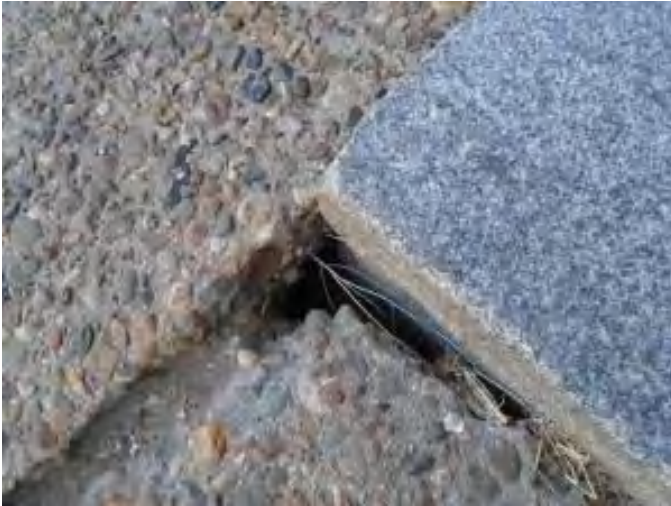
System: G2030 - Pedestrian Paving

Location: North entrance

Distress: Building Envelope Integrity

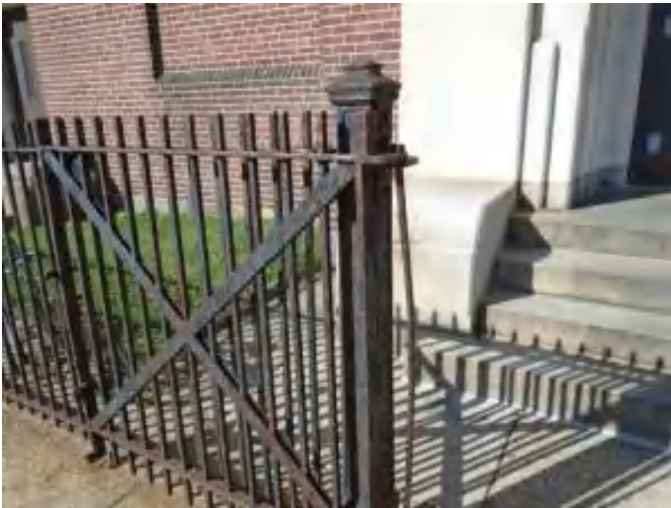
System: G2040 - Site Development

Location: Site

Distress: Health Hazard / Risk

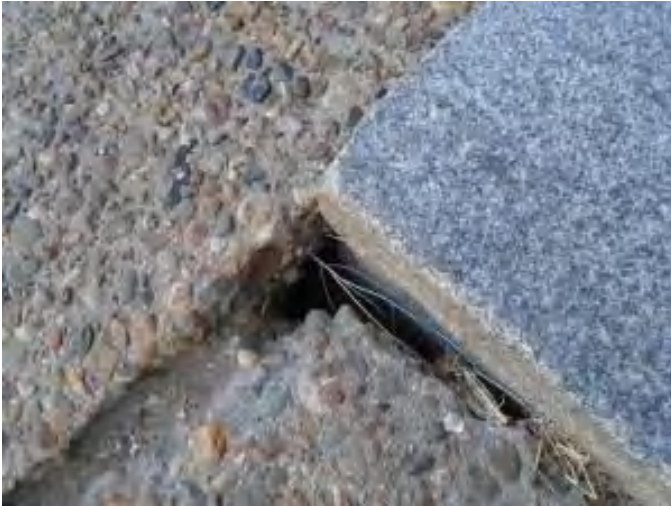
System: G2030 - Pedestrian Paving

Location: Playard

Distress: Damaged

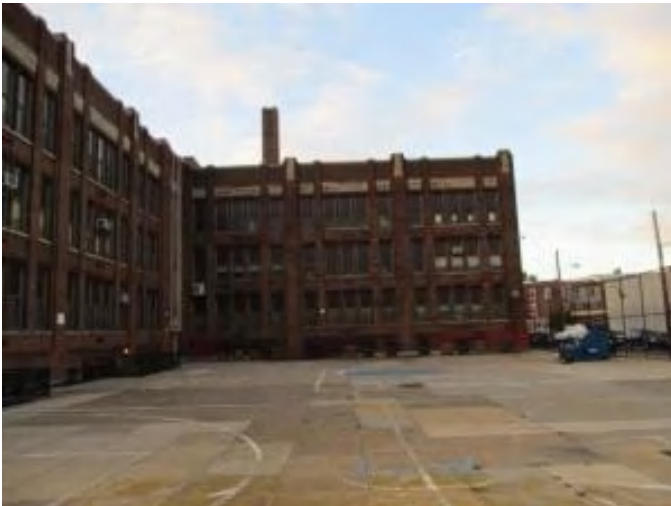
System: G4030 - Site Communications & Security

Location: Building Perimeter

Distress: Security Issue

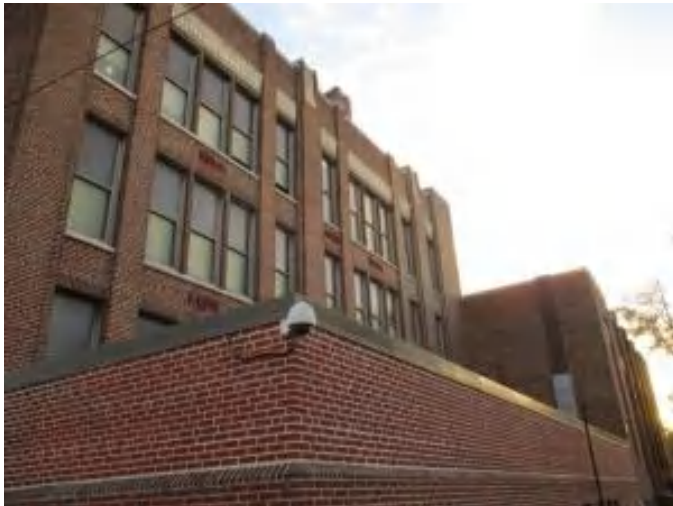
System: G4020 - Site Lighting

Location: Building Perimeter

Distress: Security Issue

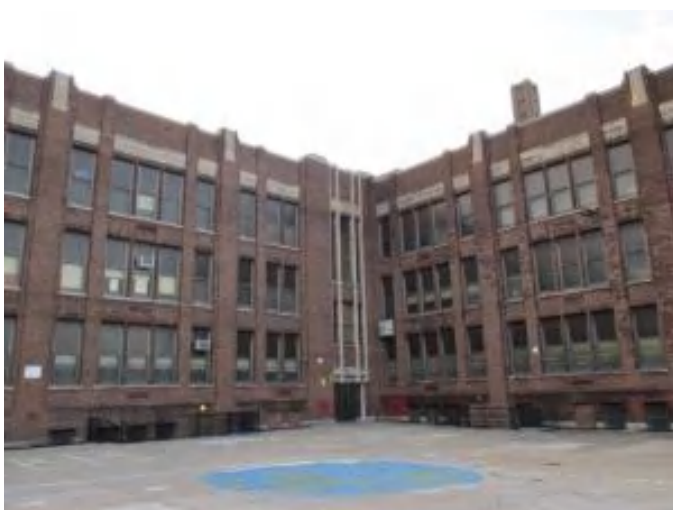
System: G4030 - Site Communications & Security

Location: Building Perimeter

Distress: Inadequate
