Rhawnhurst Elementary School

Addition and Major Renovation Scope Determination Report

August 27, 2019

School District of Philadelphia
Office of Capital Programs
440 N. Broad Street, 3rd Floor
Philadelphia, PA 19130

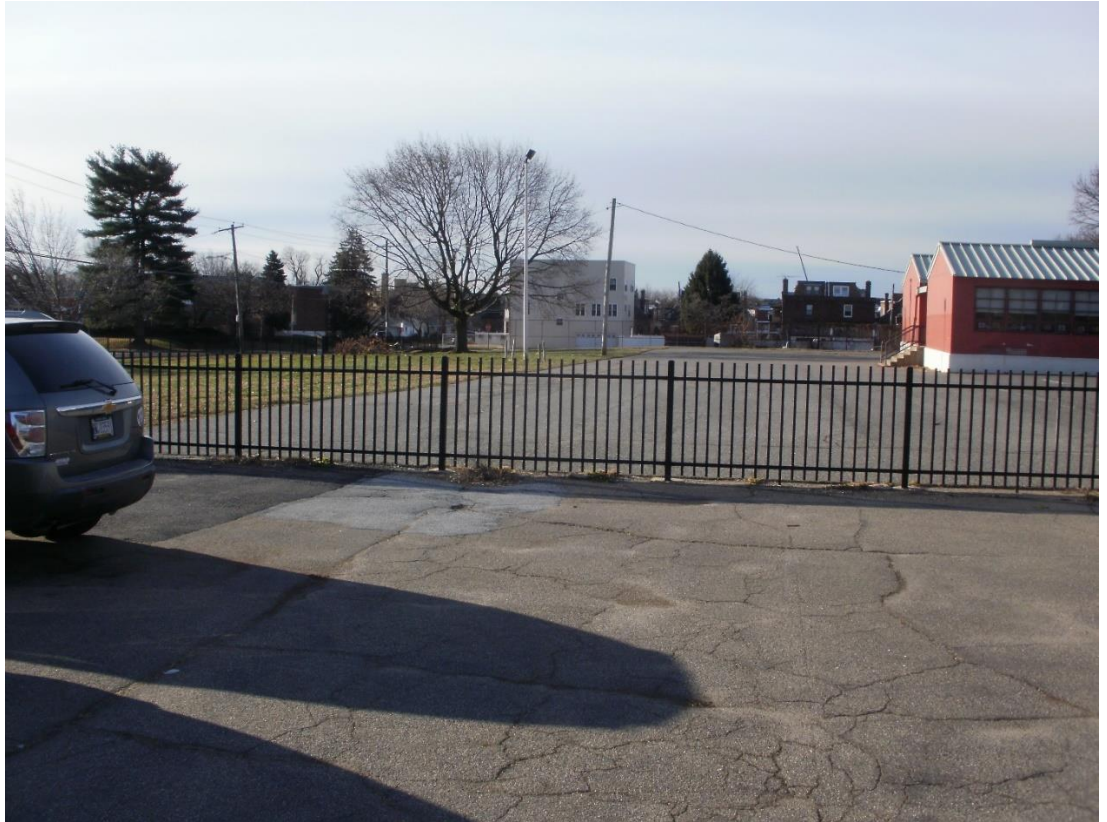
The site is currently asphalt and contains the main school building footprint along with one modular building in the center of the property. Asphalt is in moderate to good condition throughout with surface cracking evident in certain locations, primarily in the southwest and southeast portions of the parking lot. Asphalt condition is poorest in the designated

teacher parking area, which is separated from the schoolyard via a low decorative fence. The parking appears to be at maximum capacity and is in need of organization and additional space. Dumpsters are located on the North side of the school with trucks entering from the northernmost curb cut along Castor Avenue. The site landscaping is well maintained.

View of Pavement @ Parking Lot

- Mill and Overlay asphalt (86,301 sf)
 - Dumpster pad and enclosure - 200 sf concrete, 8" thick slab, reinforced with galvanized wire mesh on 6" thick 2a modified stone base; steel and composite wood dumpster enclosure; and new area drain and CIP connection to existing sewer.

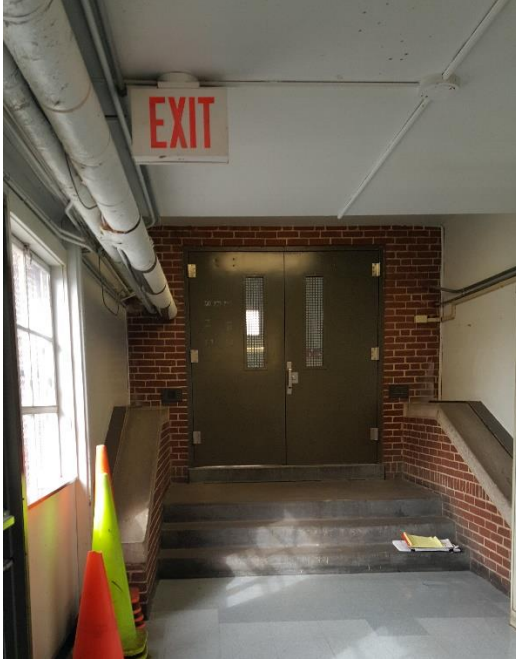
Annex Connector Corridor Interior

The building annex system was originally manufactured by Steelex Industrial Buildings, with the Steelex lightweight interlocking frameless structural wall and roof panels on a raised reinforced concrete slab and foundation, all of which shall be demolished. The connector corridor is flashed into the masonry façade and the removal of utilities back to their source, require masonry repair/restoration. Selective demolition of perimeter connective surfaces and restoration of steps, provision of features for accessibility and safety such as new ramps, handrails and exterior lighting will be required. All utilities and services to the Annex must be disconnected to the source.

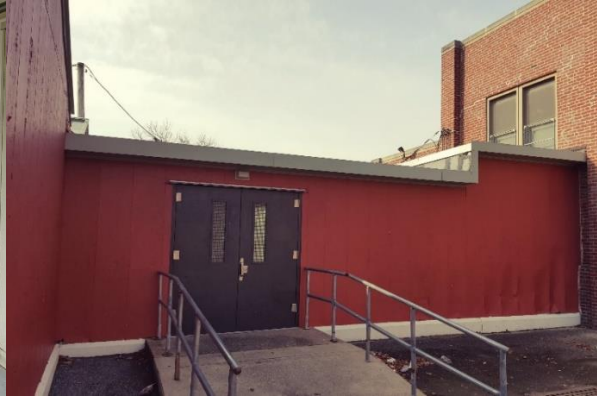
Annex Connector Corridor Exterior

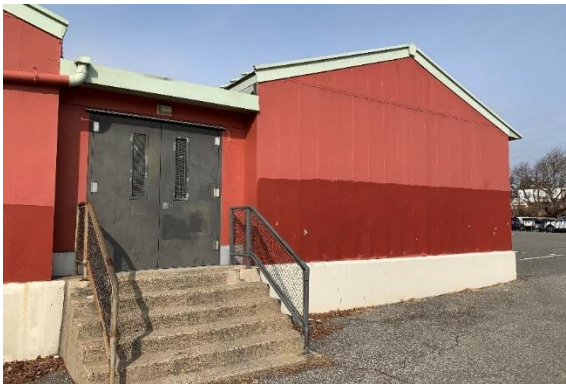
Annex Rear Elevation

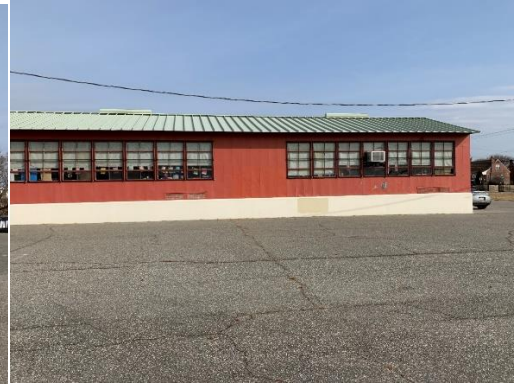
Annex Side Elevation

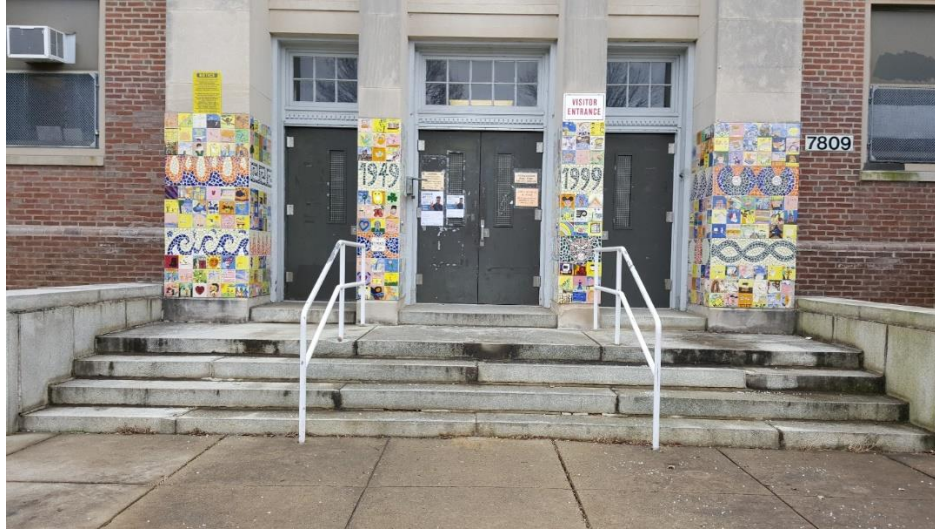
At the main building, the exterior doors are primarily hollow metal steel doors and frames. The main entrance doors are in poor condition. The surrounding doors are in average to poor condition.

Front Entrance

- a. Replace the main entrance doors, (one pair of double doors and two single entrance doors) with more historically sensitive raised metal panel doors, code compliant hardware, egress bars and intercom activated access. Sand prime and paint transom and trim surrounding the main entrance doors. Replace all remaining exterior doors and hardware, closers, weatherstrip, and thresholds budget permitting.
- b. Provide accessibly visible complete directional signage to accessible entrance.

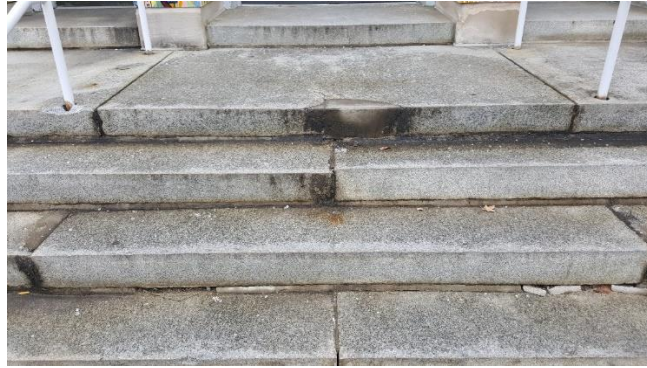
The main entrance steps are discolored granite with loose or missing grout at all joints. Cores for handrails have spalled and are collecting surface water. Precast stone surround at the main entrance and precast coping at the roof, have darkened due to weathering and grime. Brick is exhibiting signs of spalling and efflorescence in several areas at the first floor level indicating water penetration from above.

Front Steps

- a. Clean and patch granite steps, landing, and walls at the main building entrance with outdoor adhesives and epoxies. Clean out and fill granite cores at handrails with epoxy set to drain. Remove and replace grout and sealant.

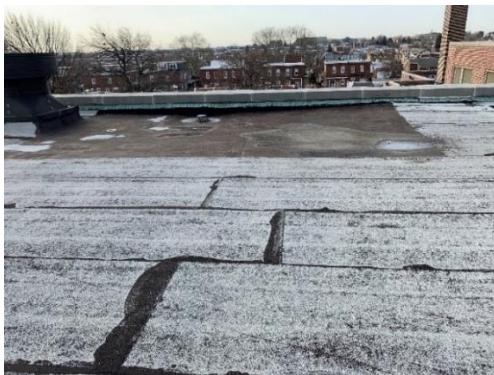
The roof of the main building is a fully adhered build-up rolled asphalt membrane system with impregnated surface granules. At approximately 27 years of age, it is at the end of its expected lifespan. Patched areas show deterioration and ponding with reports of persistent water penetration problems at sections above the auditorium and at the connection to the Annex. Throughout the roof of the main building, tar at seams and curbs is alligating.

Roof Patching

Remove existing upper roof, flashing and insulation. Replace with torch-applied 2-ply SBS-modified bitumen roofing system, with flashing, counter flashing and coping on insulated substrate sloped to drains. Scope existing roof drain lines and replace existing inlets with new raised inlets to accommodate new insulation. Provide complete metal coping cover over existing stone cap and at the rear portions of the main building, such as over the auditorium, cafeteria and gymnasium, where the parapet is short. Coping should match as closely as possible the stone as it is, and be attached without cutting into the existing stone. Provide brick reglet termination and sealant at the front of the building where the parapet is higher. Replace termination flashing and provide warranty. Evaluate condition of existing parapet and provide for repairs if required. Provide evaluation of lower roofs for applied coating(s) to extend the usable lifespan for twenty five years.

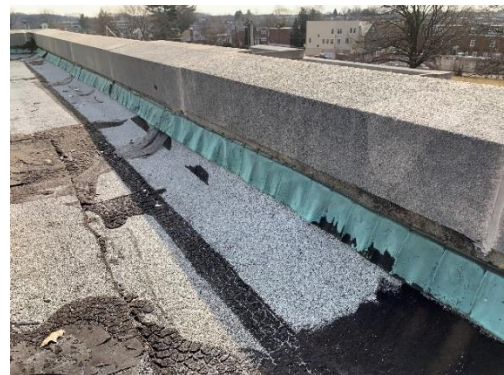
Roof Flashing

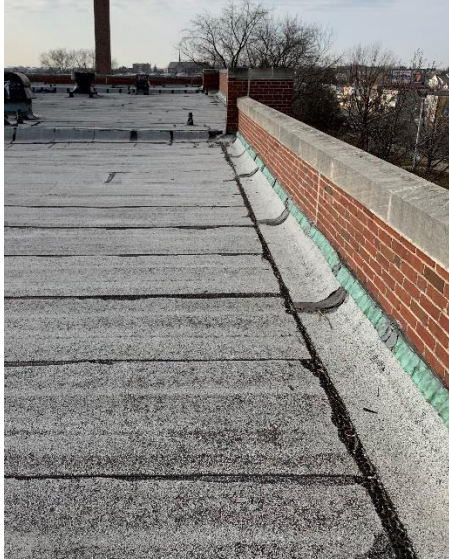
Roof Coping

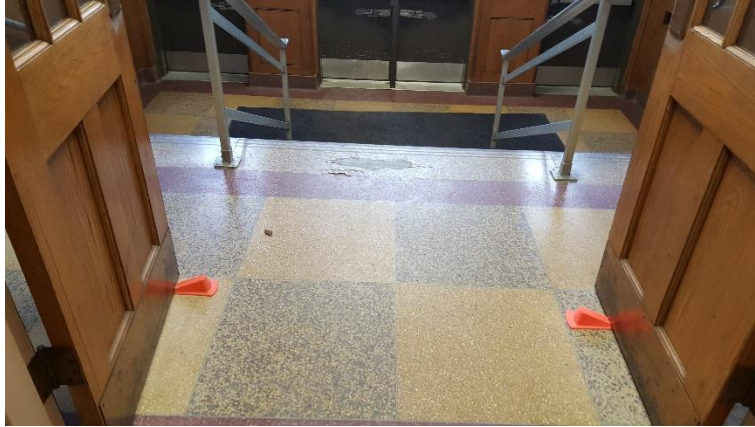
Terrazzo at main entrance

- a. Flooring: Existing Terrazzo at main entrance vestibule and steps to be stripped, and cleaned. Patches to be replaced with compatible restoration material and sealed for heavy duty wearing conditions. Grit strips shall be restored for heavy duty wearing conditions.

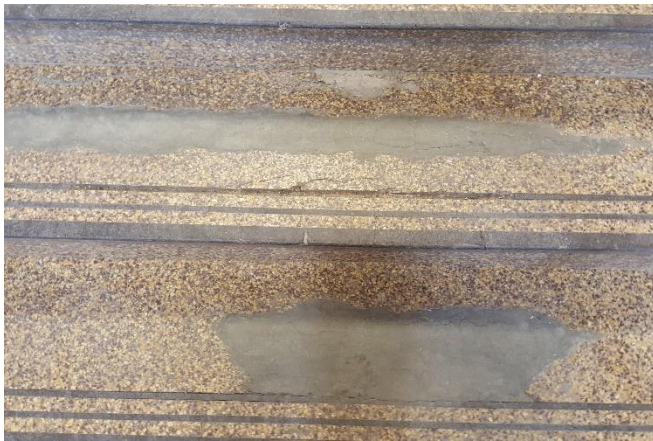
Concrete floor in stairway

- b. Concrete floor in stairway, bathrooms and teacher storage rooms to be stripped, cleaned, evaluated for staining to improve appearance, and sealed.

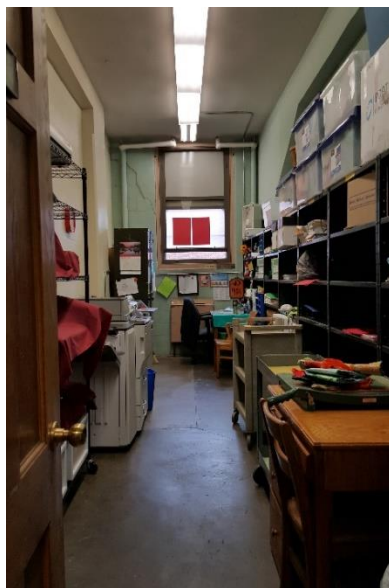
Concrete floor in storage room.

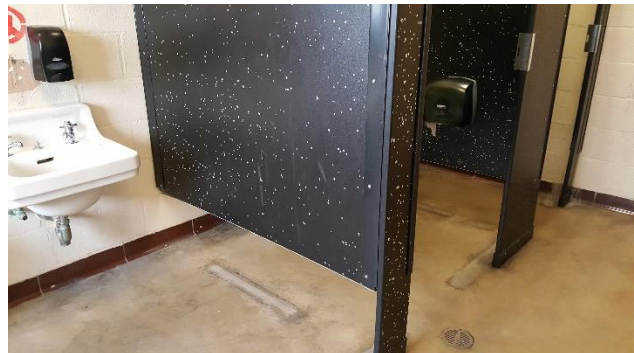
Concrete floor in bathrooms

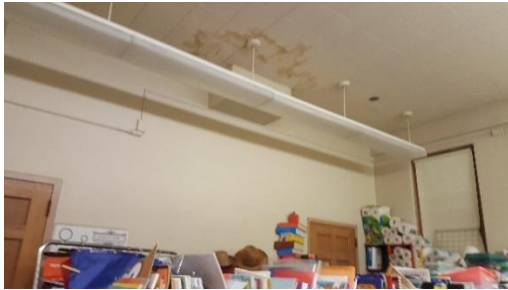
ACT Ceiling Damage @ K Coatroom 100A

- c. Existing concrete floor at Boiler Room to be thoroughly cleaned, stripped and sealed.
- d. Ceilings: Paint all the ceilings at the areas of damaged Acoustical Ceiling Tiles (ACT) at all main building corridors and Kindergarten Coat Room 100A.

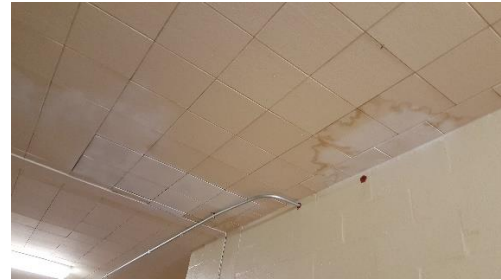
ACT @ Corridors

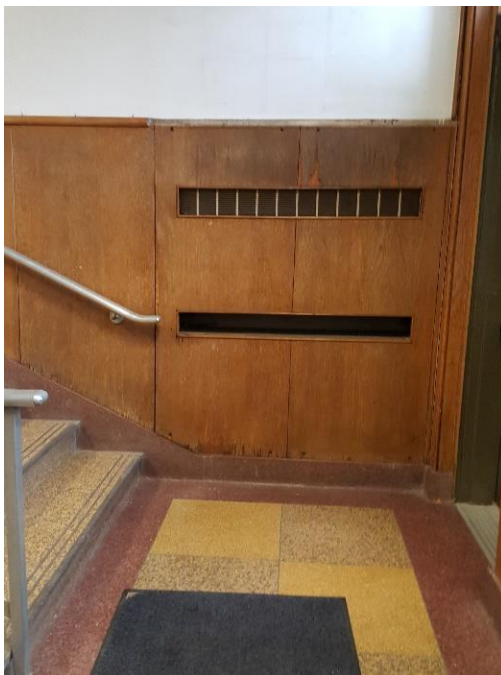
Wood panel wainscot @ Main Entrance

- e. Walls: Replace deteriorated wood panel wainscot at main entrance vestibule with a moisture resistant, high impact resistant wall board with trim and grilles to match (or be similar) to existing. Refinish deteriorated wood panel wainscot, baseboard and trim at Kindergarten classroom drinking fountain with marine grade finish panel to match existing.

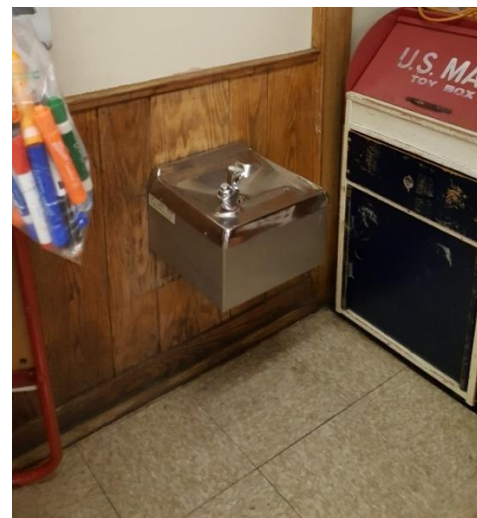
Wood panel wainscot at drinking fountain

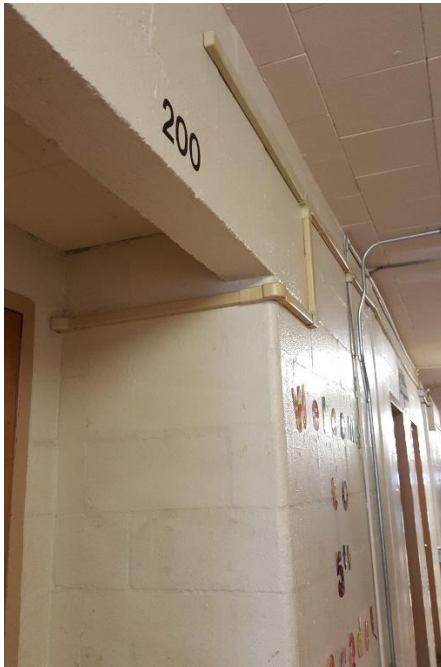
CMU block walls @ Main Corridor

- f. Remove all miscellaneous fasteners, staples, and adhesives at CMU walls and repaint CMU walls in the corridors. Do not paint glazed CMU base. Paint

all Corridor and Bathroom walls and ceilings and replace classroom numbers. Provide tack strips at all corridors according to SDP Standards.

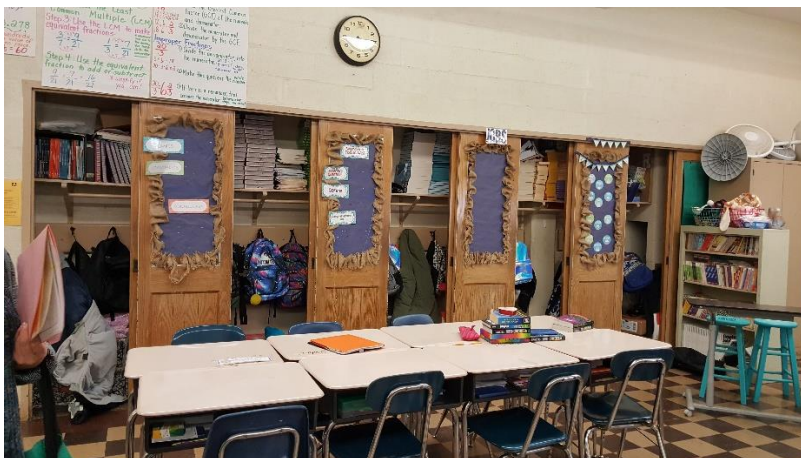
Sliding panel doors to be removed

- g. Doors: Replace high use doors at bathrooms, side pair of auditorium doors with wood doors. Replace Kindergarten classroom double doors with wood doors with vision panel. Replace all other interior doors. Provide ADA accessible hardware at all new doors. Provide rated doors, closers and panic hardware required by code. Remove existing wood panel doors that are non-operational in tracks in main building classroom coat storage closets. Trim tracks for concealment, paint interior wall of coat storage and metal frames. Evaluate cost effective means for enhancing the overhead storage.

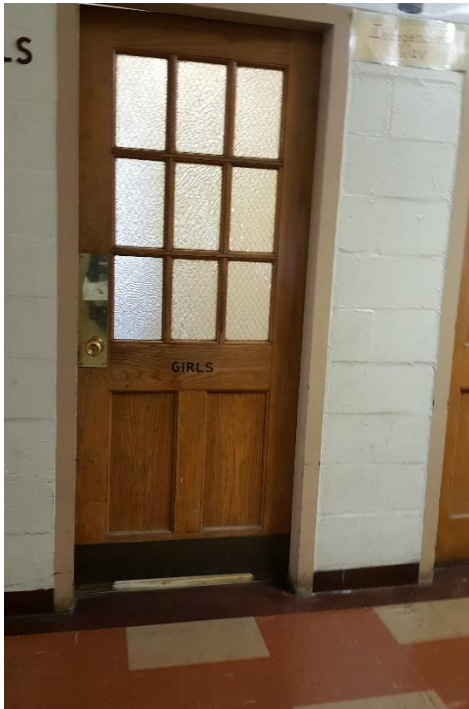
Typical bathroom doors and hardware to be replaced

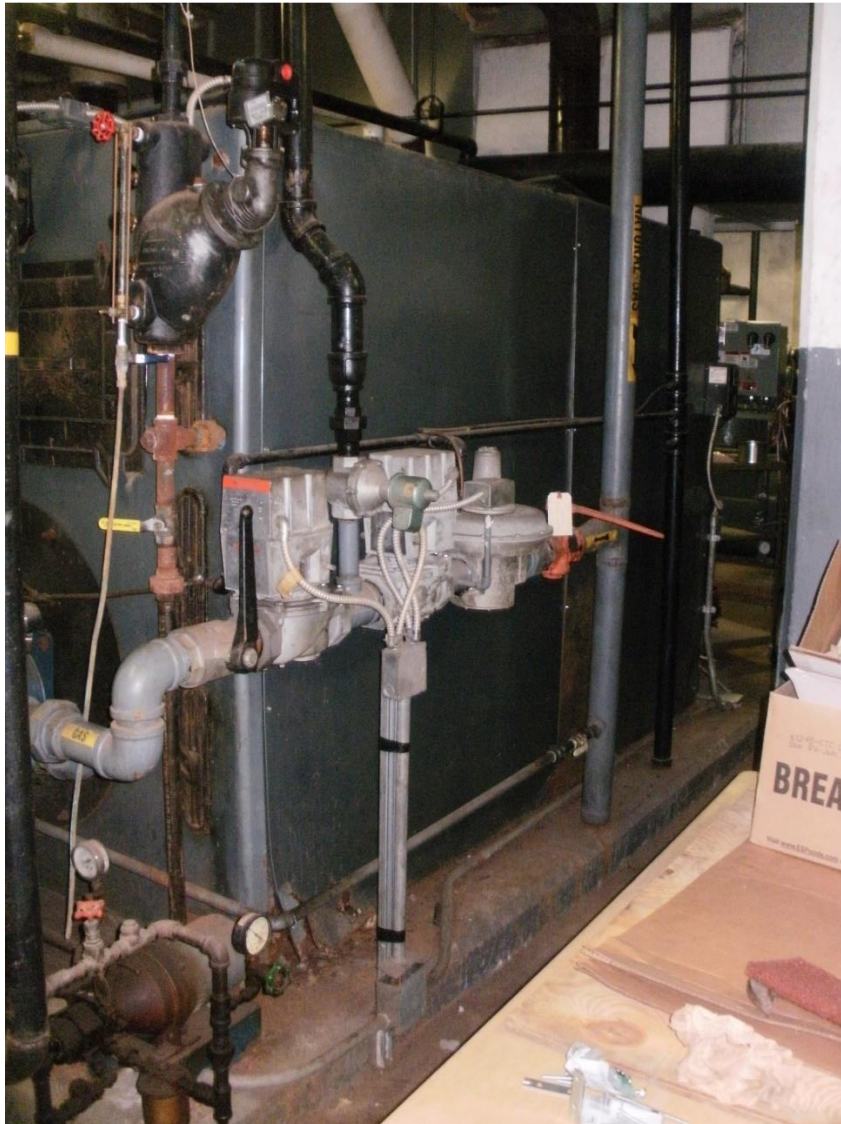
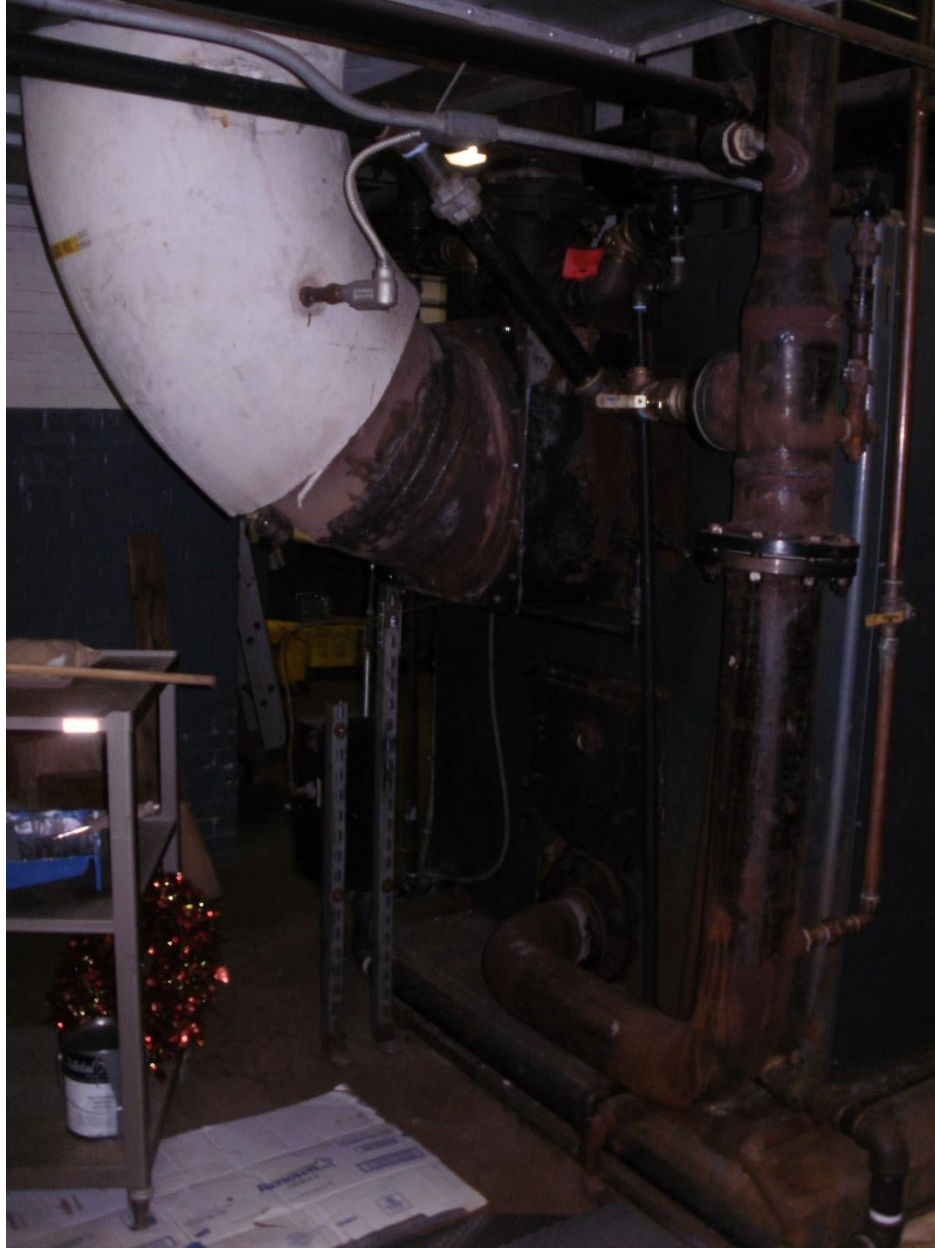
Steam Boiler

Heat Generating Systems – Low pressure steam is generated at 15 lbs/sq. in. or less by two 4,043 MBH Weil McLain 94 series steam boilers, model H-1794-WS, with dual fuel burners. All boilers are equipped with Power Flame dual fuel burners, natural gas and number 2 fuel oil, model CR4-GO-30. The boilers were installed in 1991 are 25 years old , however the boilers still have approximately 10 years of remaining service life and do not need to be replaced at this time based on the age of the equipment.. At the time of our survey one boiler had nipples leaks and cannot be run due to this. There is draft control on both boiler flues. Combustion air louvers serve the boiler room to provide combustion air for the boiler operation. Burner controls provide full modulation with electronic ignition, digital flame sensing and pressure atomization on oil. Burner oil pumps are driven by independent motors. The gas train serving each boiler appears to have code required venting of the regulators and dual solenoid valves with venting of the chamber between. The oil supply to the burner is equipped with dual solenoid valves and strainer/disposable media filter.

The two original low pressure 4 MM Weil McLain steam boilers, located in the basement that are operational need to be demolished and removed. The SOW listed below encompasses the demolition/removal and replacement of the two original low pressure steam boilers and all associated ancillary equipment, located in the basement boiler room.

- b. Furnish and install two new 5'x10' concrete mounting pads with mounting brackets for each new boiler, if needed.
- c. Furnish and install two new 18" diameter CPVC/Stainless Steel combustion air inlet/intake pipe and two new 18" diameter CPVC/Stainless Steel exhaust outlet pipe for each new condensing unit.

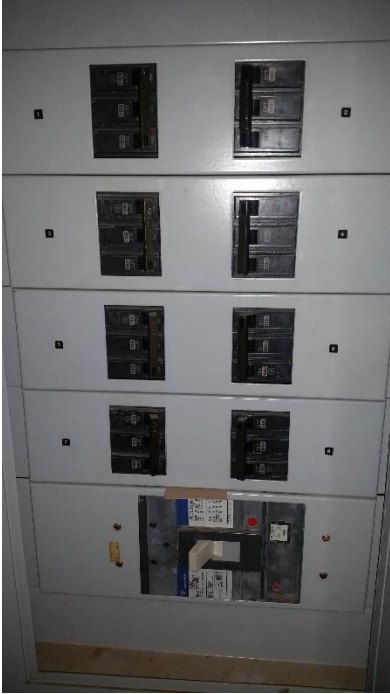
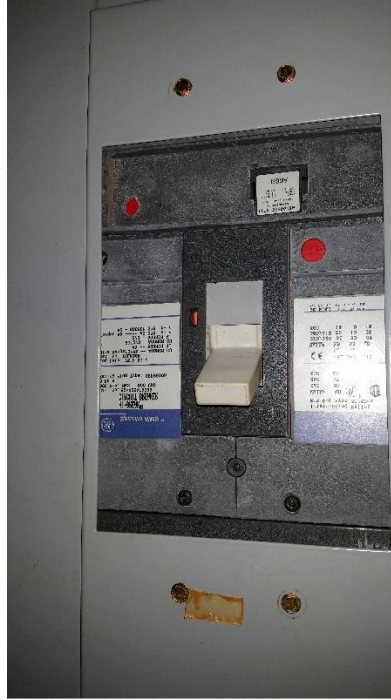
The existing electric service is a 600A, 208V/120V, 3 phase and 4 wire system. The main distribution panel is in working condition. However, this existing electric service will not be able to support the new building addition and the electrical upgrades at the existing building.

Main Distribution Panel Overcurrent Protection 600A

6. Retrofit or replace antiquated electrical panels that can no longer be maintained due to lack of parts and components.
7. Provide electrical upgrades to architectural and mechanical modifications in this report.

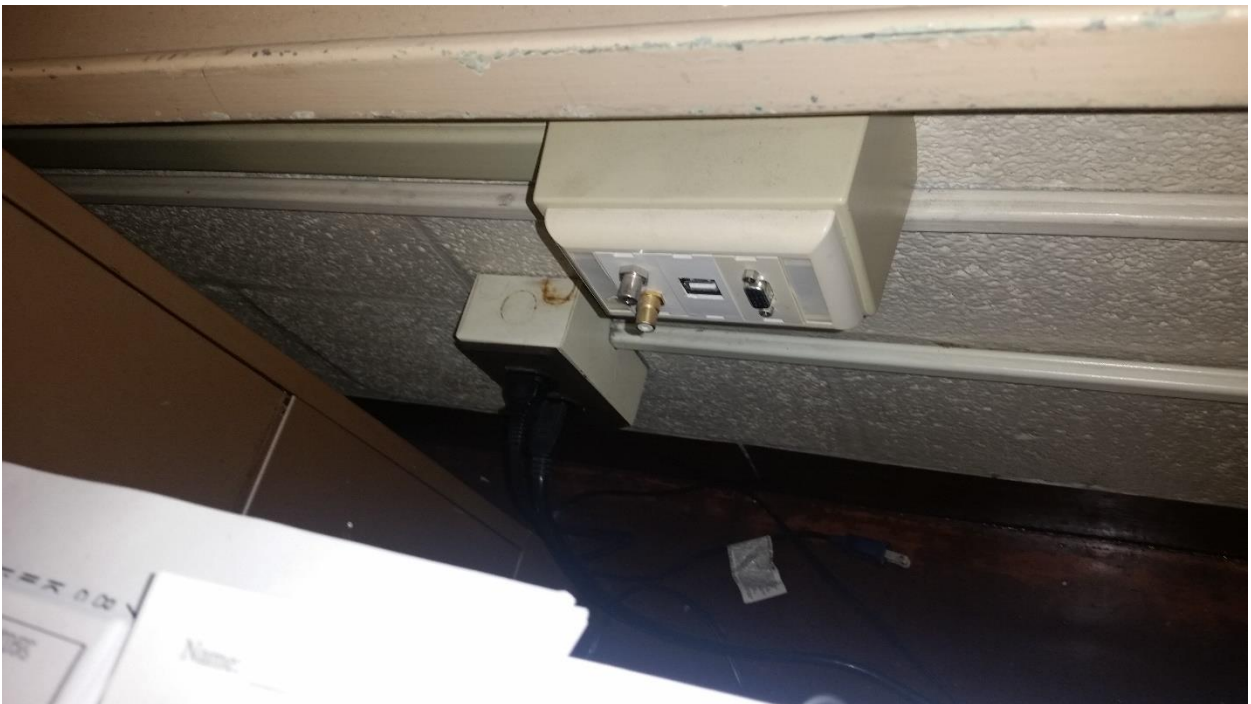
Insufficient Power Receptacles

Existing AV receptacles for Existing Smartboards

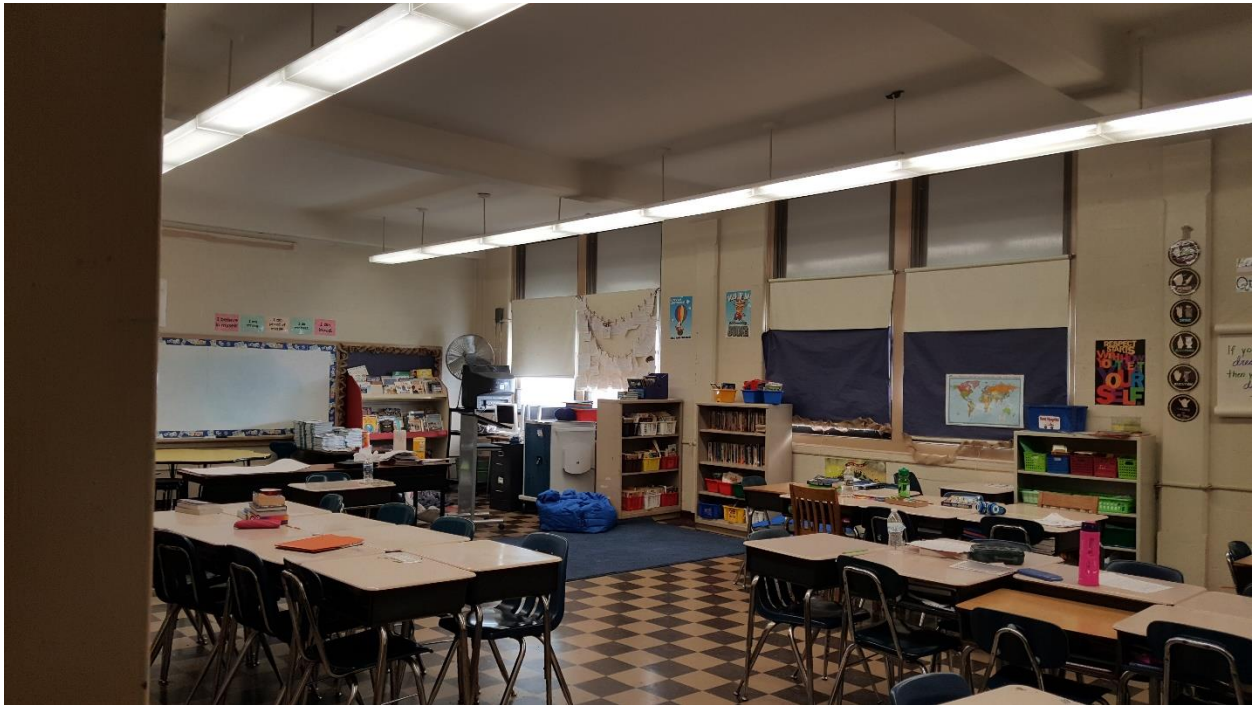
The existing building interior lighting system is mostly fluorescent lights. The exterior lighting system is high intensity discharge type. The exit signs are thermoplastic LED type.

Typical Classroom Lighting @ Main Building

1. Replace all antiquated incandescent or CFL exit signs with white thermoplastic LED exit signs and connect to generator source.
2. Replace lighting fixtures with new LED lighting fixtures throughout the existing building and provide lighting controls to comply with Philadelphia energy code. Provide generator power to sufficient number of lights in egress path to meet or exceed minimum illumination required by code.
3. Replace the exterior HID's with LED's equipped with integral photocells.
4. Provide new LED's in new building addition with dimmer controls in classrooms. Each classroom shall have minimum 2 lighting control zones. One zone of dimming control over the Interactive Panel Board and rest of the classroom on the second zone of dimming control.
5. The design consultant shall provide detailed survey, demolition and new work floor plans, and specifications.

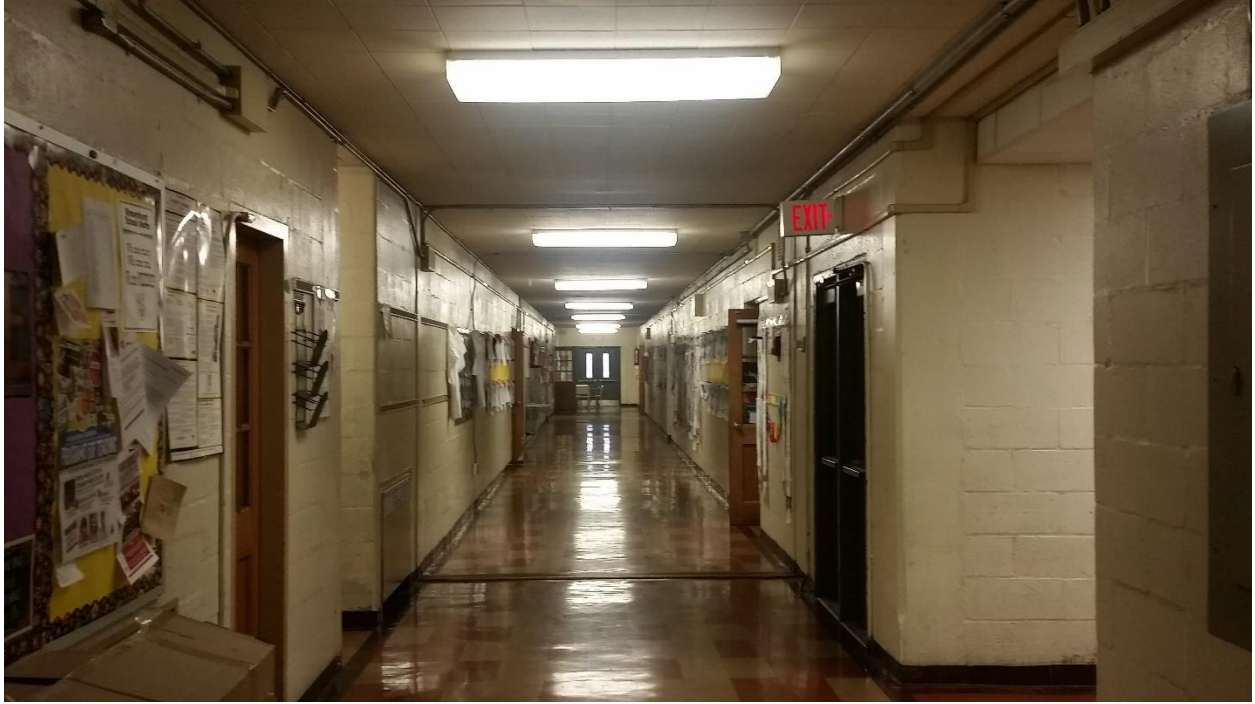
Typical Corridor Lighting @ Main Building

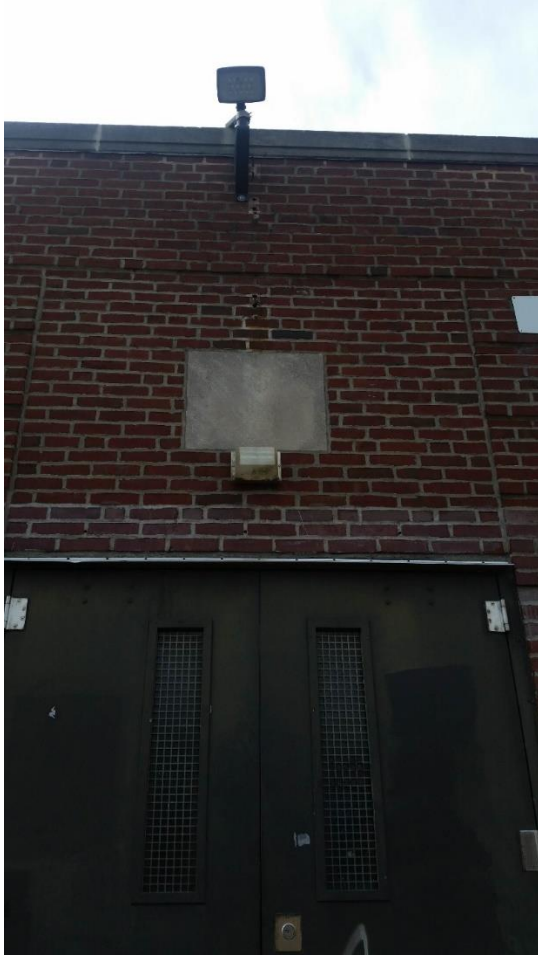
Typical Exterior Lighting

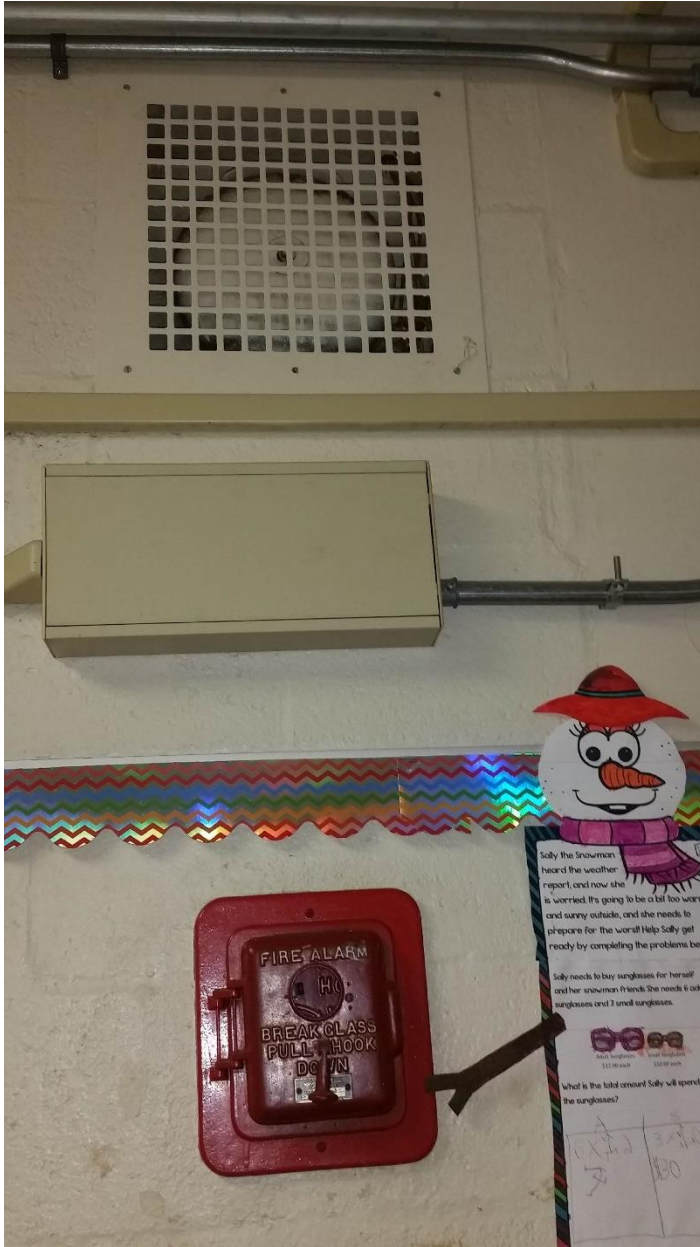
The existing fire alarm system is a coded system. This fire alarm system is antiquated and should be replaced.

Typical Fire Alarm Gong and Typical Fire Alarm Pull Station

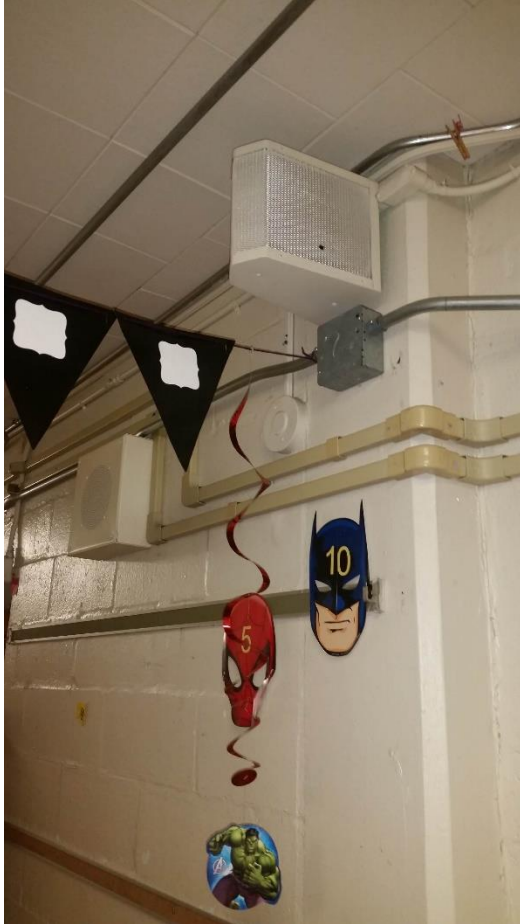
The existing phone, public announcement and bell system is operational.

Typical Decommissioned PA Stainless Steel Speaker
Typical Square PA Speaker Currently In Use

1. Construction document shall illustrate where the space is architecturally altered and require the PA speakers to be removed and reinstalled to allow for that modification.
2. Provide new PA speaker system in the new addition and connect to existing PA system.
3. Remove any phone and PA speaker that was decommissioned and abandoned.
4. Provide new phone and PA speaker replacements as needed.
5. The design consultant shall provide detailed survey, floor plans, riser and specifications.

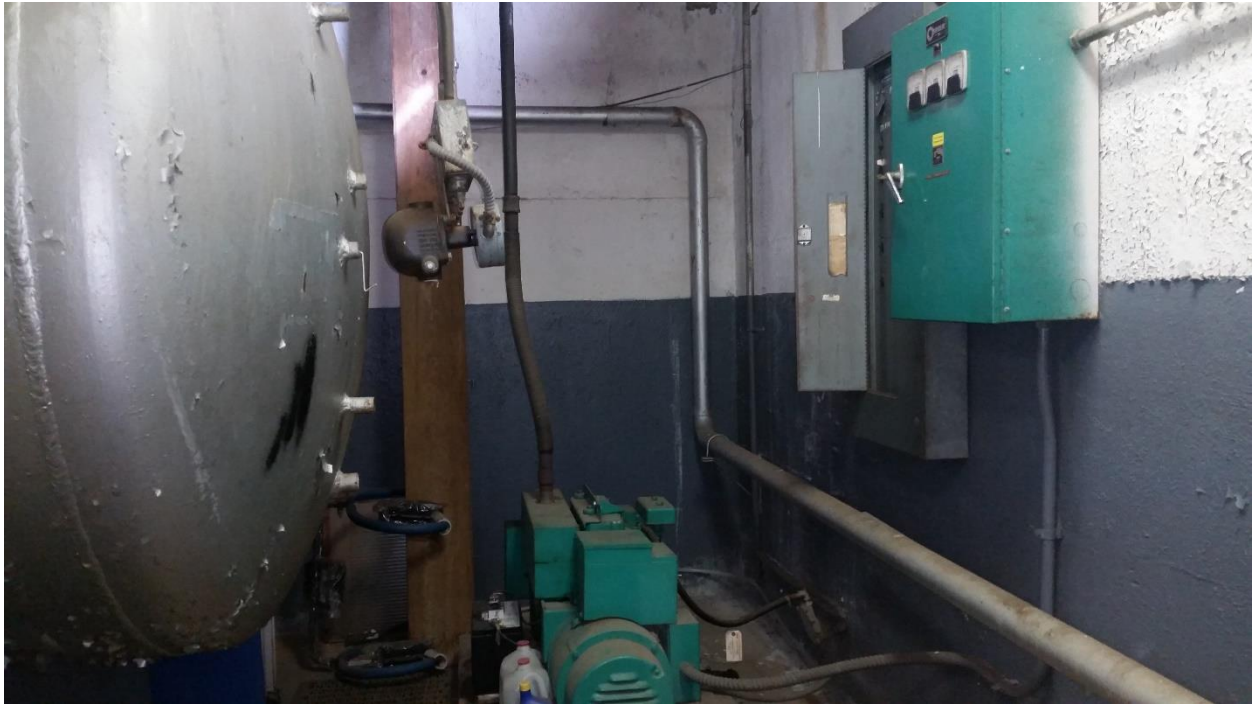
The existing natural gas generator is a 15KW, 120/240V, 1 phase and 3 wire system and is antiquated. There is not enough working clearance around this generator per NEC.

Existing Generator, Emergency Panel and ATS

1. Provide a replacement generator rated sufficiently to provide emergency and any desired standby power to existing building and new building addition. The generator KW size shall be 25% greater than the calculated generator loads.
