## Facility Condition Assessment Summary Report

### Rhawnhurst School

## **Site Assessment Report**

January 31, 2017

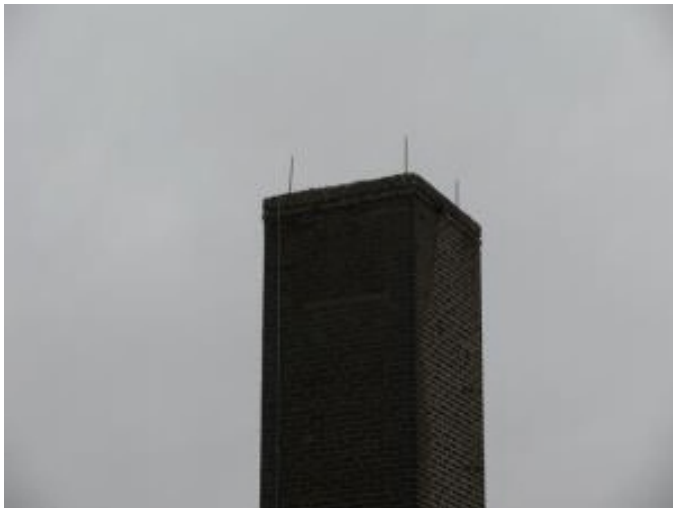
**Location:** Roof

**System: D5090 - Other Electrical Systems**

**Distress:** Health Hazard / Risk

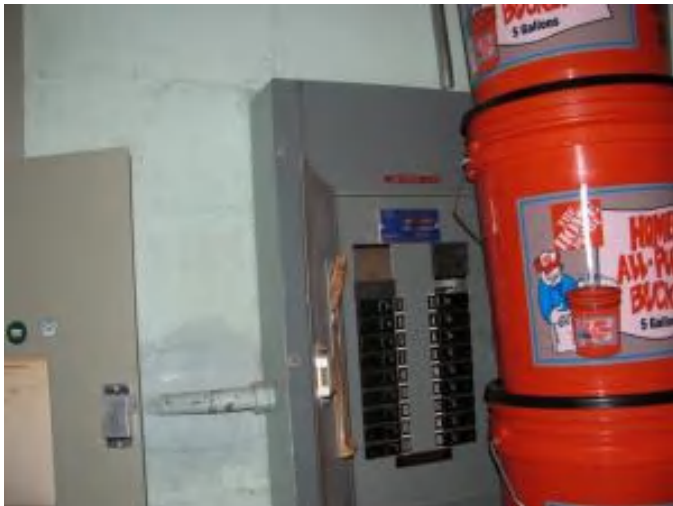
**Location:** Auditorium

**System: E1020 - Institutional Equipment**

**Distress:** Inadequate

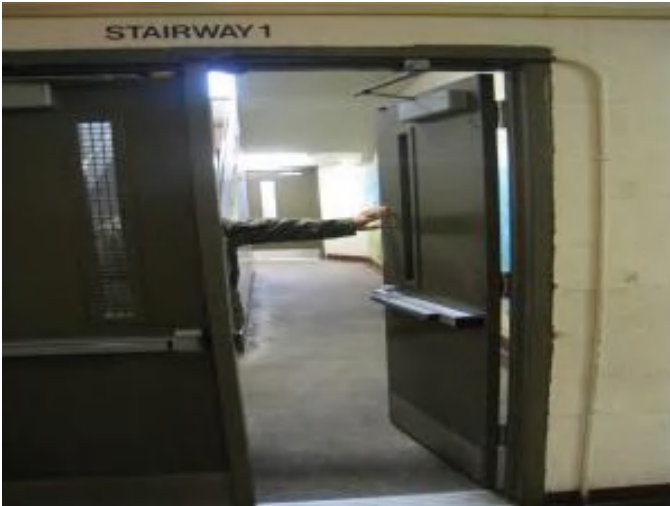
**Location:** stairway doors

**System: C1020 - Interior Doors**

**Distress:** Building / MEP Codes

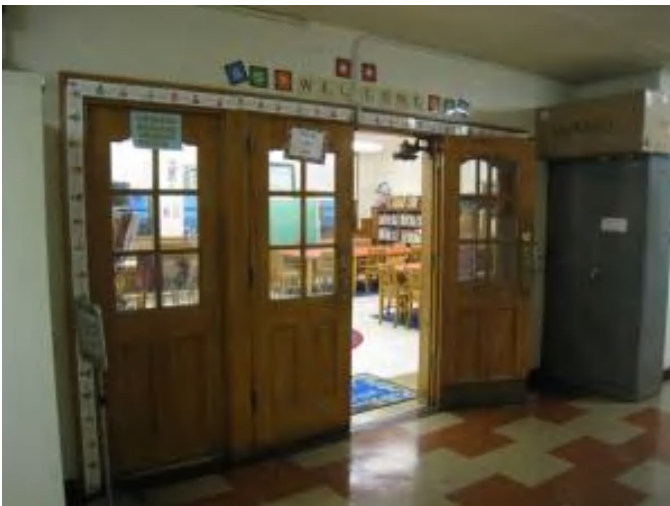
**Location:** corridor doors to classrooms and offices

**System: C1020 - Interior Doors**

**Distress:** Security Issue

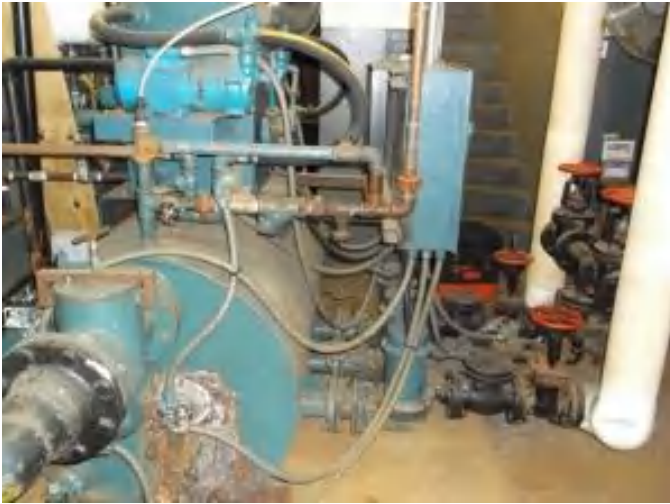
**Location:** Throughout the building

**System: D3040 - Distribution Systems**

**Distress:** Beyond Service Life

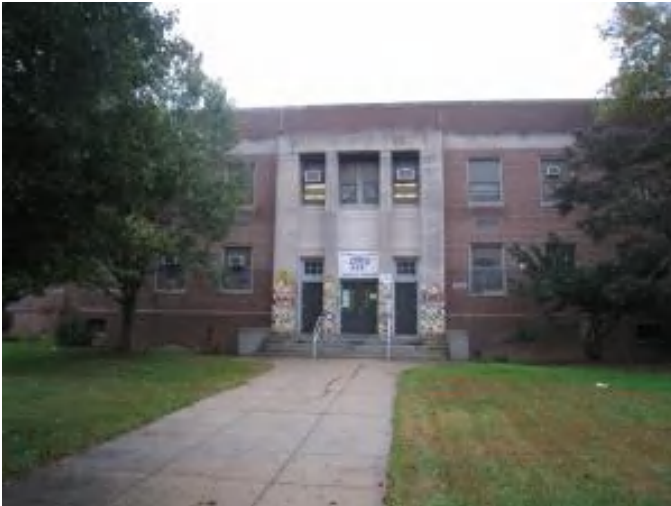
**Location:** concrete walkways

#### System: G2030 - Pedestrian Paving

**Distress:** Damaged

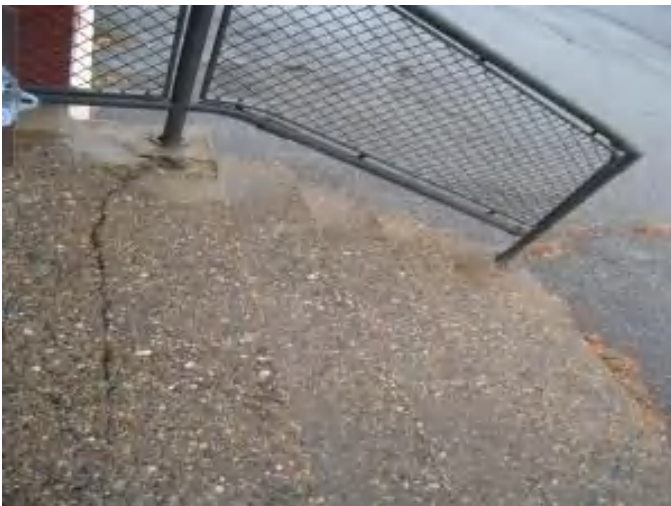
**Location:** exterior stair

#### System: G2030 - Pedestrian Paving

**Distress:** Damaged

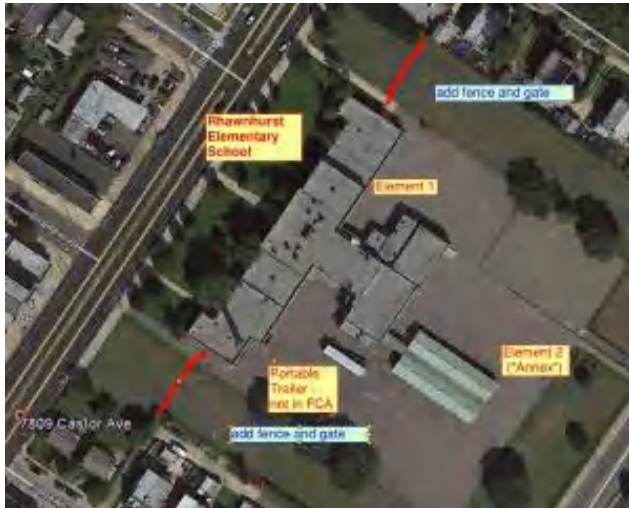
**Location:** site fence and gates at front/sides

**System: G2040 - Site Development**

**Distress:** Inadequate
