## Facility Condition Assessment Summary Report

### Elkin School

**Site Assessment Report**

**January 30, 2017**

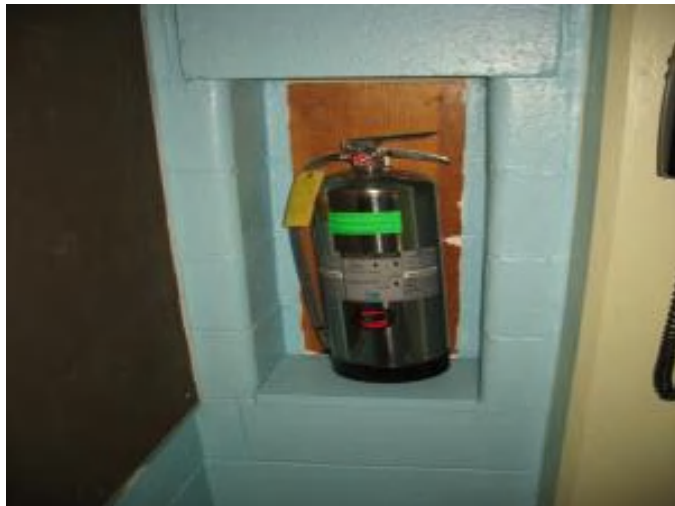
#### System: D4010 - Sprinklers

**Location:** Throughout building

**Distress:** Life Safety / NFPA / PFD

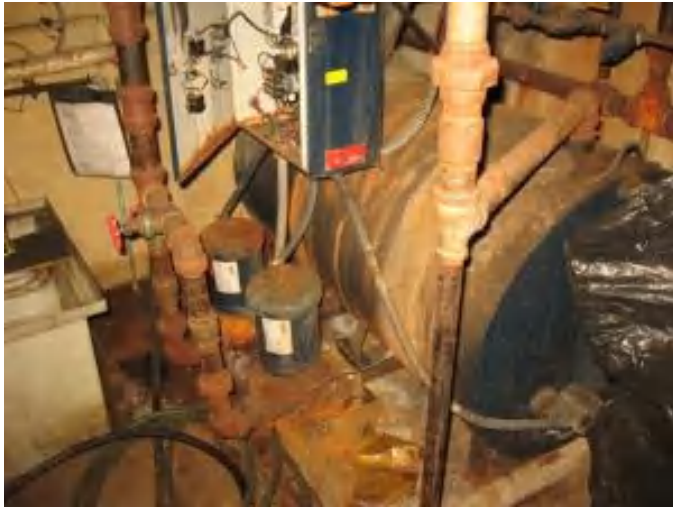
**System: D3040 - Distribution Systems**

**Location:** Boiler room

**Distress:** Damaged

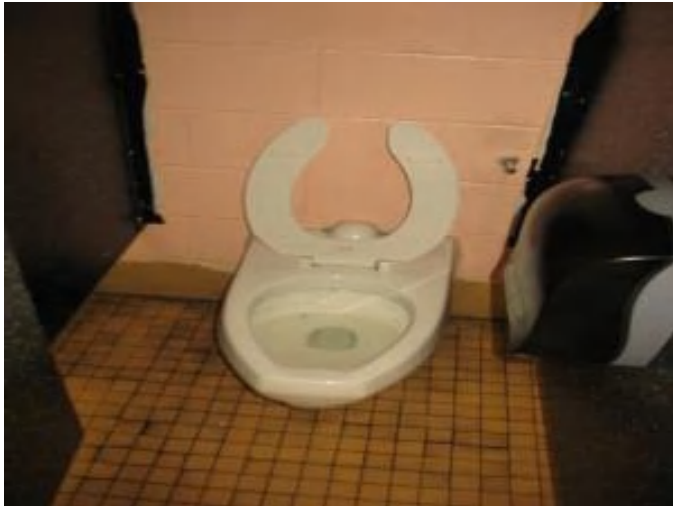
**System: D2010 - Plumbing Fixtures**

**Location:** Restrooms

**Distress:** Beyond Service Life

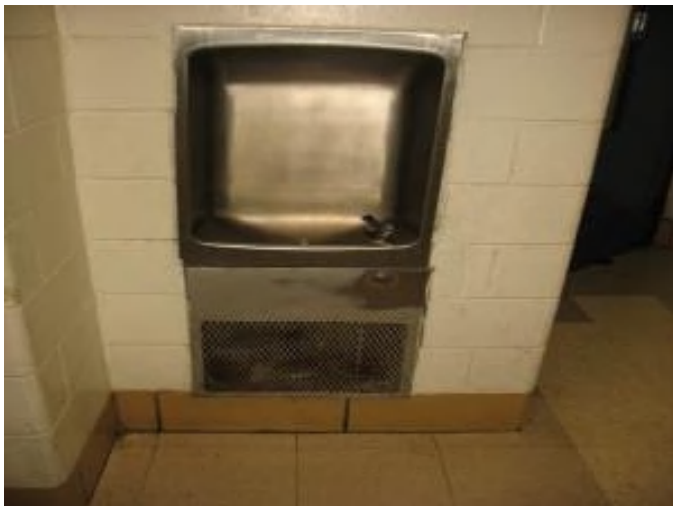
**System: D2010 - Plumbing Fixtures**

**Location:** Corridors

**Distress:** Beyond Service Life

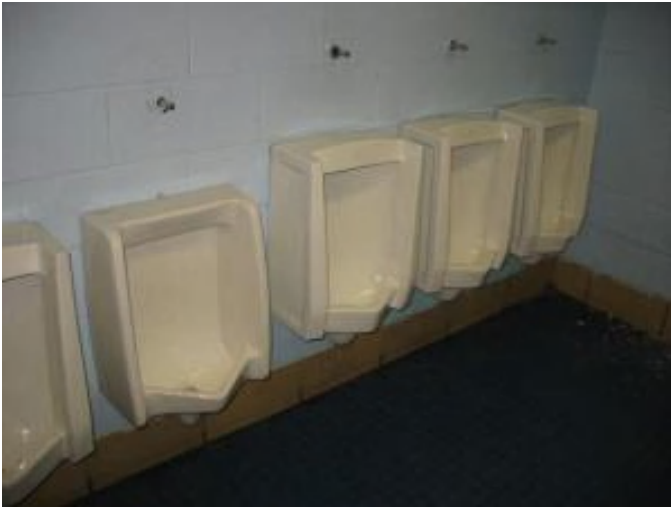
**System: D2010 - Plumbing Fixtures**

**Location:** Restrooms

**Distress:** Beyond Service Life

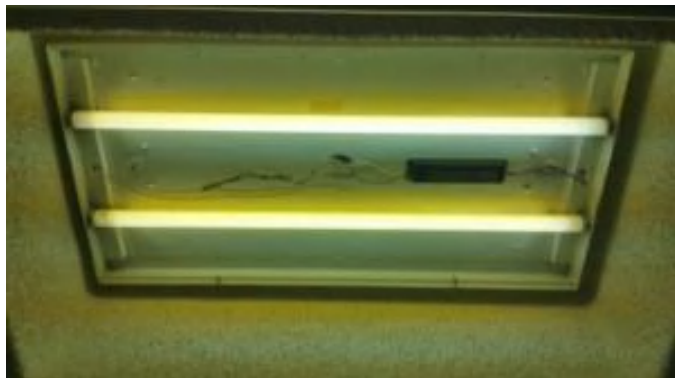
**System: D5020 - Lighting and Branch Wiring**

**Location:** throughout the building

**Distress:** Beyond Service Life

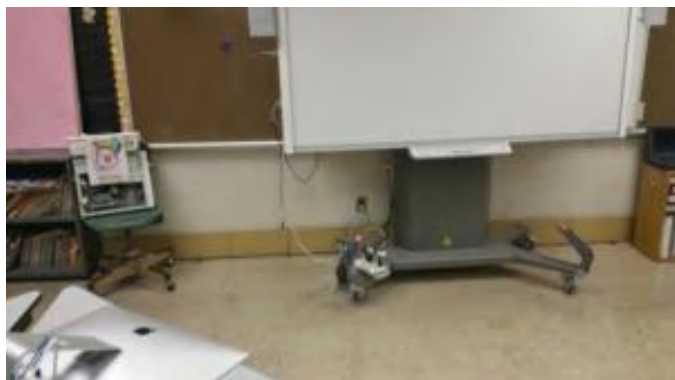
**System: D5020 - Lighting and Branch Wiring**

**Location:** throughout the building

**Distress:** Beyond Service Life

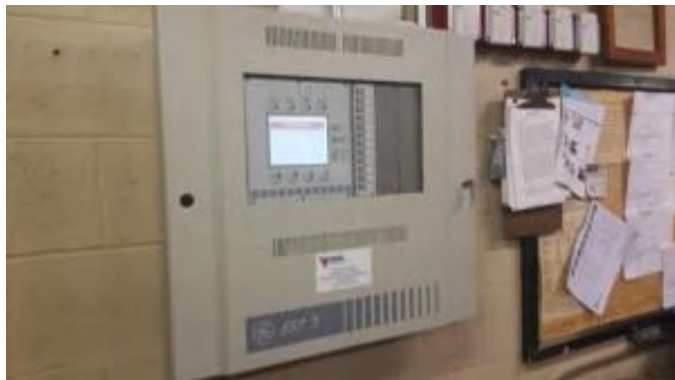
**System: D5030 - Communications and Security**

**Location:** throughout the building

**Distress:** Building / MEP Codes

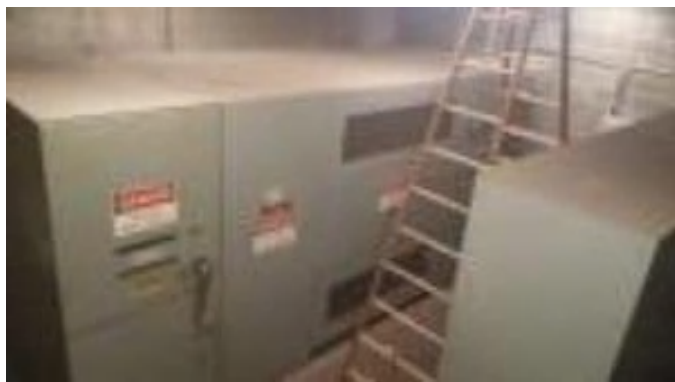
**System: D5090 - Other Electrical Systems**

**Location:** electrical room

**Distress:** Building / MEP Codes

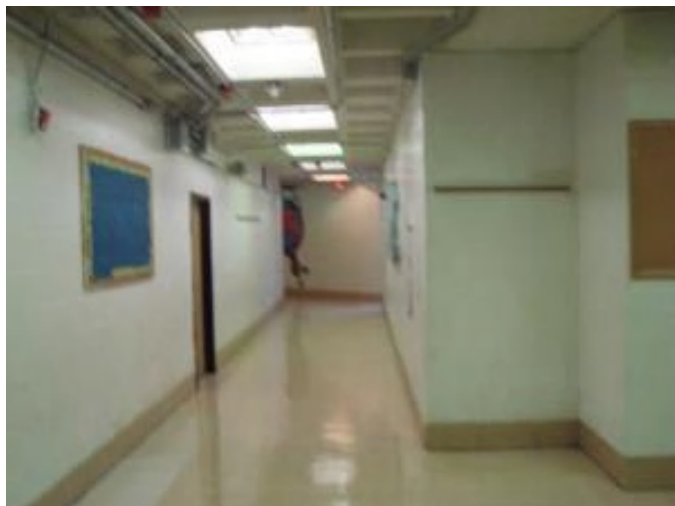
**System: D5090 - Other Electrical Systems**

**Location:** throughout the building

**Distress:** Life Safety / NFPA / PFD

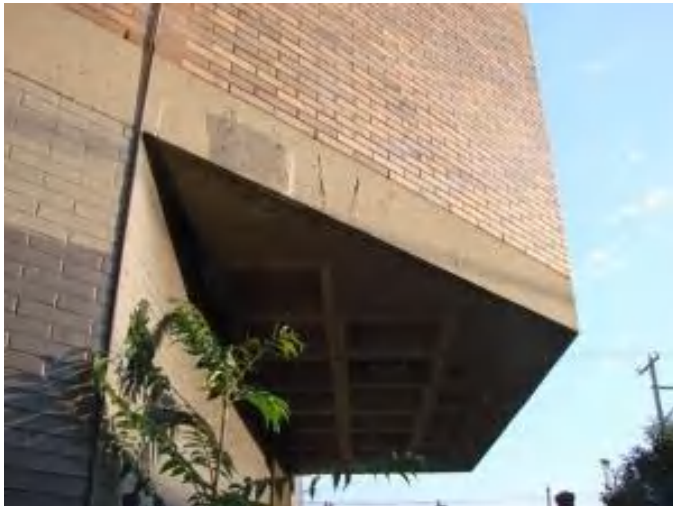
**System: B2010 - Exterior Walls**

**Location:** Exterior

**Distress:** Damaged

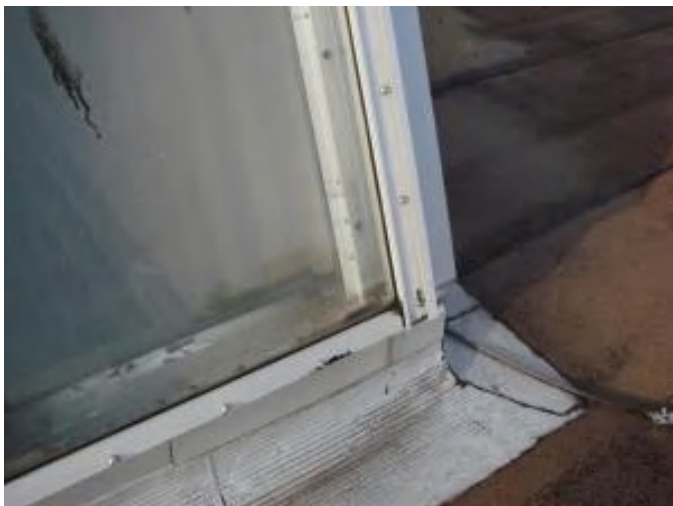
**System: B2020 - Exterior Windows**

**Location:** Exterior

**Distress:** Building Envelope Integrity

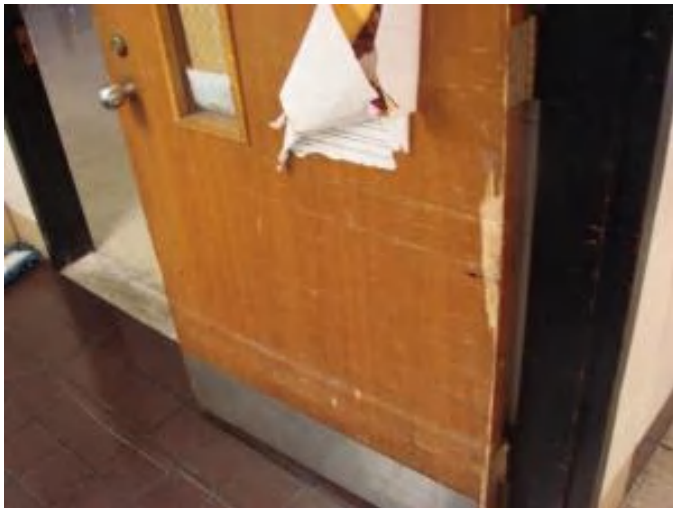
**System: C1020 - Interior Doors**

**Location:** Interior

**Distress:** Damaged

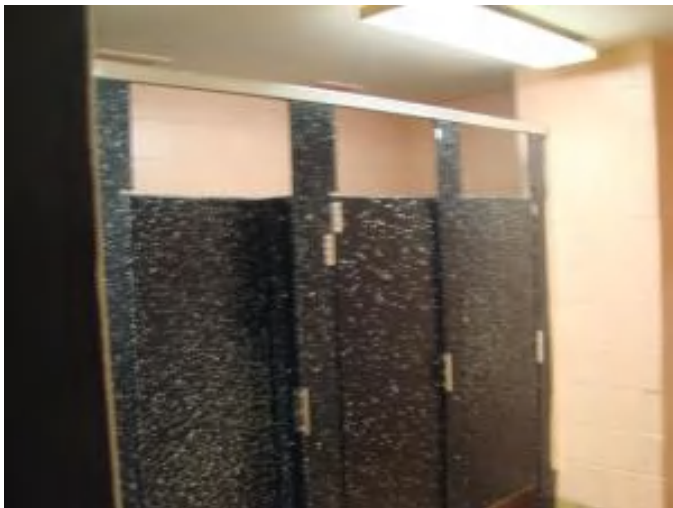
**System: C1030 - Fittings**

**Location:** Interior

**Distress:** Accessibility

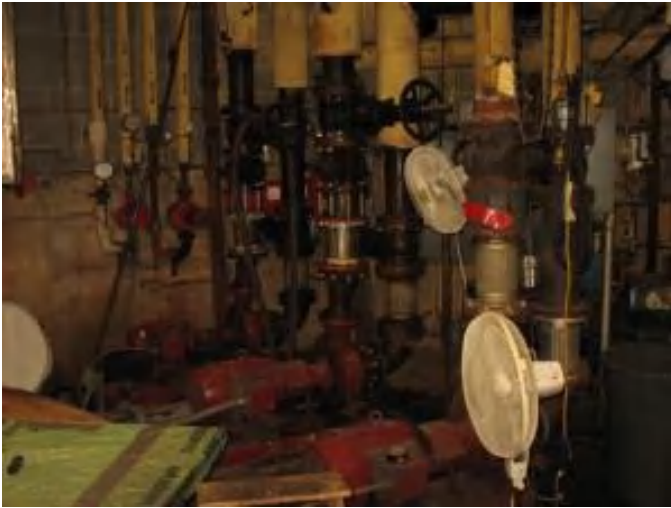
**System: D3020 - Heat Generating Systems**

**Location:** Boiler room

**Distress:** Beyond Service Life

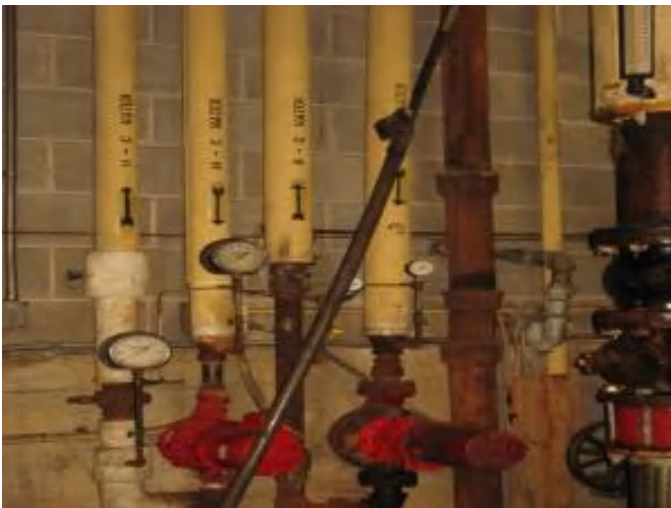
**System: D3020 - Heat Generating Systems**

**Location:** Boiler room

**Distress:** Beyond Service Life

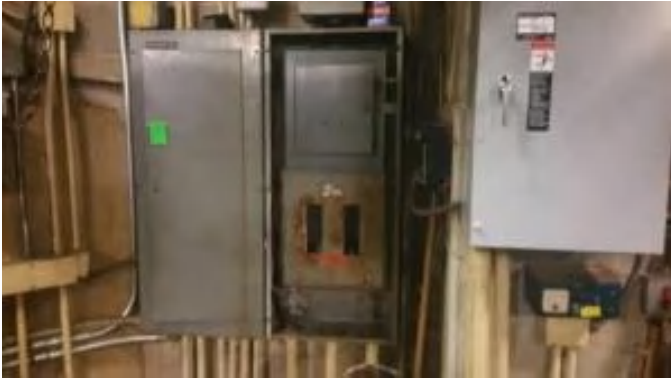
**System: D5010 - Electrical Service/Distribution**

**Location:** electrical room

**Distress:** Beyond Service Life

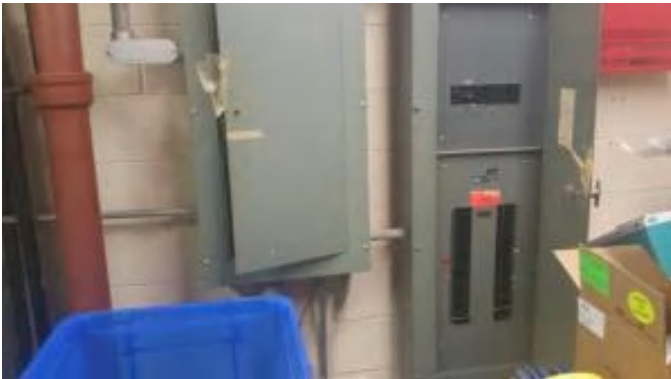
**System: D5010 - Electrical Service/Distribution**

**Location:** throughout the building

**Distress:** Beyond Service Life

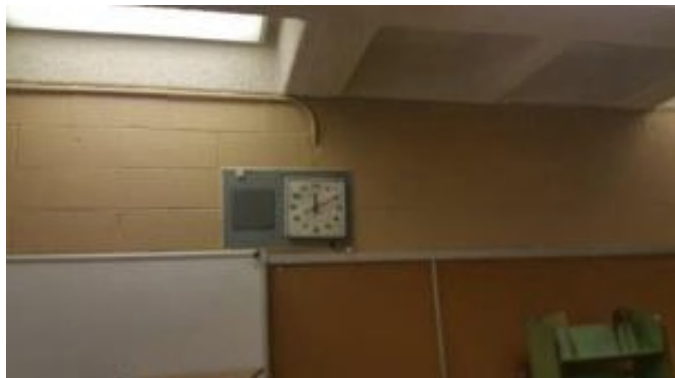
**System: D5030 - Communications and Security**

**Location:** throughout the building

**Distress:** Beyond Service Life

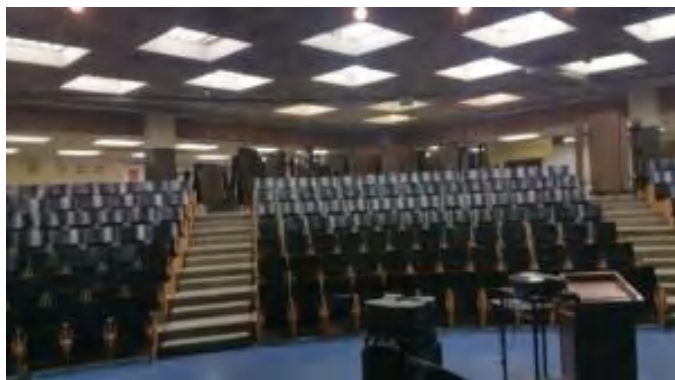
**System: E1020 - Institutional Equipment**

**Location:** auditorium

**Distress:** Beyond Service Life

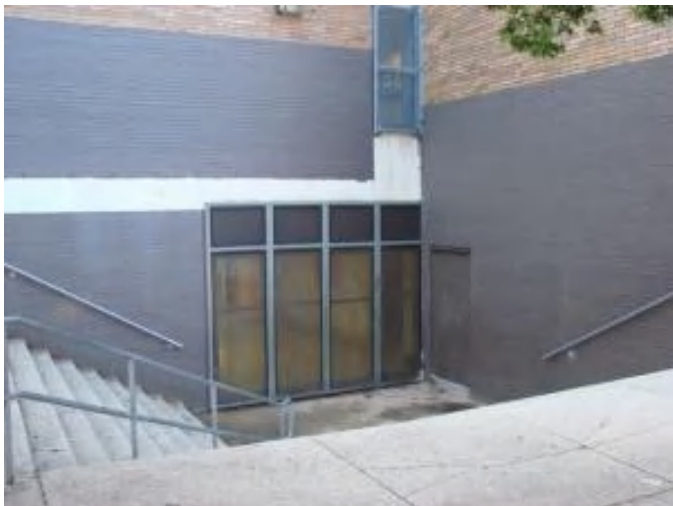
**System: B2010 - Exterior Walls**

**Location:** Exterior

**Distress:** Appearance

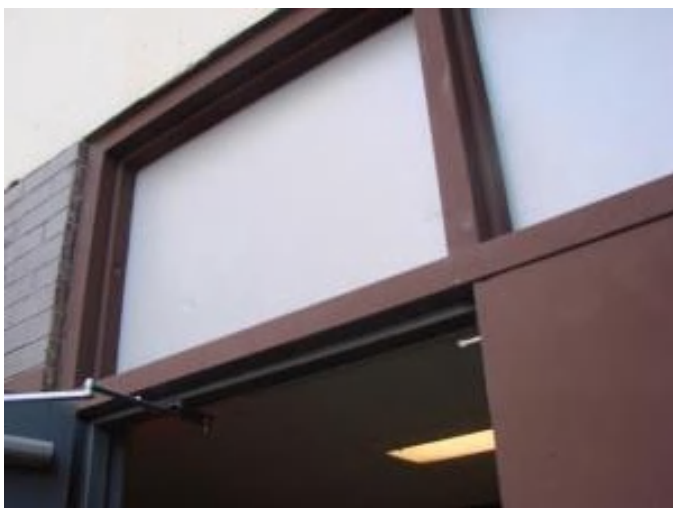
**System: B2030 - Exterior Doors**

**Location:** Exterior

**Distress:** Beyond Service Life

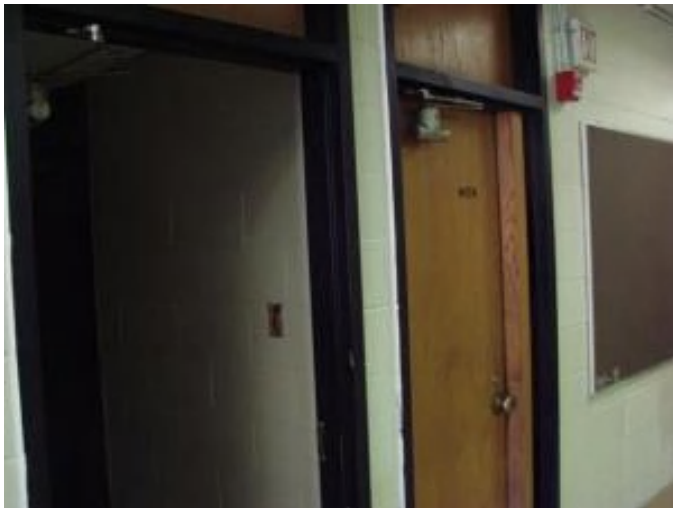
**System: C1030 - Fittings**

**Location:** Interior

**Distress:** Inadequate

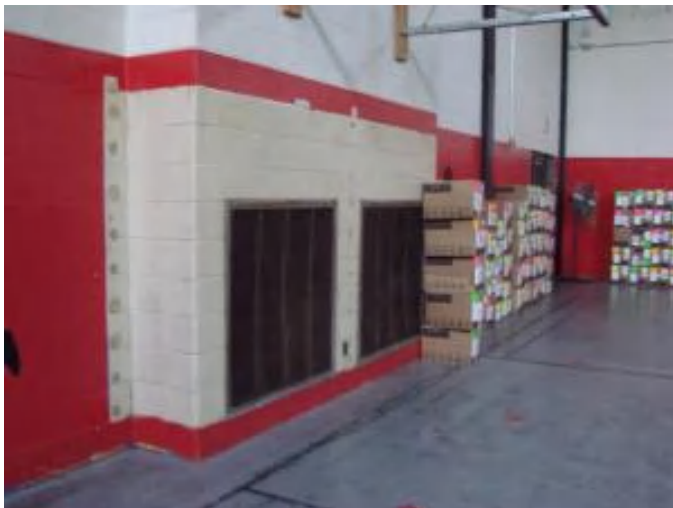
**System: C3020413 - Vinyl Flooring**

**Location:** Interior

**Distress:** Beyond Service Life

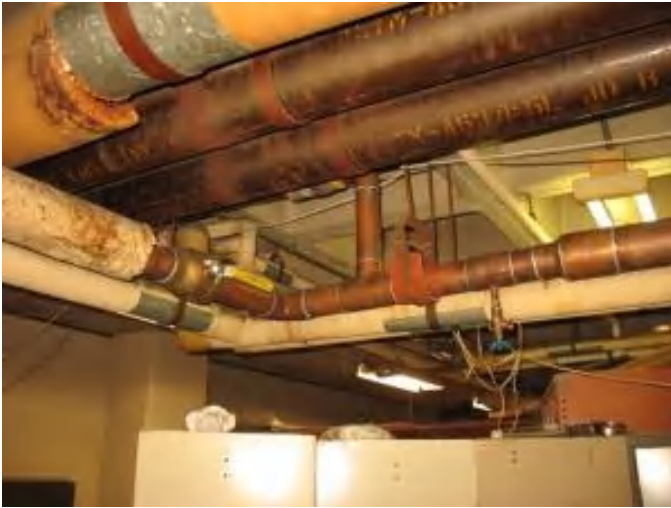
**System: D2020 - Domestic Water Distribution**

**Location:** Throughout building

**Distress:** Beyond Service Life

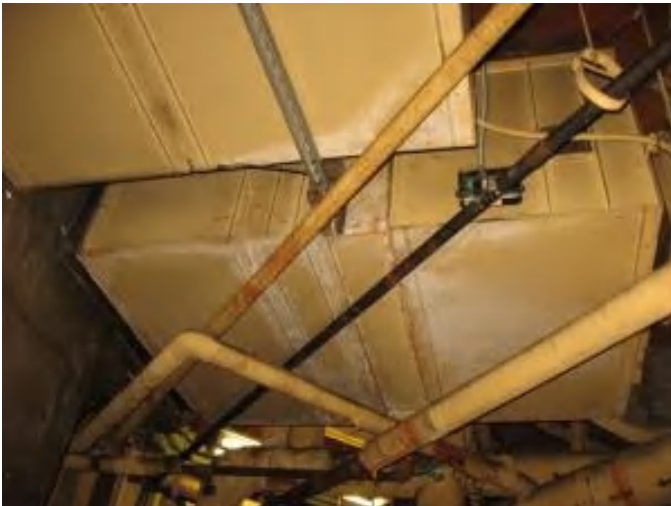
**System: D3040 - Distribution Systems**

**Location:** Cafetorium

**Distress:** Beyond Service Life

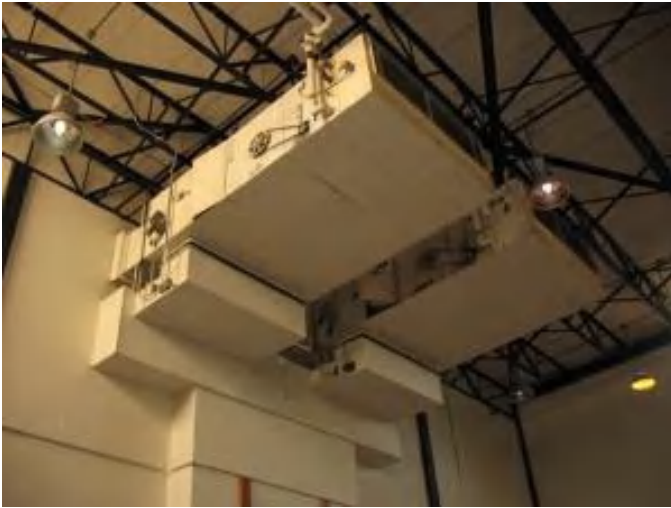
**System: D3040 - Distribution Systems**

**Location:** Gymnasium

**Distress:** Health Hazard / Risk

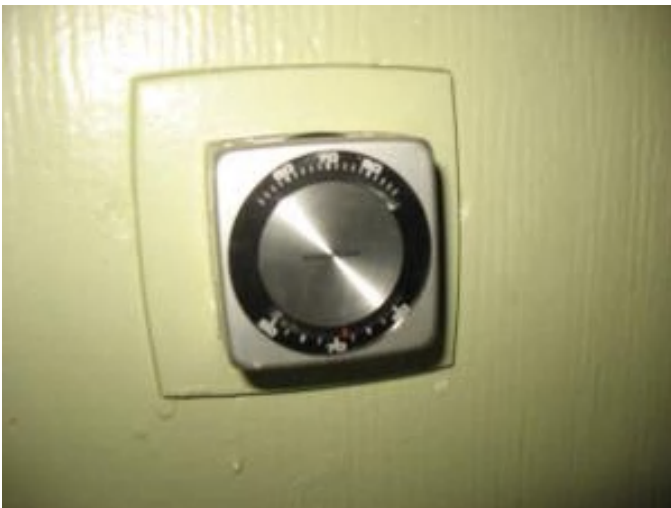
**System: D3060 - Controls & Instrumentation**

**Location:** Throughout building

**Distress:** Inadequate

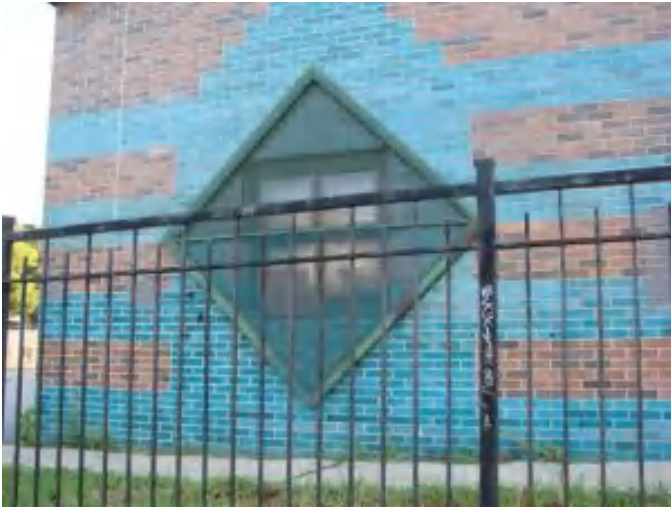
#### System: B2020 - Exterior Windows

**Location:** Exterior

**Distress:** Security Issue

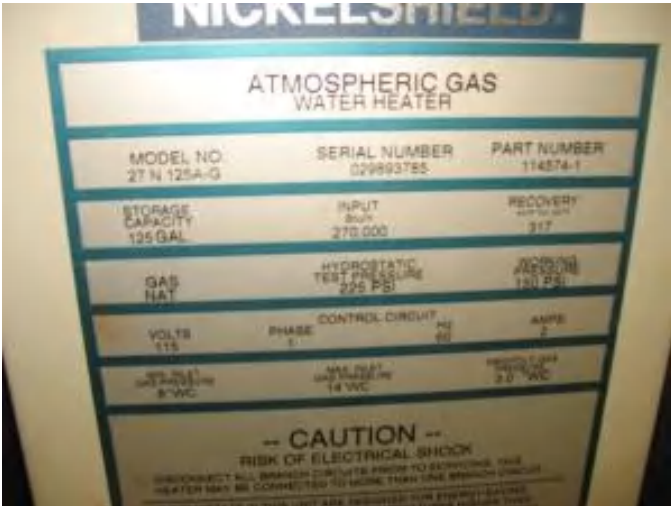
#### System: D2020 - Domestic Water Distribution

**Location:** Mechanical room

**Distress:** Beyond Service Life

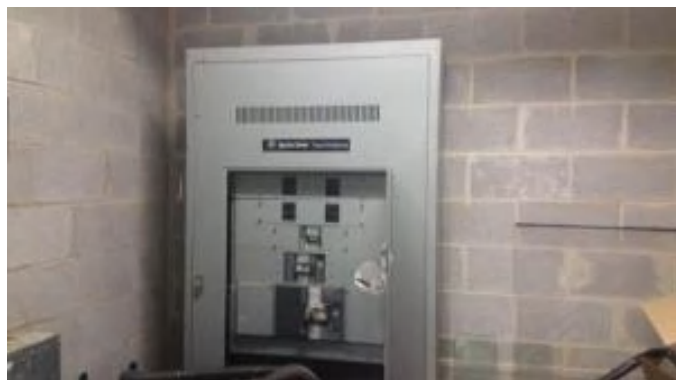
**System: D5090 - Other Electrical Systems**

**Location:** electrical room

**Distress:** Building / MEP Codes

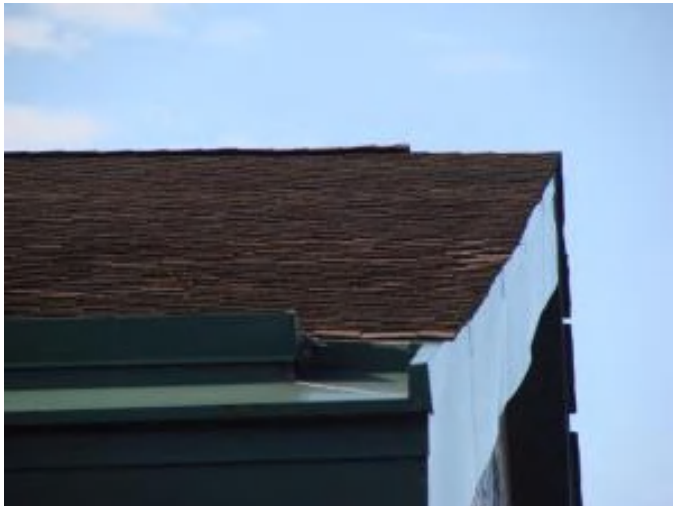
**System: B3010140 - Shingle & Tile**

**Location:** Exterior

**Distress:** Beyond Service Life

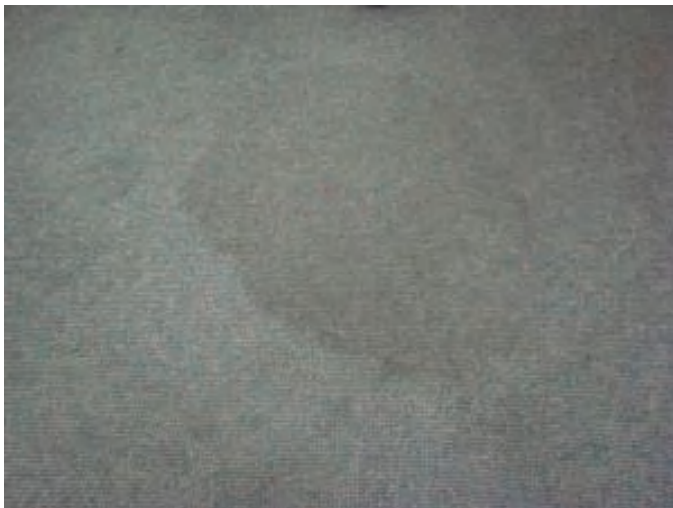
**System: C3020411 - Carpet**

**Location:** Interior

**Distress:** Beyond Service Life

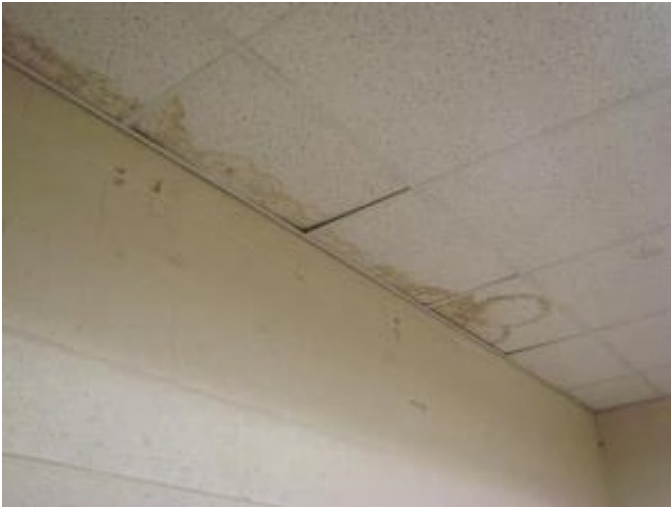
**System: C3030 - Ceiling Finishes**

**Location:** Interior

**Distress:** Beyond Service Life

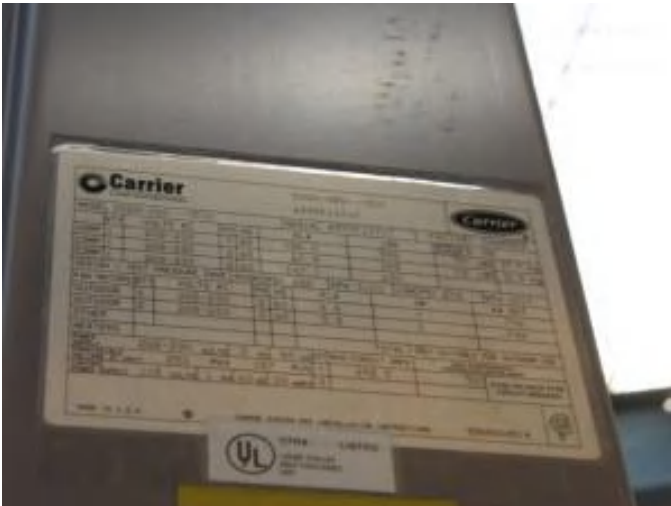
**System: D3030 - Cooling Generating Systems**

**Location:** Mechanical yard

**Distress:** Beyond Service Life

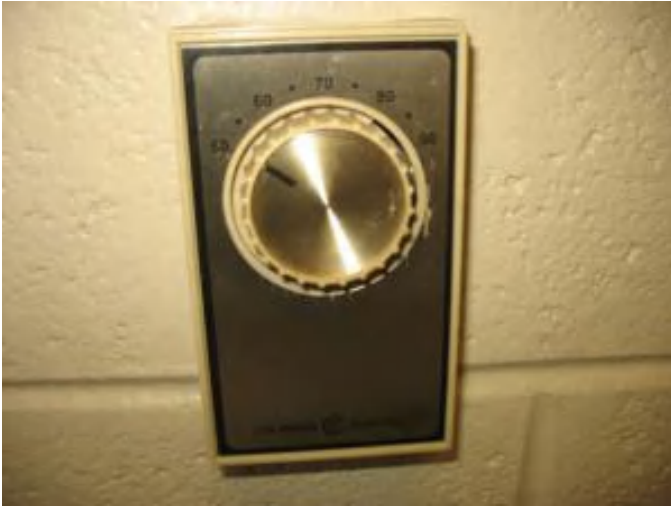
**System: D3060 - Controls & Instrumentation**

**Location:** Throughout building

**Distress:** Failing

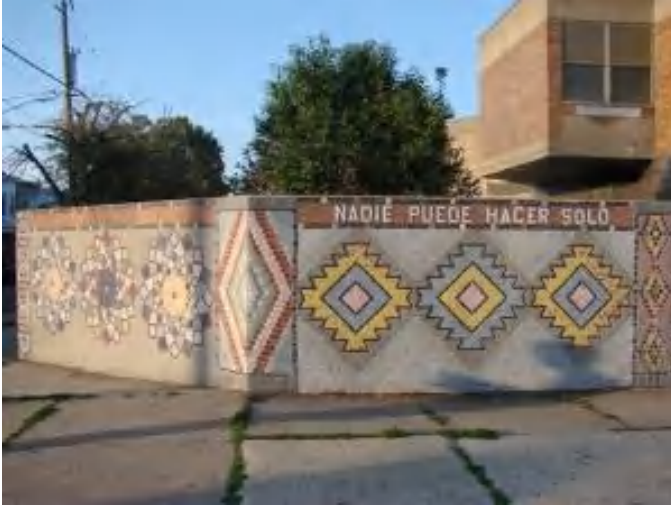
#### System: G2030 - Pedestrian Paving

**Location:** Grounds/ site

**Distress:** Beyond Service Life
