**Henry C. Lea Elementary School**  
4700 Locust Street  
Philadelphia, Pennsylvania

## **Paint and Plaster Stabilization Project Final Report**

**DECEMBER 8, 2022**

The Vertex Companies, LLC  
2501 Seaport Drive, Suite BH110  
Chester, Pennsylvania 19013  
**PHONE** 610.558.8902

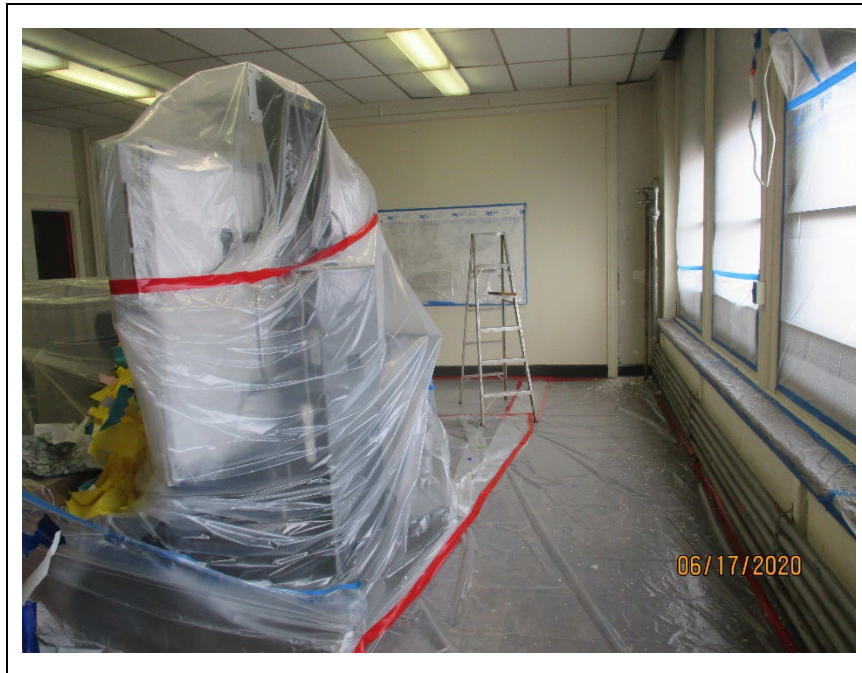
**Photograph 1** – Classroom undergoing prep

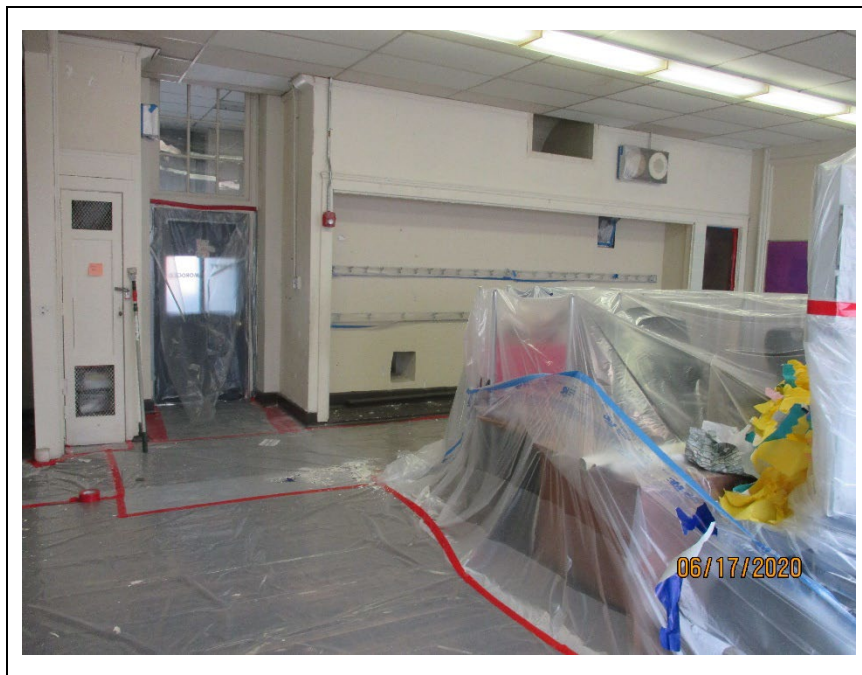
**Photograph 2** – Classroom materials covered in center of room

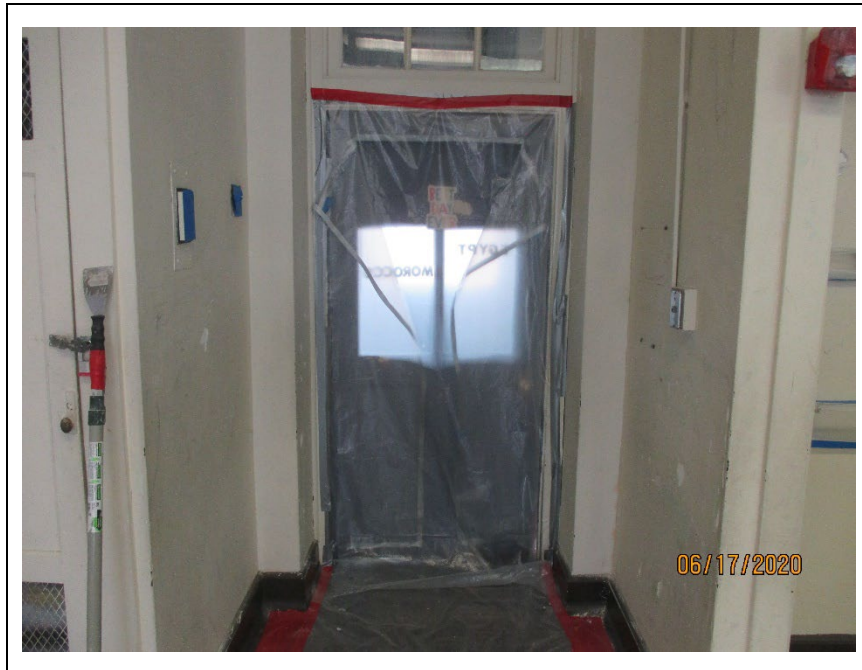
**Photograph 3** – Plastic flap at entrance to space

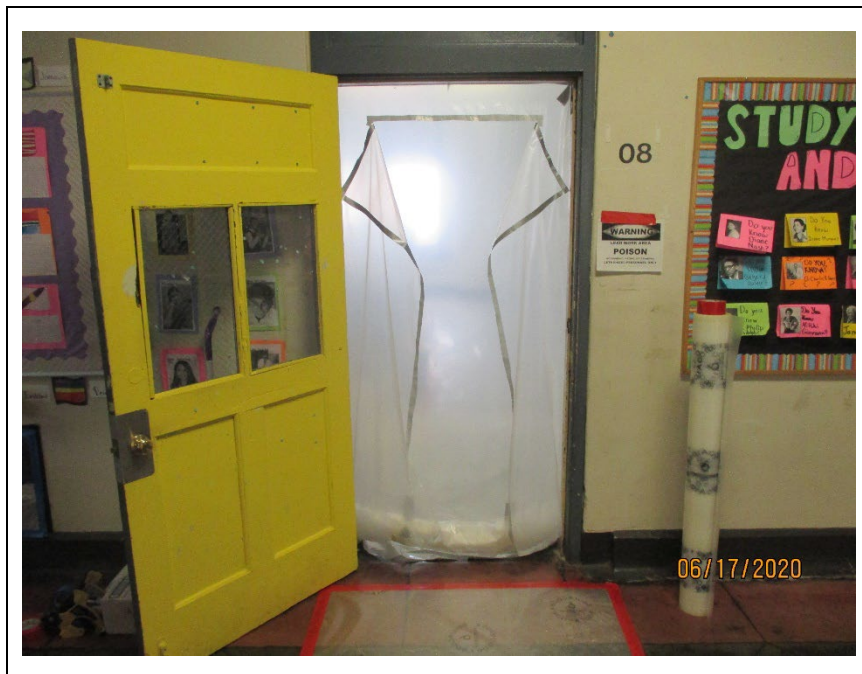
**Photograph 4** – Plastic flap at entrance to space with lead warning sign

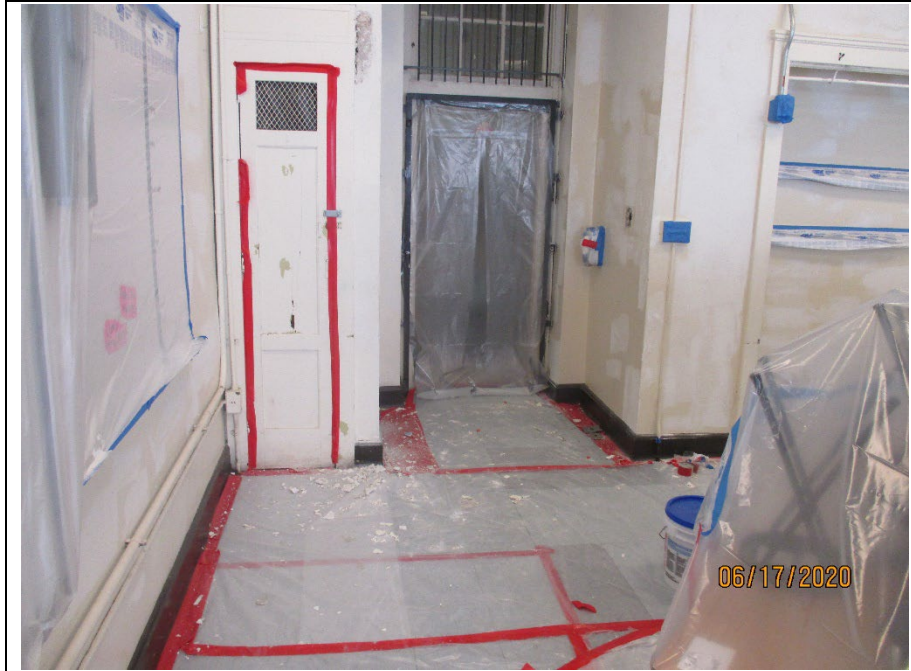
**Photograph 5** – Classroom undergoing stabilization

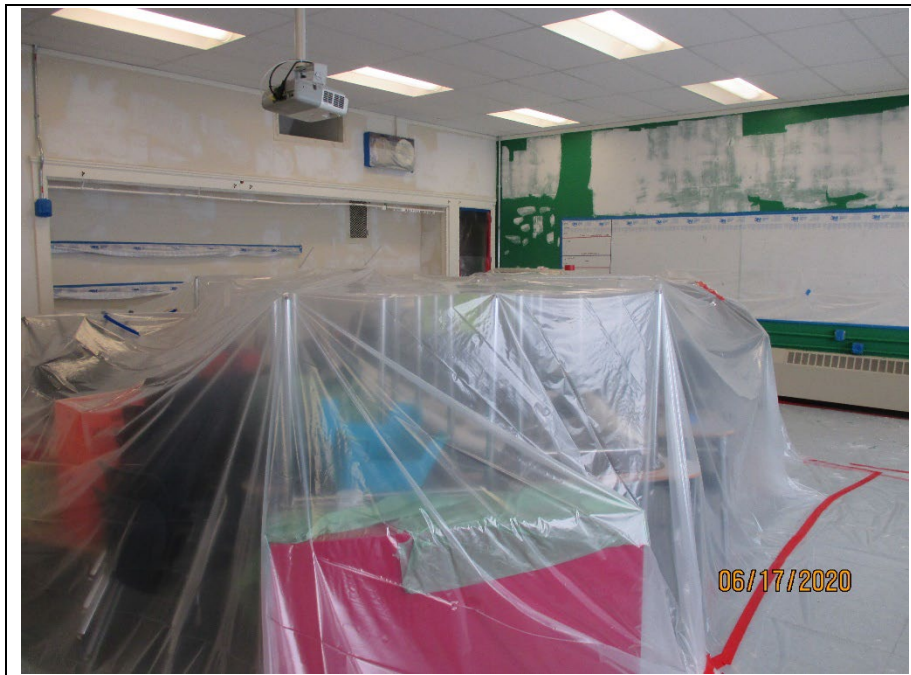
**Photograph 6** – Classroom undergoing stabilization

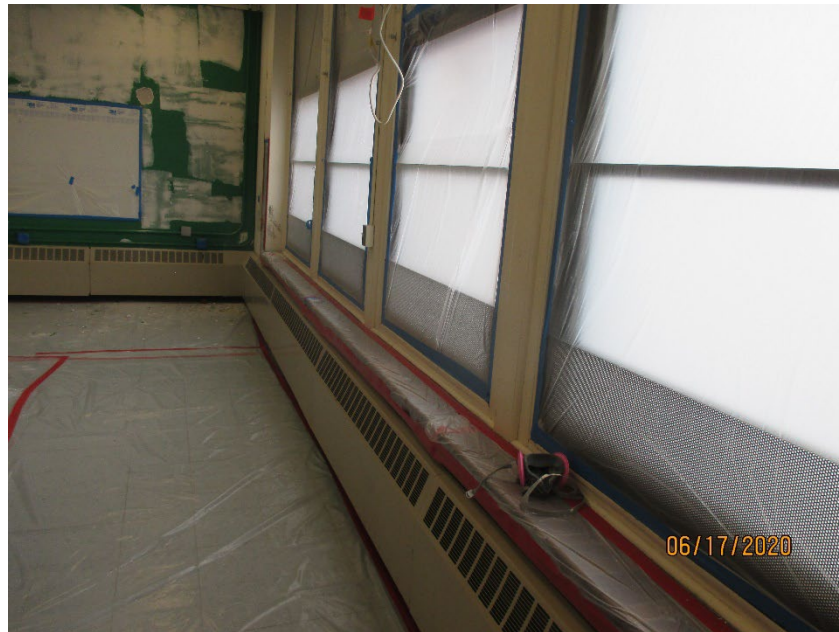
**Photograph 7** – Classroom undergoing stabilization with plastic still in place

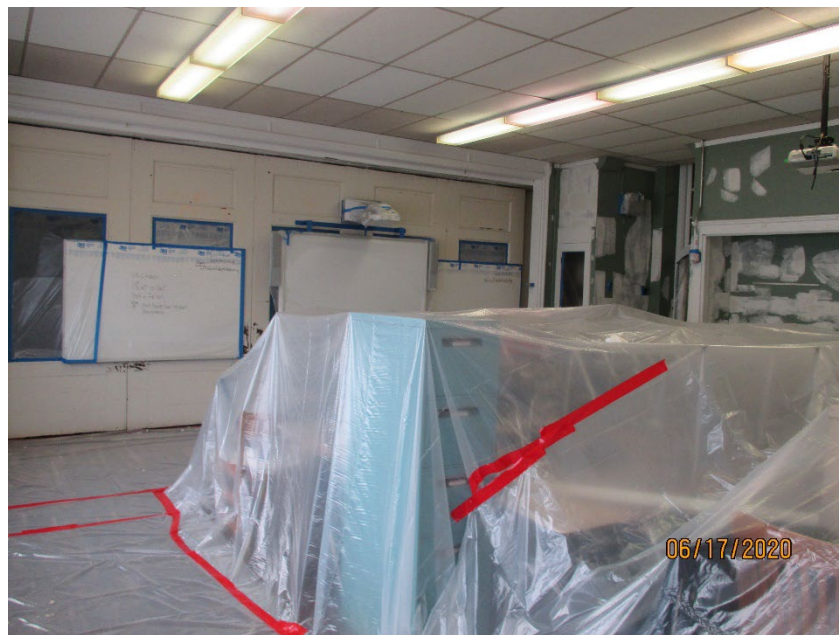
**Photograph 8** – Classroom undergoing stabilization with plastic still in place

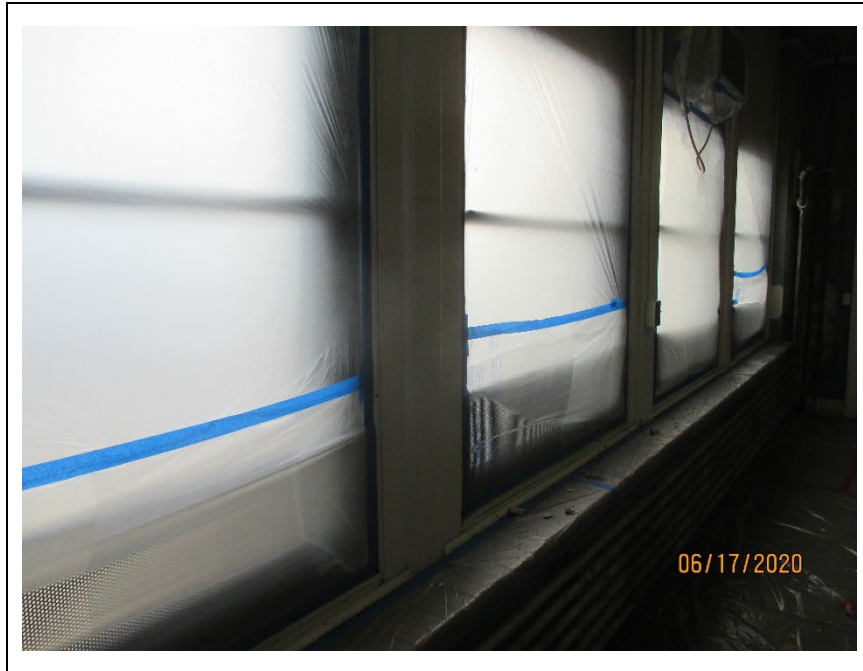
**Photograph 9** – Classroom windows sealed for stabilization

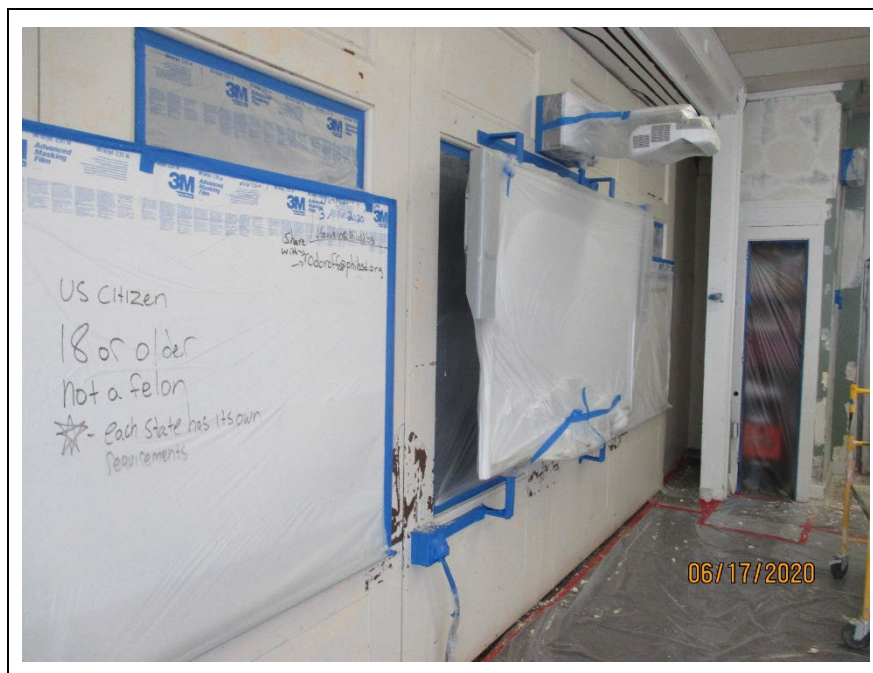
**Photograph 10** – Non-movable objects covered for stabilization

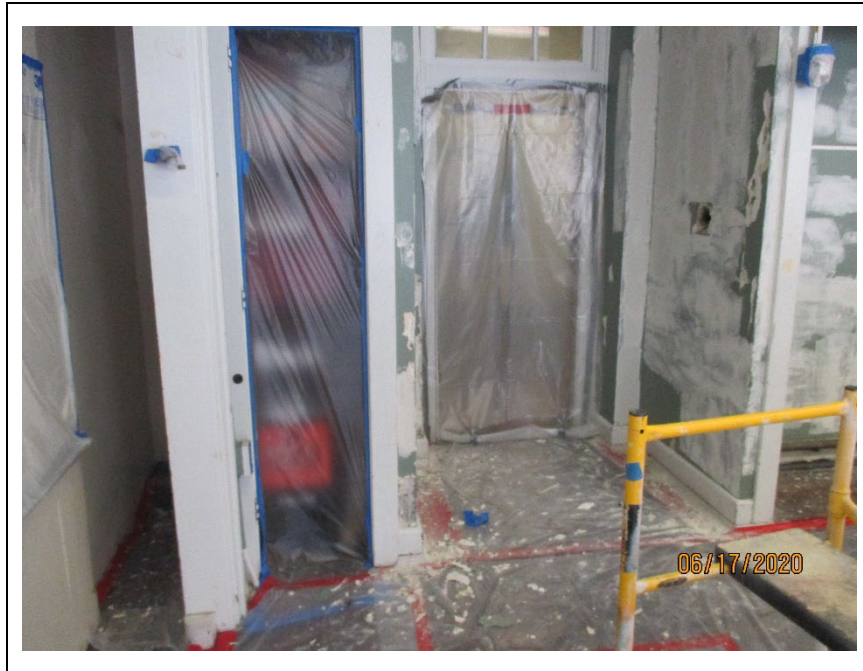
**Photograph 11 – Classroom undergoing stabilization**

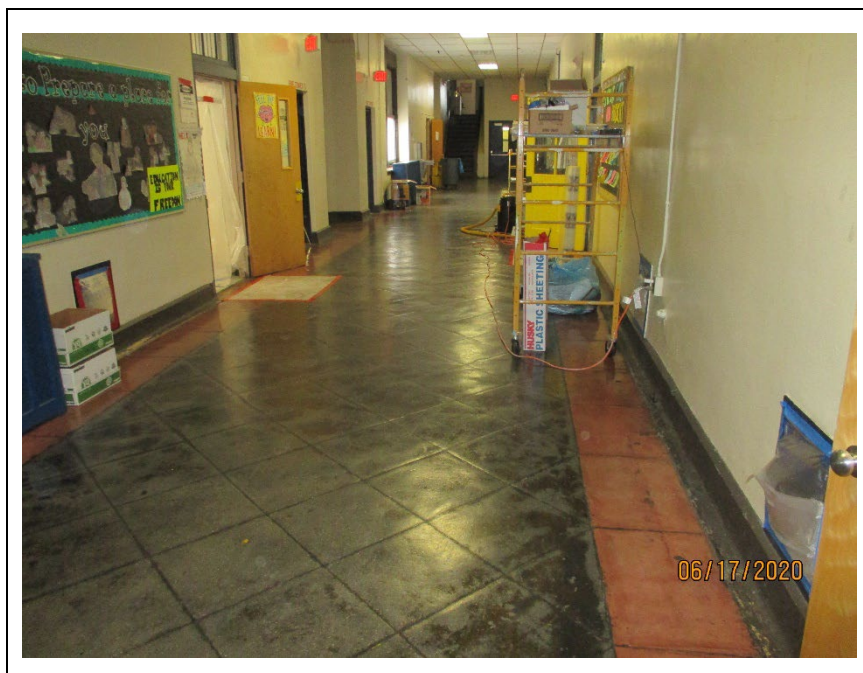
**Photograph 12 – Hallway after stabilization**
