**Summary of Paint & Plaster Stabilization  
Activities**

**Clara Barton Elementary School  
(ULCS No.: 7200)  
4600 Rosehill Street  
Philadelphia, Pennsylvania 19120  
Project Number: 1292**

**December 5, 2018**

**Project Dates: July 30, 2018 – November 20, 2018**

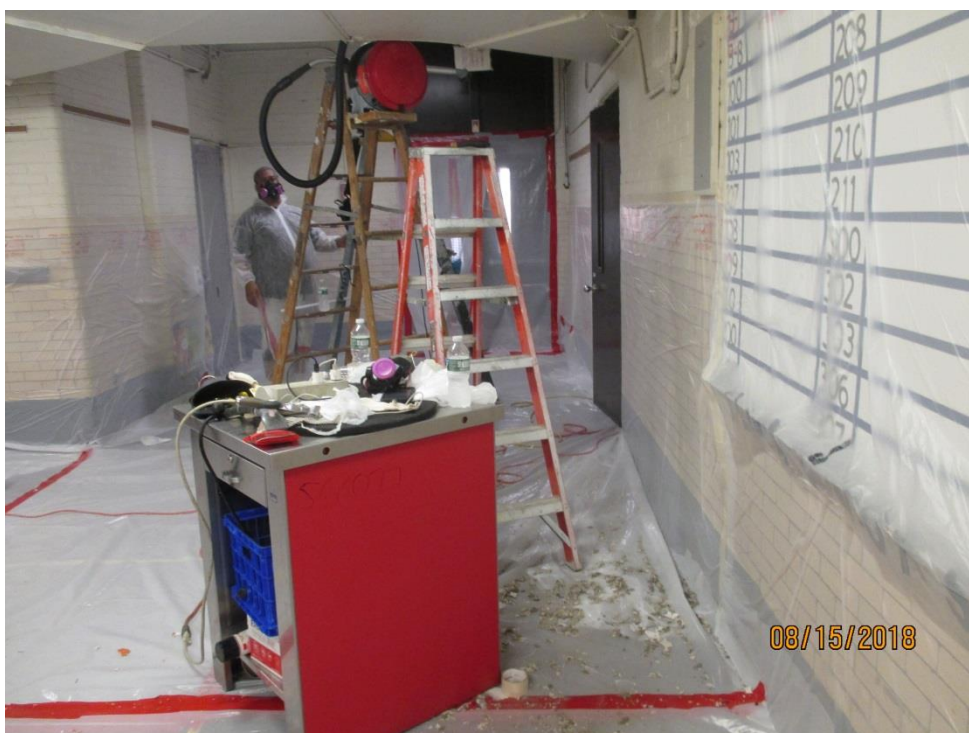
Photo 8 – Scraping/Removing Flaking Paint in Basement Hallway Containment Area.

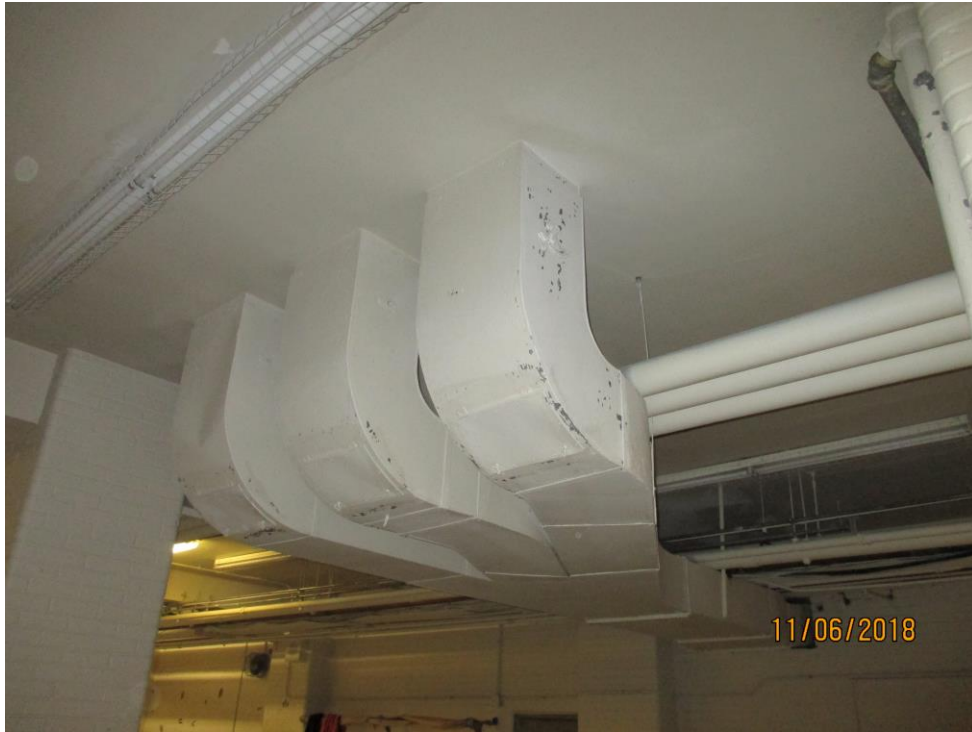
Photo 11 – Flaking Paint prior to Scraping in Gymnasium Containment Area.

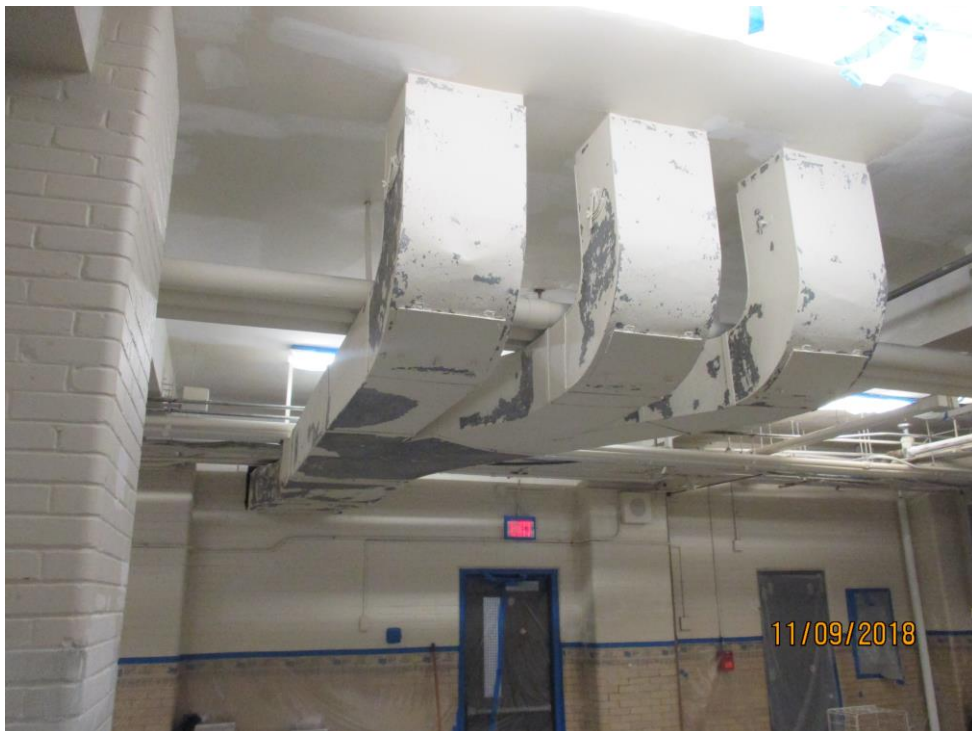
Photo 12 – Scraping/Removing Flaking Paint in Gymnasium Containment Area.

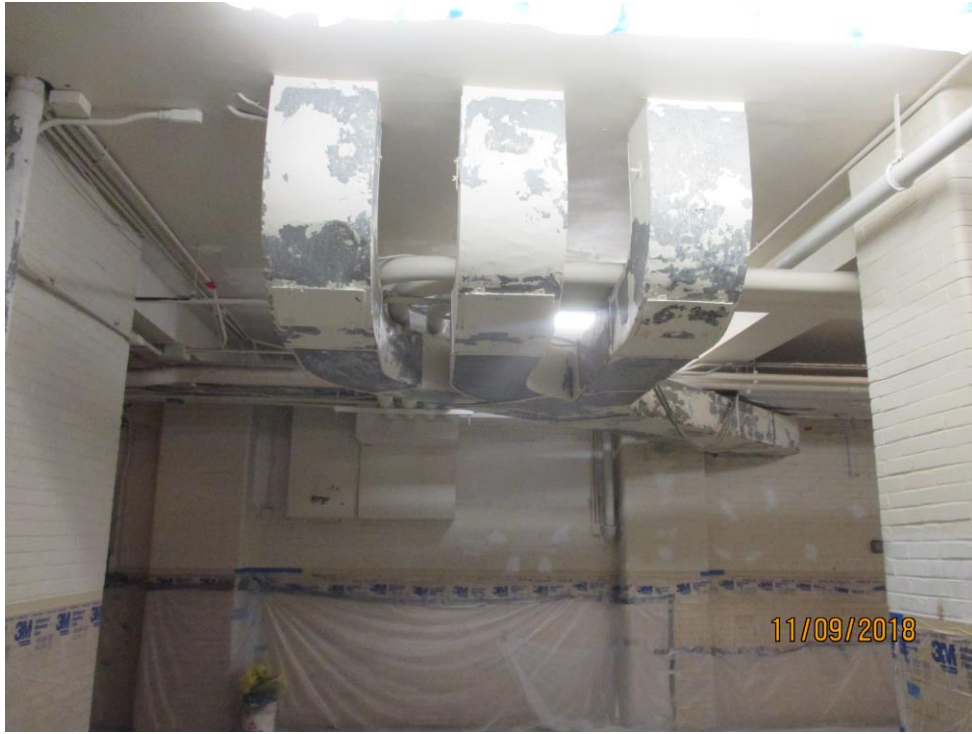
Photo 13 – Scraping/Removing Flaking Paint in Gymnasium Containment Area.

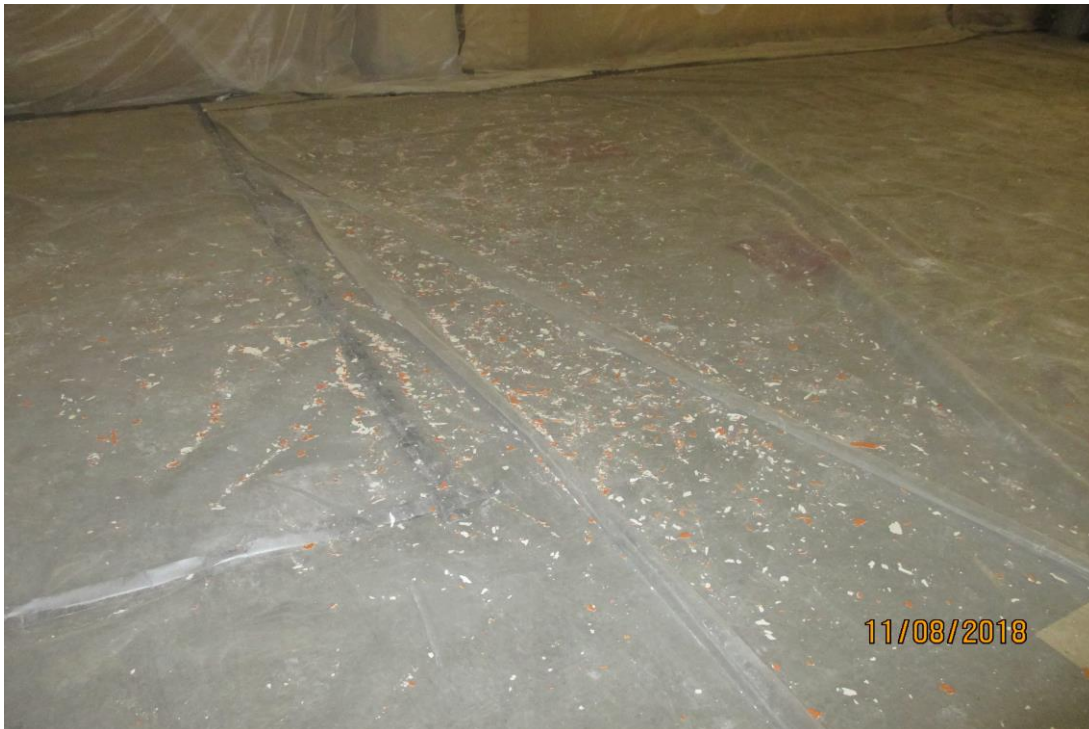
Photo 14 – Removed Flaking Paint Chips in Gymnasium Containment Area.

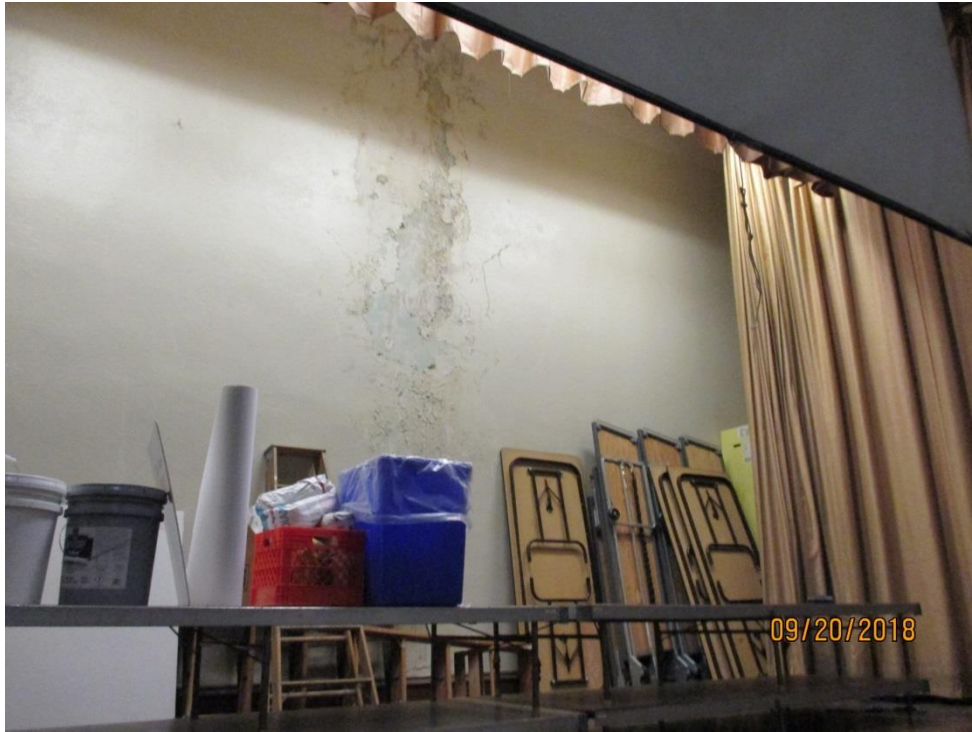
Photo 17 – Stage Wall Damage Prior to Prepping and Scraping.

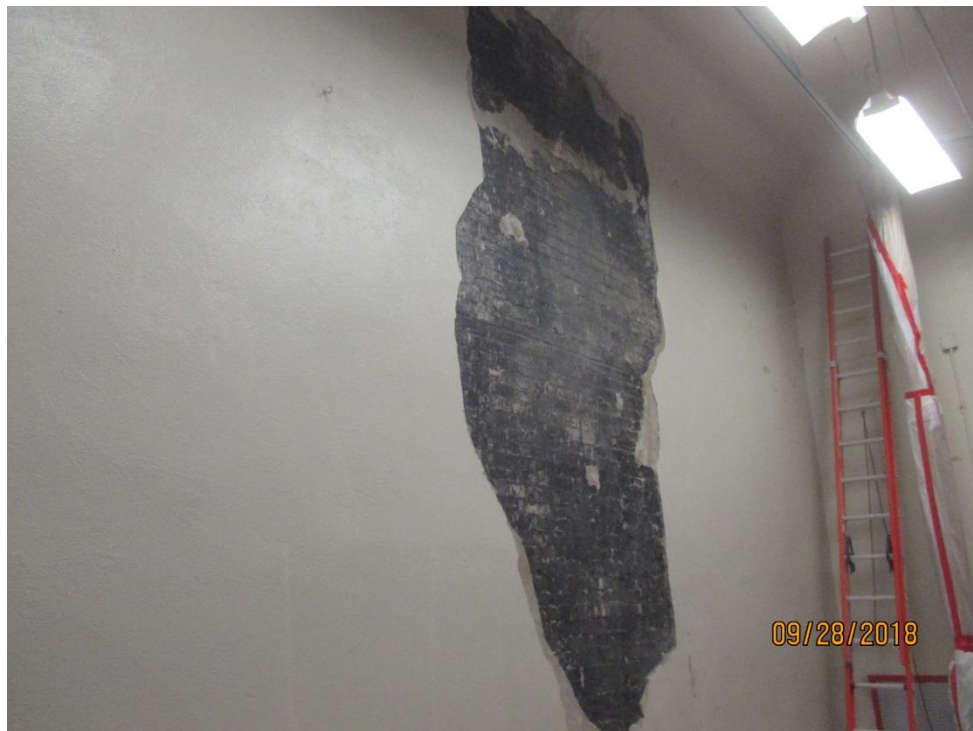
Photo 18 – Stage Wall following Scraping and Prior to Plastering/Painting.

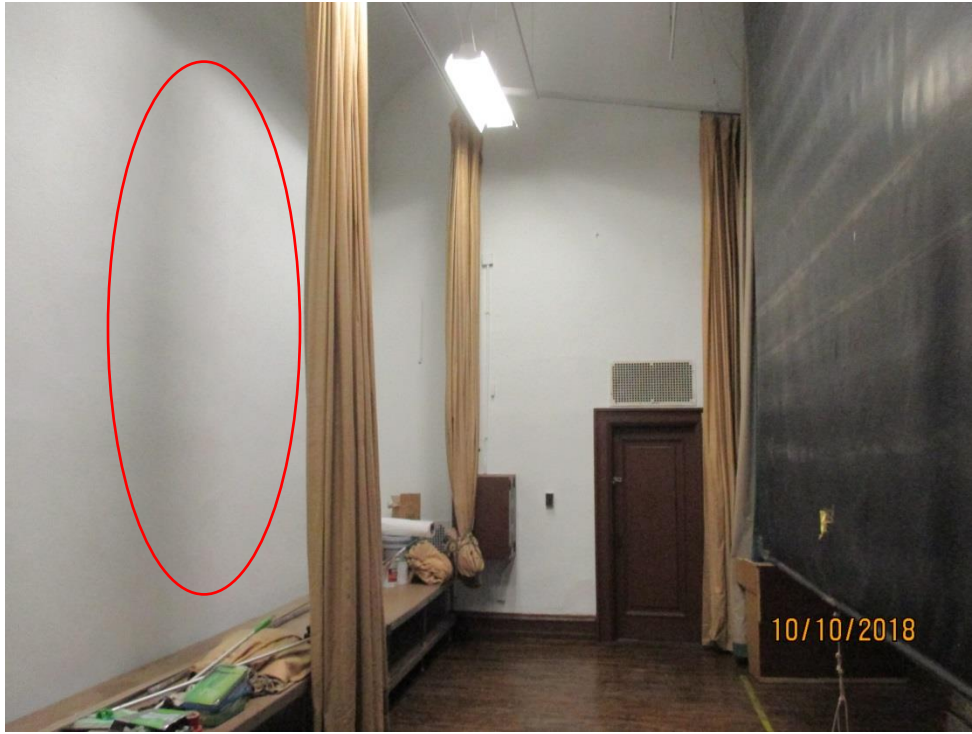
Photo 19 – Stage Following Completion of Work (oval indicates area of damaged wall).

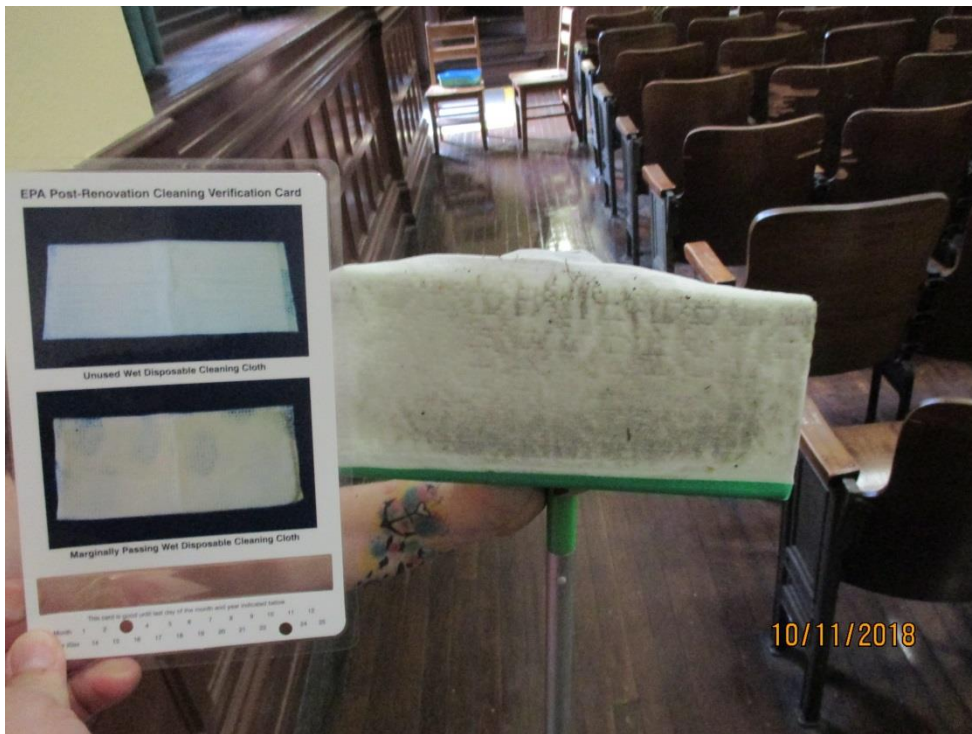
Photo 26 – Failed Swiffer Wipe (per 40 SF) Compared to the EPA Post-Renovation Cleaning Verification Card.

If the colorimetric testing "failed", then the 40 SF area was re-wiped by EPA RRP Wipes. The process continued until both testing methods confirmed a "pass".

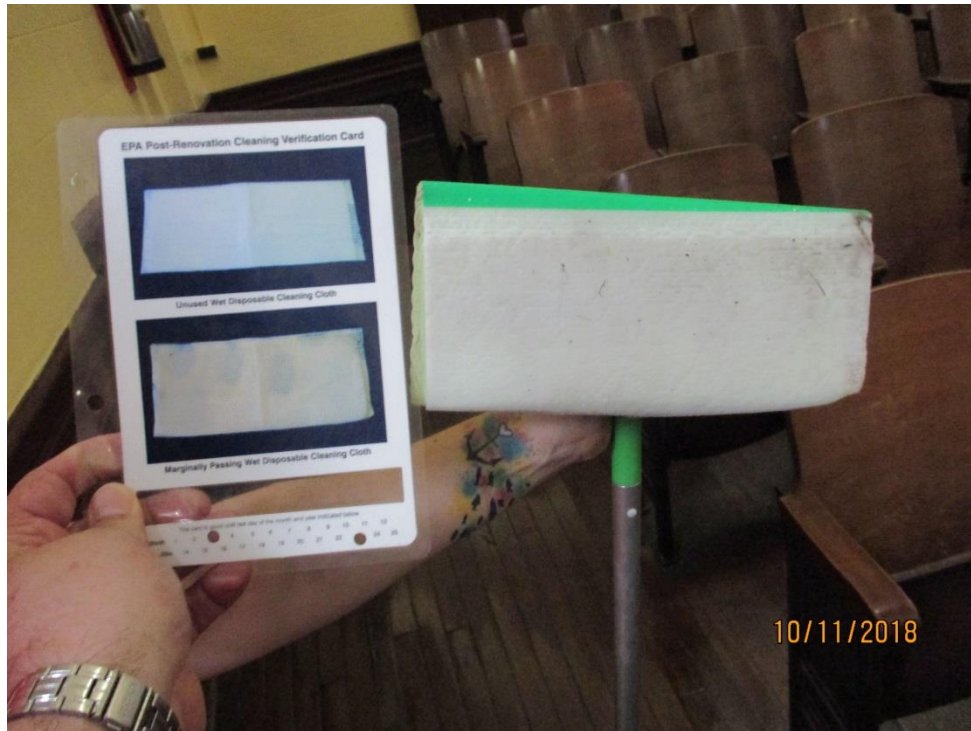
Photo 27 – Passed Swiffer Wipe (per 40 SF) Compared to the EPA Post-Renovation Cleaning Verification Card.

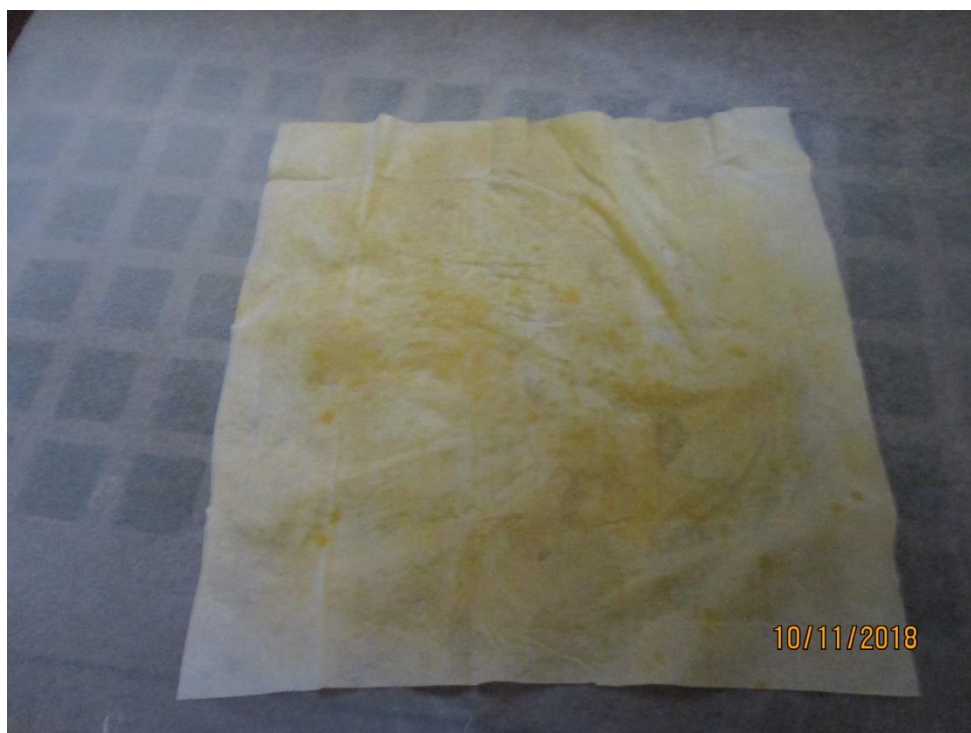
Photo 30 – Colorimetric Wipe Sample (Yellow Color = Passed).
