Summary of Paint & Plaster Stabilization Activities

**#7310 – Feltonville Head Start School
4901 Rising Sun Avenue
Philadelphia, PA 19120**

November 21, 2019

192379

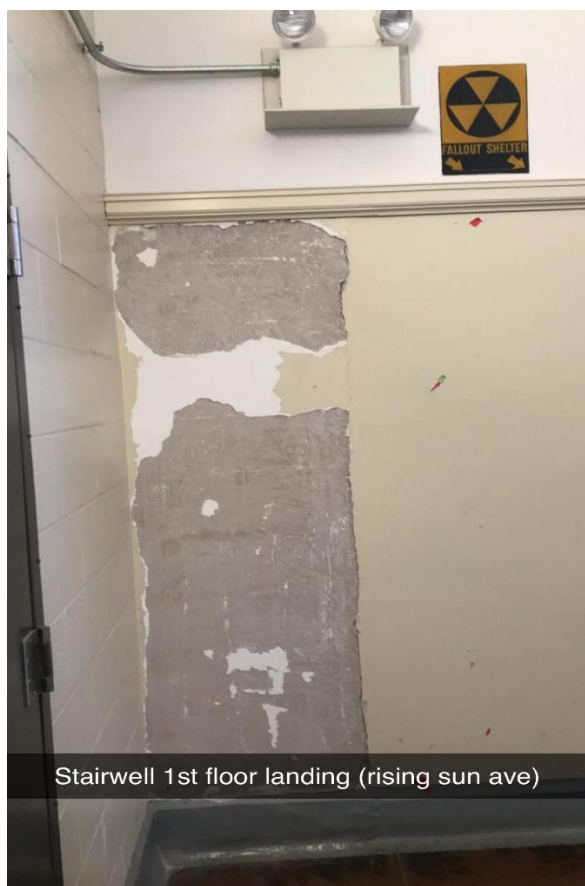
Stairwell 1st floor landing (rising sun ave)

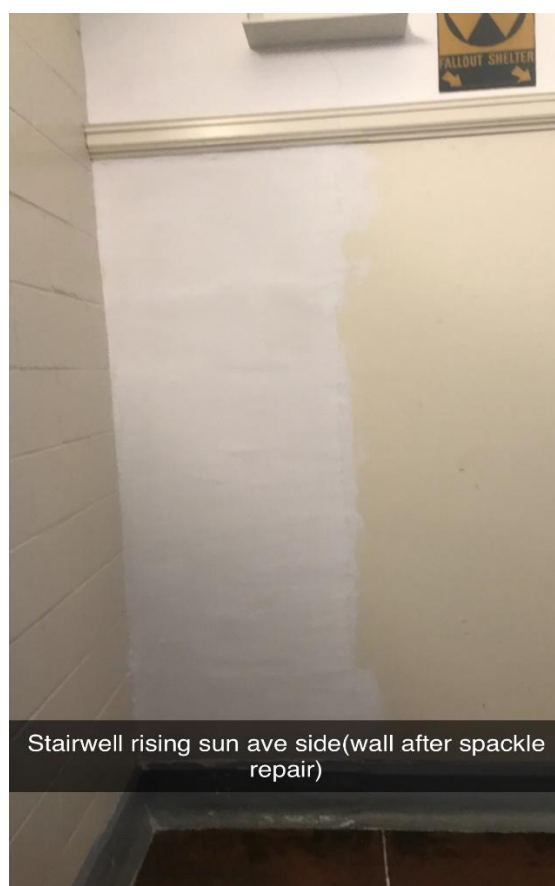
Stairwell rising sun ave side (wall after spackle repair)
