**Carnell Elementary School**  
1100 Devereaux Avenue  
Philadelphia, Pennsylvania

## **Paint and Plaster Stabilization Project Final Report**

**MAY 28, 2020**

**VERTEX Project No:** 57324

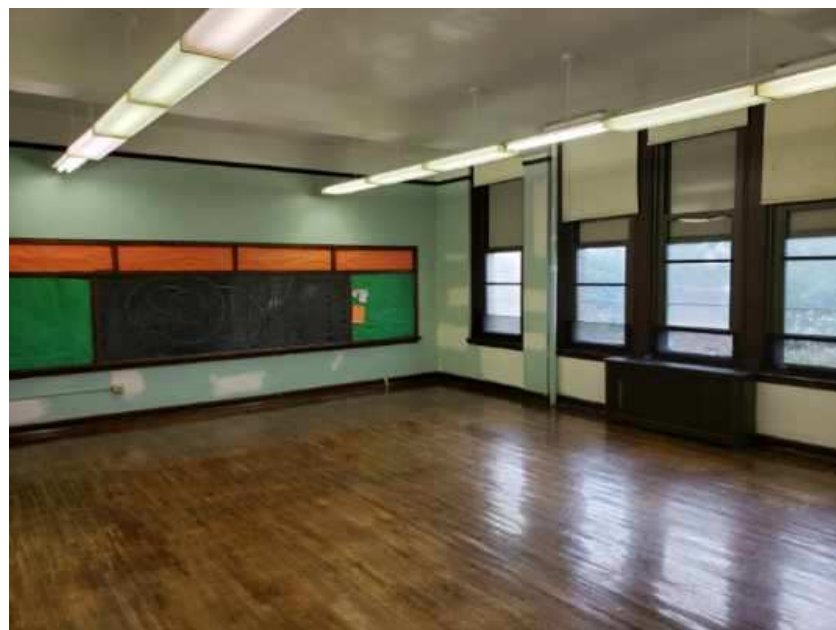
**Photograph 1** – Typical classroom after stabilization but prior to painting.

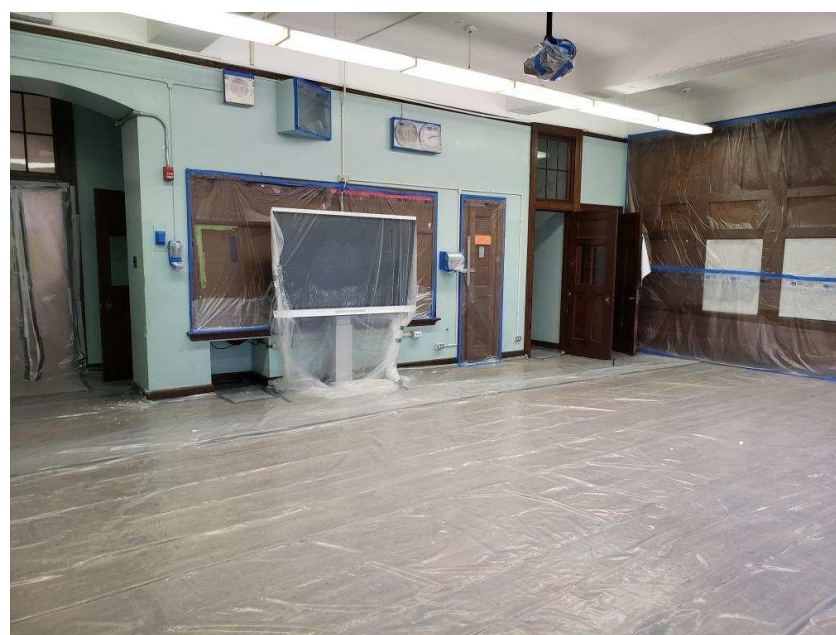
**Photograph 2** – Typical classroom prepped for stabilization.

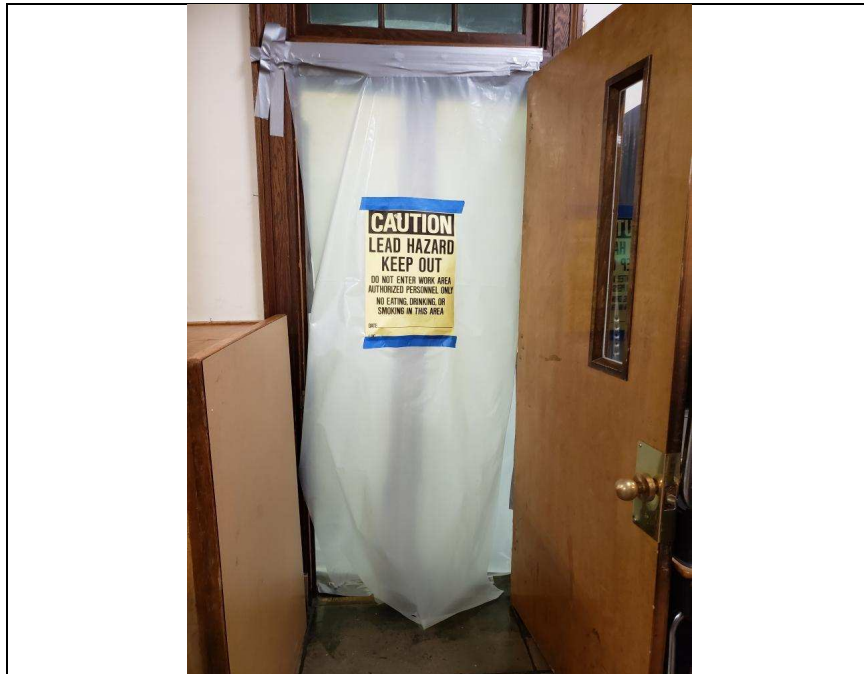
**Photograph 3** – Warning sign at entrance to work area.

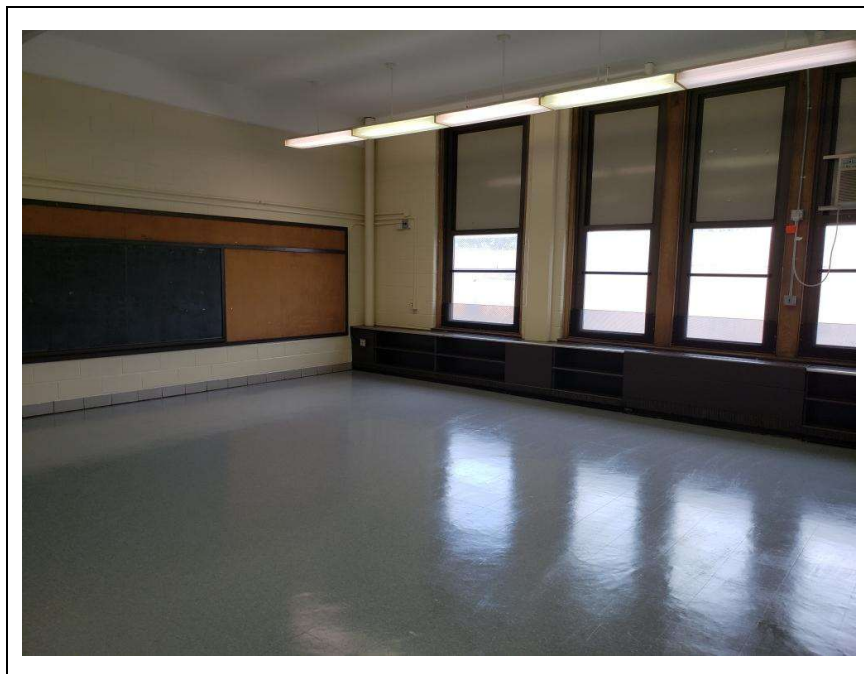
**Photograph 4** – Typical classroom after stabilization and painting.

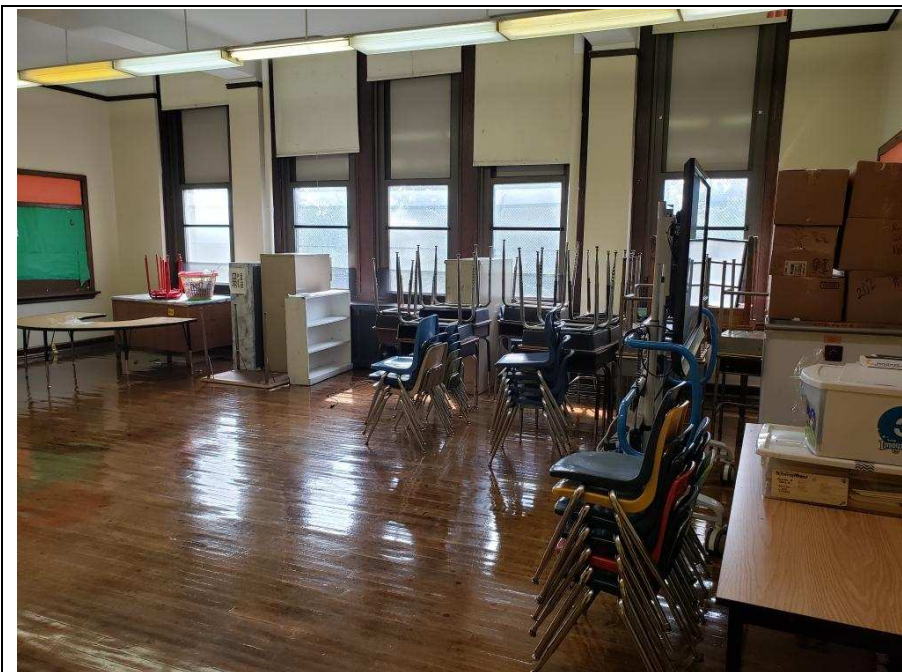
**Photograph 5** – Typical classroom after stabilization and painting with contents back in.

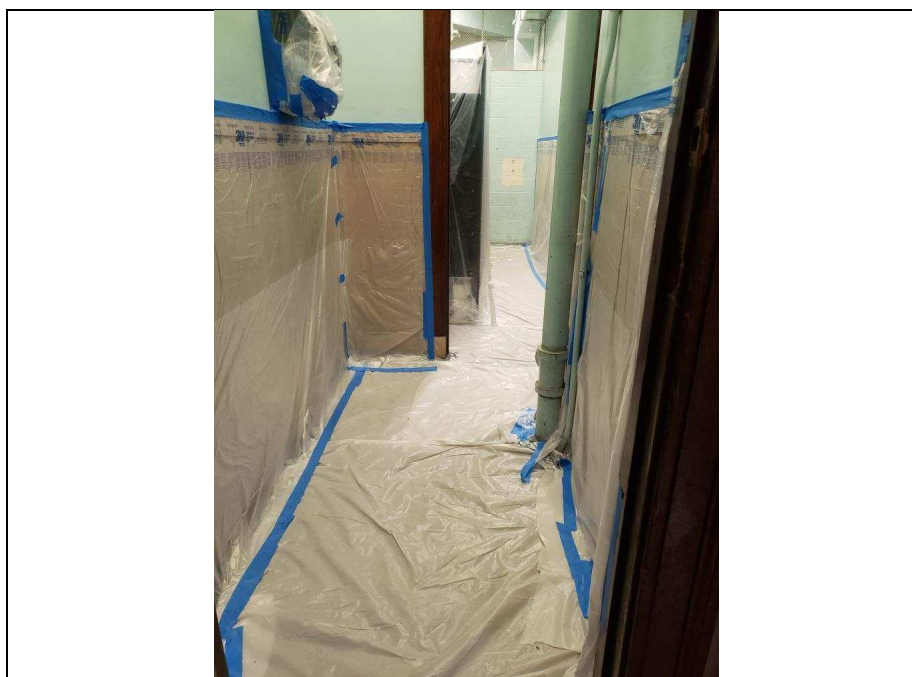
**Photograph 6** – Typical restroom prepped for stabilization.

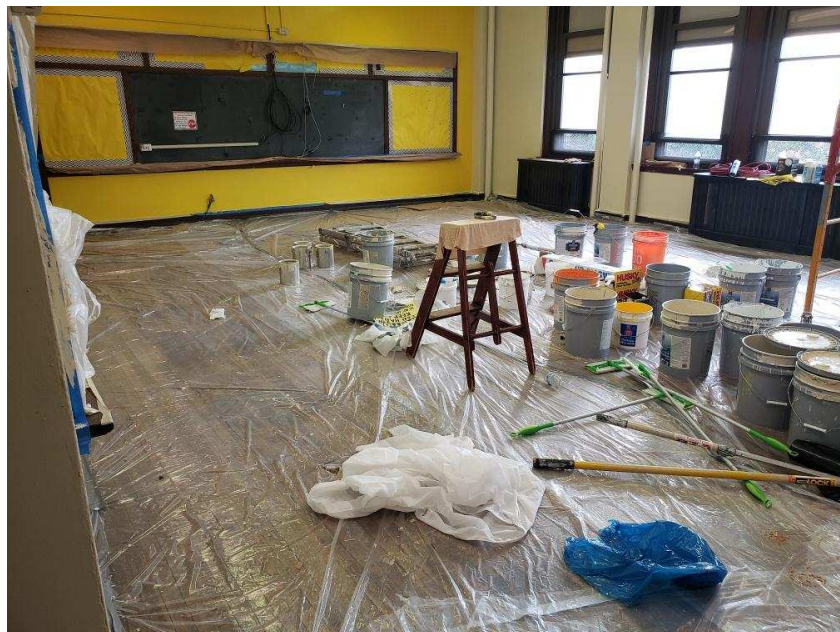
**Photograph 7** – Typical classroom prepped during painting.

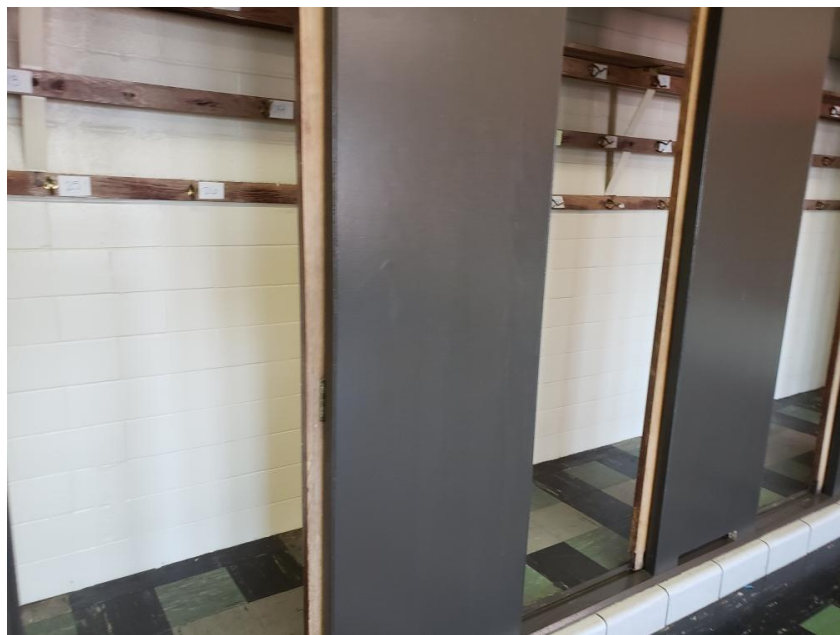
**Photograph 8** – Typical closet after stabilization and painting.

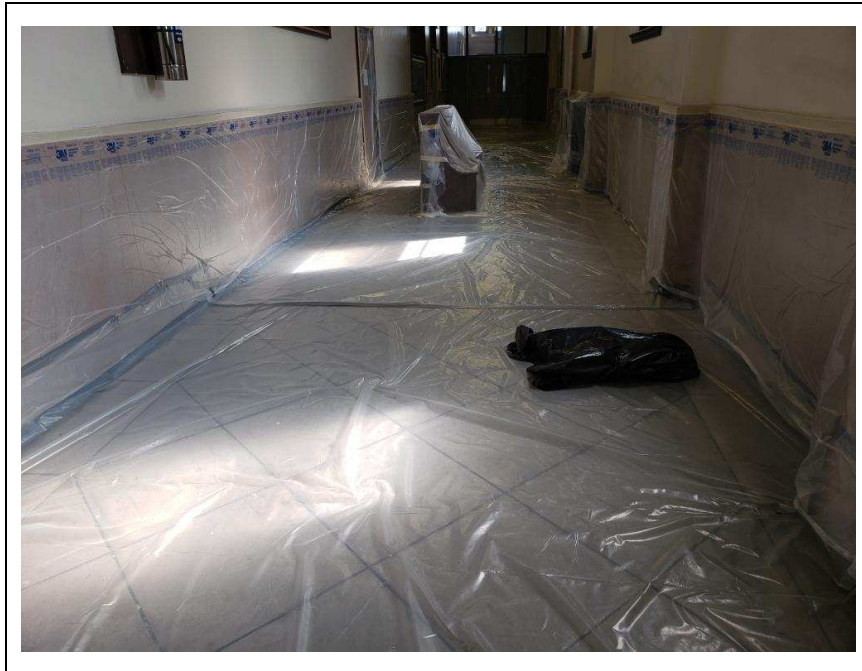
**Photograph 9** – Typical hallway prepped for stabilization.

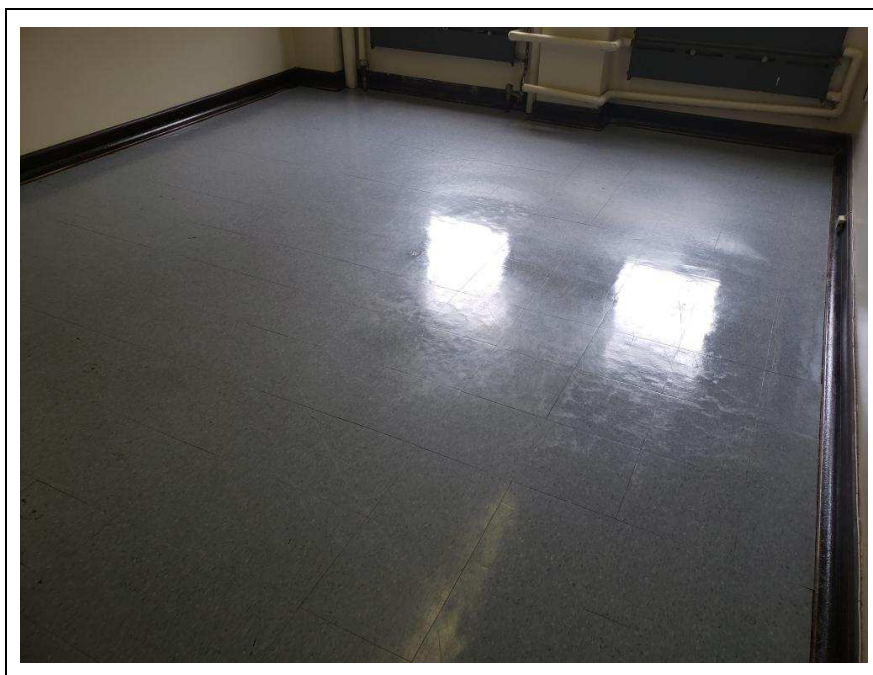
**Photograph 10** – Typical office after stabilization and painting.
