Summary of Paint & Plaster Stabilization Activities

**#6250 – Charles W. Henry Elementary School
601 Carpenter Lane
Philadelphia, PA 19119**

September 11, 2019

191516

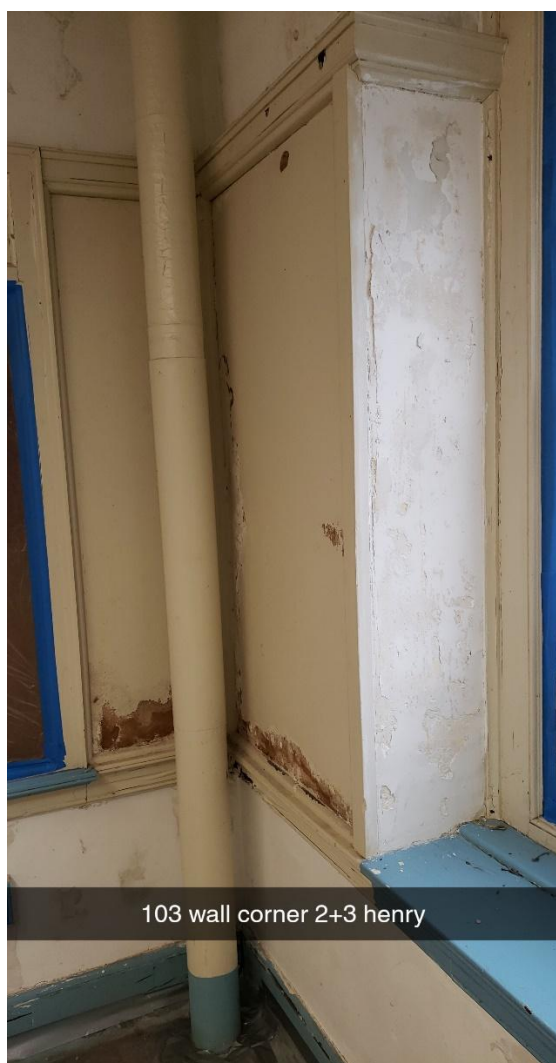
Classroom 103 – Pre-Stabilization

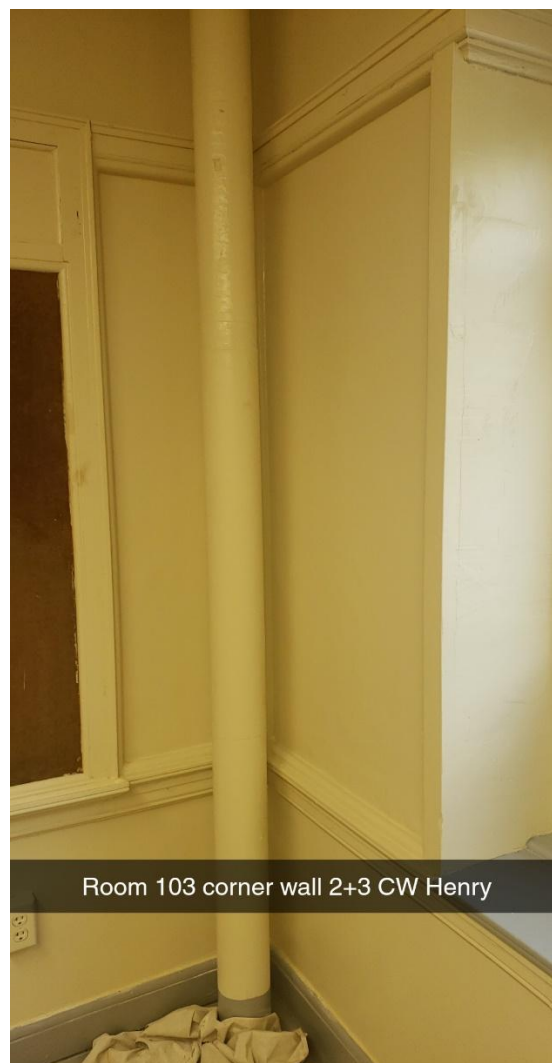
Classroom 103 – Post Stabilization

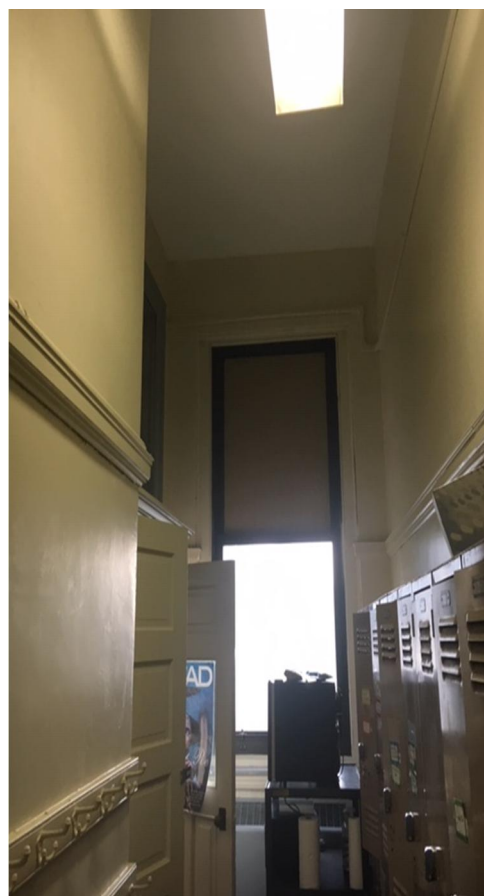
Classroom 107, Closet - Post Stabilization

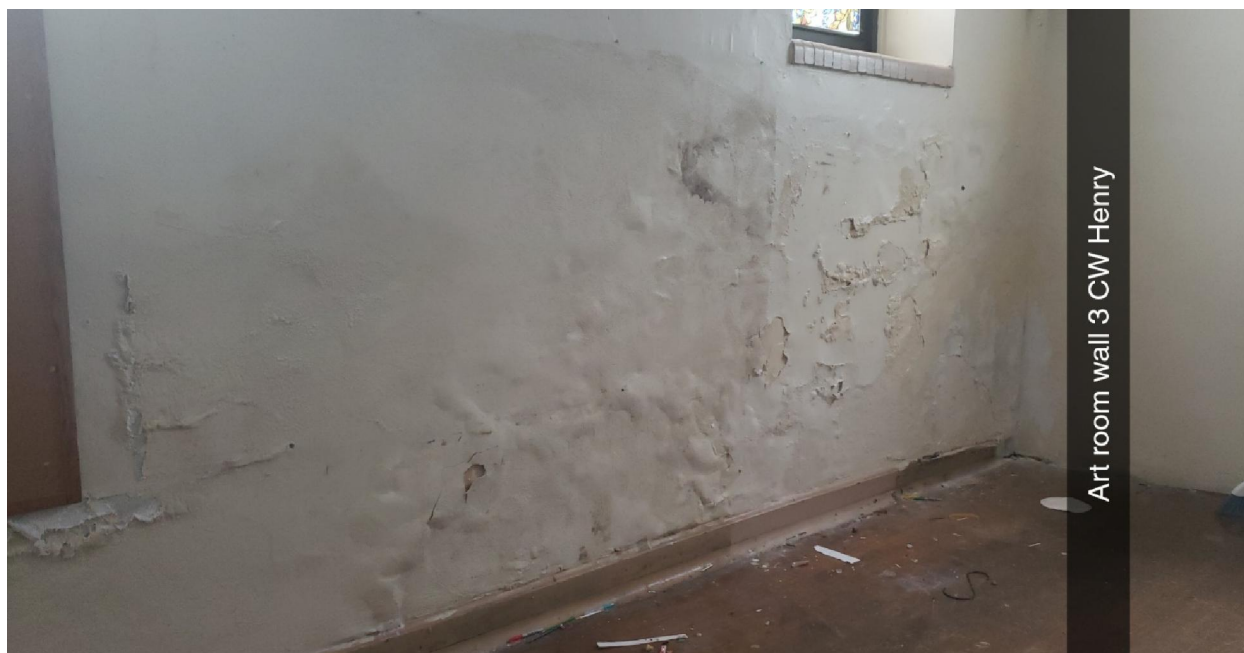
Basement – Art Room – Pre - Stabilization

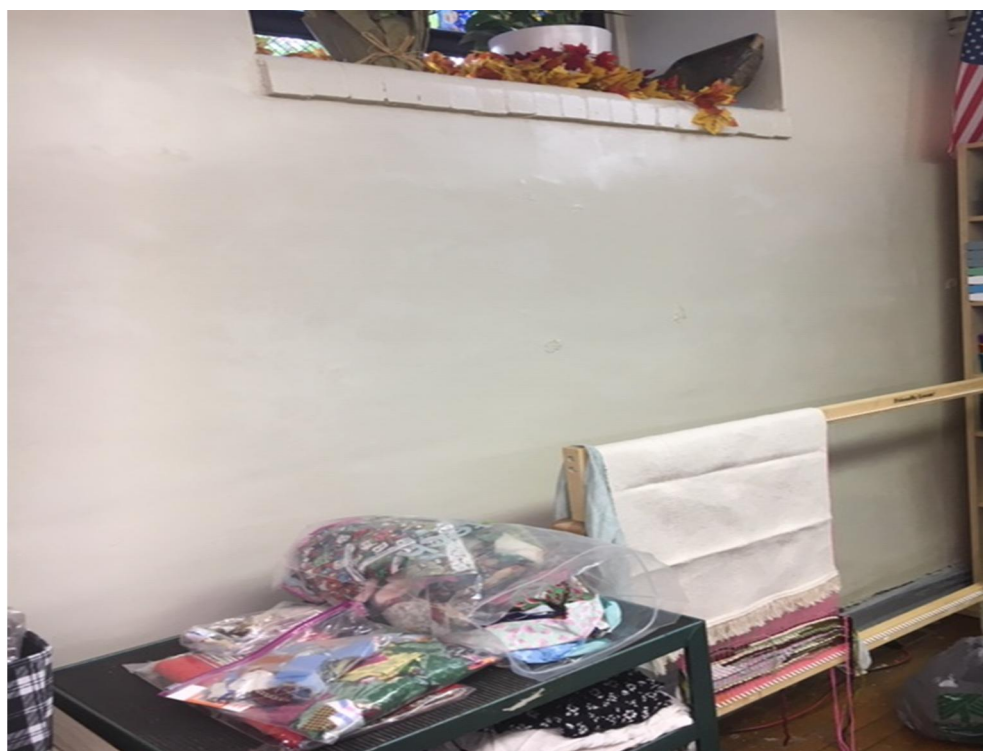
Basement – Art Room Post Stabilization
