LEAD SAFE CERTIFICATION
F.S. EDMONDS ELEMENTARY SCHOOL
8025 Thouron Avenue
Philadelphia, Pennsylvania 19150
ULCS # 6210

THE SCHOOL DISTRICT OF PHILADELPHIA
OFFICE OF ENVIRONMENTAL MANAGEMENT
440 North Broad Street
3rd Floor
Philadelphia, Pennsylvania 19130

SYNERTECH INCORPORATED
228 Moore Street
Philadelphia, Pennsylvania 19148
Project # 010-4402

August 26th, 2019

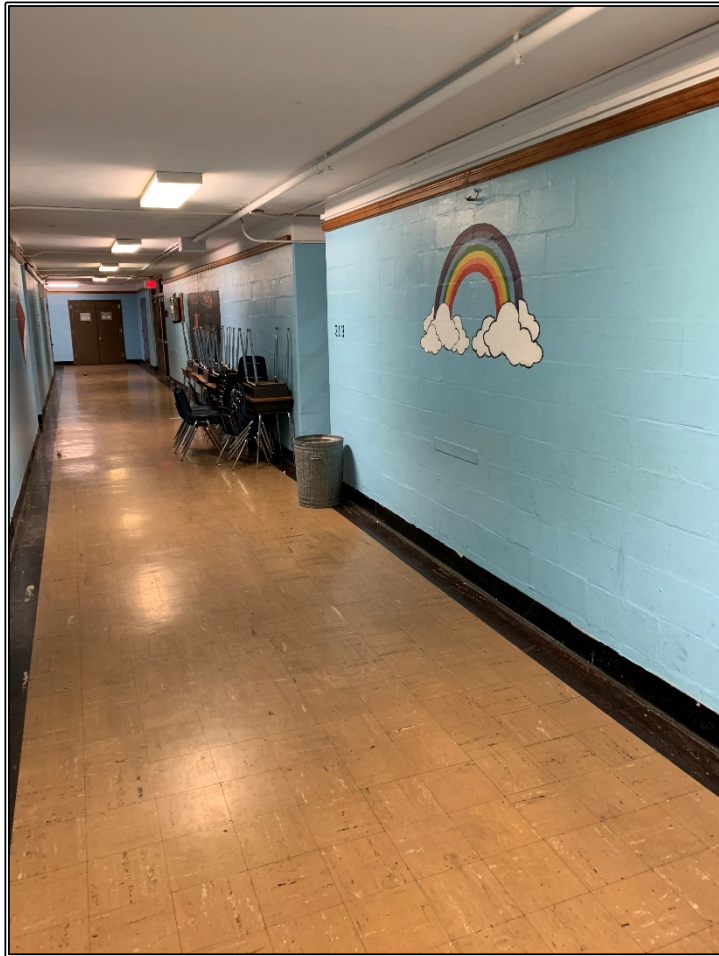
Photo 1
Non-lead Based Paint on Concrete Walls & Ceilings

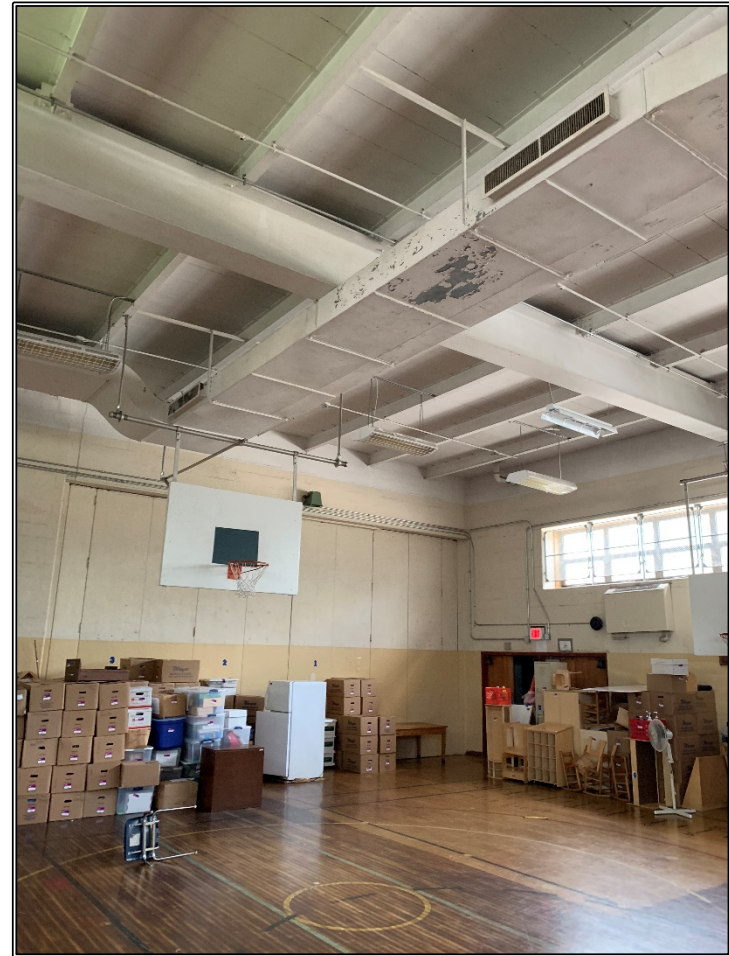
Photo 2
Lead Based Paint on Steel Beams in Gym

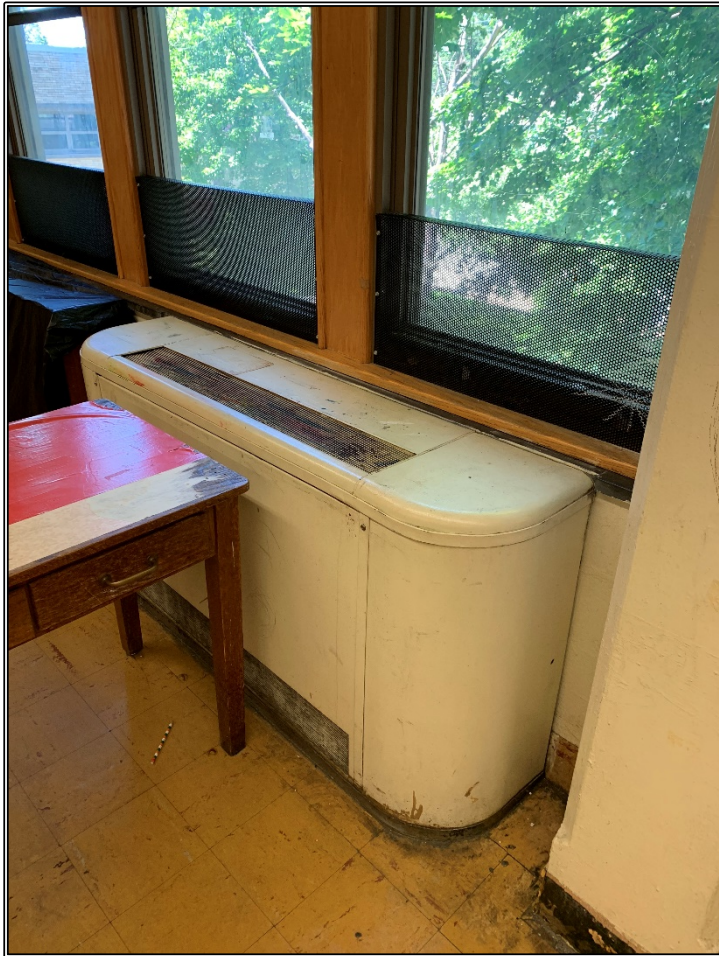
Photo 3

Non-lead Based Paint on a Typical Radiator Cover

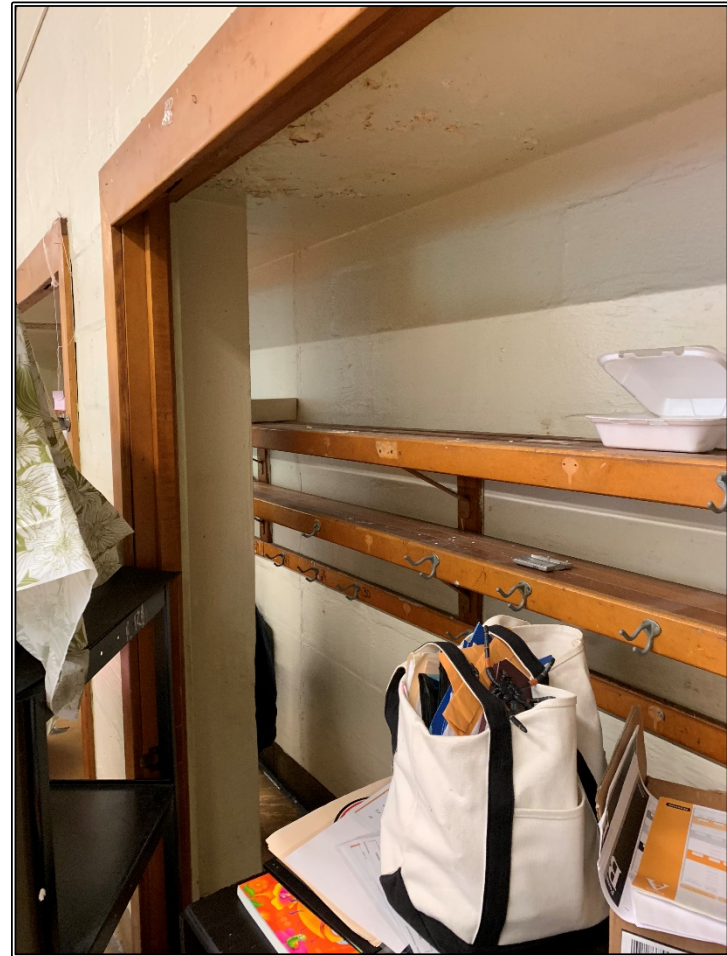
Photo 4

Non-lead Based Paint on Classroom Walls & Ceilings

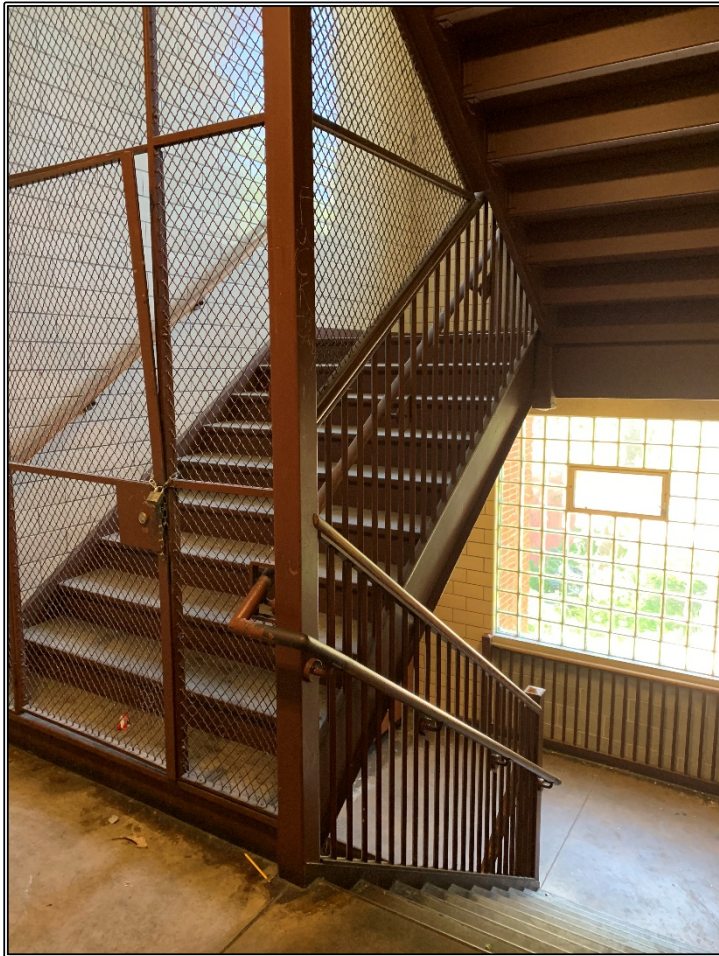
Photo 5

Lead Based Paint on Metal Stairwell Components

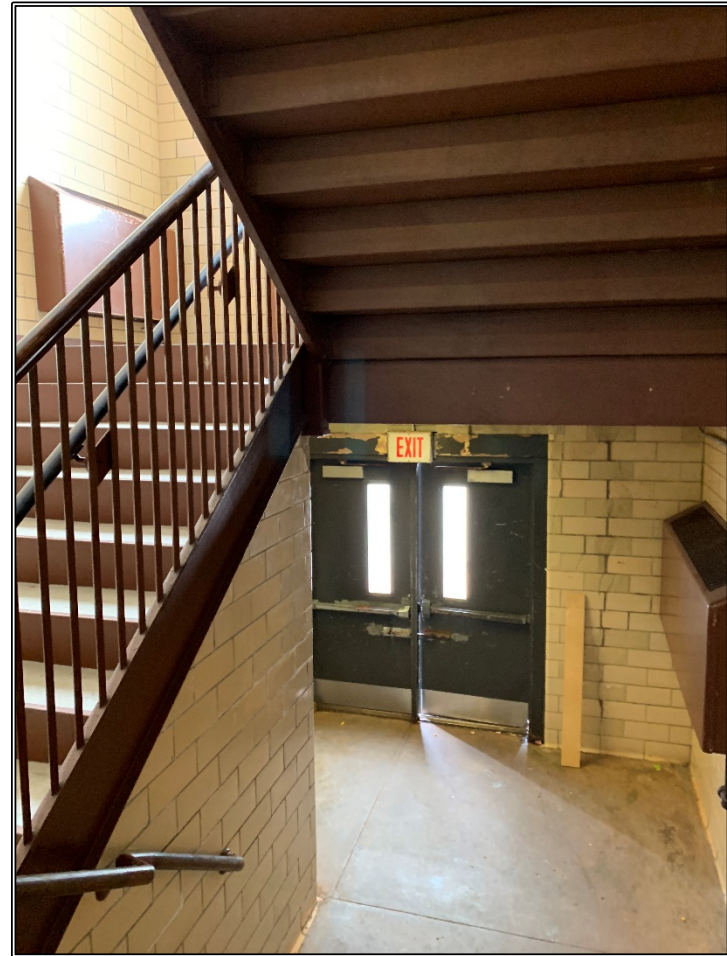
Photo 6

Lead Based Paint on Metal Stairwell Components
