PAINT AND PLASTER STABILIZATION
EDWARD HESTON ELEMENTARY SCHOOL
1621 N. 54th Street
Philadelphia, Pennsylvania 19131
ULCS# 2340

THE SCHOOL DISTRICT OF PHILADELPHIA
OFFICE OF ENVIRONMENTAL MANAGEMENT
440 North Broad Street
3rd Floor
Philadelphia, Pennsylvania 19130

SYNERTECH INCORPORATED
228 Moore Street
Philadelphia, Pennsylvania 19148
Project # 010-4468

November 5th, 2019

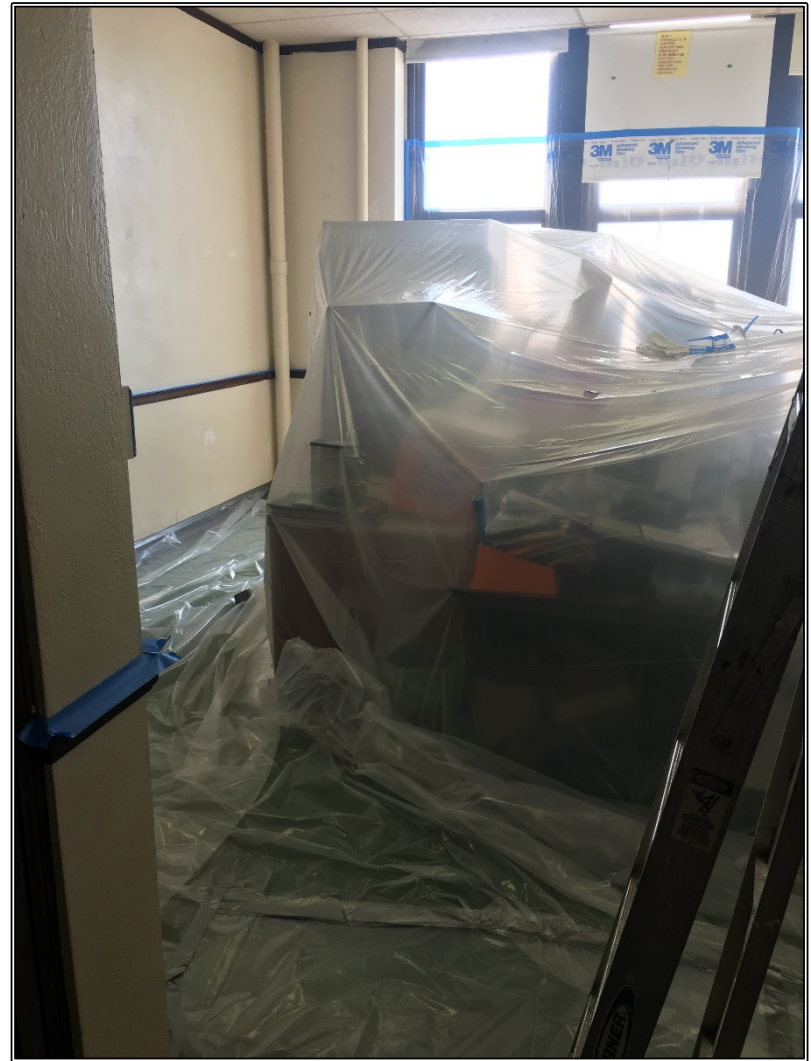
Photos 1 & 2
Typical Contained Classroom Prior to Renovation

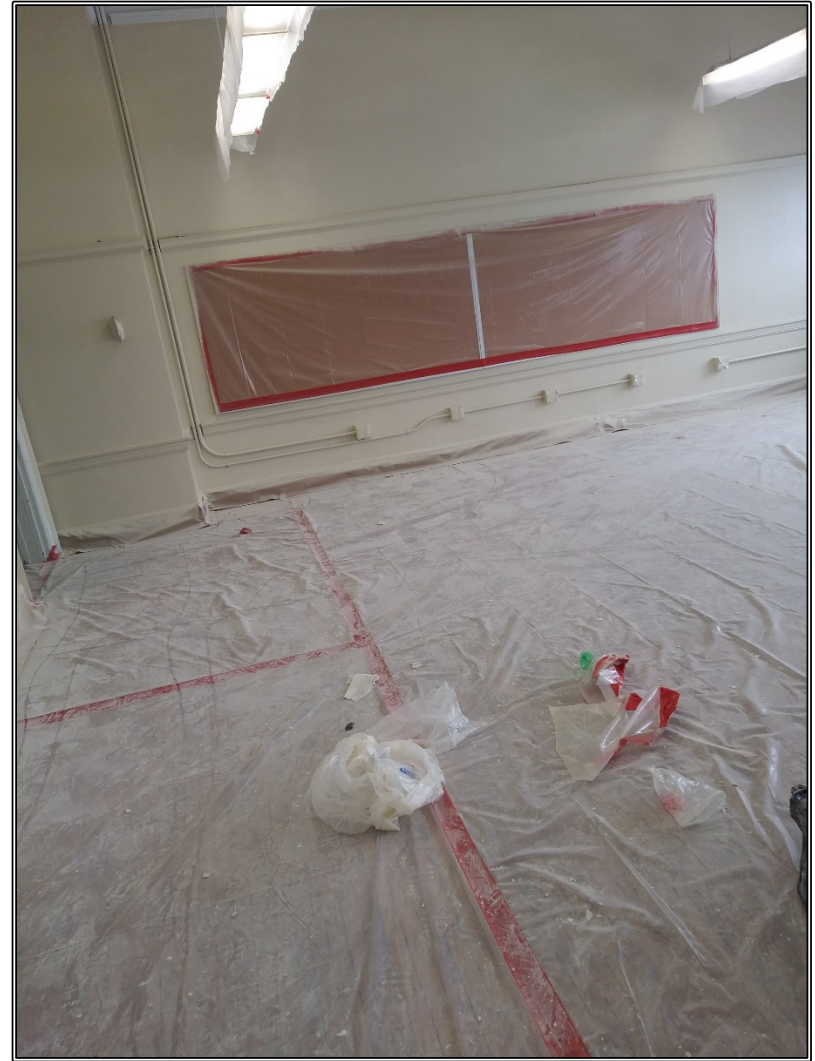
Photos 3 & 4
Typical Contained Classroom During Renovation
