**Hopkinson Elementary School**

4001 L Street
Philadelphia, Pennsylvania

Paint and Plaster Stabilization Project Final Report**DECEMBER 3, 2020****PREPARED FOR:**

VERTEX Project No: 62843

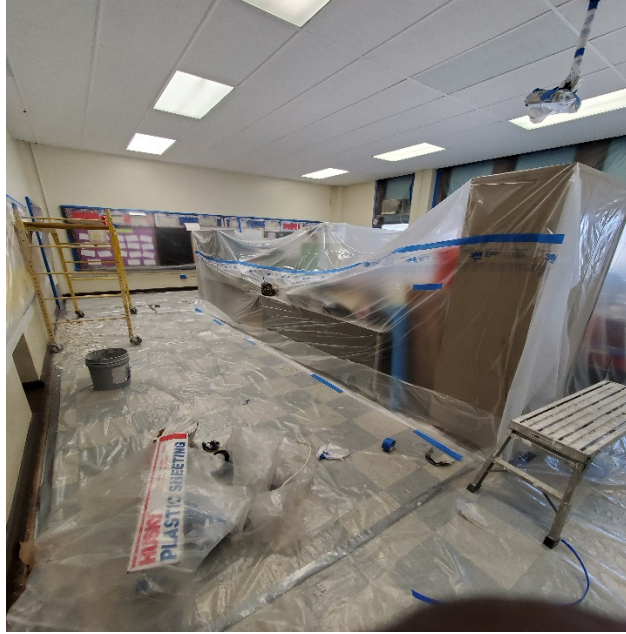
Photograph 1 – Classroom prepped for stabilization

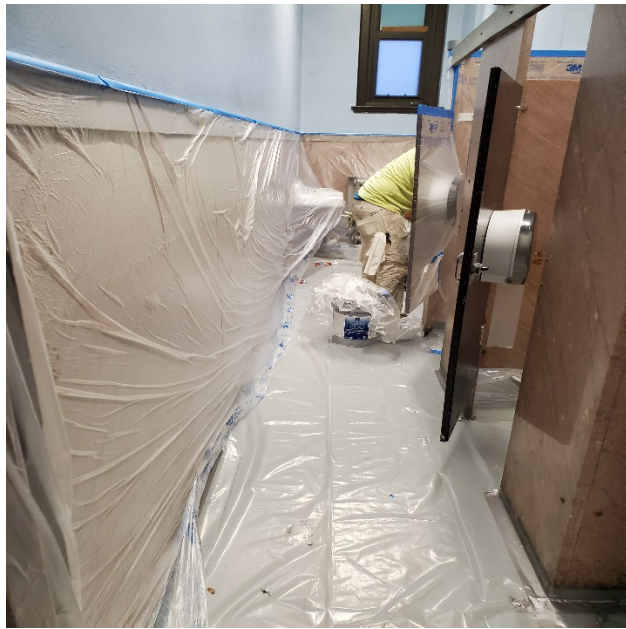
Photograph 2 – Restroom being prepped for stabilization

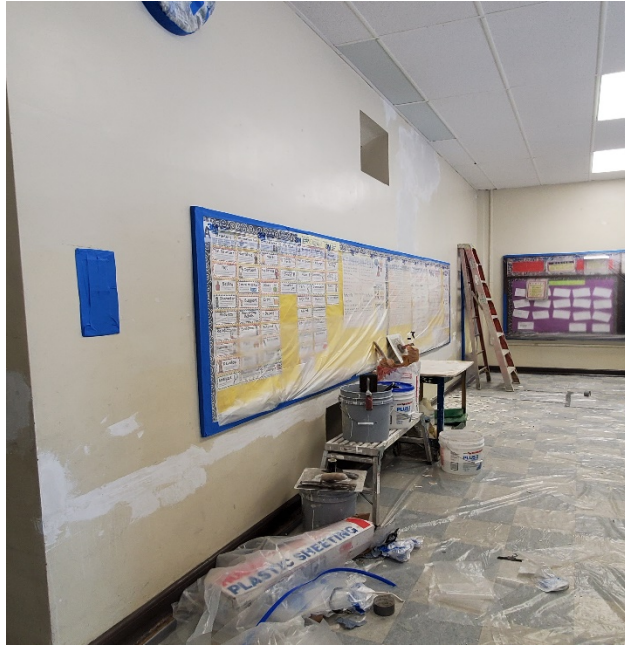
Photograph 3 – Classroom undergoing stabilization (plastering)

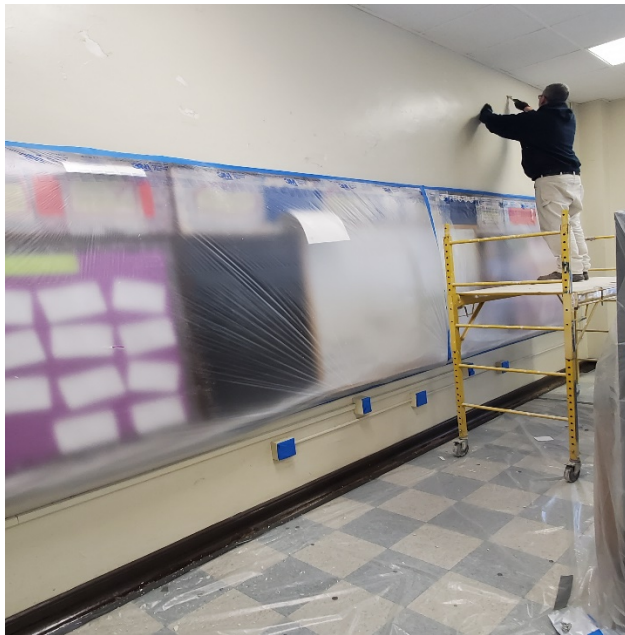
Photograph 4 – Classroom being painted

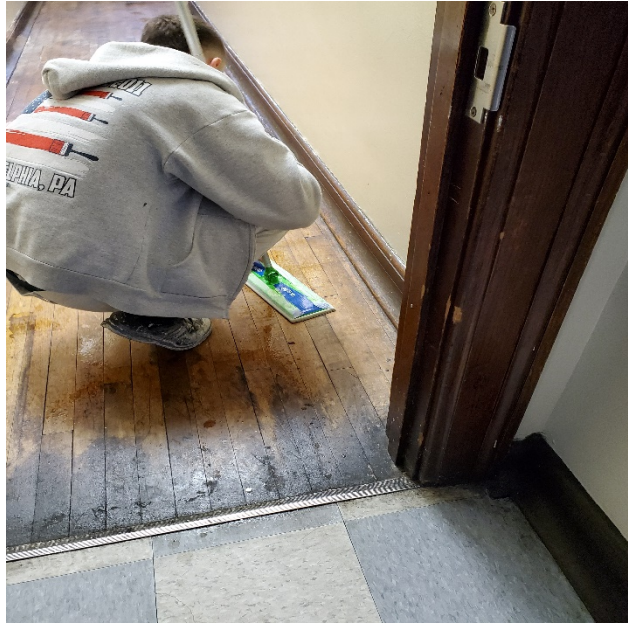
Photograph 5 – RRP wipe on wood floor

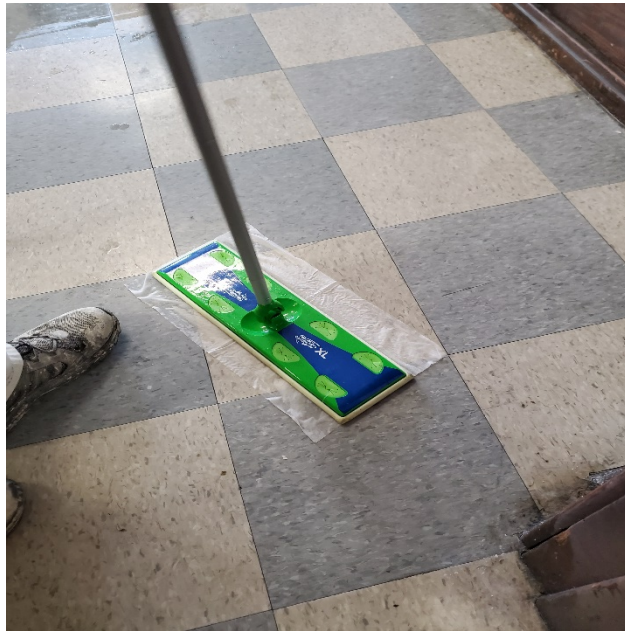
Photograph 6 – RRP wipe on tile floor

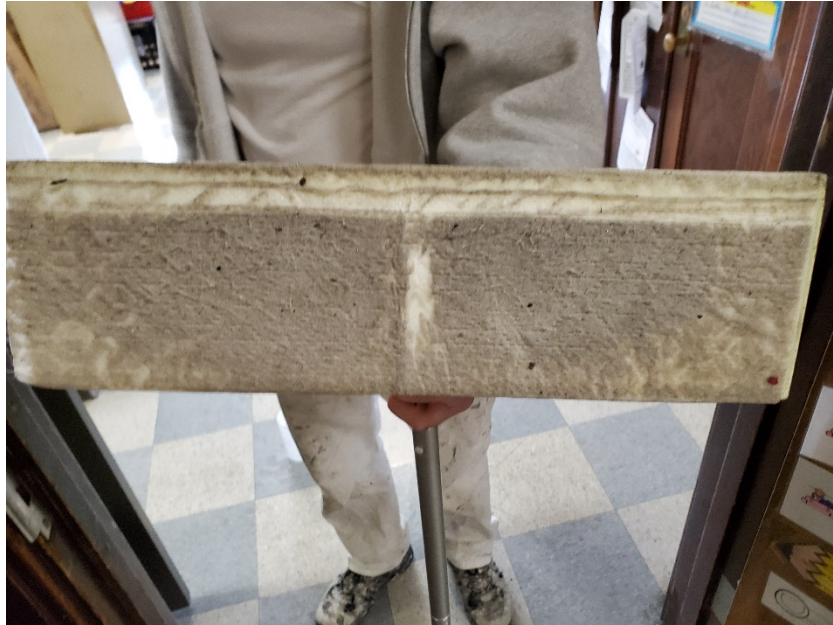
Photograph 7 – Failing RRP wipe

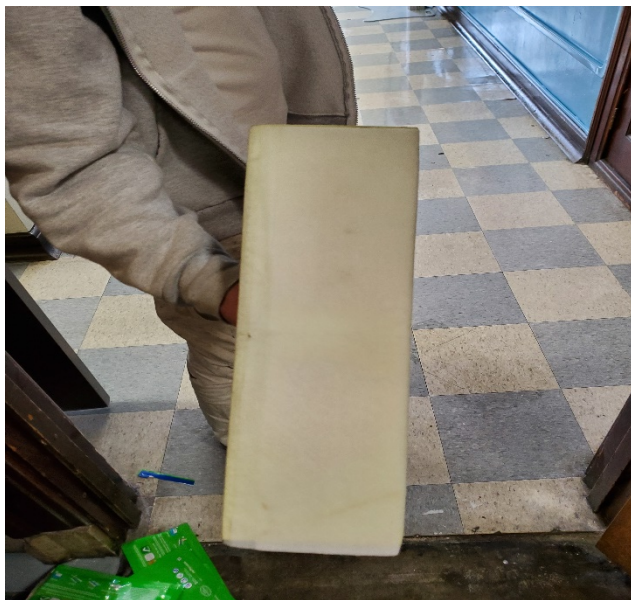
Photograph 8 – Passing RRP wipe

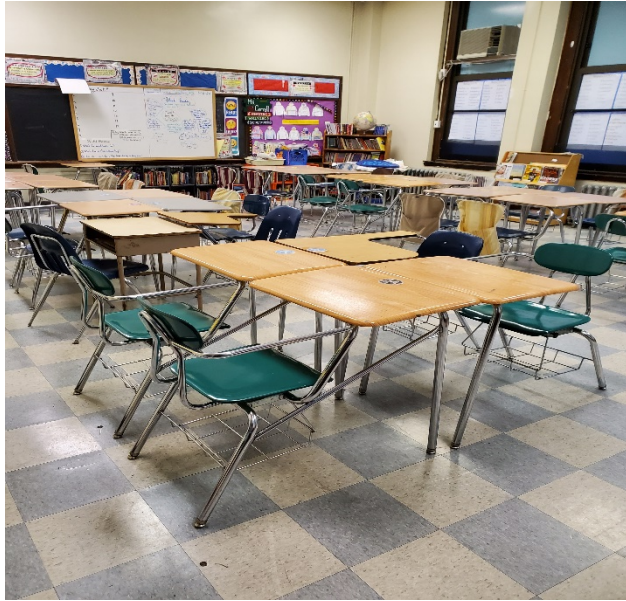
Photograph 9 – Classroom after stabilization and painting

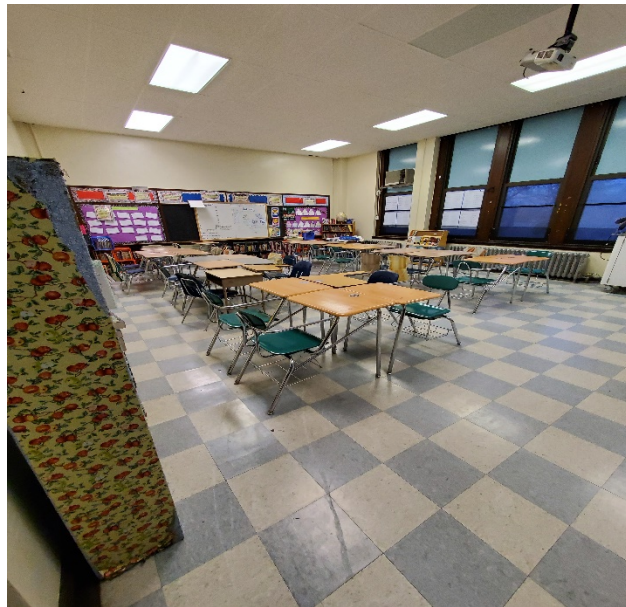
Photograph 10 – Classroom after stabilization and painting
