Batta Environmental Associates, Inc. (BATTa), was requested by the School District of Philadelphia's (SDP) Office of Environmental Management Services (OEMS) to perform oversight and clearance testing during a paint and plaster stabilization project being performed at the Henry H. Houston Elementary School located at 7300 Rural Lane in Philadelphia, PA (the "School"). The purpose of the oversight was to document that all requirements of the US Environmental Protection Agency (EPA) Lead Renovation, Repair and Painting (RRP) rules were being followed and documented.

A scope of work was developed for the Henry H. Houston Elementary School following a previous room-by-room inspection of the school. During the inspection, the location and quantity of damaged paint and plaster, along with any associated debris and whether the damage was the result of an on-going moisture intrusion problem, were noted. This information was entered into a scope of work spreadsheet, which was provided to the SDP's painting contractors in order to create a schedule for the work to be completed.

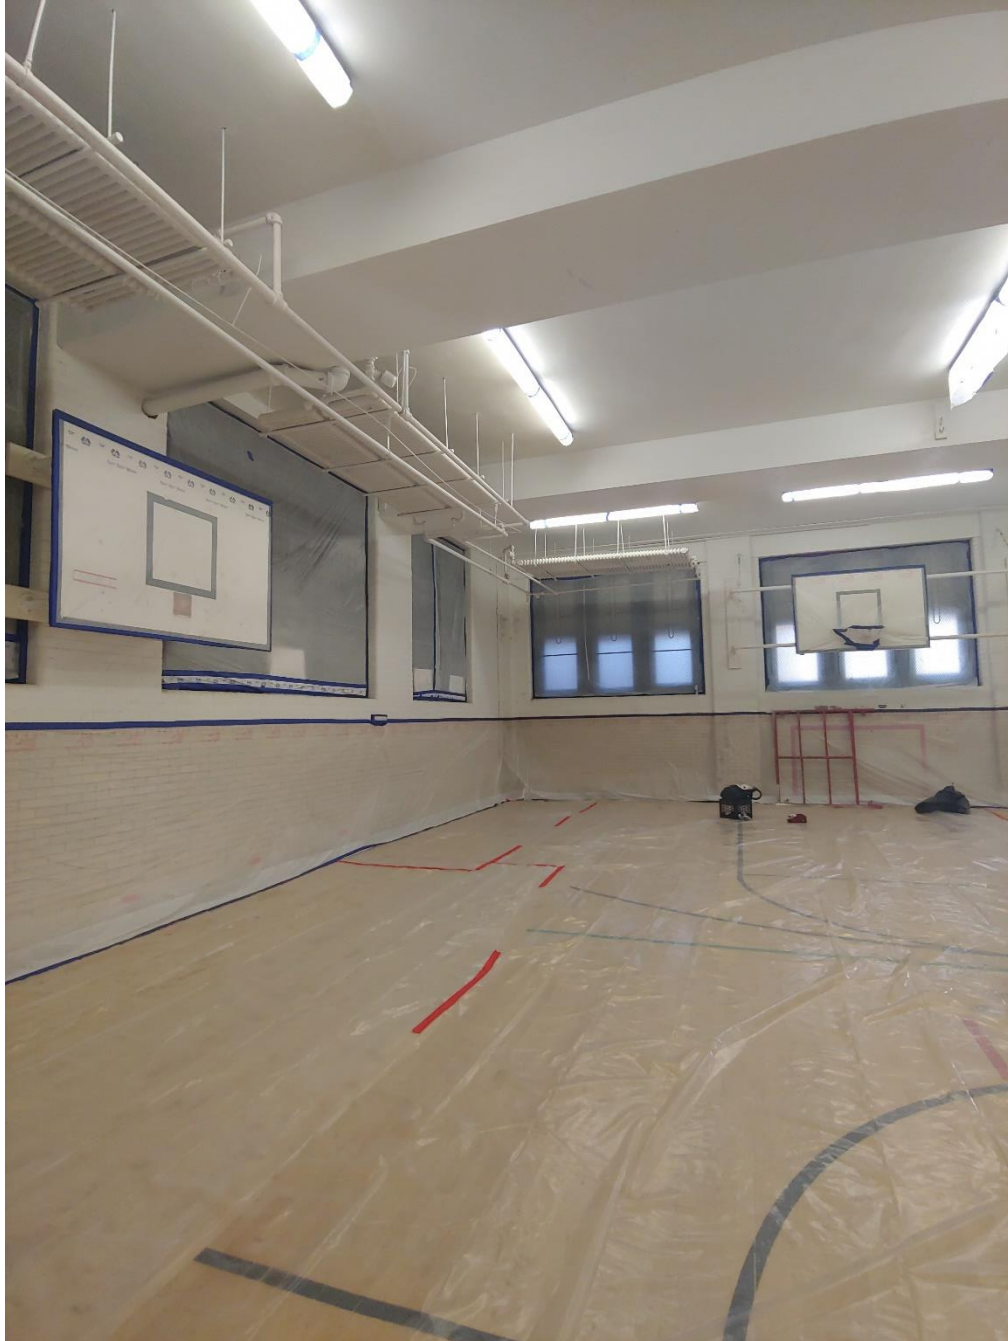
Gymnasium prepped for lead  
stabilization

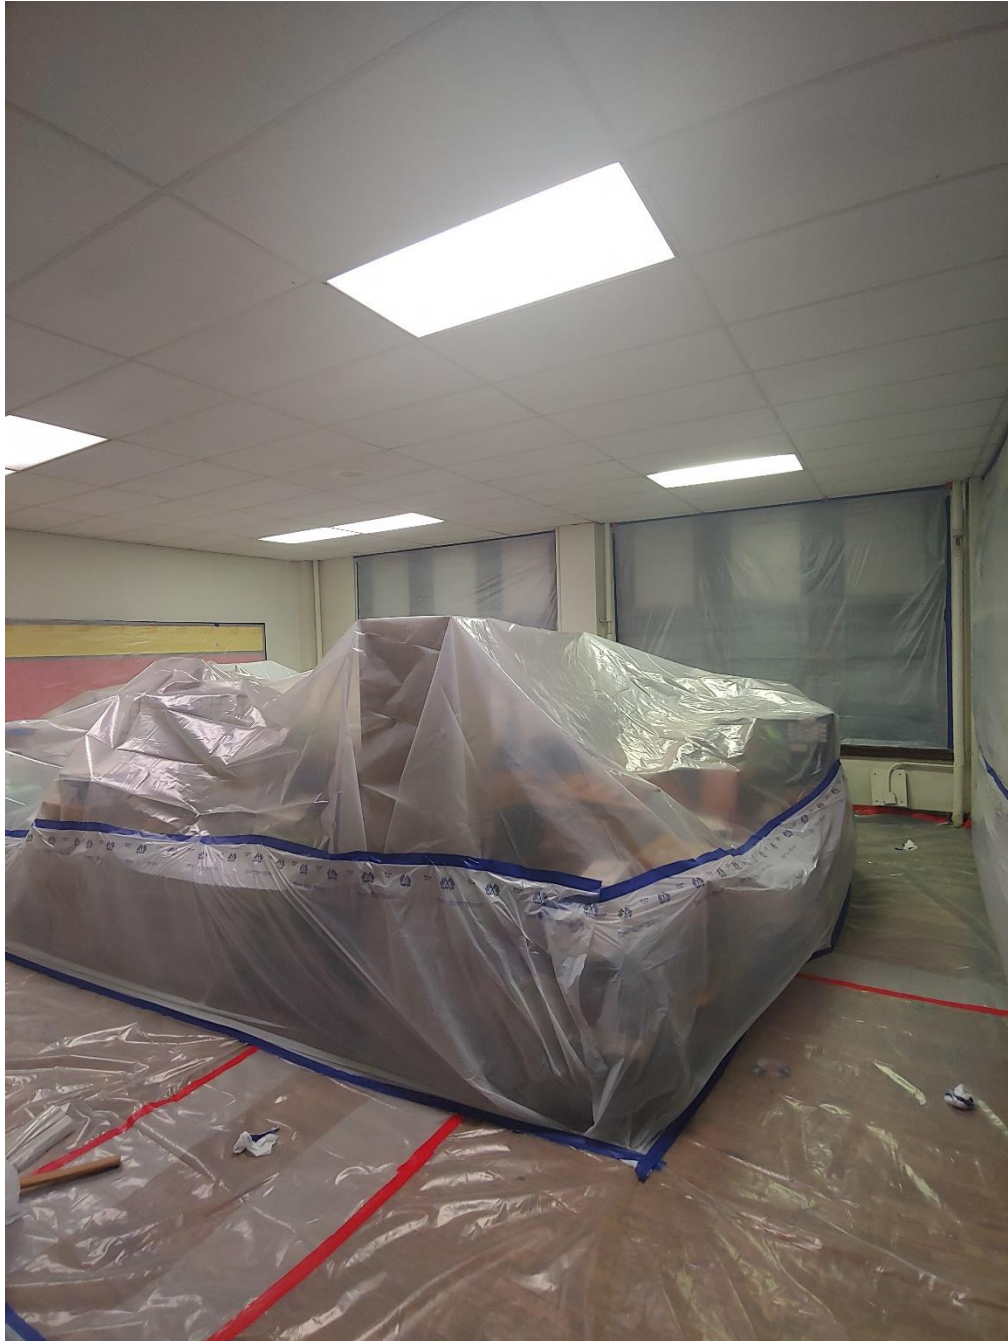
Classroom prepped for lead  
stabilization

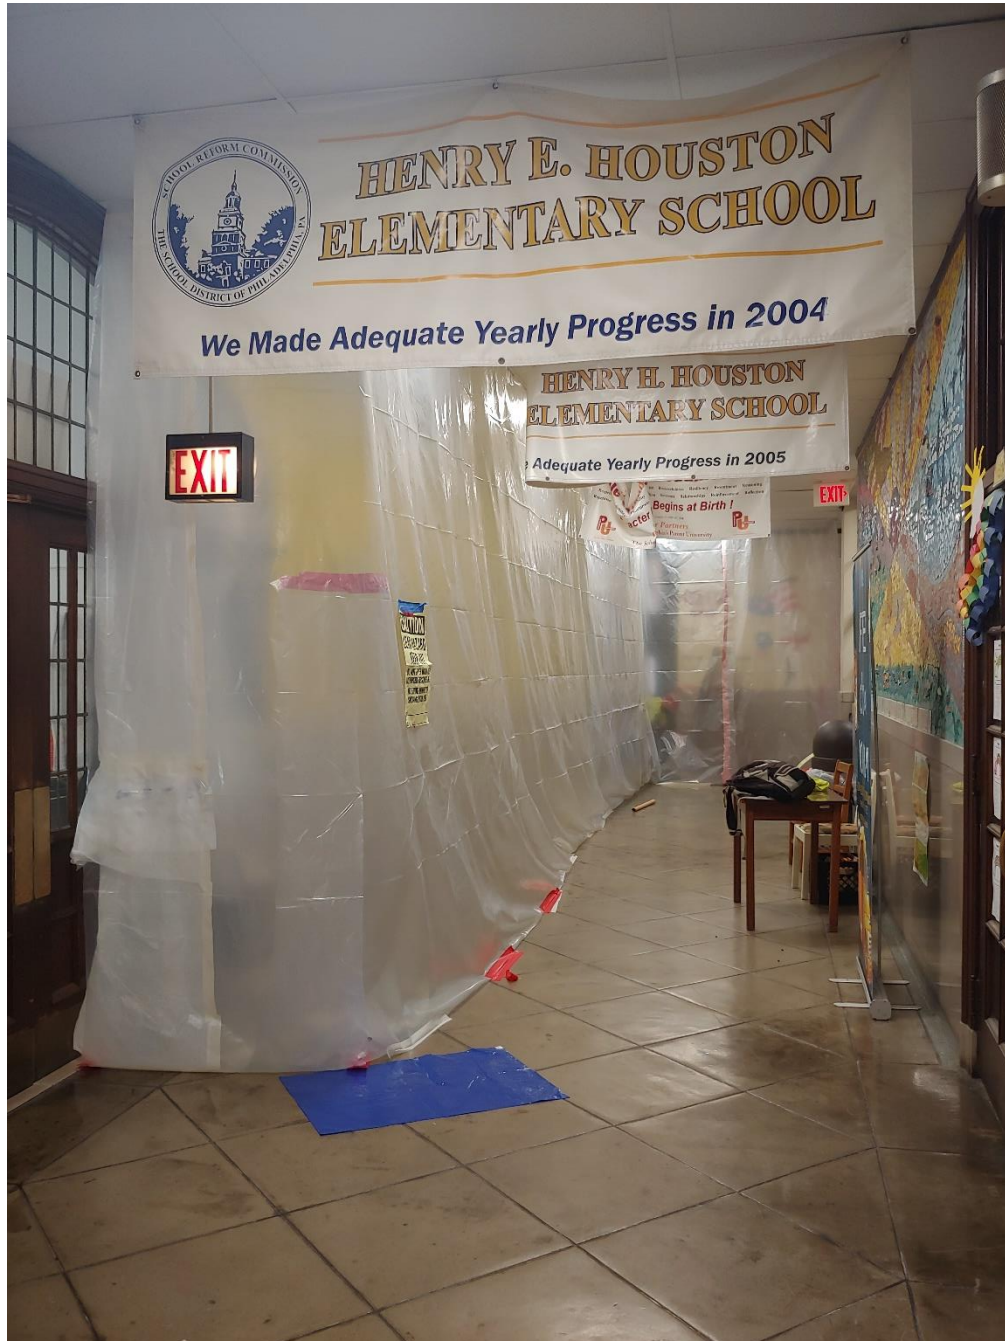
Hallway 12 prepped for lead  
stabilization

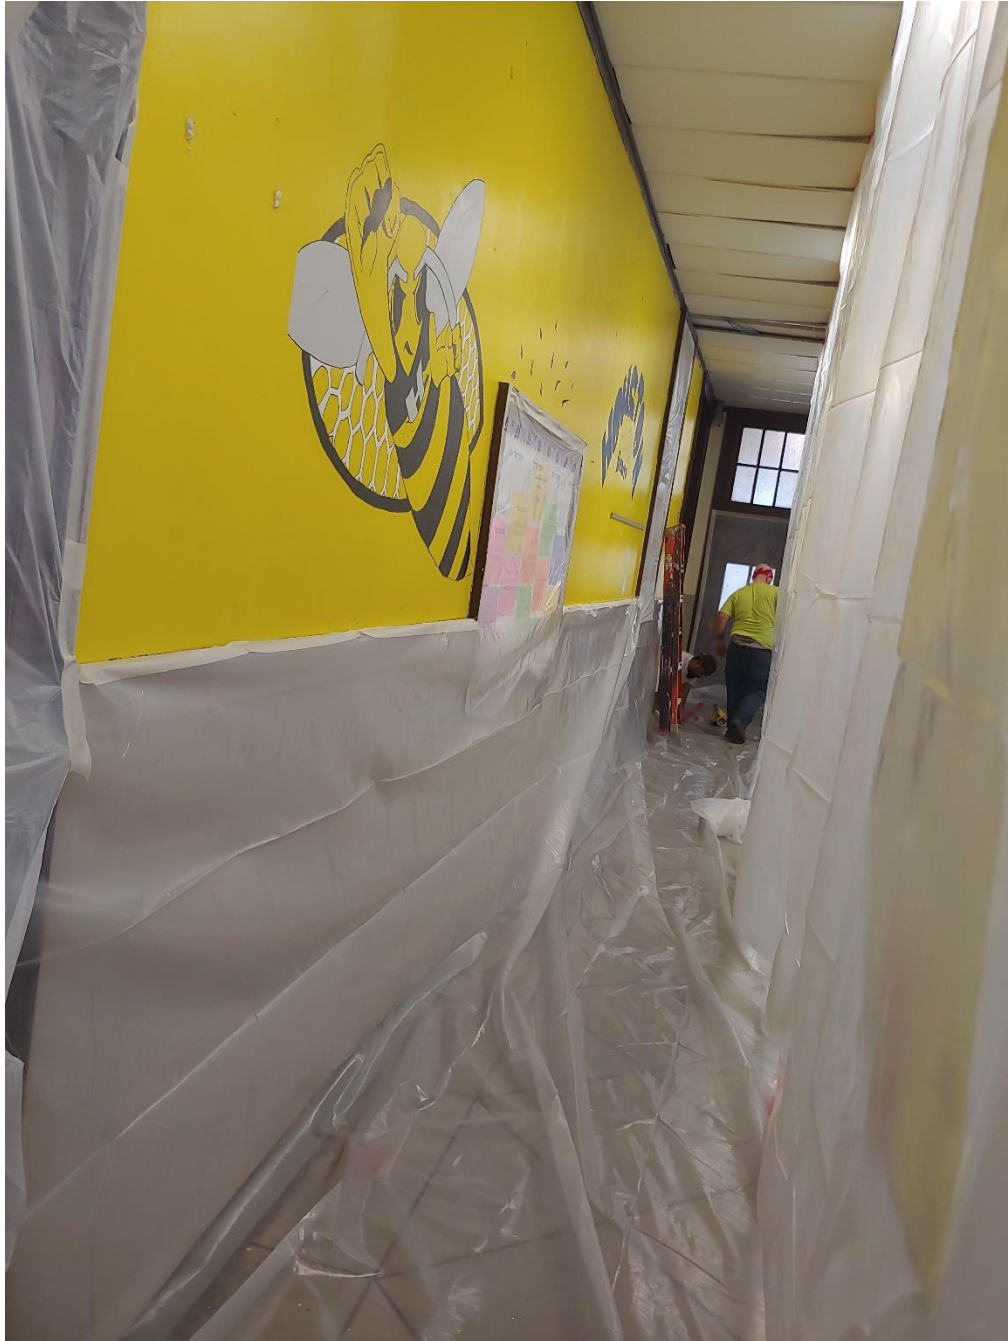
Hallway 12 prepped for lead  
stabilization

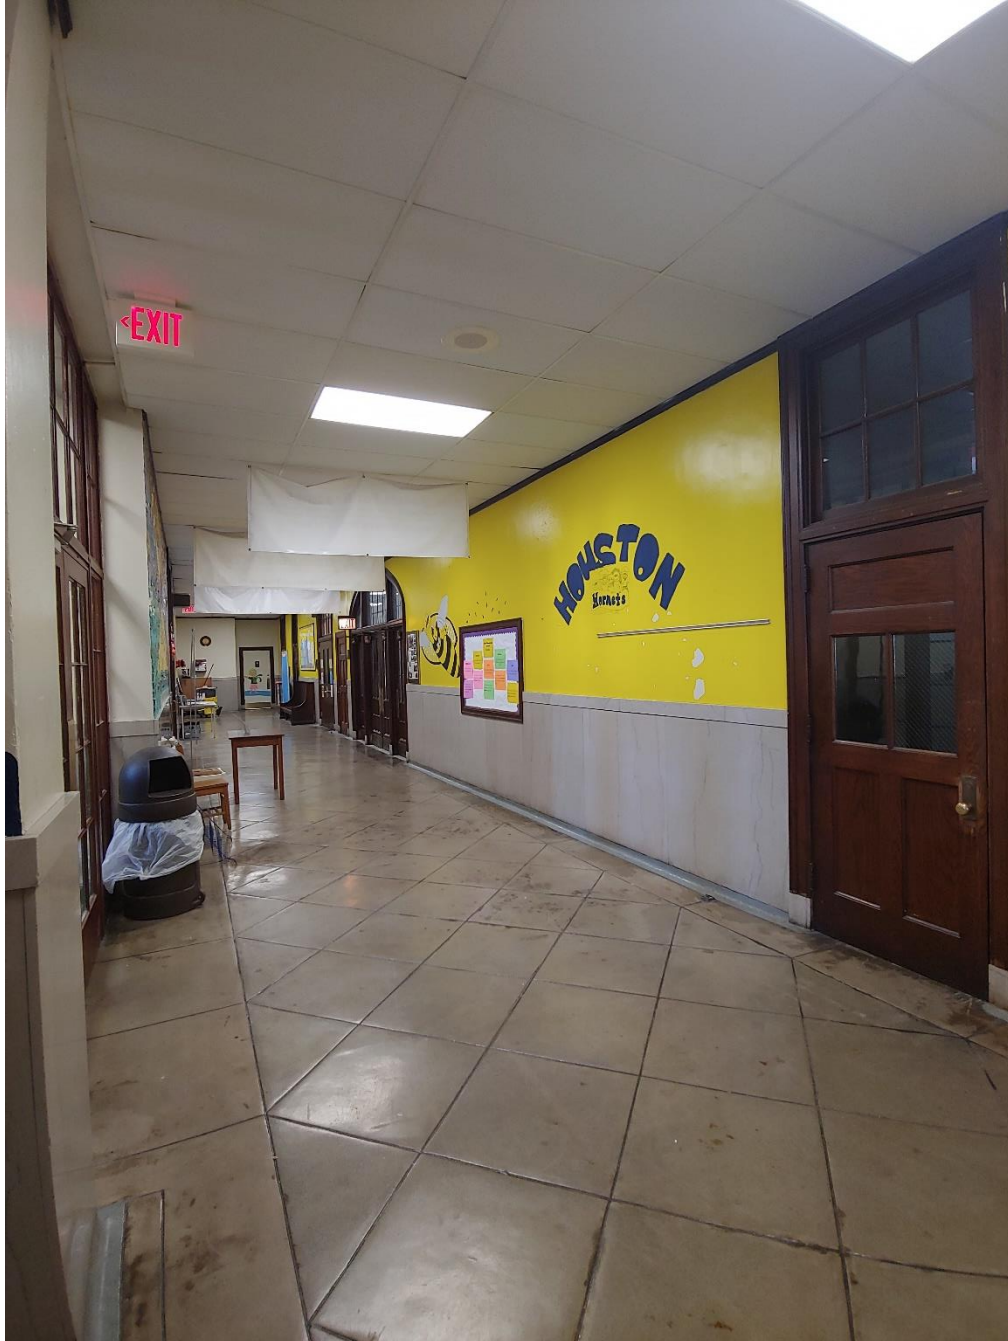
Hallway 12 following stabilization
