# ***Summary of Paint & Plaster Stabilization Activities***

**#2580– Kirkbride Elementary School  
1501 S. 7th Street  
Philadelphia, PA 19147**

**Criterion Laboratories, Inc.  
January 28, 2019**

**Project Number: 181786  
Project Dates: August 7 – October 12, 2018**

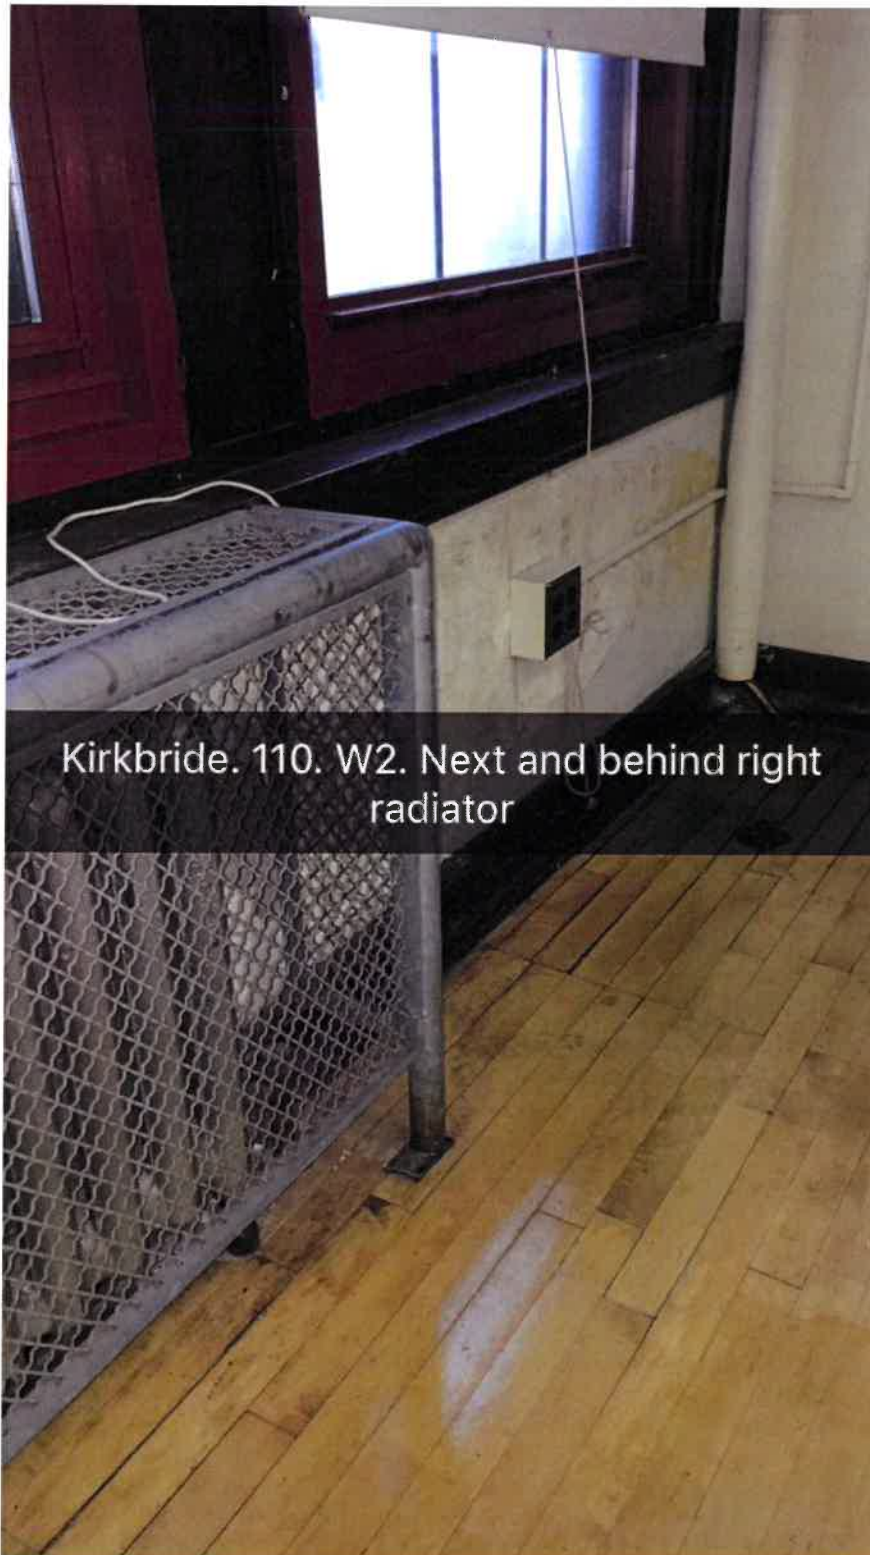
Kirkbride. 110. W2. Next and behind right radiator

Prior to stabilization.

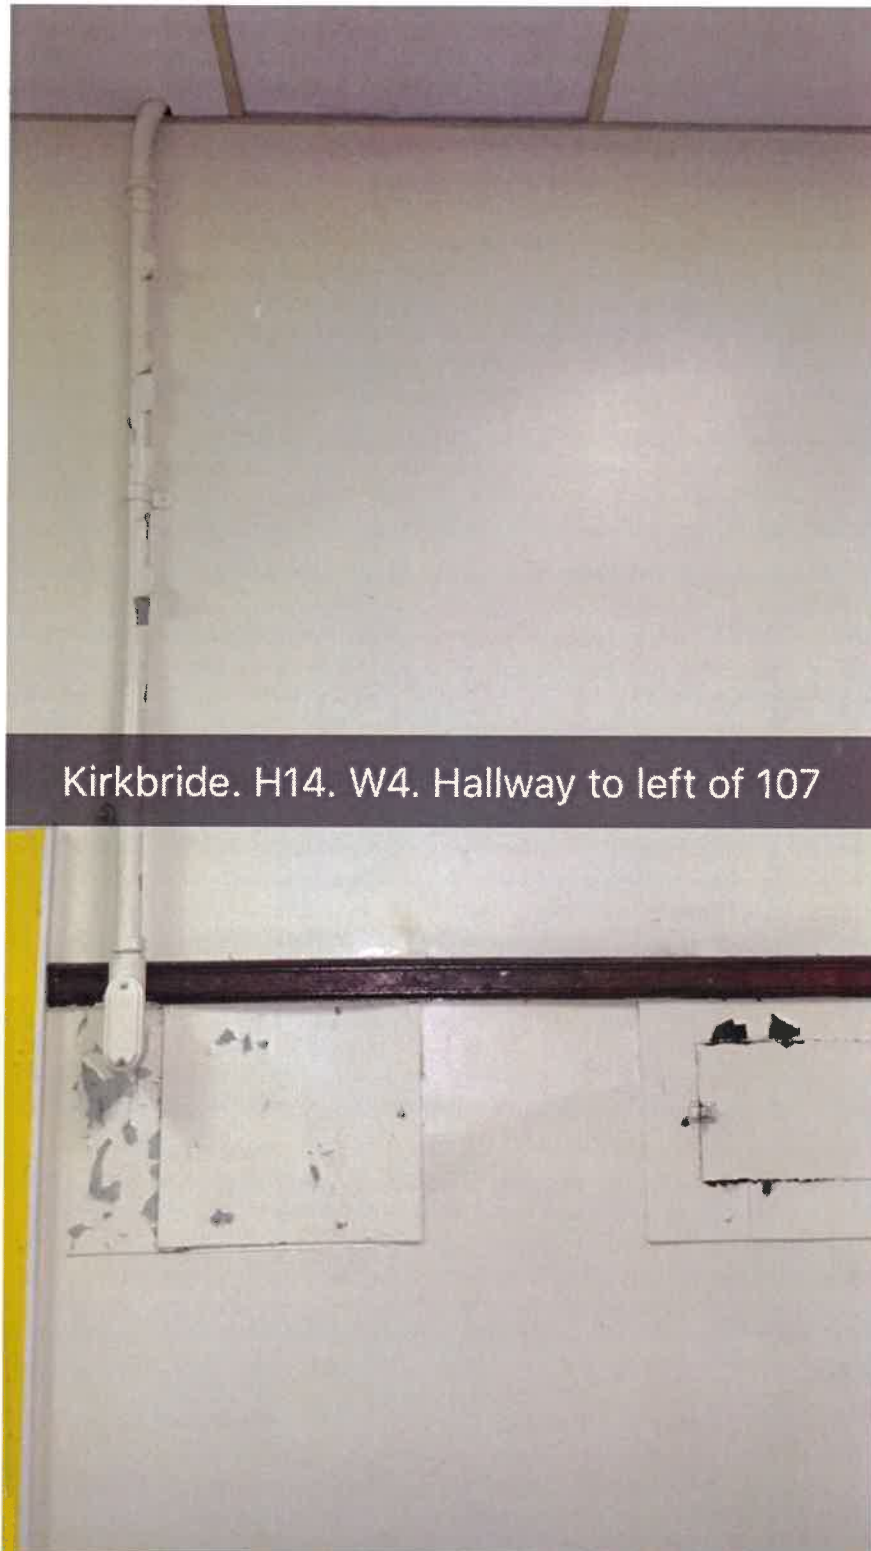
Kirkbride. H14. W4. Hallway to left of 107

Prior to stabilization.

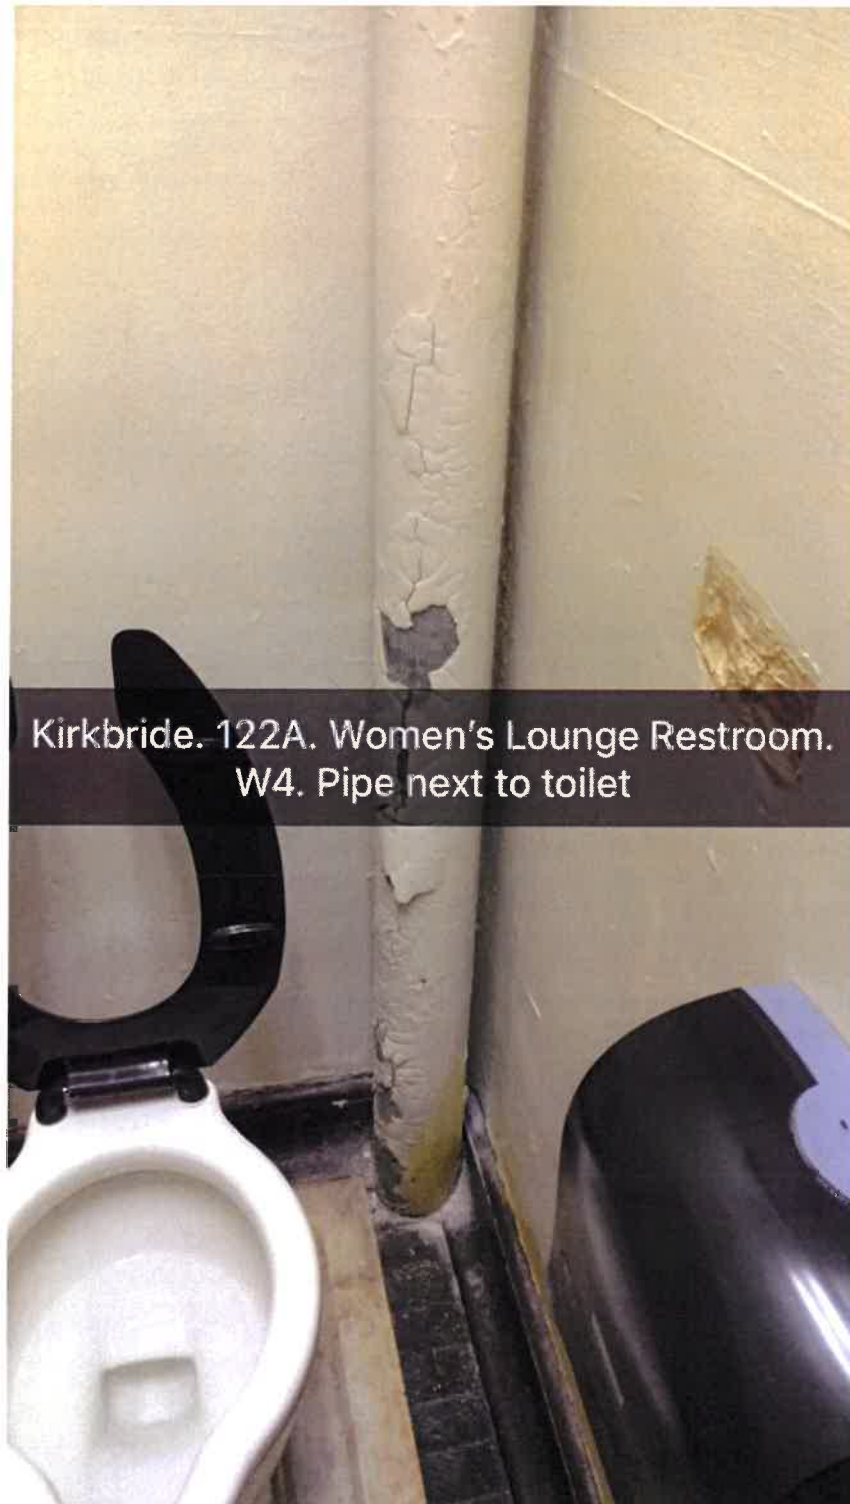
Kirkbride. 122A. Women's Lounge Restroom.  
W4. Pipe next to toilet

Prior to stabilization.

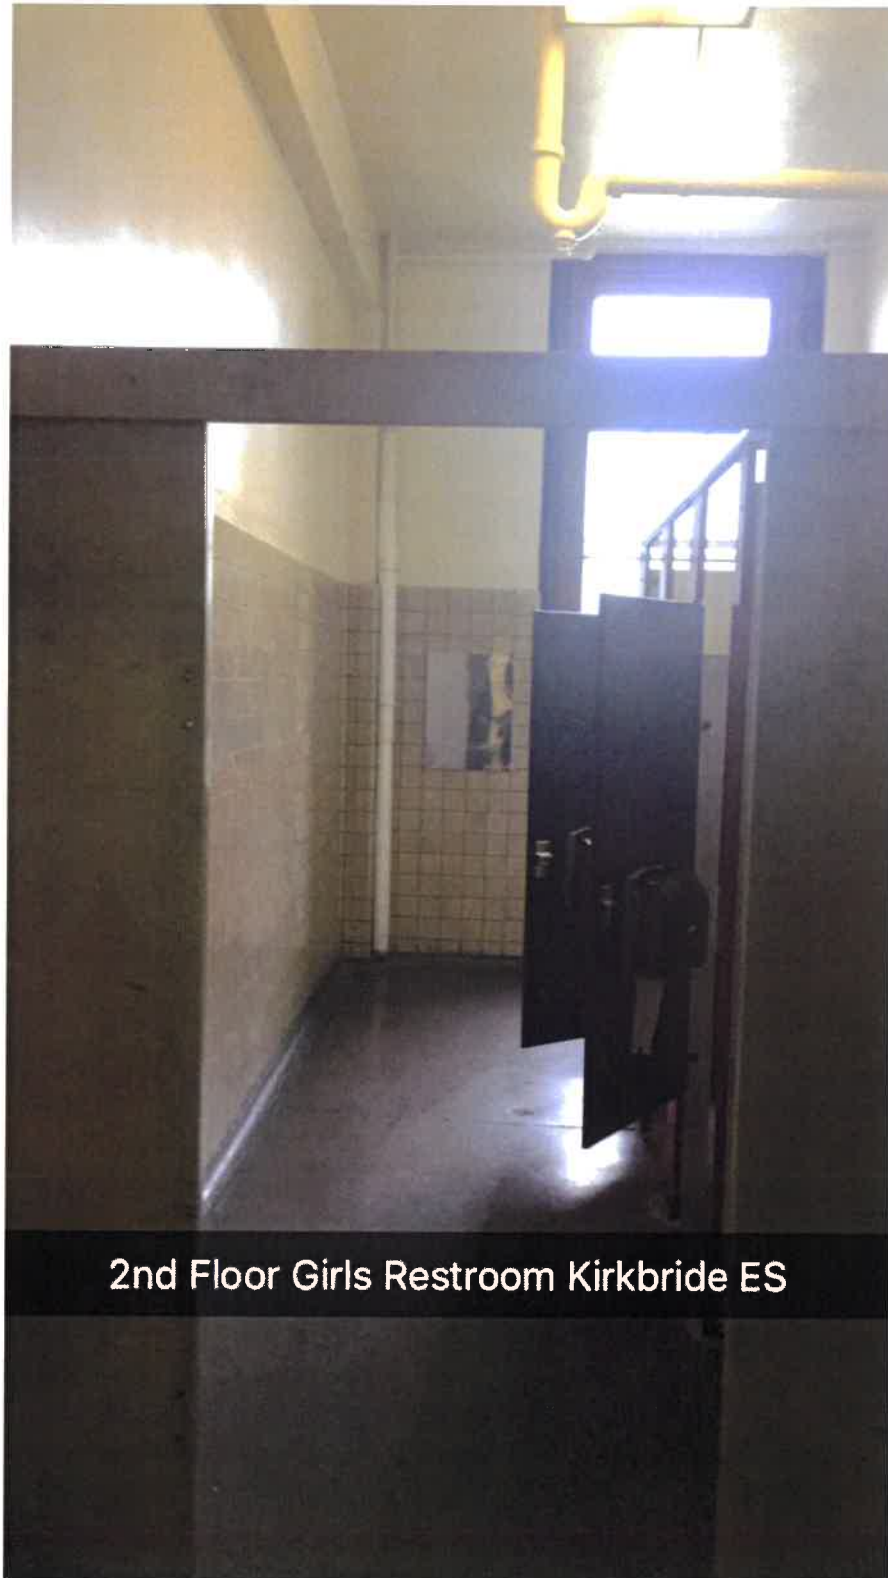
**2nd Floor Girls Restroom Kirkbride ES**

Following stabilization

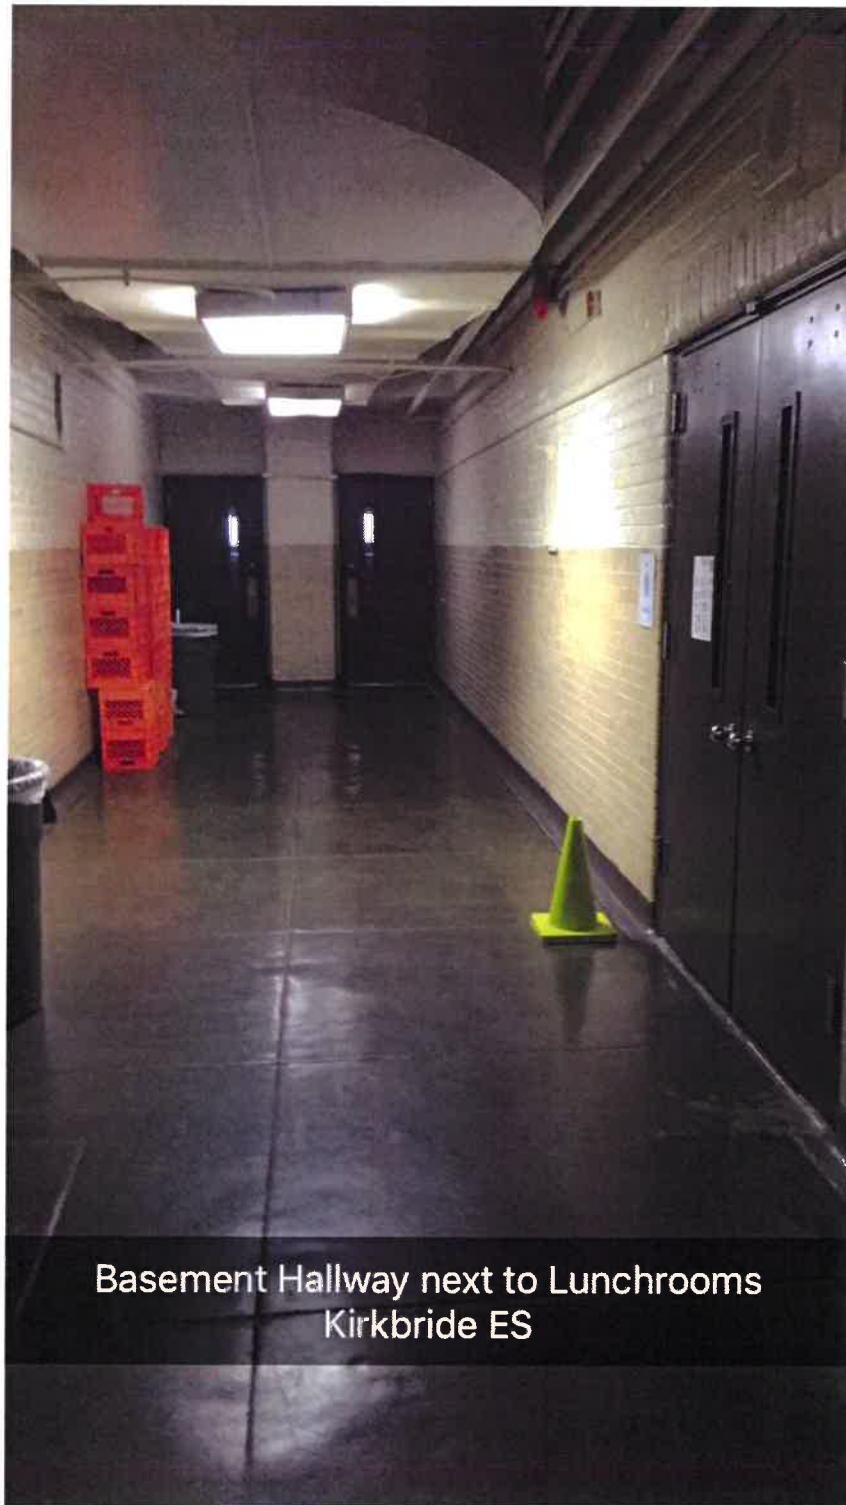
Basement Hallway next to Lunchrooms  
Kirkbride ES

Following stabilization

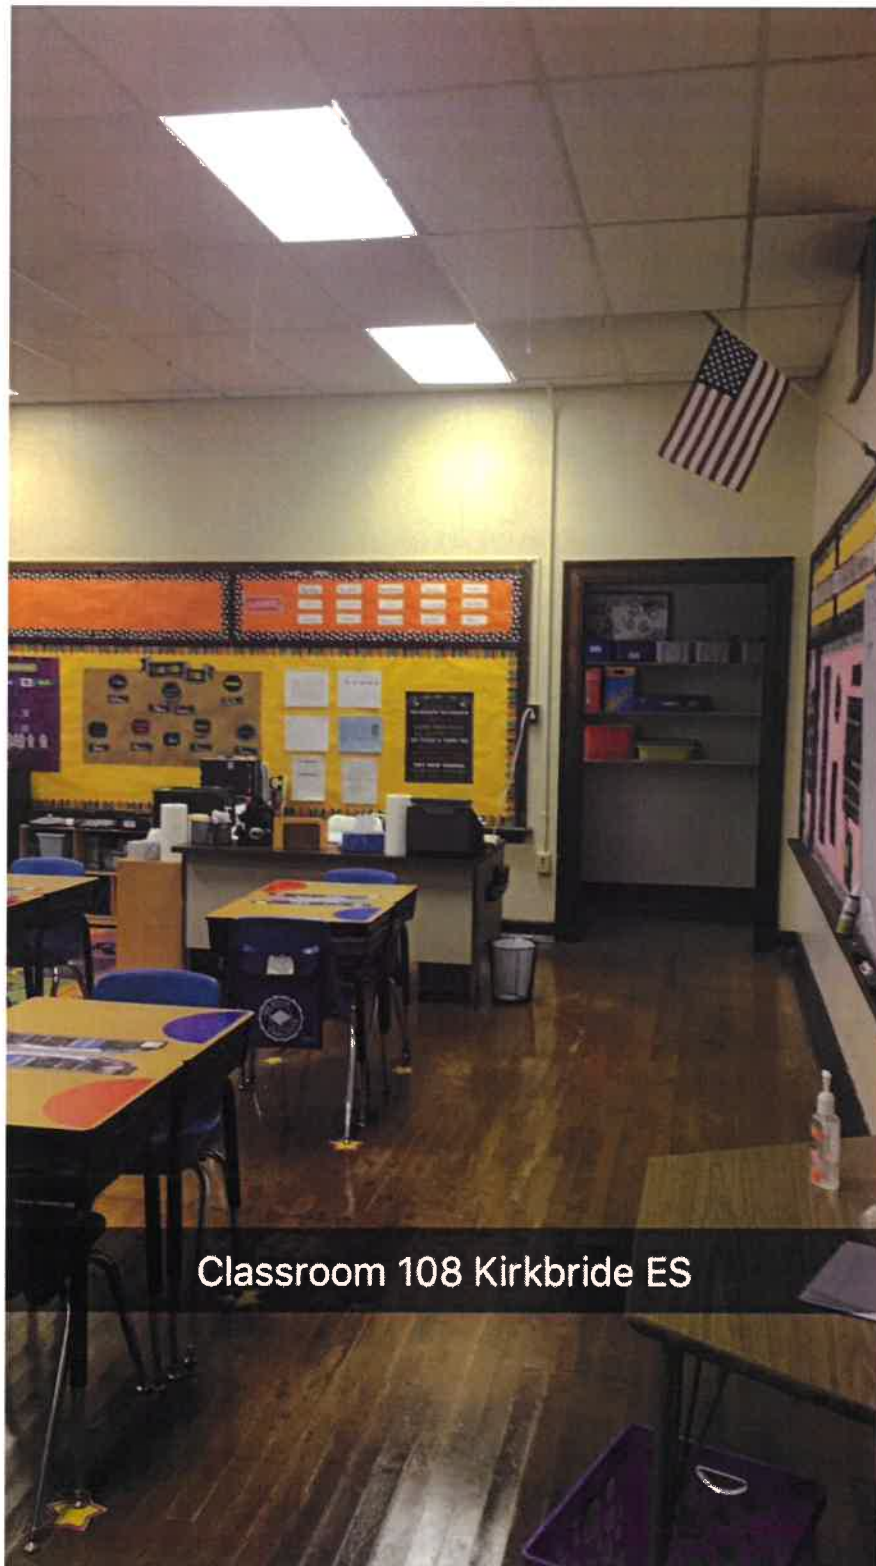
Following stabilization
