Summary of Paint & Plaster Stabilization Activities

**#4570– Meade Elementary School
1600 N. 18th Street
Philadelphia, PA 19121**

**Criterion Laboratories, Inc.
May 28, 2019**

**Project Number: 182832
Project Dates: December 17, 2018 – May 25, 2019**

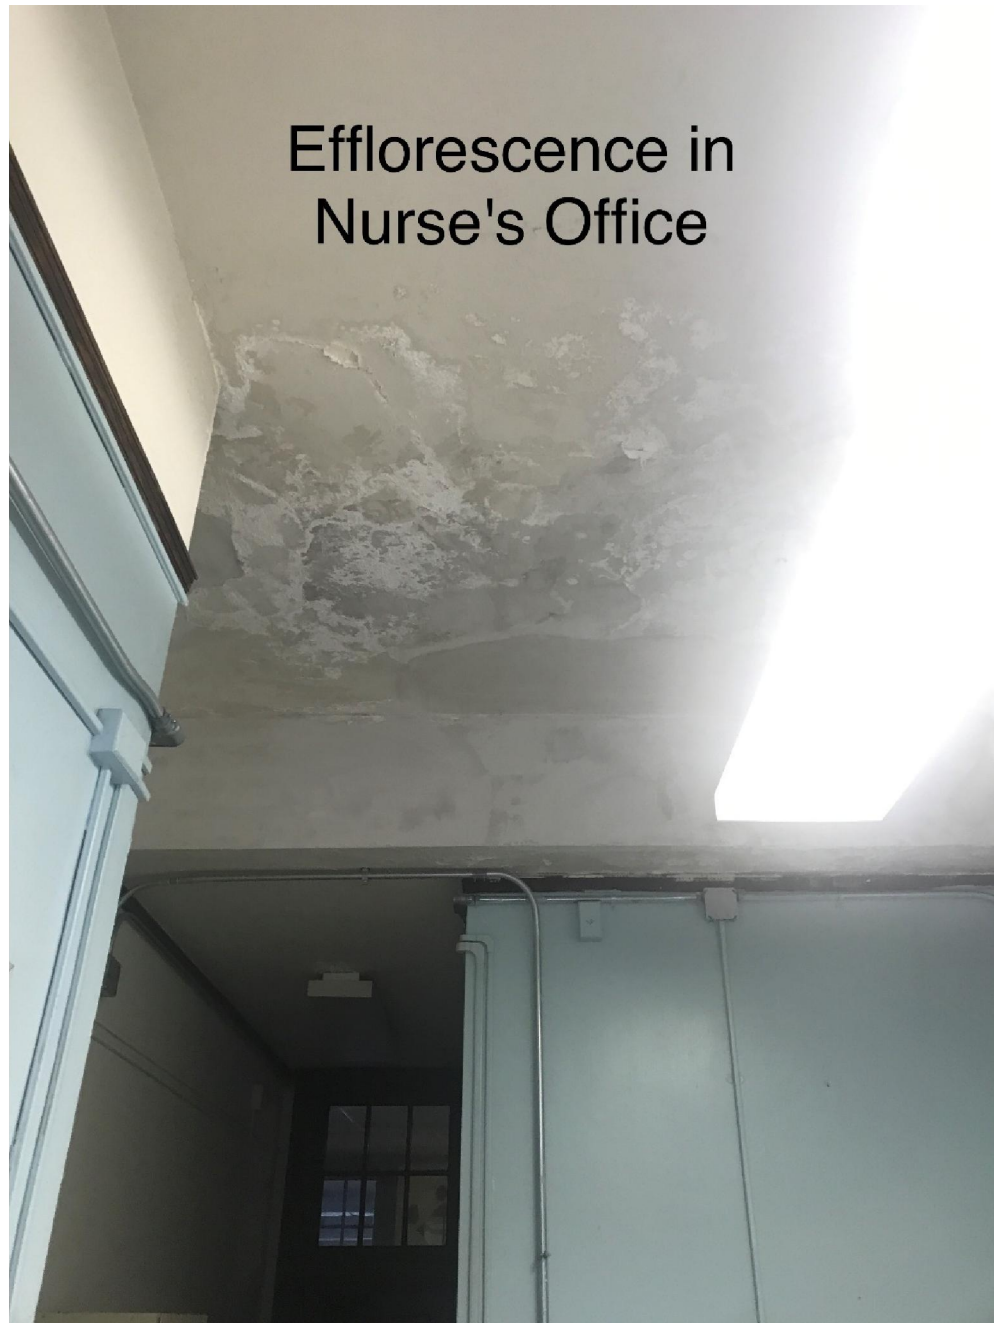
Before Stabilization

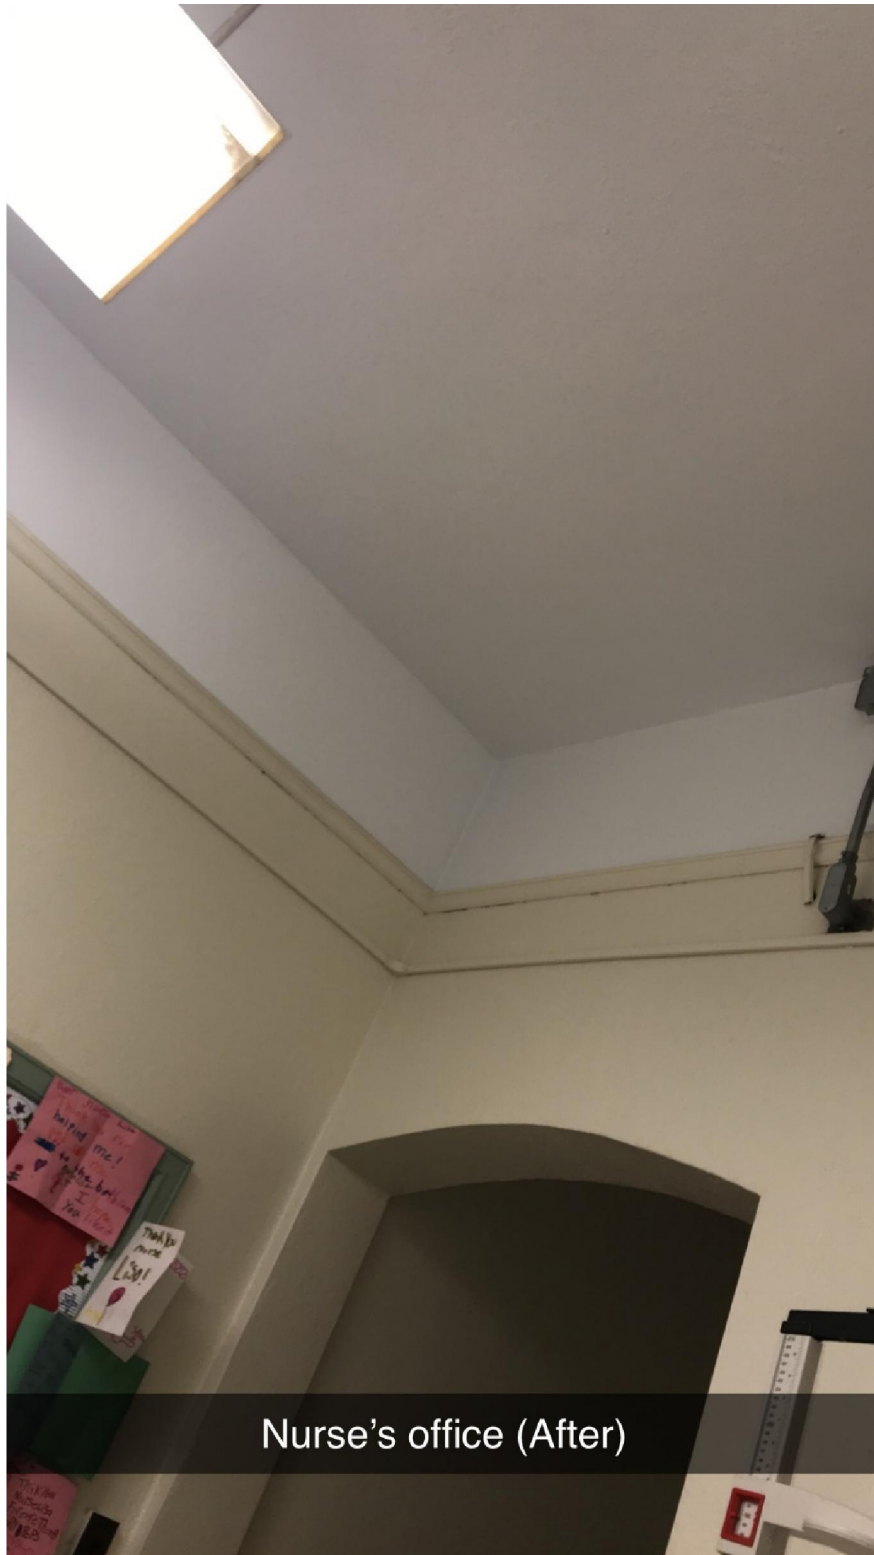
Nurse's office (After)

After Stabilization

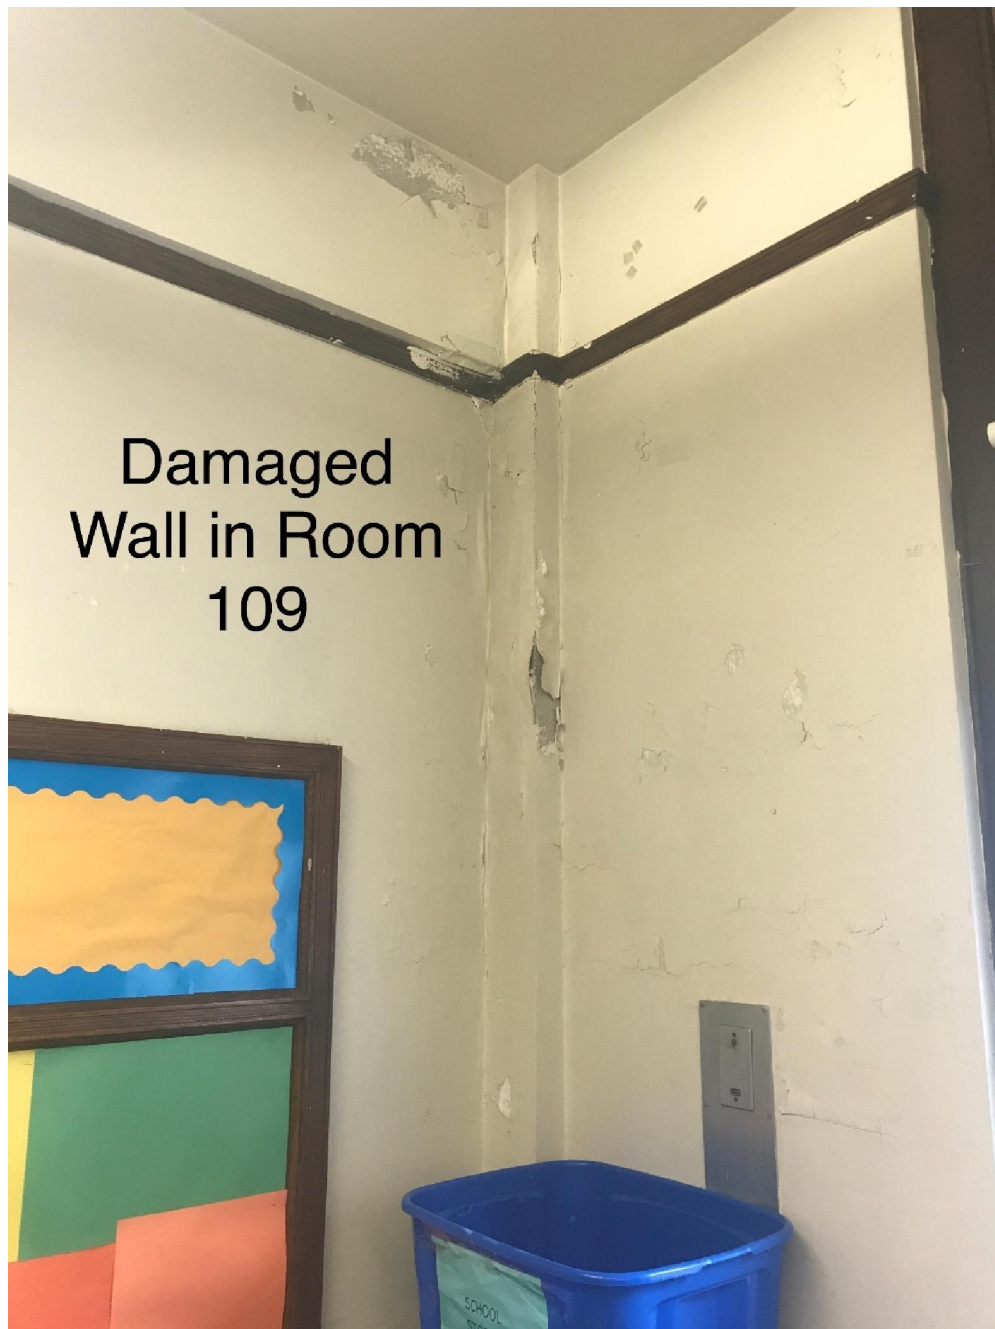
Before Stabilization

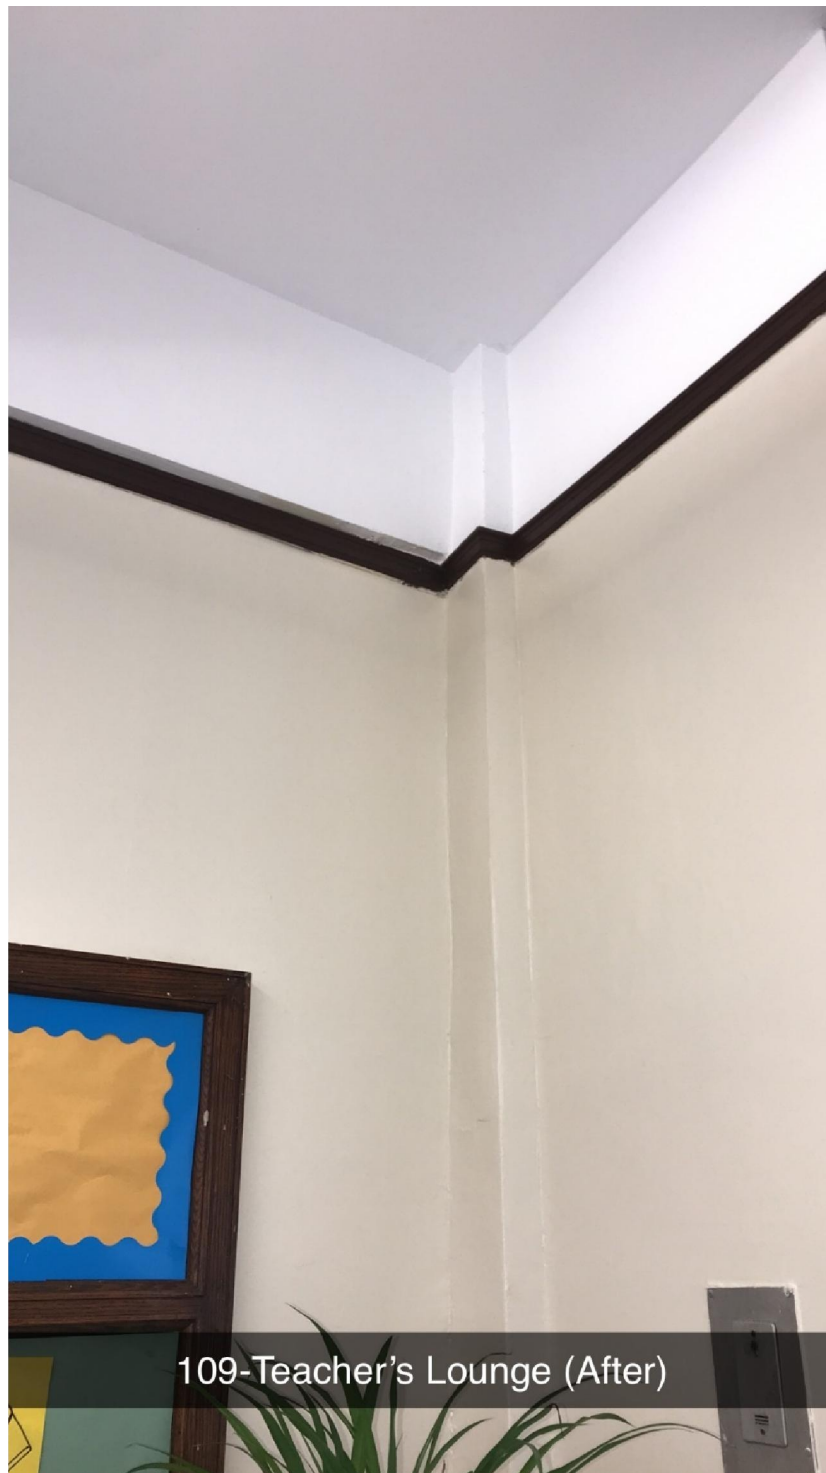
109-Teacher's Lounge (After)

After Stabilization
