PAINT AND PLASTER STABILIZATION
Olney ELEMENTARY SCHOOL
5301 North Water Street
Philadelphia, Pennsylvania 19120
ULCS # 7400

THE SCHOOL DISTRICT OF PHILADELPHIA
OFFICE OF ENVIRONMENTAL MANAGEMENT
440 North Broad Street
3rd Floor
Philadelphia, Pennsylvania 19130

SYNERTECH INCORPORATED
228 Moore Street
Philadelphia, Pennsylvania 19148
Project # 010-4535

September 28th, 2020

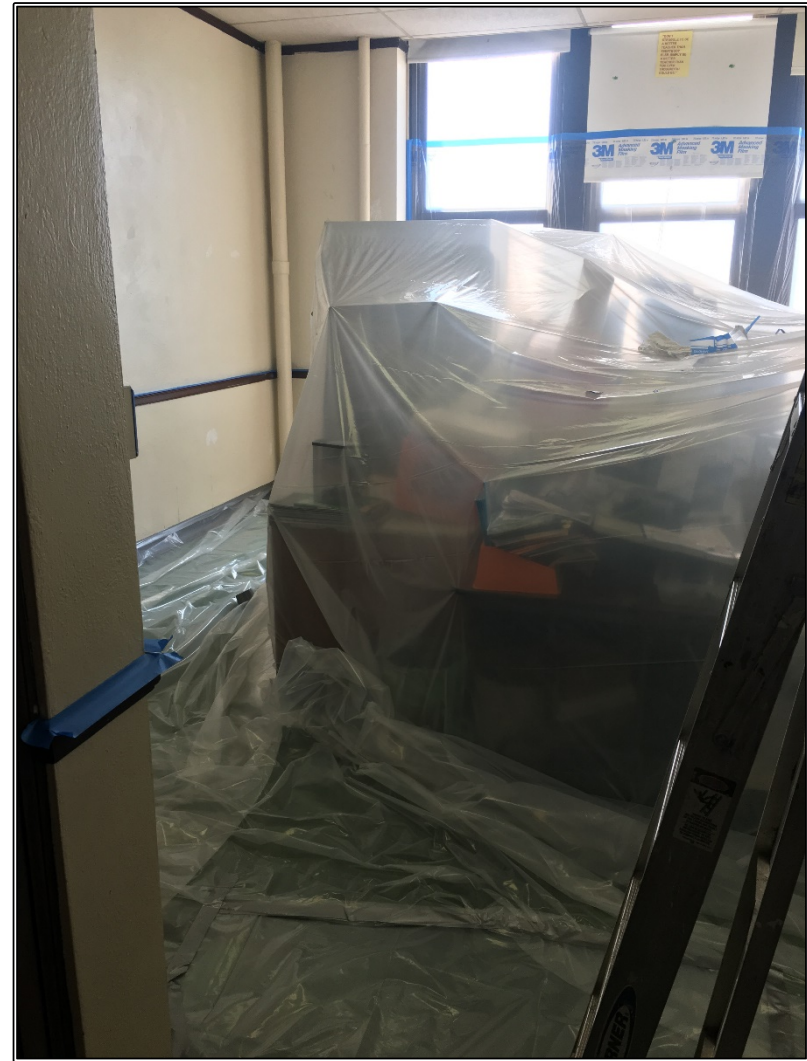
Photos 1 & 2
Typical Contained Classroom Prior to Renovation
