Summary of Paint & Plaster Stabilization Activities

**#6110– Roosevelt Elementary School
430 E. Washington Lane
Philadelphia, PA 19144**

**Criterion Laboratories, Inc.
June 7, 2019**

**Project Number: 182831
Project Dates: December 17, 2018 – June 5, 2019**

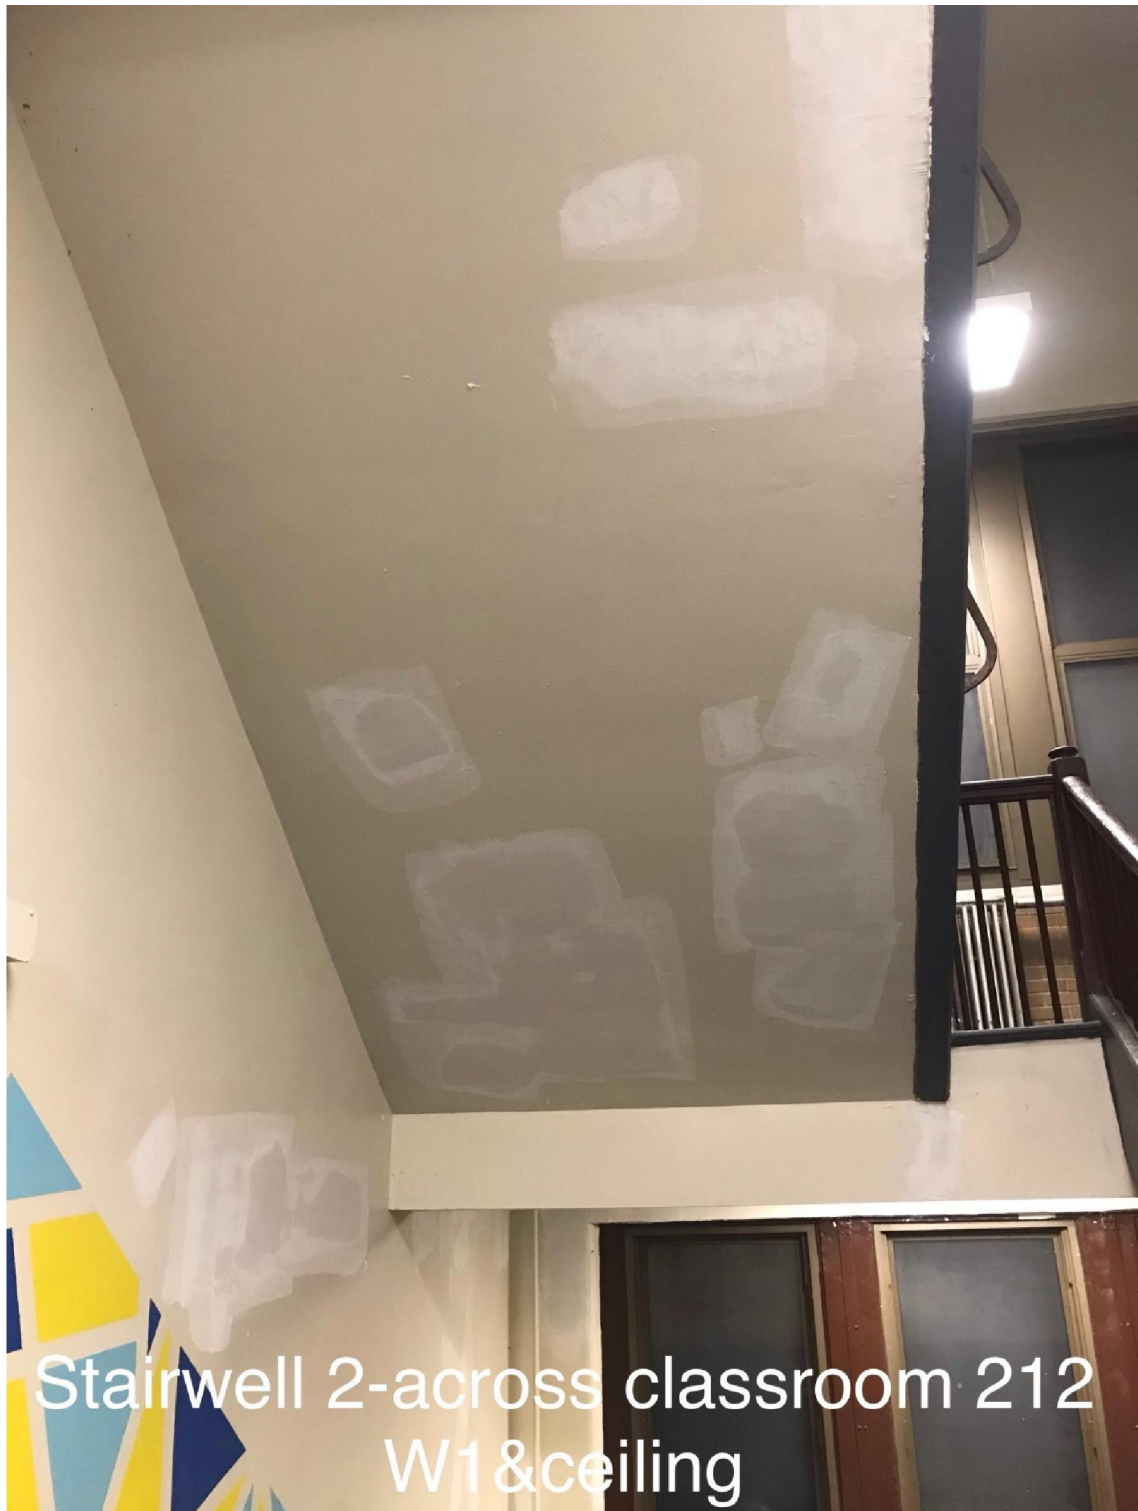
Post Stabilization but before painting

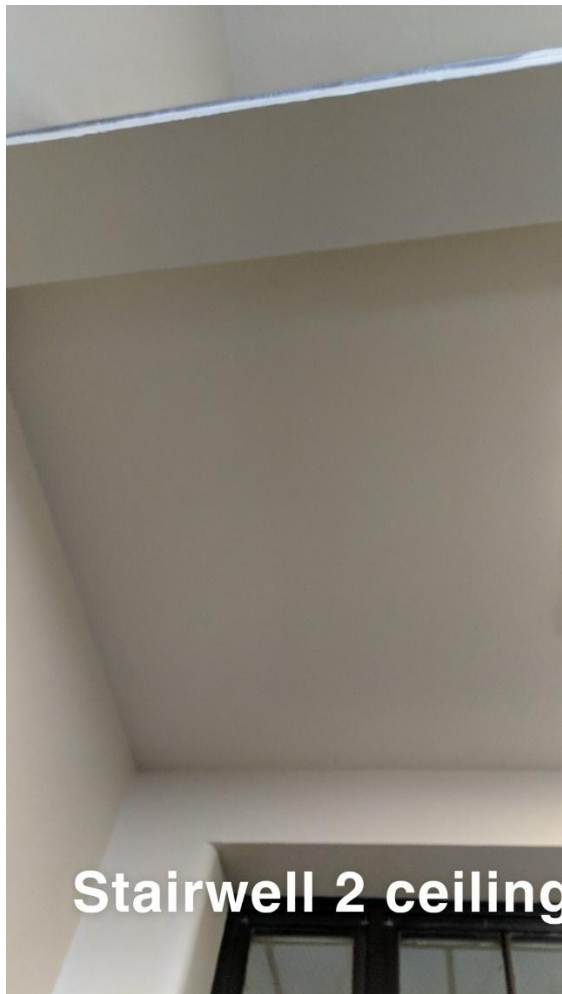
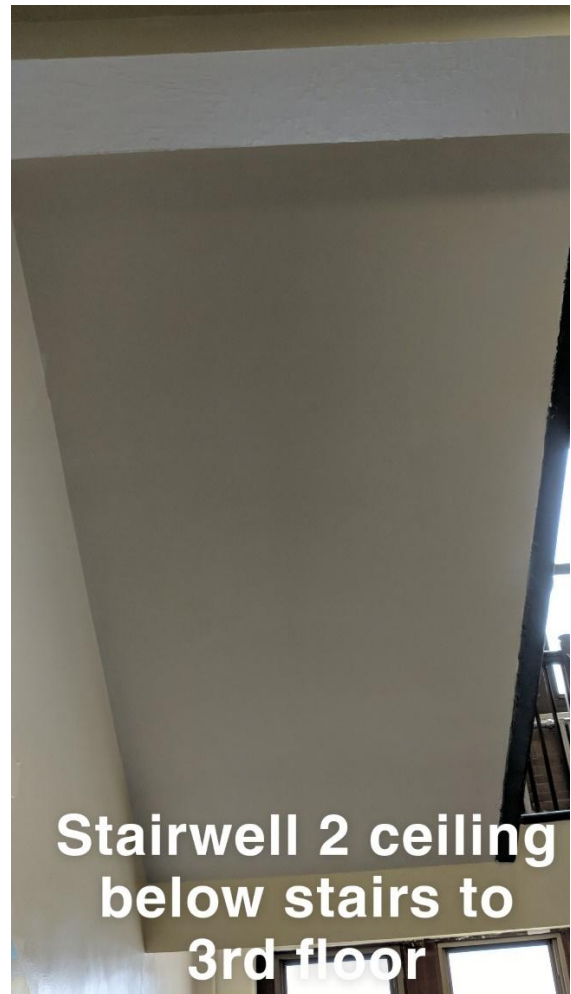
Post painting
