PAINT AND PLASTER STABILIZATION
SOUTHWARK ELEMENTARY SCHOOL

1835 South 9th Street
Philadelphia, Pennsylvania 19148
ULCS# 2640

THE SCHOOL DISTRICT OF PHILADELPHIA
OFFICE OF ENVIRONMENTAL MANAGEMENT

SYNERTECH INCORPORATED

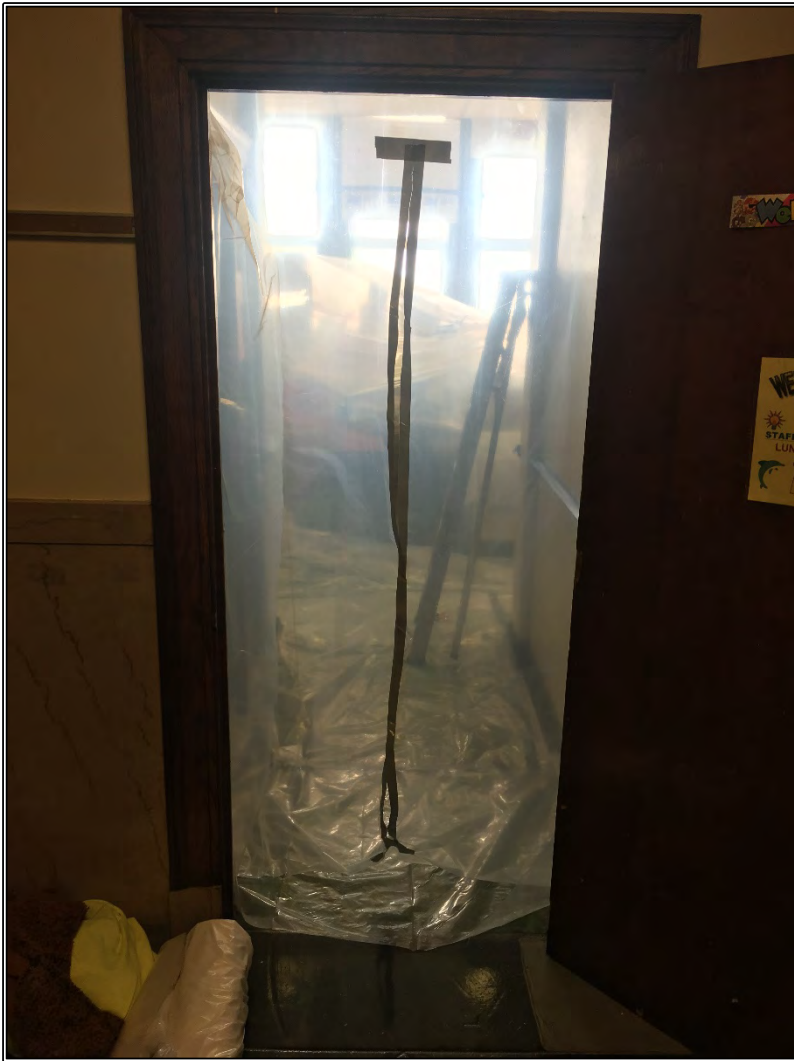
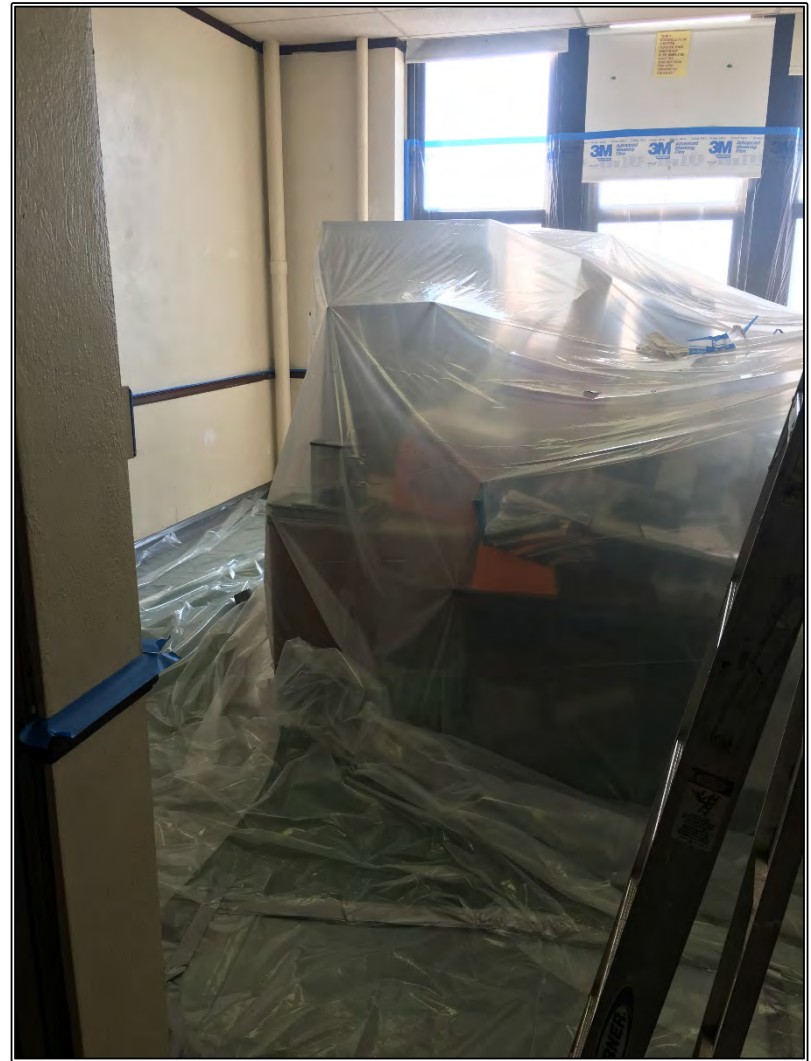
Photos 1 & 2
Typical Contained Classroom Prior to Renovation

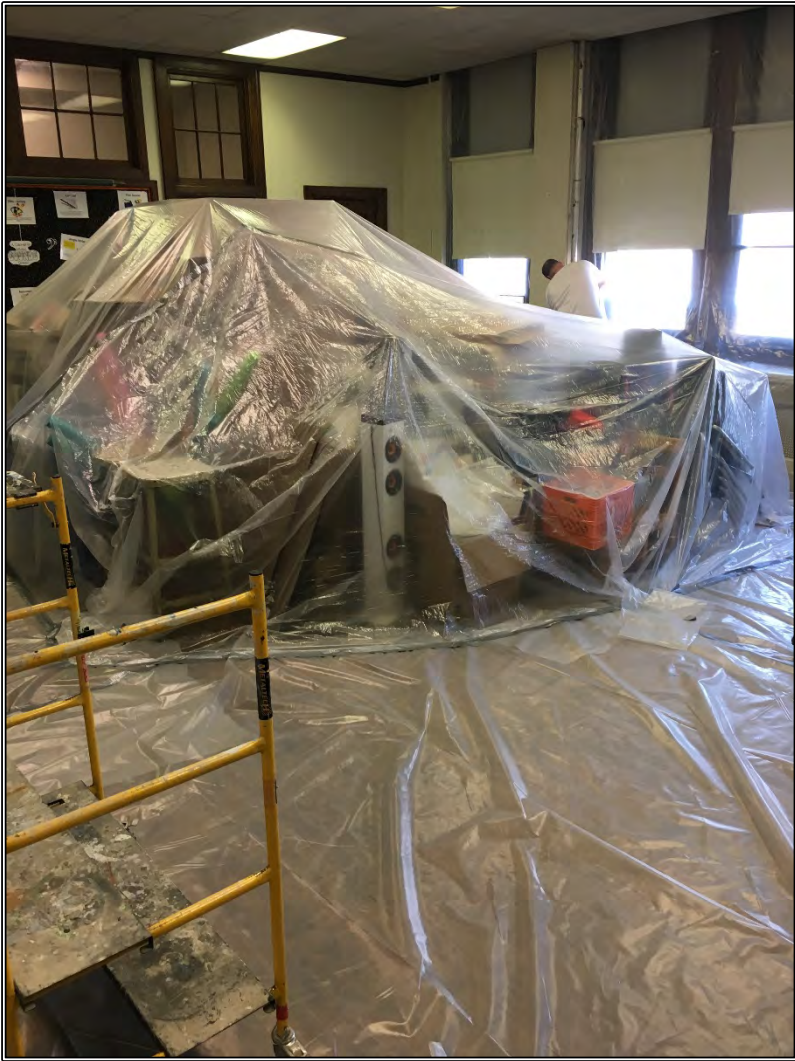
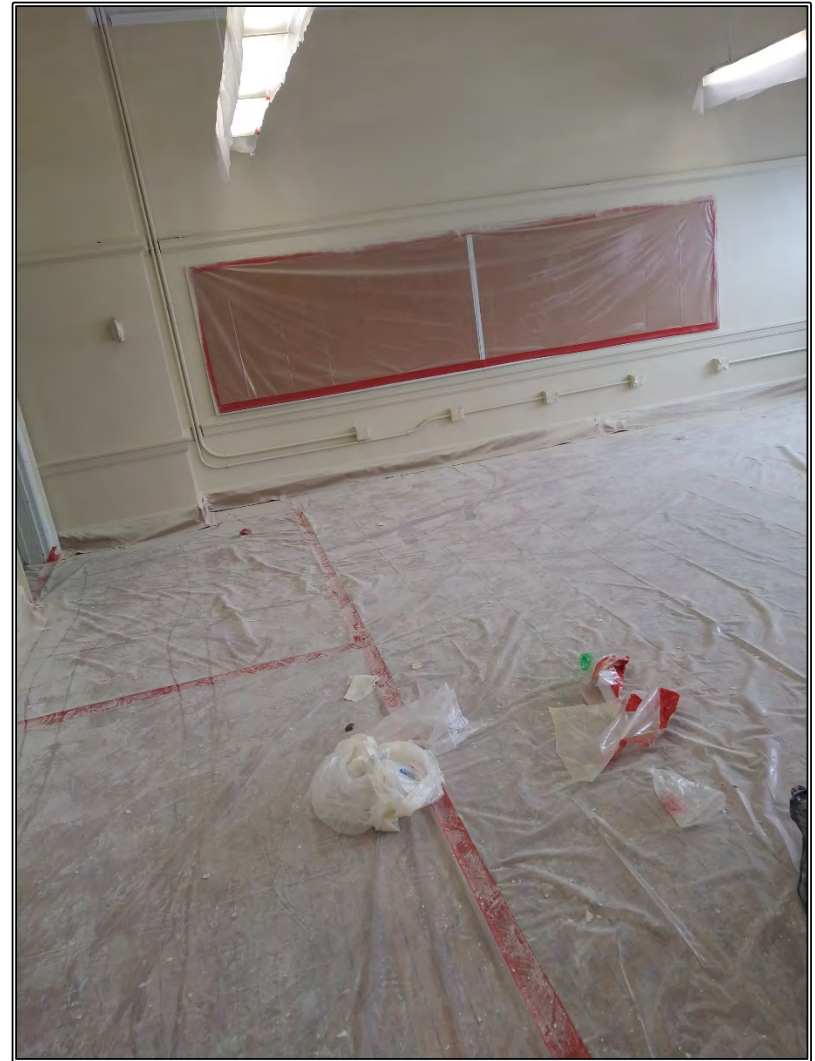
Photos 3 & 4
Typical Contained Classroom During Renovation
