John Taggart Elementary School
400 West Porter Street
Philadelphia, Pennsylvania

Paint and Plaster Stabilization Project Final Report

NOVEMBER 7, 2019

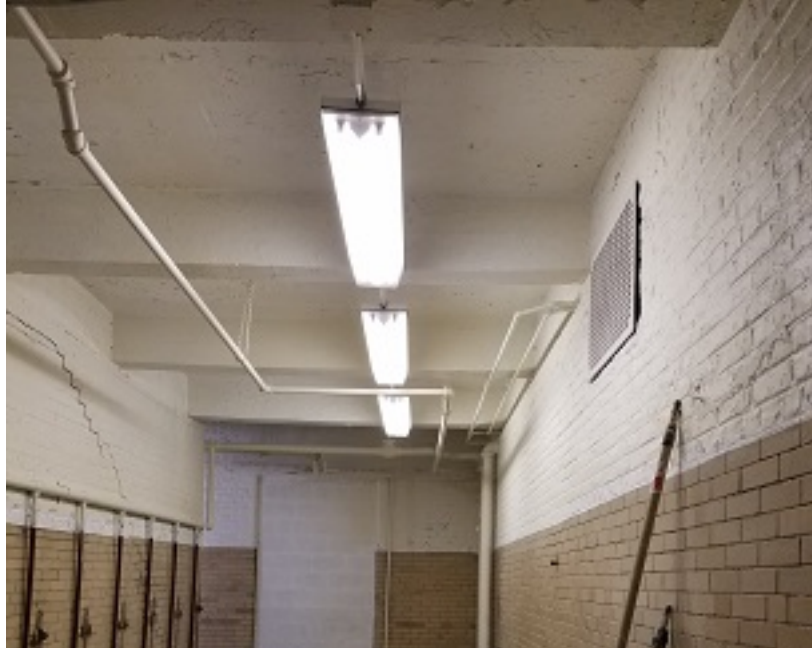
Photographic Documentation**Paint and Plaster Stabilization Project
Taggart Elementary School
400 West Porter Street
VERTEX Project No. 54628****Photograph: 1****Description:****Girl's Restroom before
Stabilization 1**

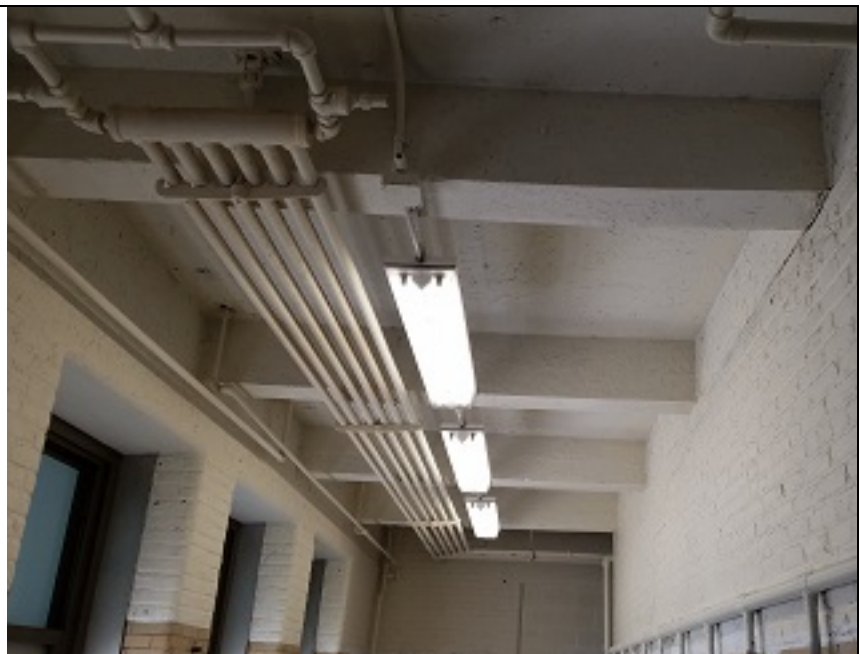
**Photograph: 2****Description:****Girl's Restroom before
Stabilization 2**

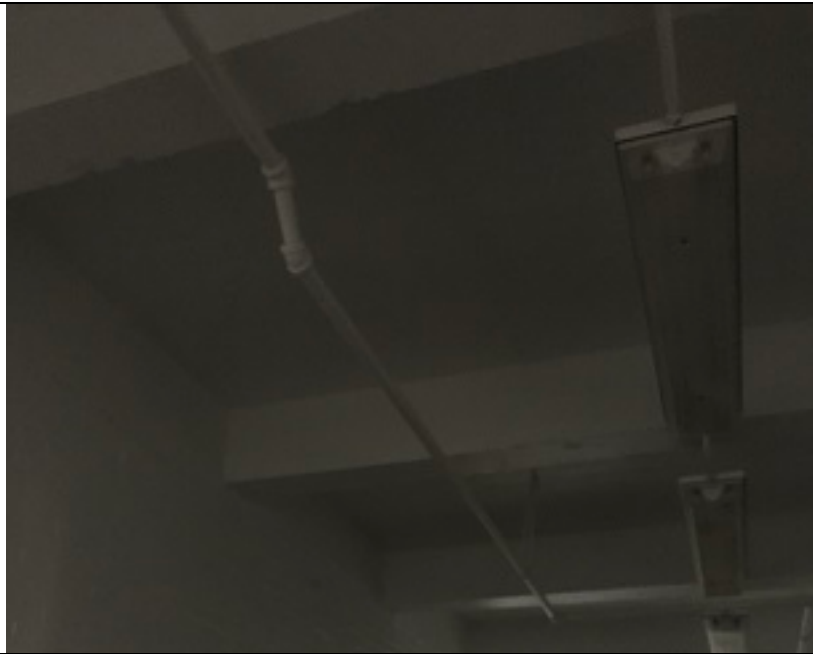
Photographic Documentation**Paint and Plaster Stabilization Project
Taggart Elementary School
400 West Porter Street
VERTEX Project No. 54628****Photograph: 3****Description:****Girl's Restroom after
Stabilization 1**

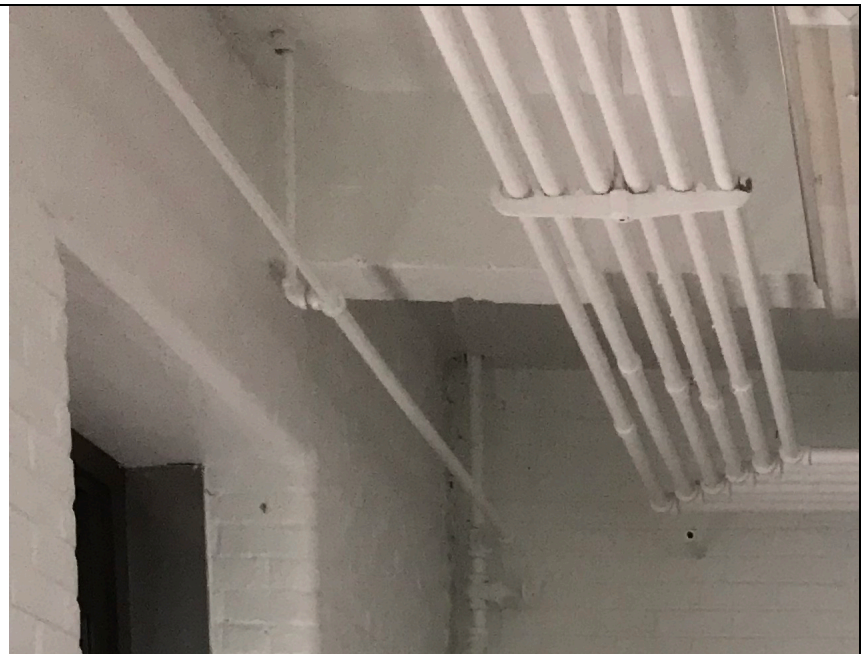
**Photograph: 4****Description:****Girl's Restroom after
Stabilization 2**

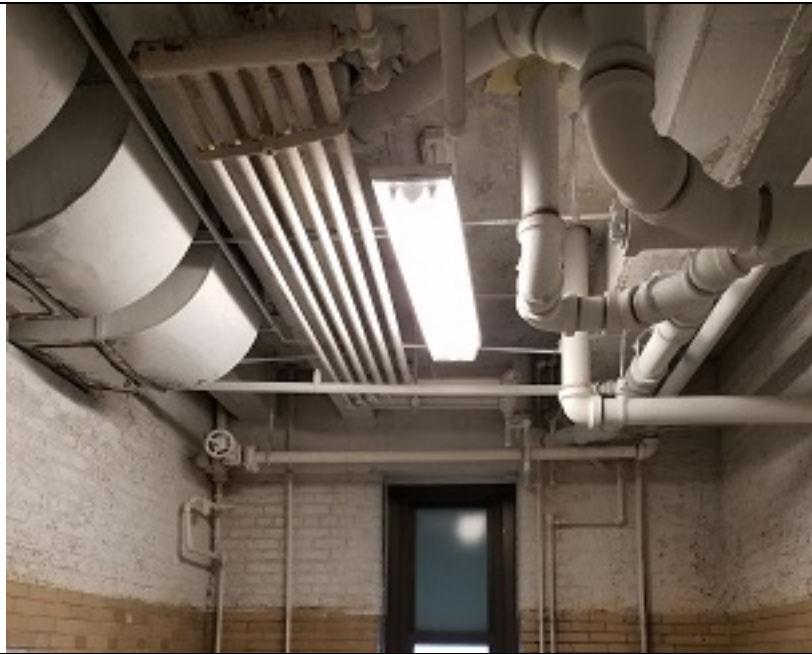
Photographic Documentation**Paint and Plaster Stabilization Project
Taggart Elementary School
400 West Porter Street
VERTEX Project No. 54628****Photograph: 5****Description:****Boy's Restroom before
Stabilization 1**

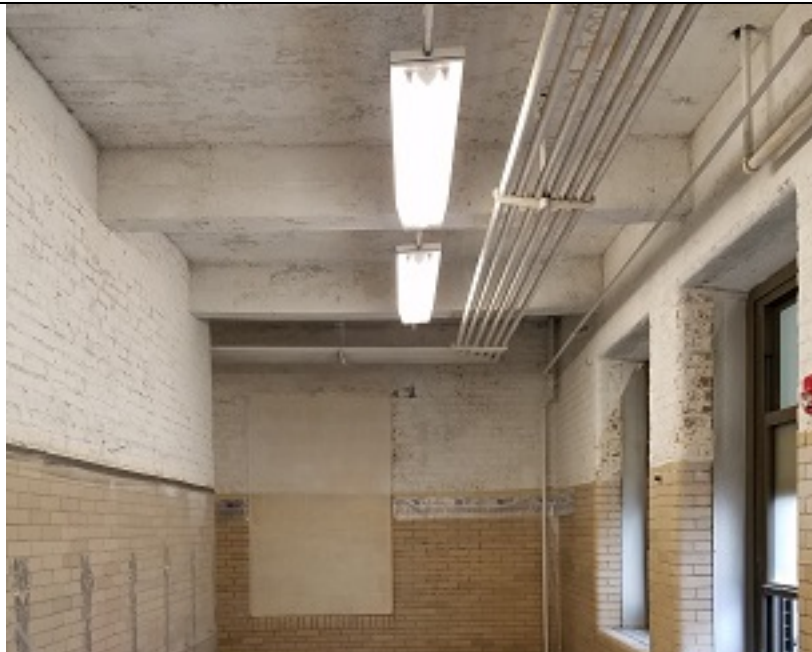
**Photograph: 6****Description:****Boy's Restroom before
Stabilization 2**

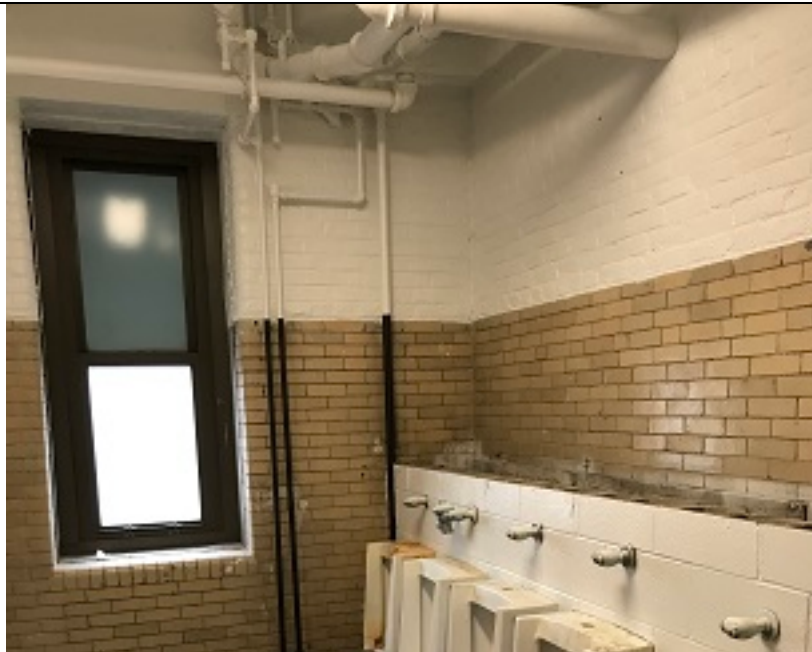
Photograph: 7**Description:**

**Boy's Restroom after
Stabilization 1**

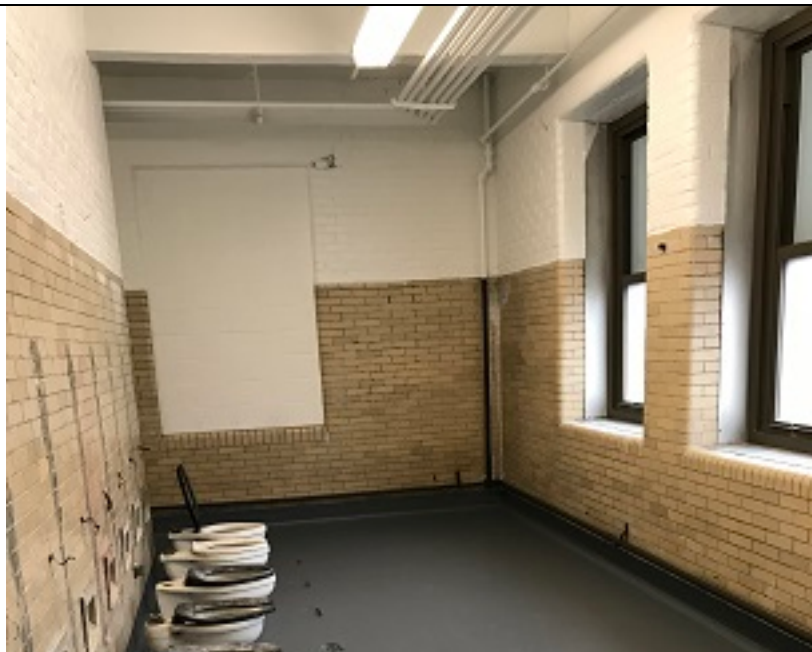
**Photograph: 8****Description:**

**Boy's Restroom after
Stabilization 2**

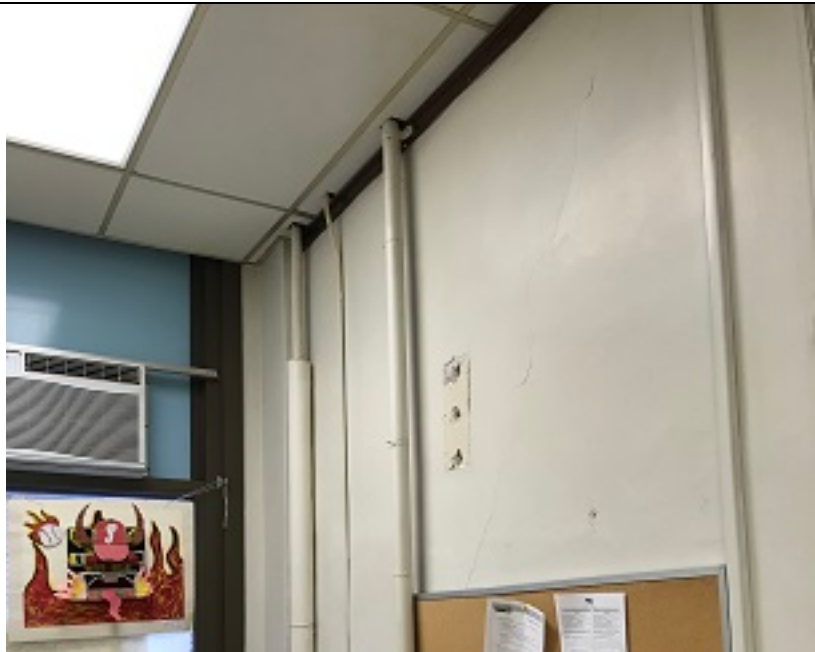
Photographic Documentation**Paint and Plaster Stabilization Project
Taggart Elementary School
400 West Porter Street
VERTEX Project No. 54628****Photograph: 9****Description:****Main Office before
Stabilization**

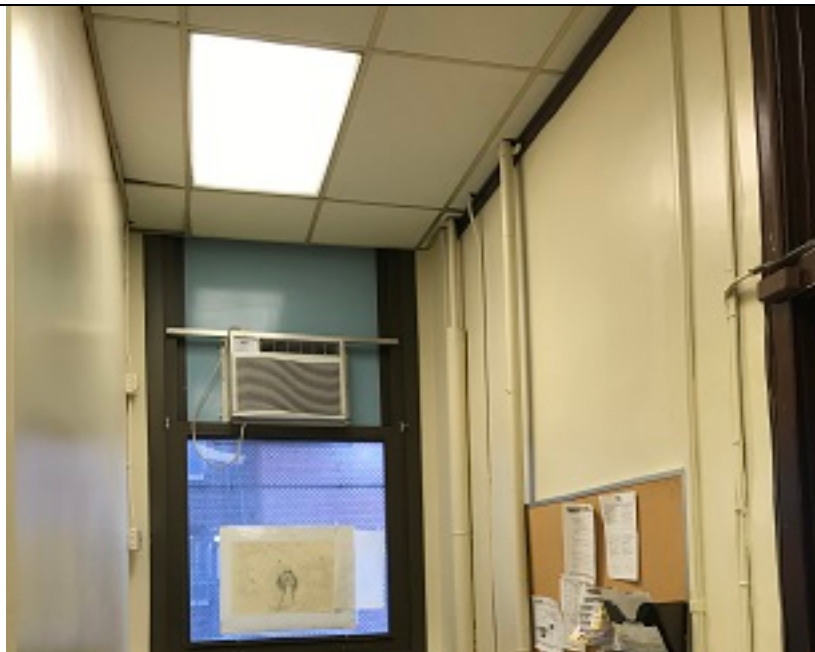
**Photograph: 10****Description:****Main Office after
Stabilization**
