**Science Leadership Academy
at Beeber Middle School**

5925 Malvern Avenue
Philadelphia, Pennsylvania

**Lead-Safe Paint and Plaster Targeted Stabilization Project
- Final Report****FEBRUARY 15, 2024 (REVISED APRIL 4, 2024)****PREPARED FOR:**

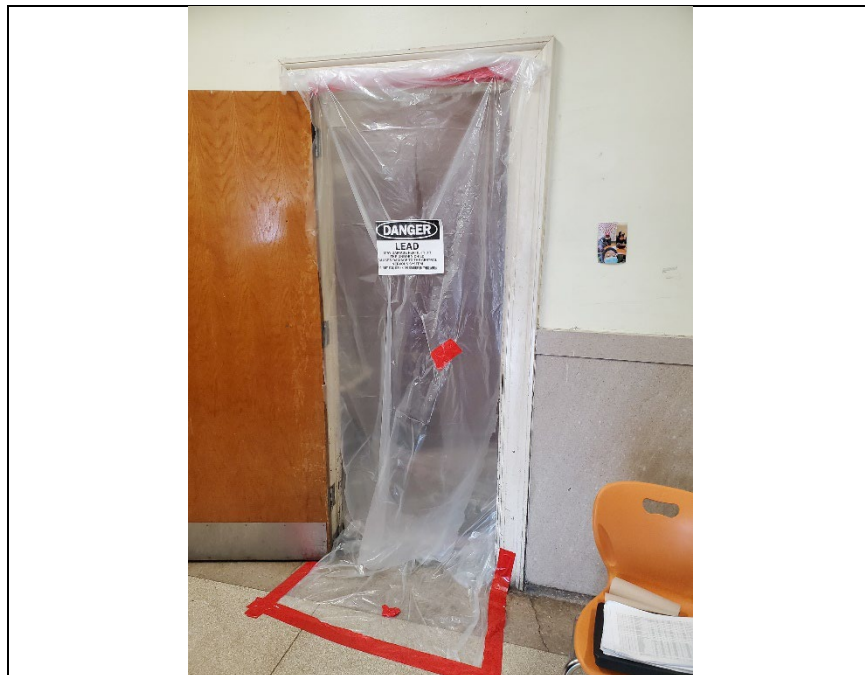
Photograph 1 – Service Closet Prep
