Summary of Paint & Plaster Stabilization Activities

**#2510– Jackson Elementary School
1213 S 12th Street
Philadelphia, PA 19147**

**Criterion Laboratories, Inc.
December 6, 2018**

**Project Number: 180847
Project Dates: April 9, 2018 – July 6, 2018**

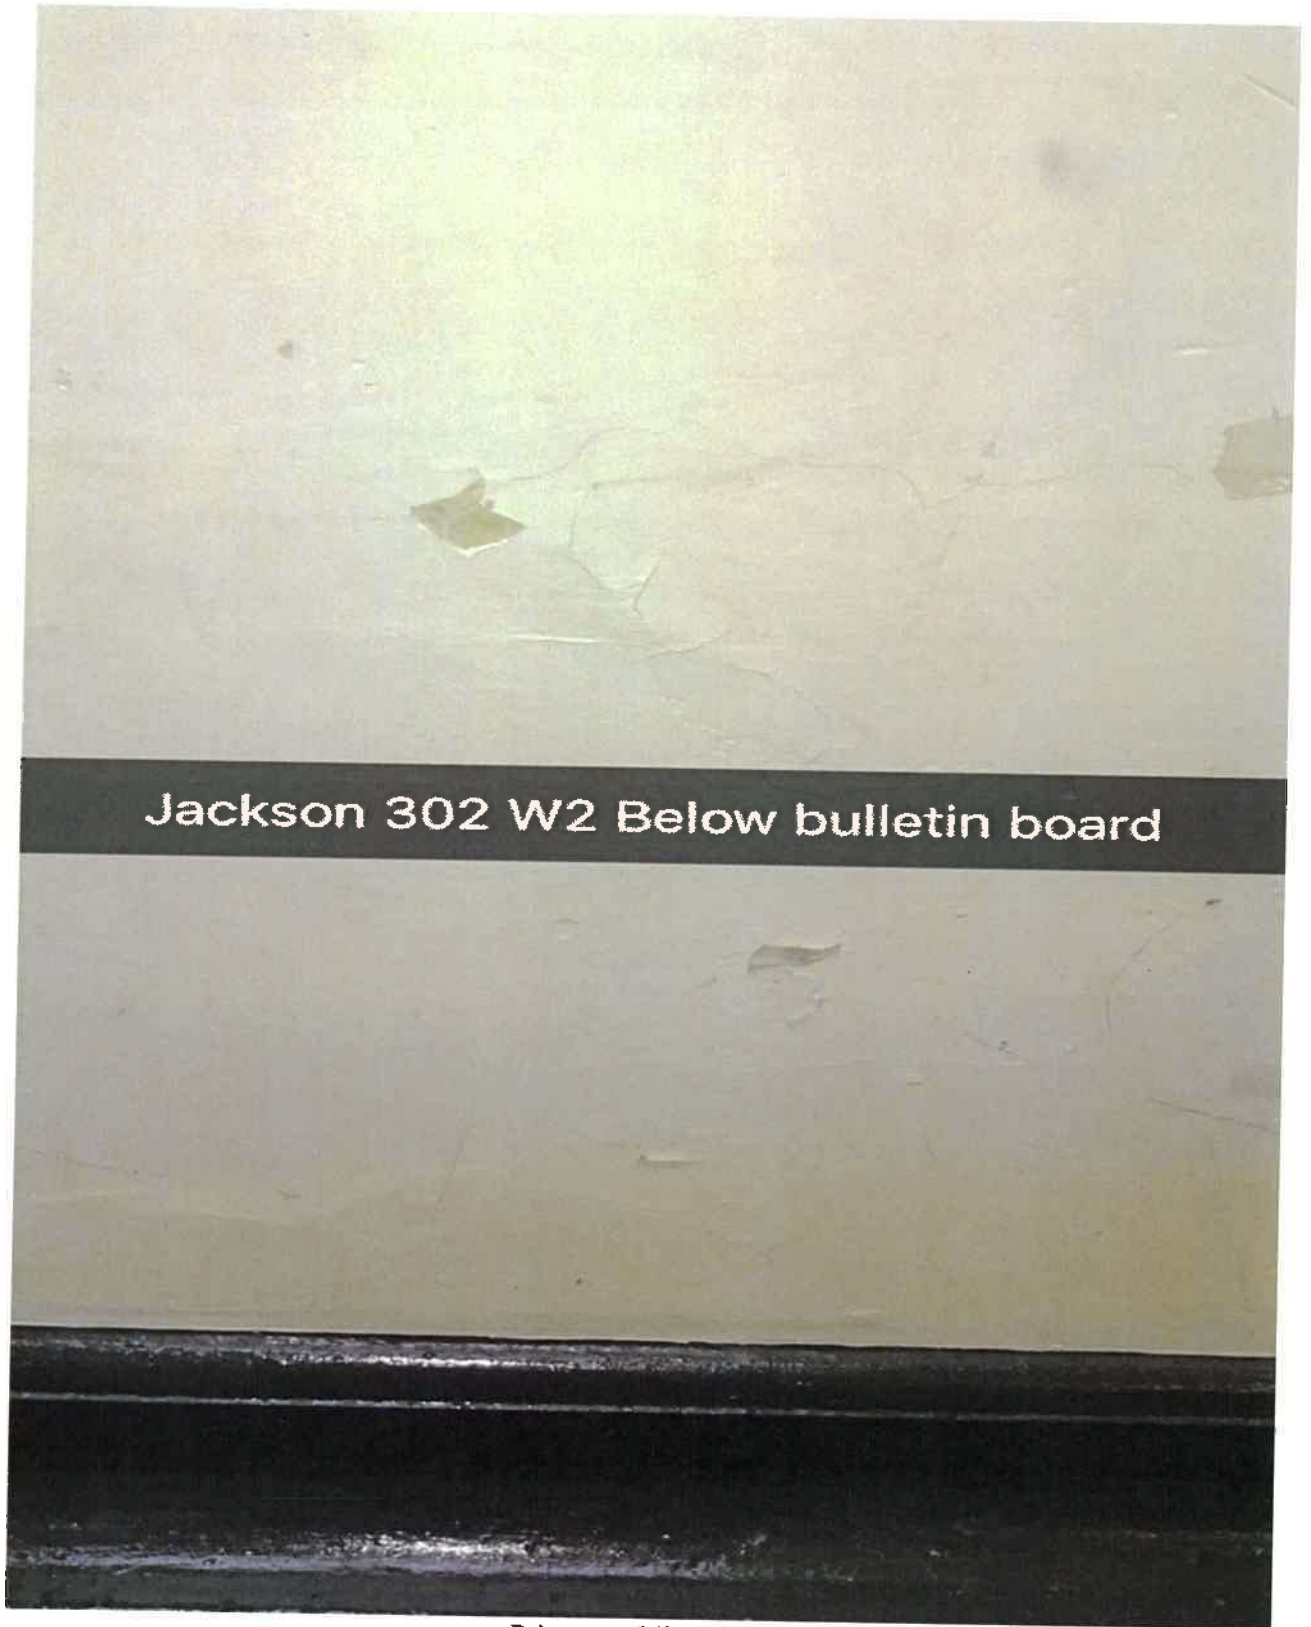
Classroom 302

Prior to stabilization.

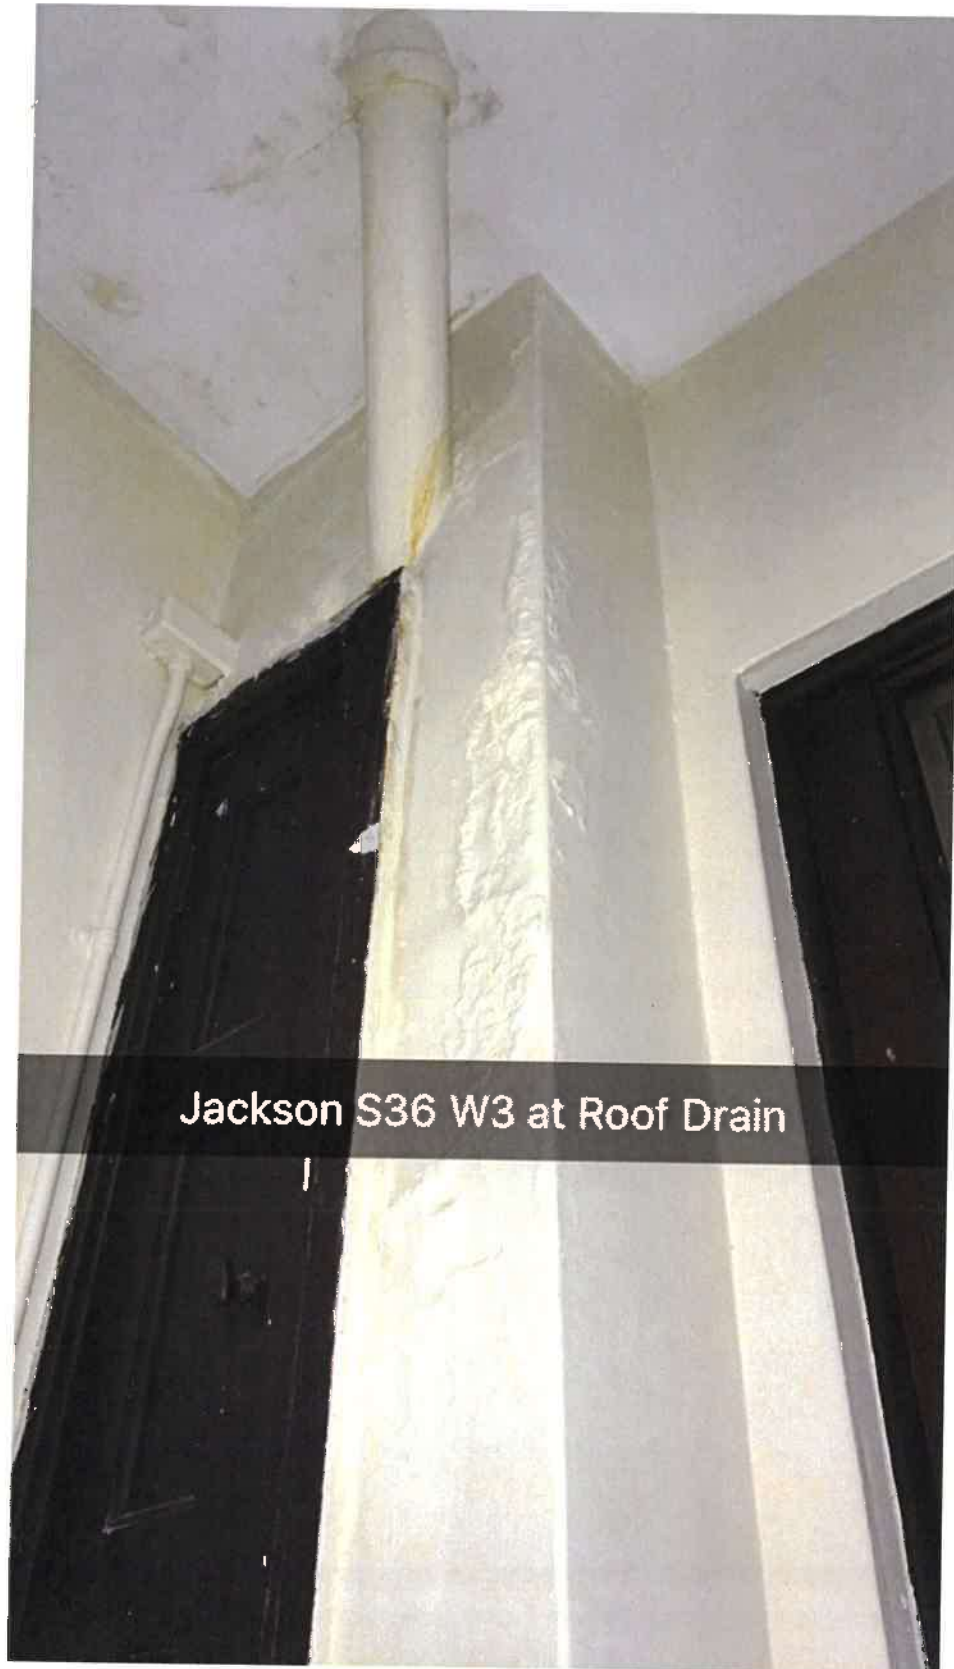
Stairwell next to Classroom 301

Prior to stabilization

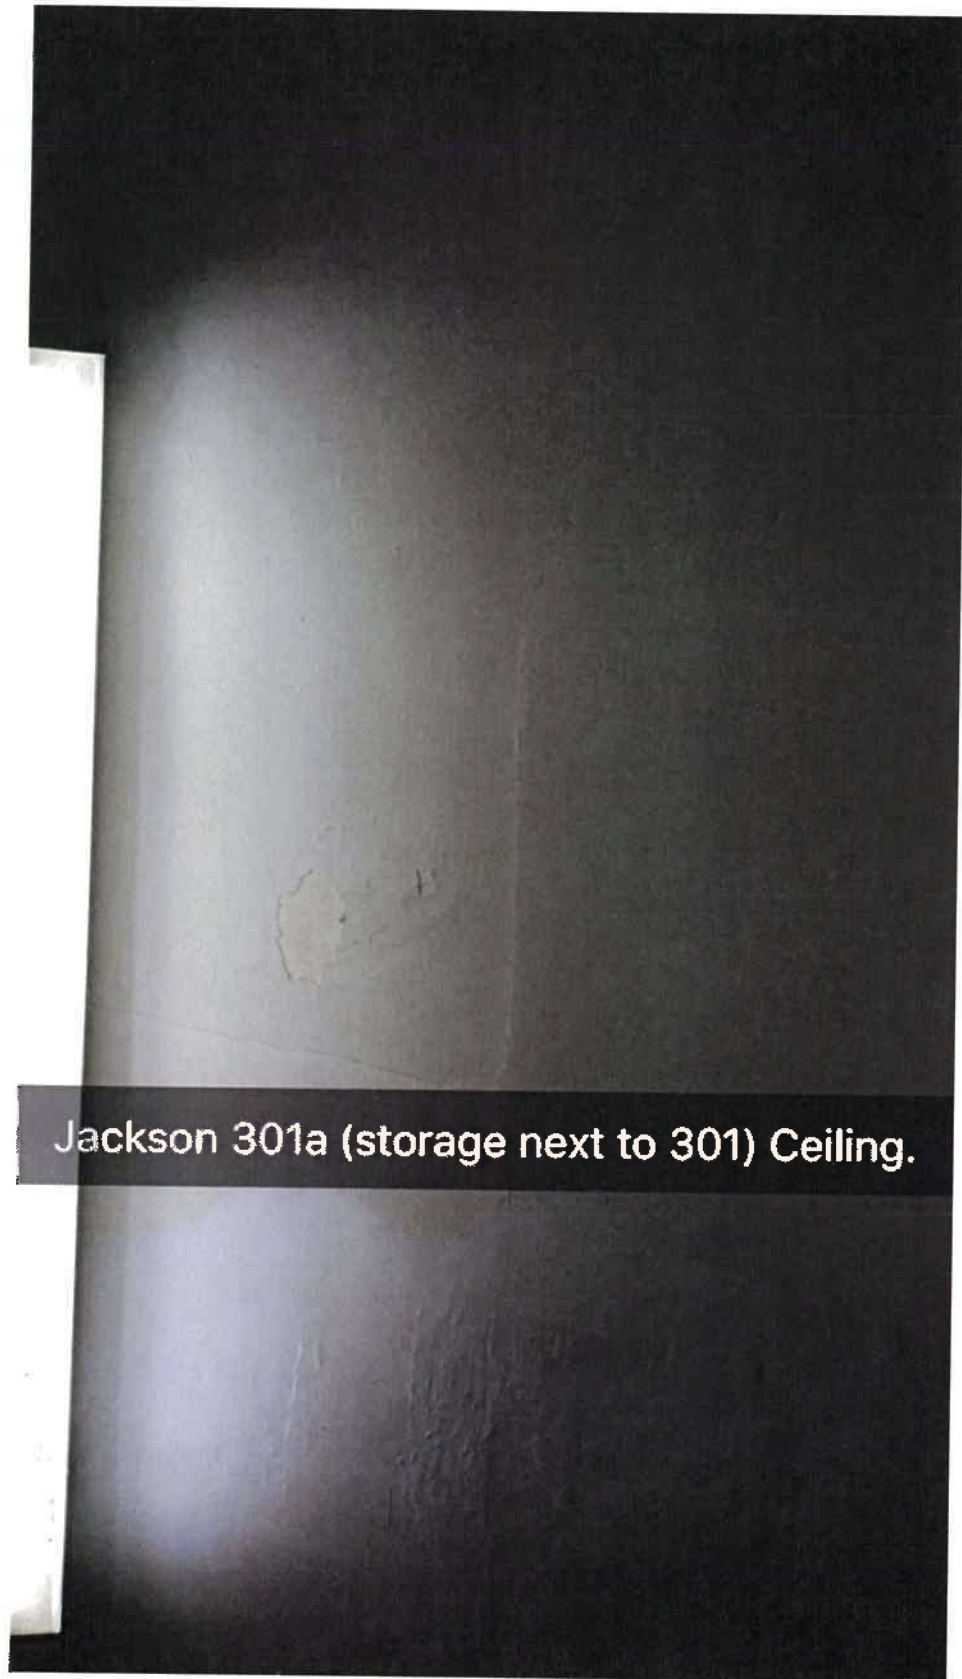
Storage Closet next to Classroom 301

Prior to stabilization
