Summary of Paint & Plaster Stabilization Activities

**#2580– Kirkbride Elementary School
1501 S. 7th Street
Philadelphia, PA 19147**

**Criterion Laboratories, Inc.
January 28, 2019**

**Project Number: 181786
Project Dates: August 7 – October 12, 2018**

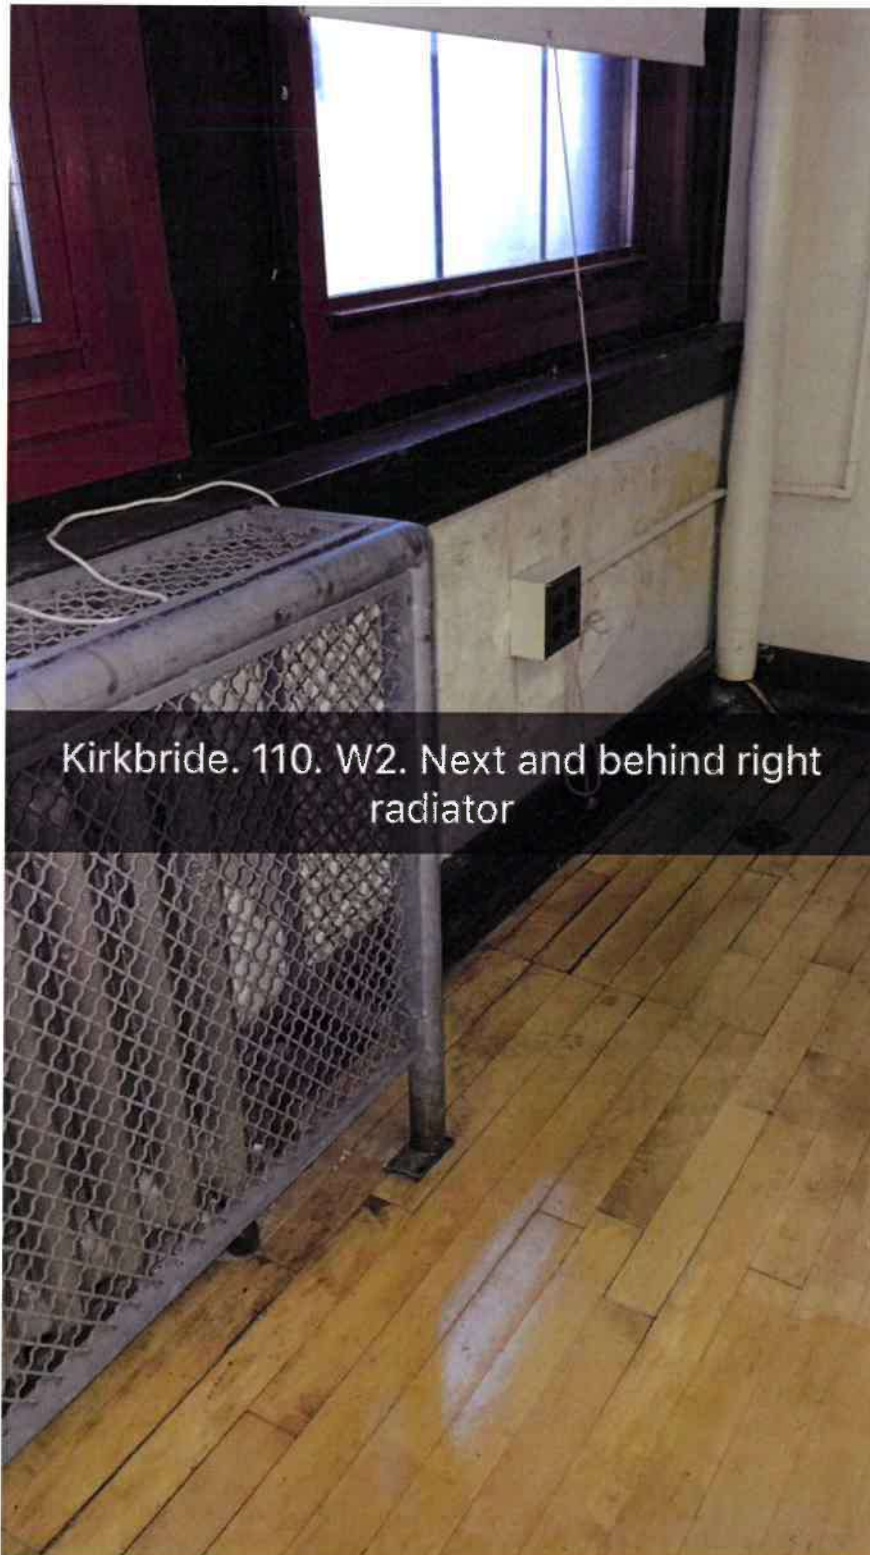
Kirkbride. 110. W2. Next and behind right radiator

Prior to stabilization.

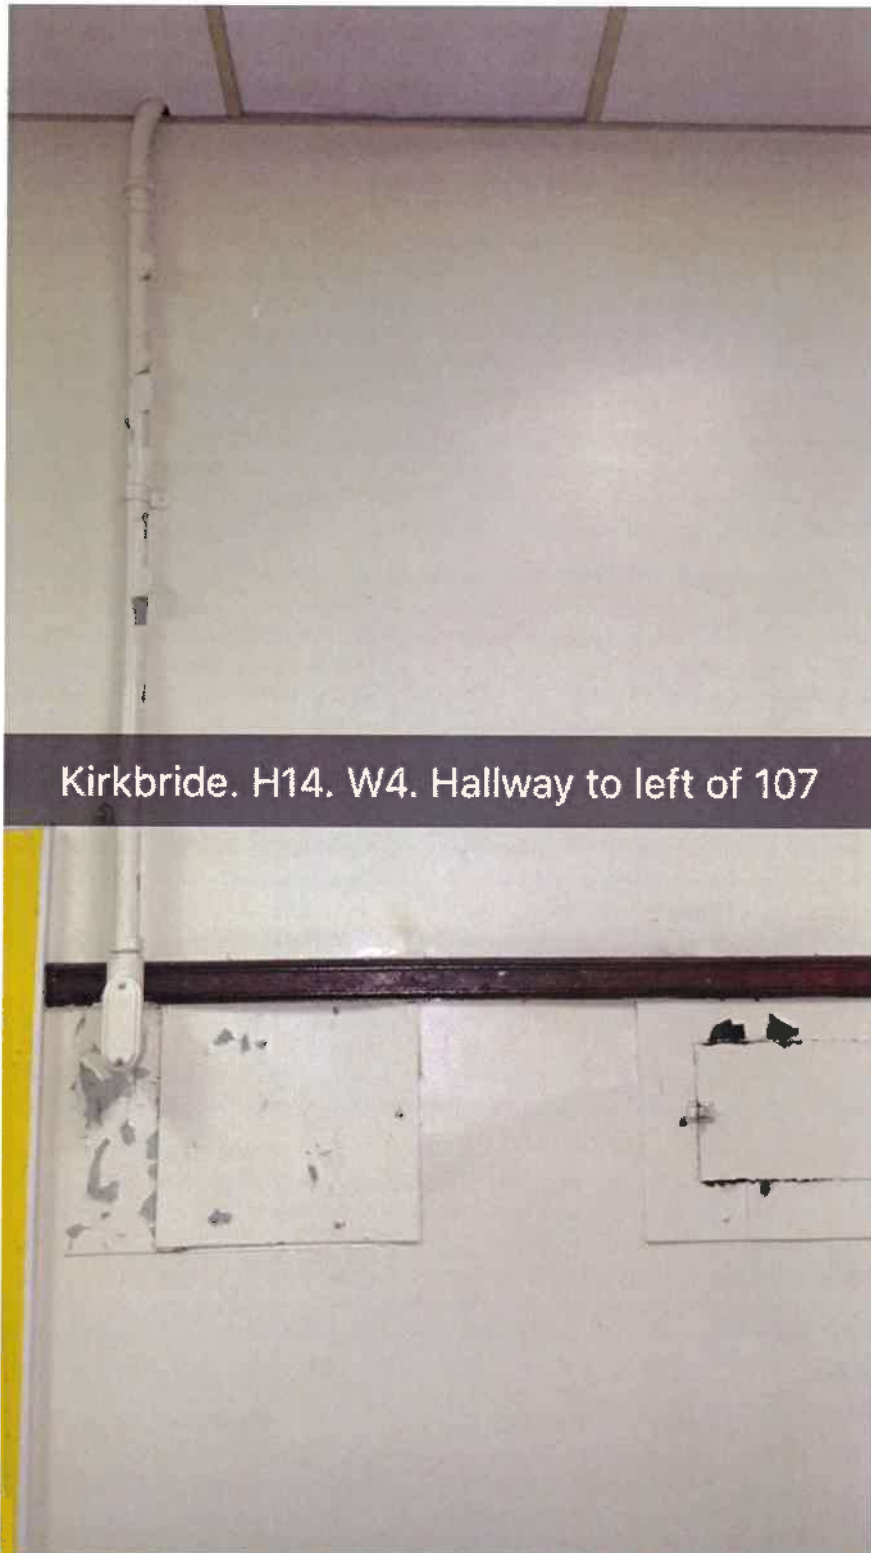
Prior to stabilization.

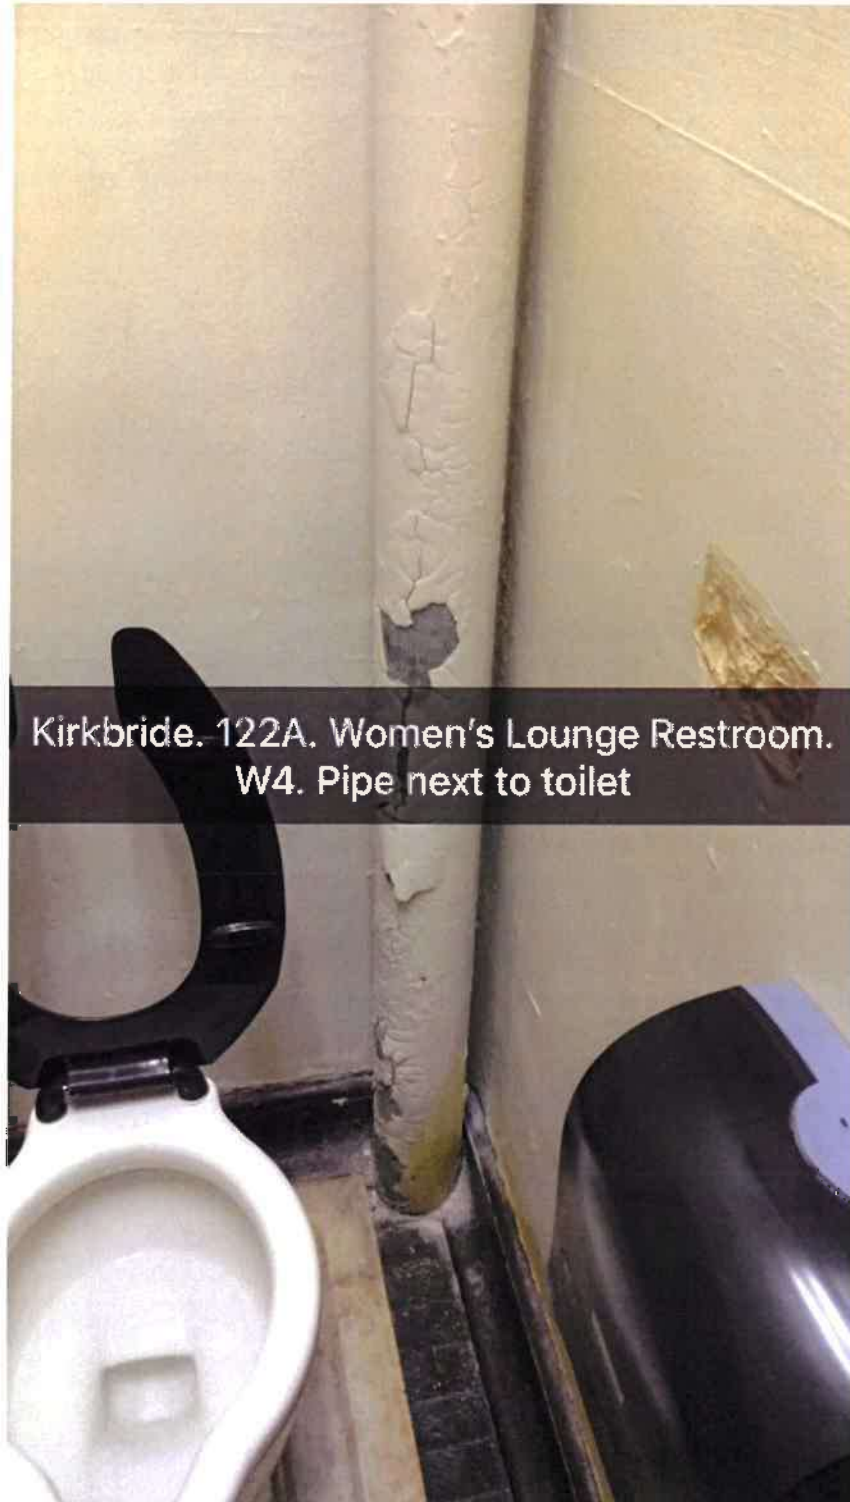
Prior to stabilization.
