PAINT AND PLASTER STABILIZATION  
PENROSE ELEMENTARY SCHOOL

2515 S. 78<sup>th</sup> Street  
Philadelphia, Pennsylvania 19153  
ULCS # 1016/1440

THE SCHOOL DISTRICT OF PHILADELPHIA  
OFFICE OF ENVIRONMENTAL MANAGEMENT

SYNERTECH INCORPORATED

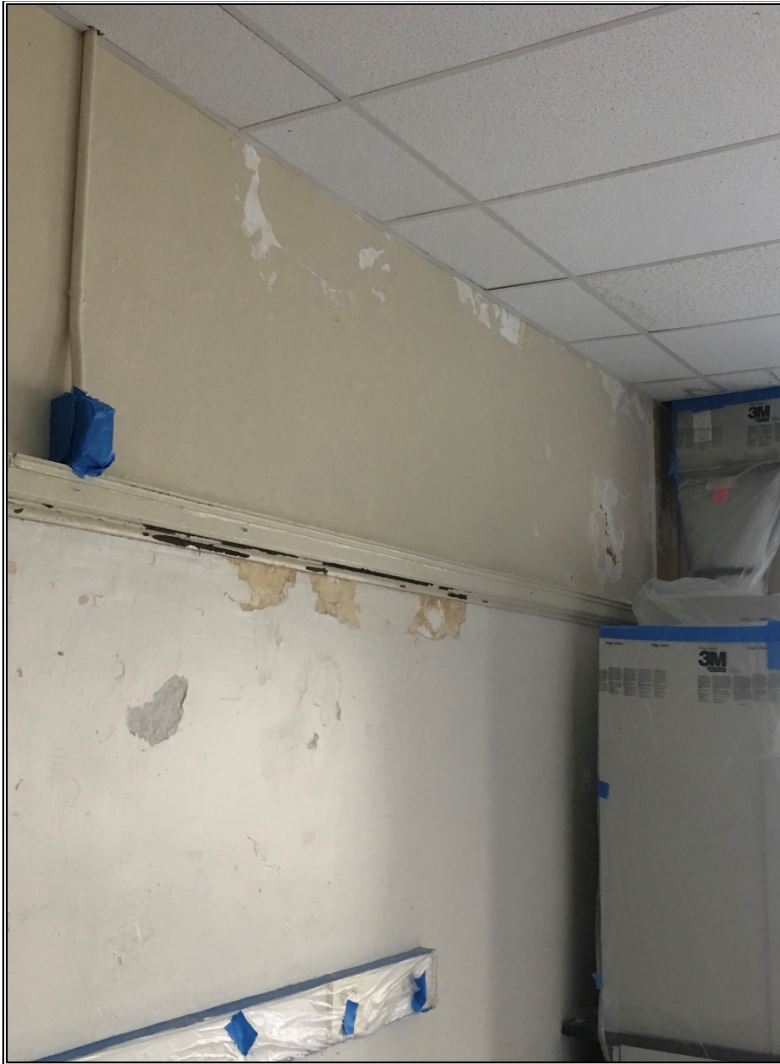
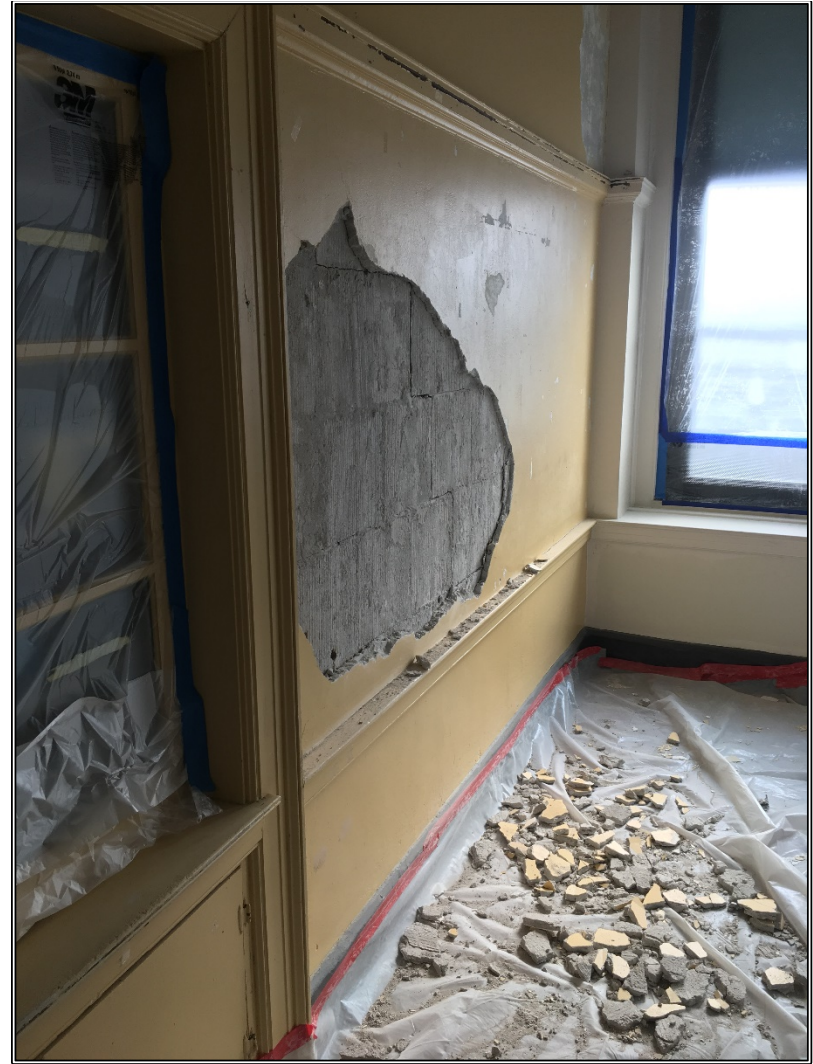
**Photos 1 & 2**

Damaged Paint and Plaster before and during Stabilization

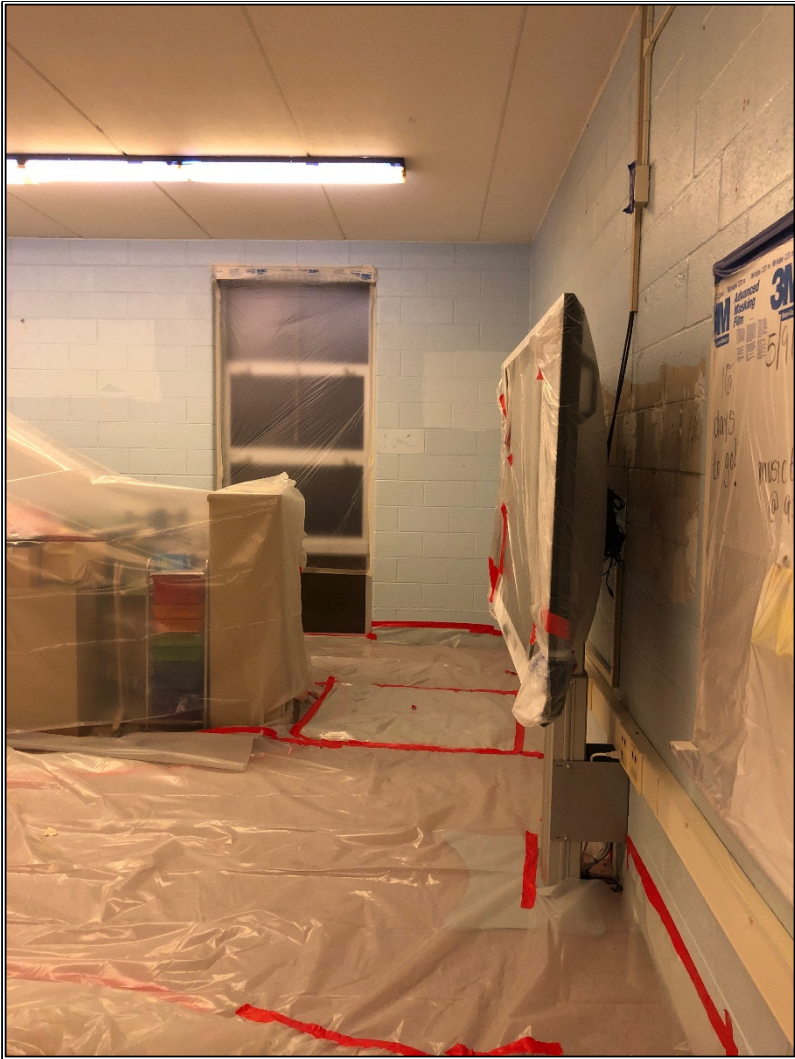
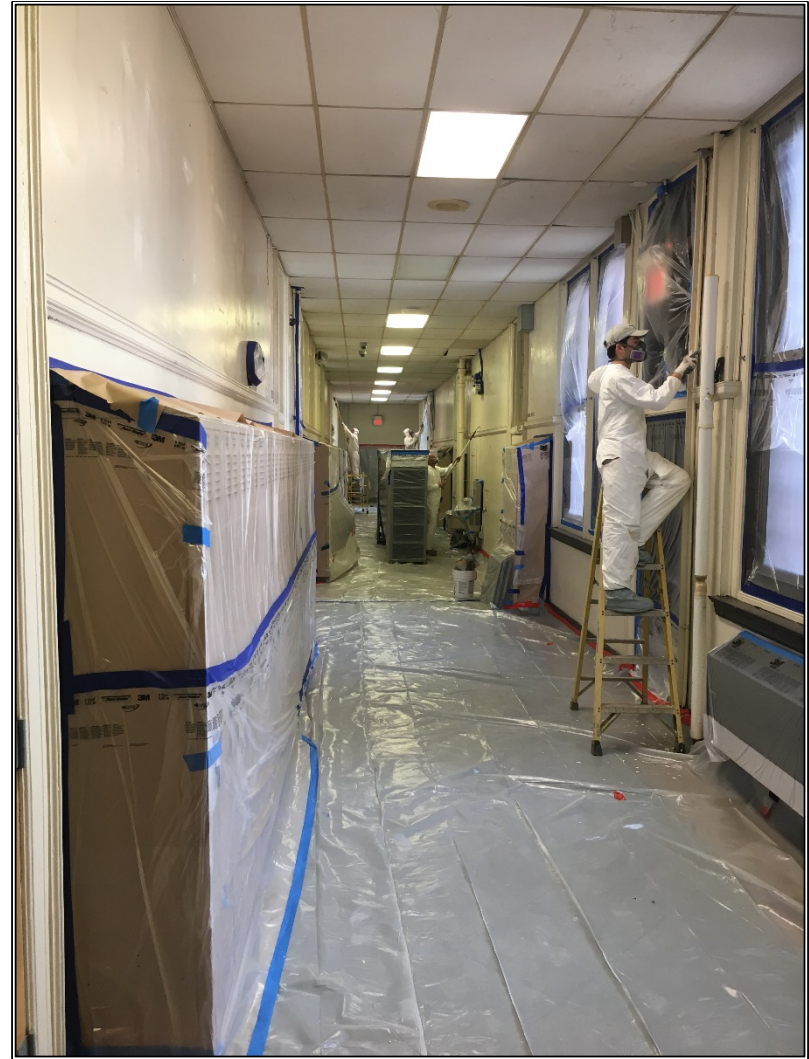
**Photos 3 & 4**

Work Areas Contained during Stabilization

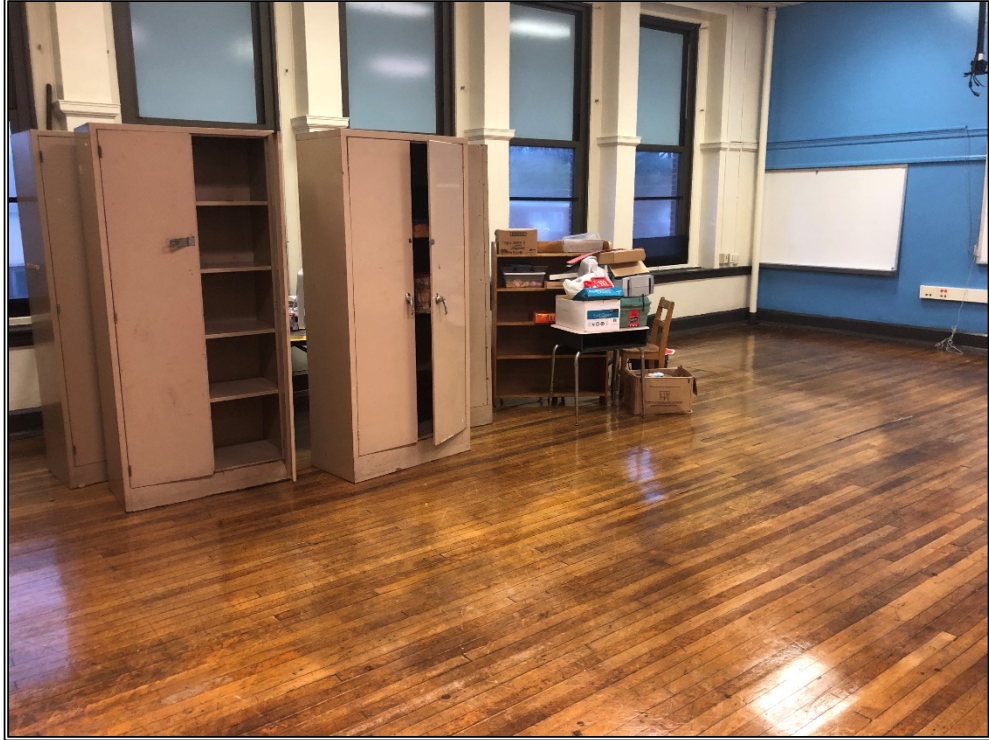
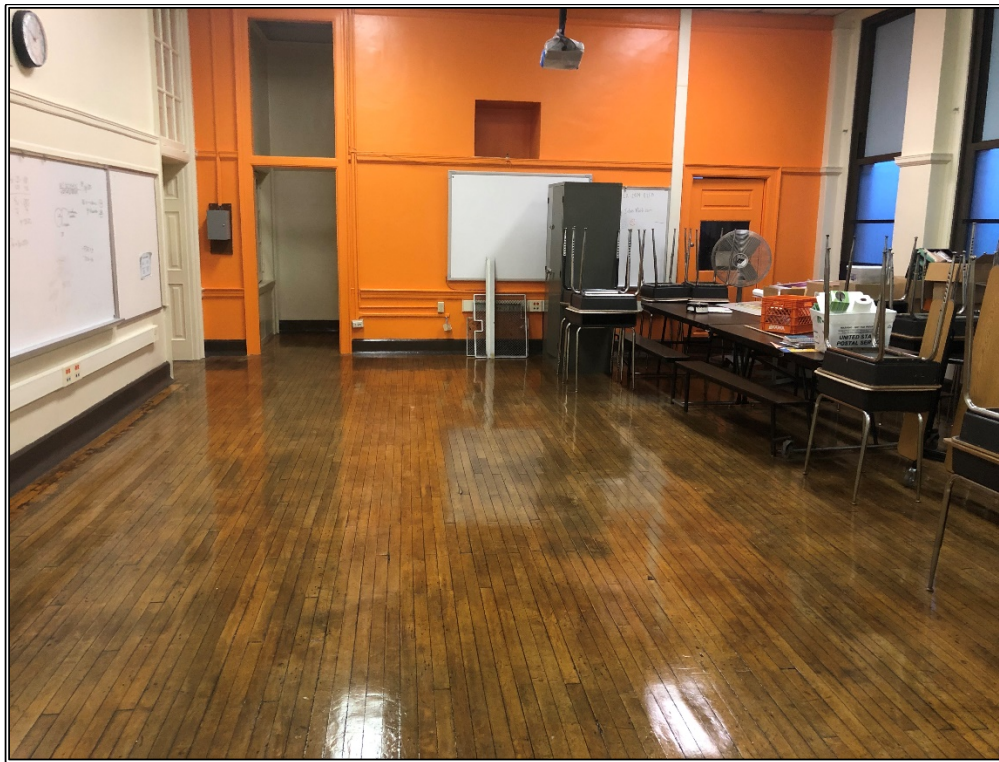
**Photos 5 & 6**

Completed Classrooms after Testing and Deep Cleaning
