Summary of Paint & Plaster Stabilization Activities

**#8390 – Aloysius Fitzpatrick Elementary
School
11061 Knights Road
Philadelphia, PA 19154**

September 11, 2019

191518

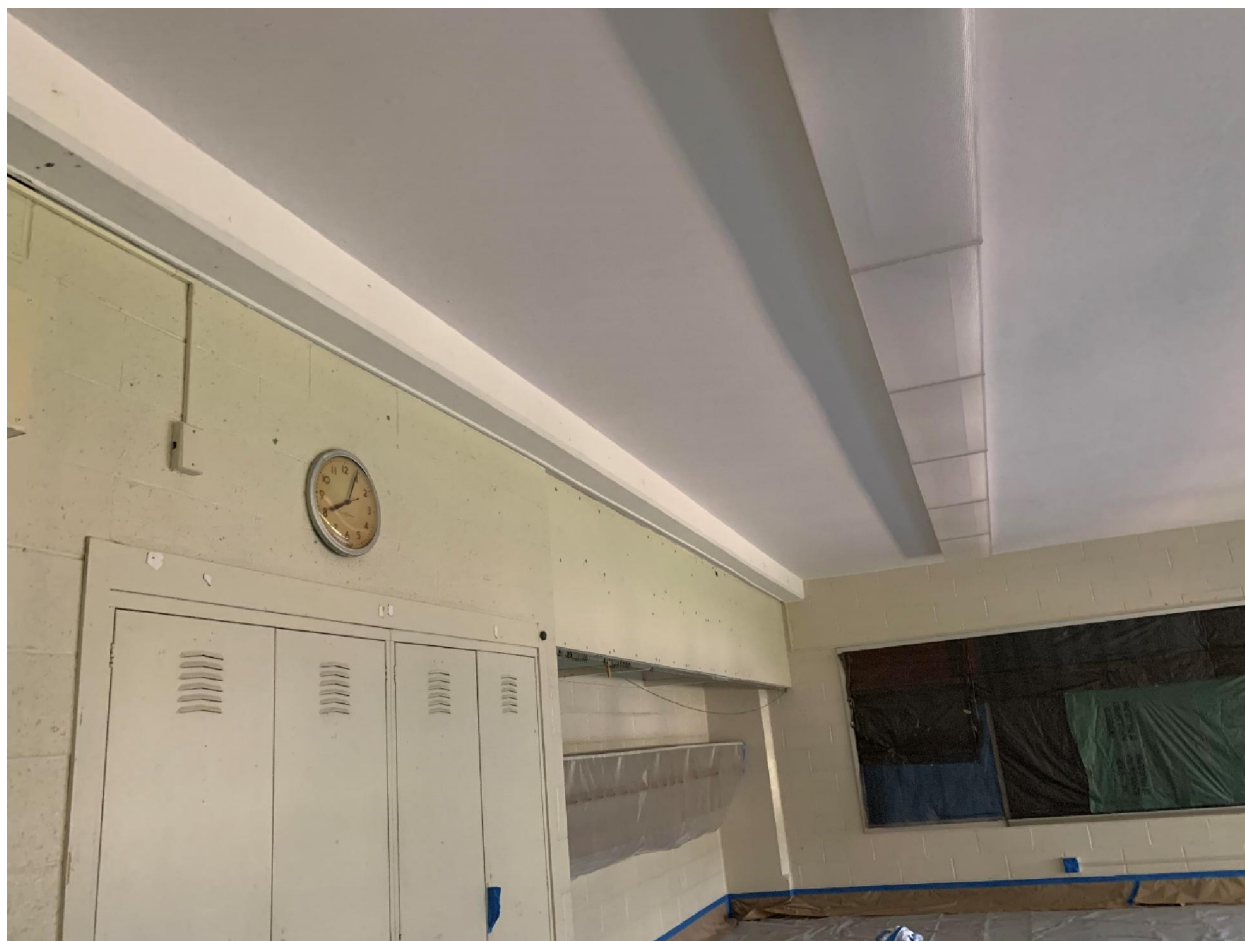
Room 110 – Post Stabilization

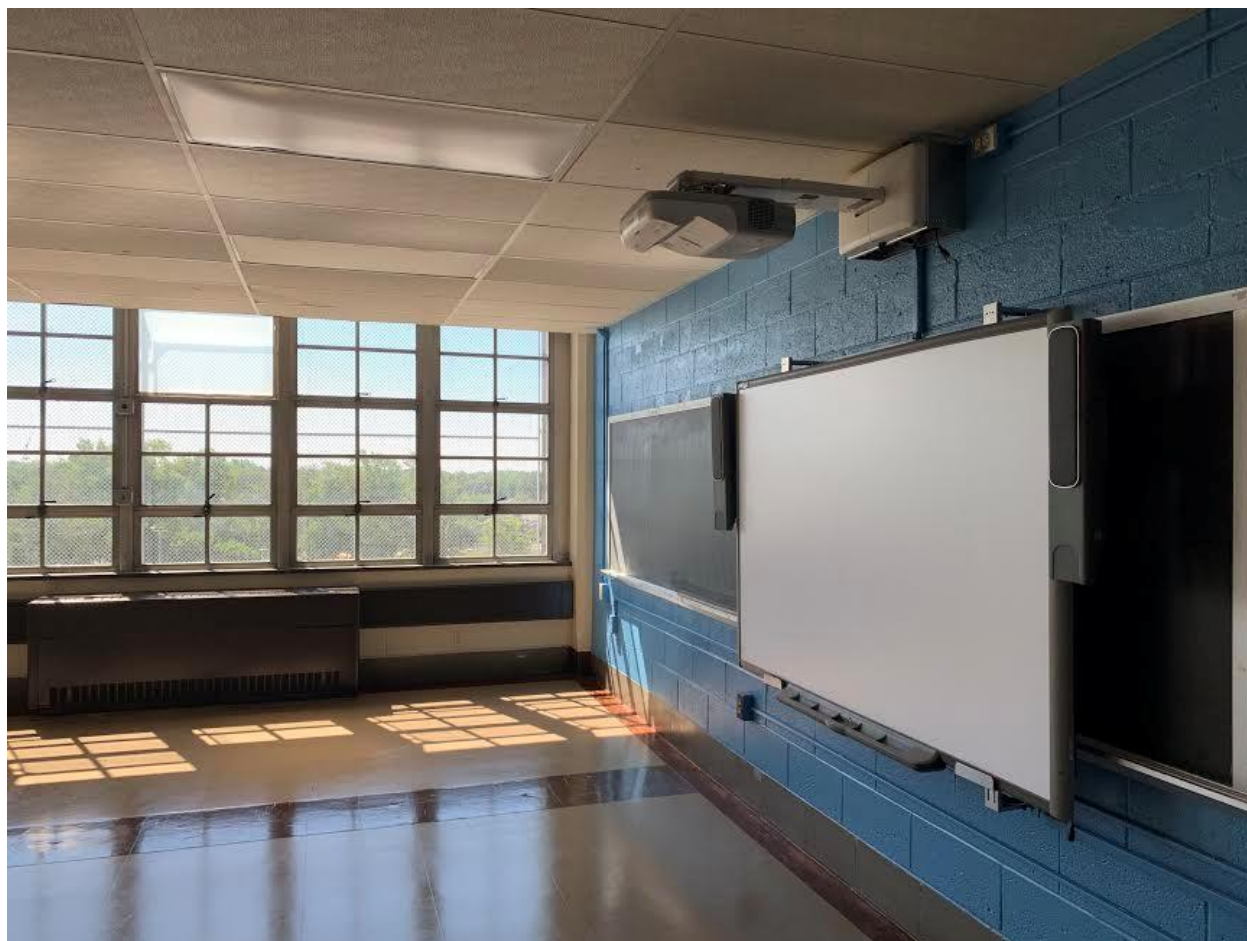
Room 218 – Post Stabilization

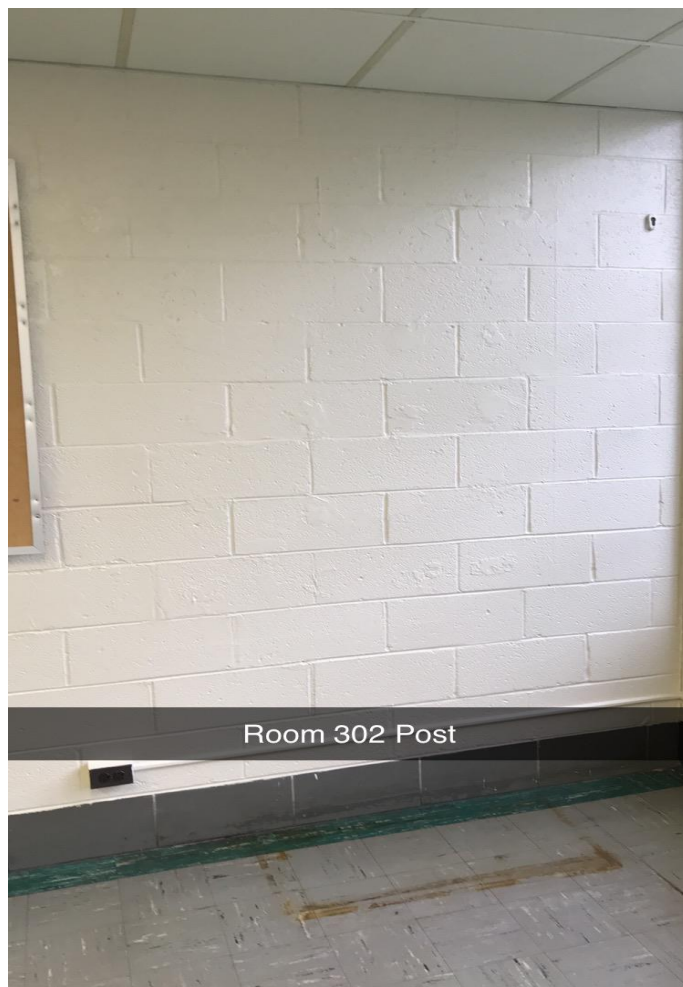
Room 302 - Post Stabilization

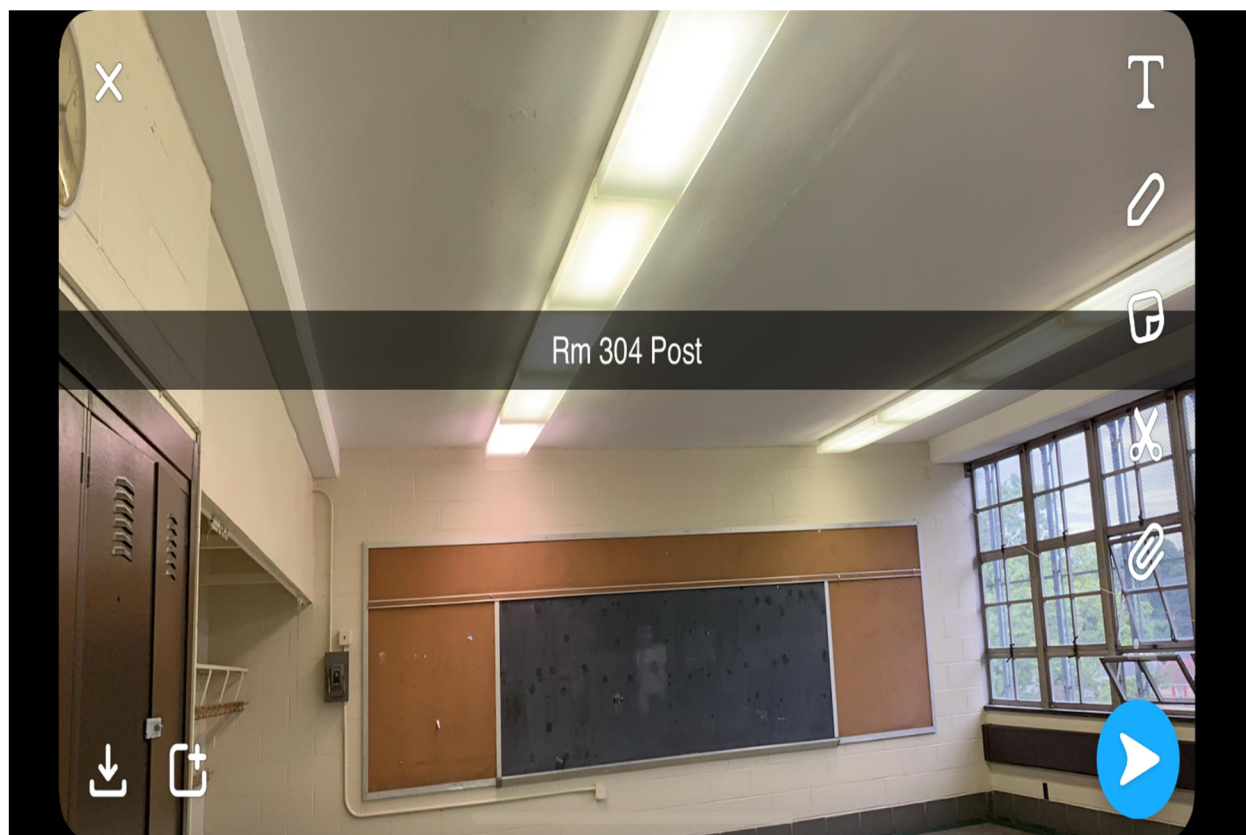
Room 304 - Post Stabilization
