PAINT AND PLASTER STABILIZATION  
GENERAL GEORGE A. McCALL ELEMENTARY SCHOOL  
325 S. 7<sup>th</sup> Street  
Philadelphia, Pennsylvania 19106  
ULCS# 2340

THE SCHOOL DISTRICT OF PHILADELPHIA  
OFFICE OF ENVIRONMENTAL MANAGEMENT  
440 North Broad Street  
3rd Floor  
Philadelphia, Pennsylvania 19130

SYNERTECH INCORPORATED  
228 Moore Street  
Philadelphia, Pennsylvania 19148  
Project # 010-4466

November 3<sup>rd</sup>, 2019

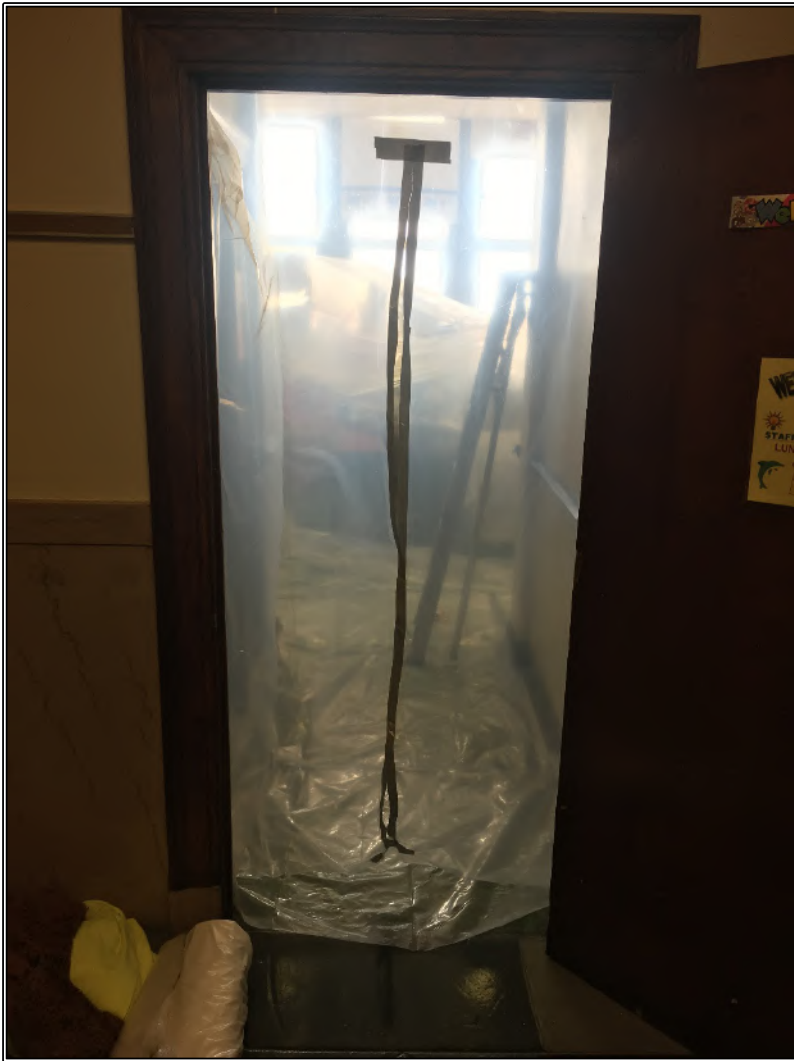
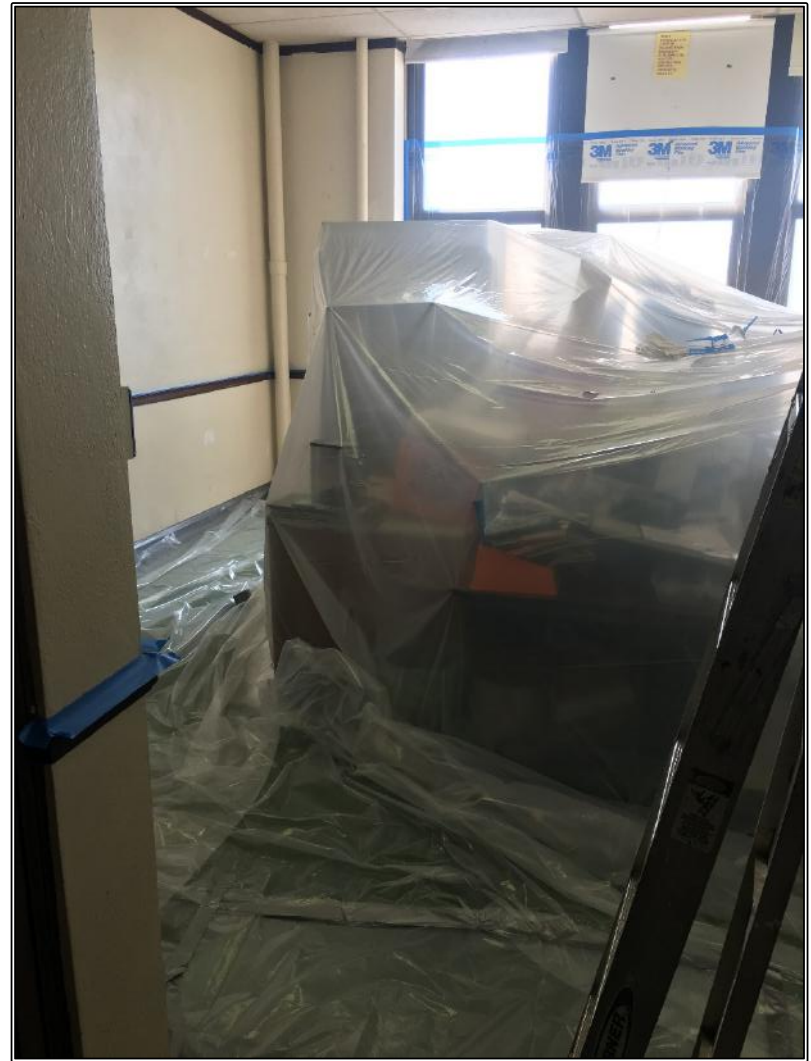
**Photos 1 & 2**  
Typical Contained Classroom Prior to Renovation

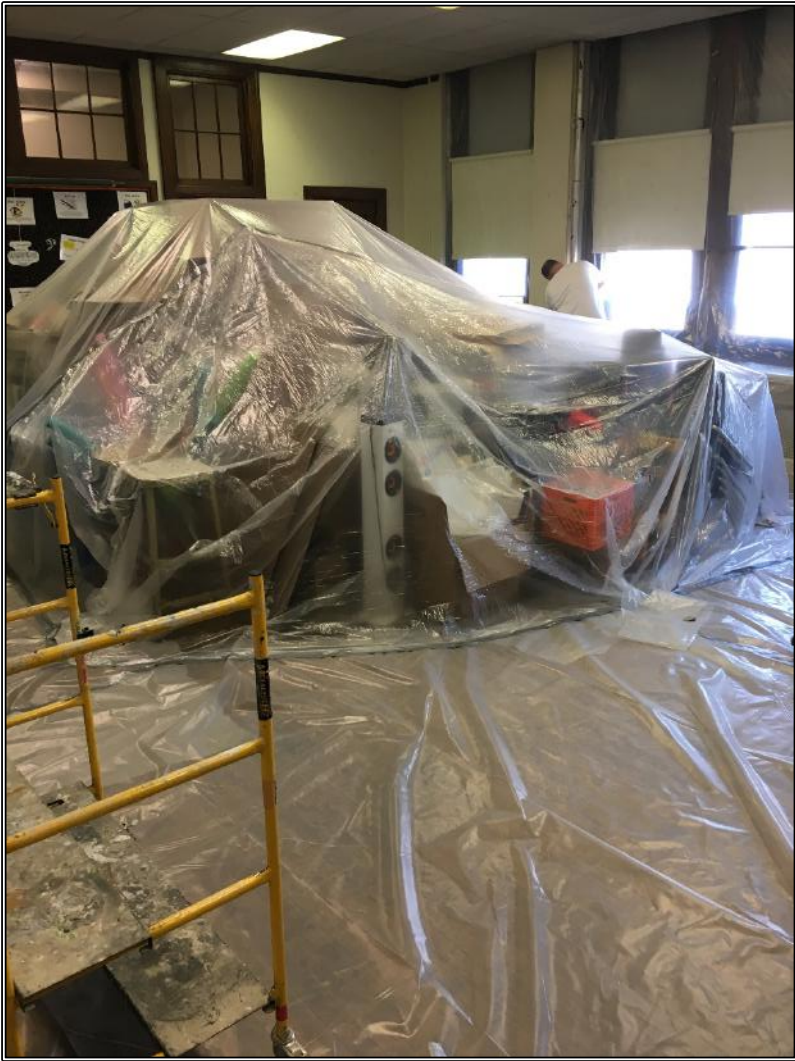
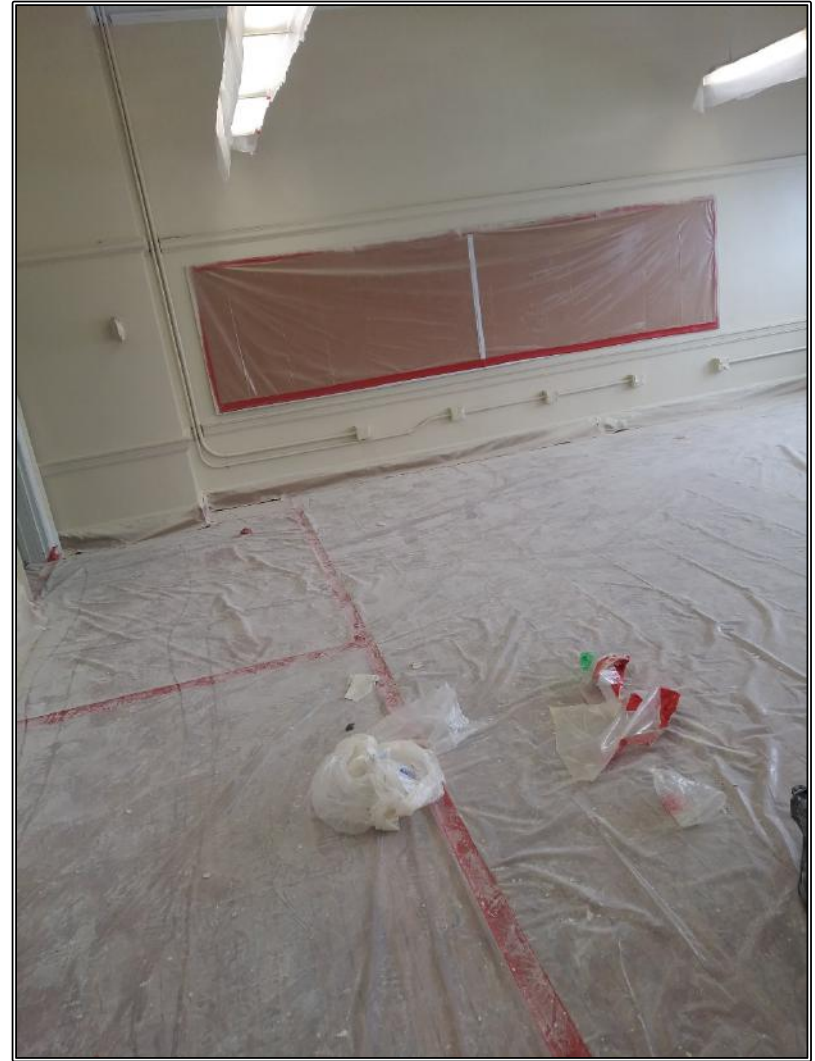
**Photos 3 & 4**  
Typical Contained Classroom During Renovation
