PAINT AND PLASTER STABILIZATION  
BACHE-MARTIN ELEMENTARY SCHOOL

801 North 22<sup>nd</sup> Street/2201 Brown Street  
Philadelphia, Pennsylvania 19130  
ULCS# 2210/2360

THE SCHOOL DISTRICT OF PHILADELPHIA  
OFFICE OF ENVIRONMENTAL MANAGEMENT

228 Moore Street  
Philadelphia, Pennsylvania 19148  
Project # 010-4469

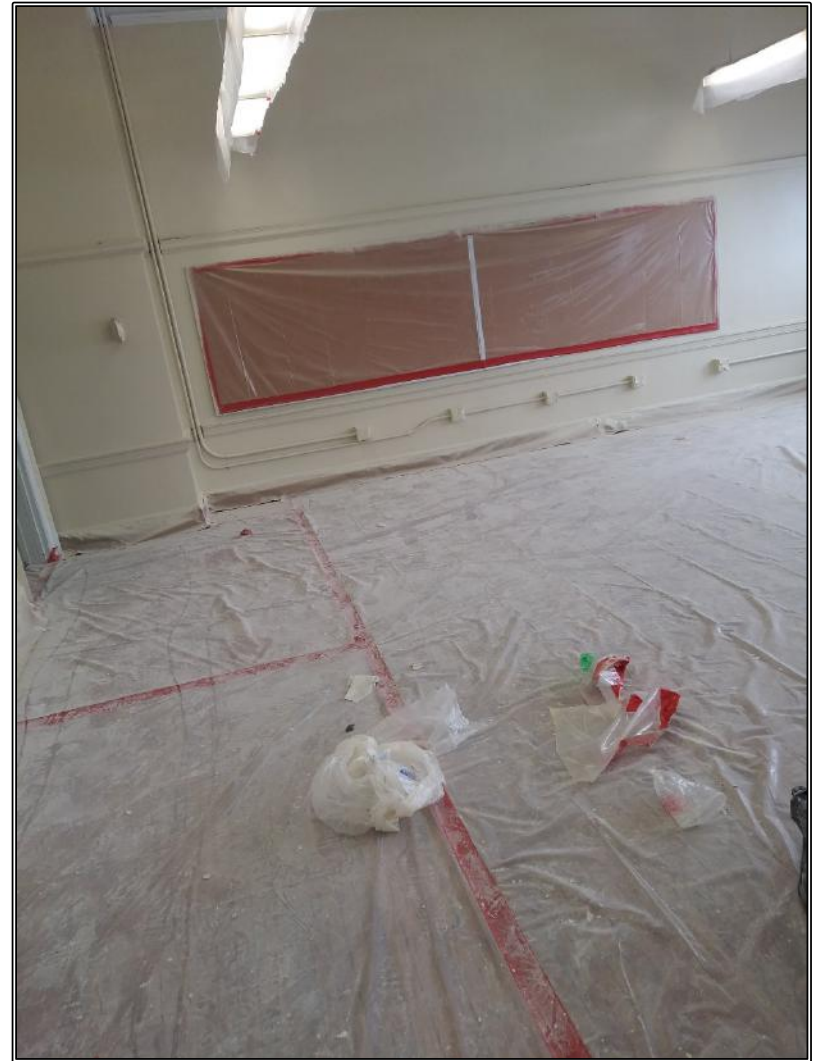
**Photos 3 & 4**  
Typical Contained Classroom During Renovation
