**Eleanor Cope Emlen Elementary School**  
6501 Chew Avenue  
Philadelphia, Pennsylvania

## **Paint and Plaster Stabilization Project Final Report**

**DECEMBER 10, 2018**

**VERTEX Project No: 48596**

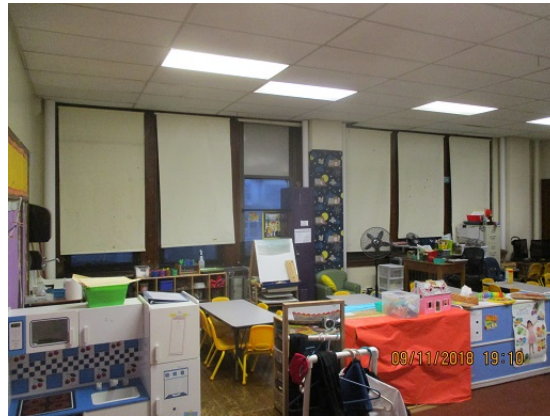
**Classroom 101 after  
stabilization**

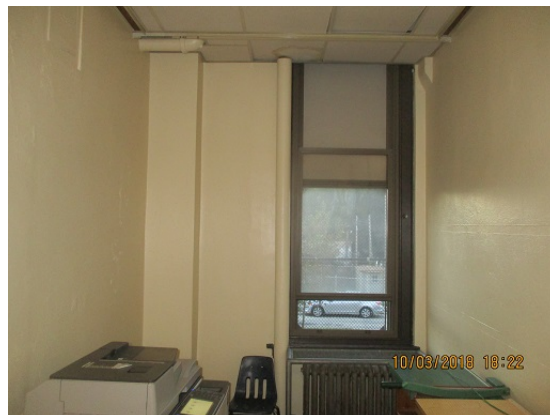
**Photograph: 2**

**Copy Room 101A after  
stabilization**

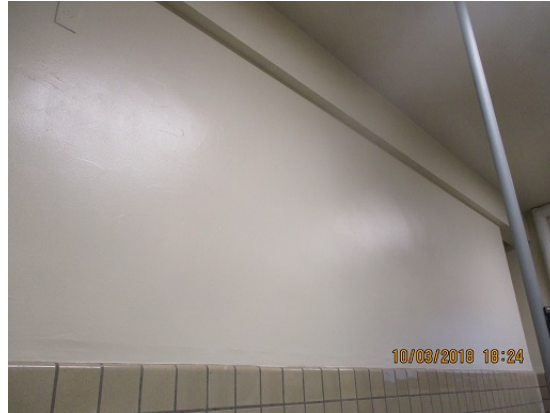
**Girl's Restroom after stabilization**

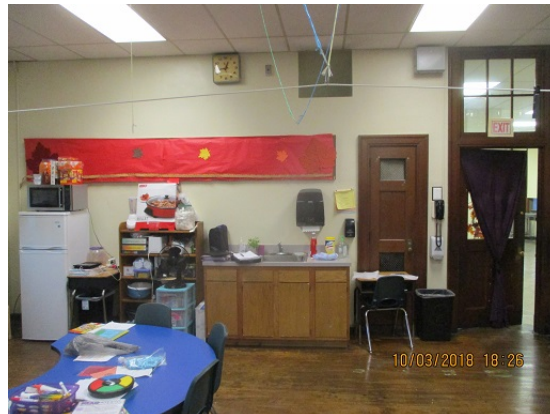
**Photograph: 4**

**Classroom 102 after stabilization**

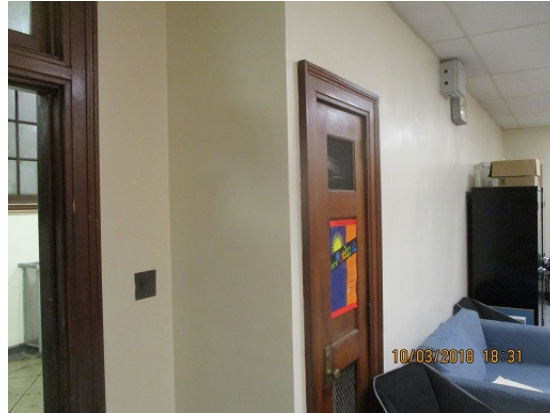
**Counselor's Suite 105  
after stabilization**

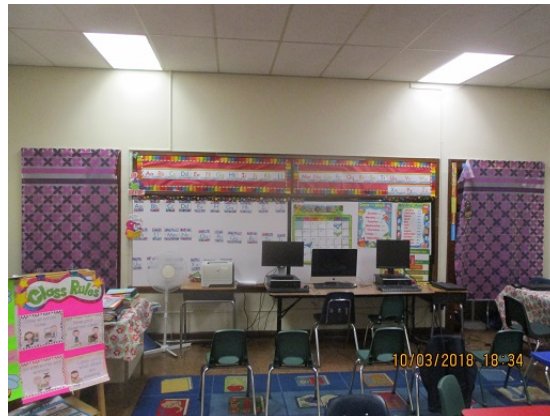
**Photograph: 6**

**Classroom 106 after  
stabilization**

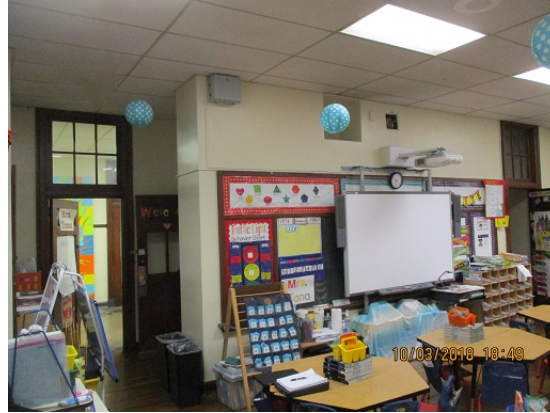
**Photographic Documentation****Paint and Plaster Stabilization Project  
Emlen Elementary School  
6501 Chew Avenue  
VERTEX Project No. 48596****Photograph: 9****Description:****Classroom 108 after  
stabilization**

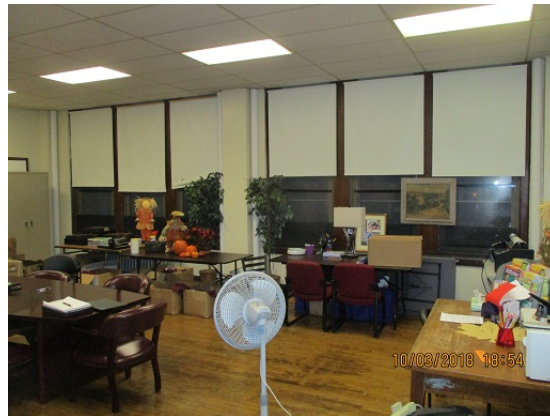
**Photograph: 10****Description:****Conference Room 110  
after stabilization**
