PAINT AND PLASTER STABILIZATION A.S. JENKS ELEMENTARY SCHOOL 2501 South 13<sup>th</sup> Street Philadelphia, Pennsylvania 19148

# THE SCHOOL DISTRICT OF PHILADELPHIA OFFICE OF ENVIRONMENTAL MANAGEMENT 440 North Broad Street 3rd Floor Philadelphia, Pennsylvania 19130

## SYNERTECH INCORPORATED 228 Moore Street Philadelphia, Pennsylvania 19148 Project # 010-4313

January 8, 2019

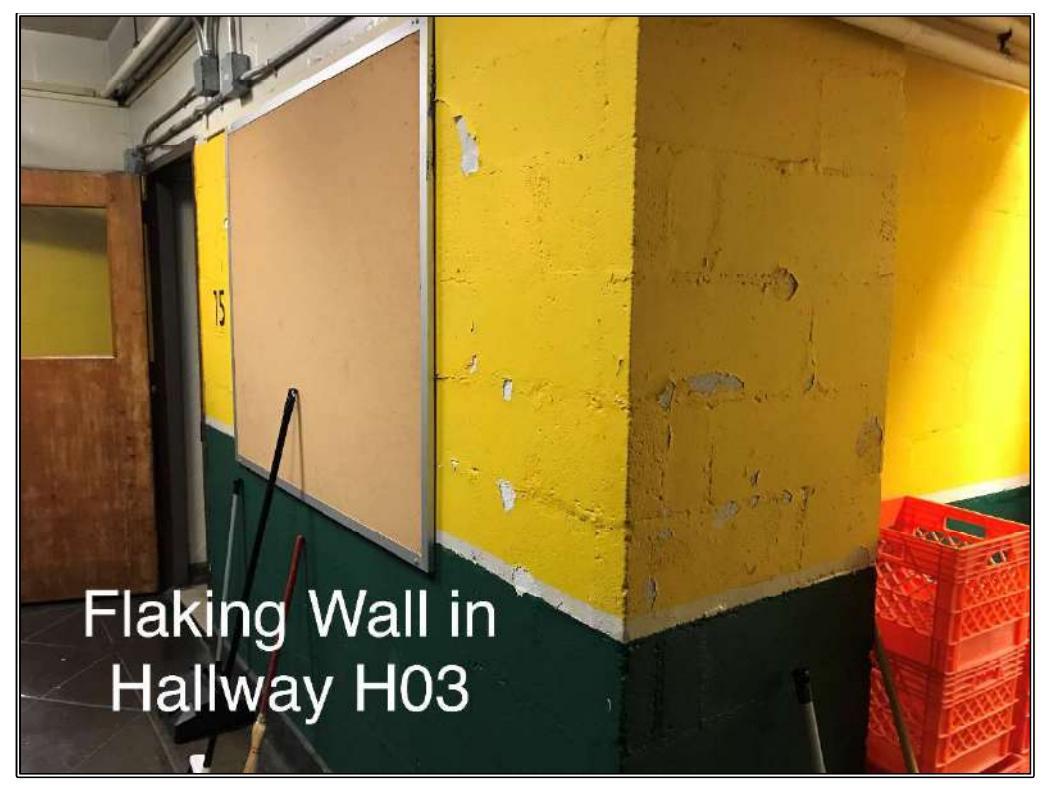
Photo 1: Flaking Paint in Basement Hallway Prior to Stabilization

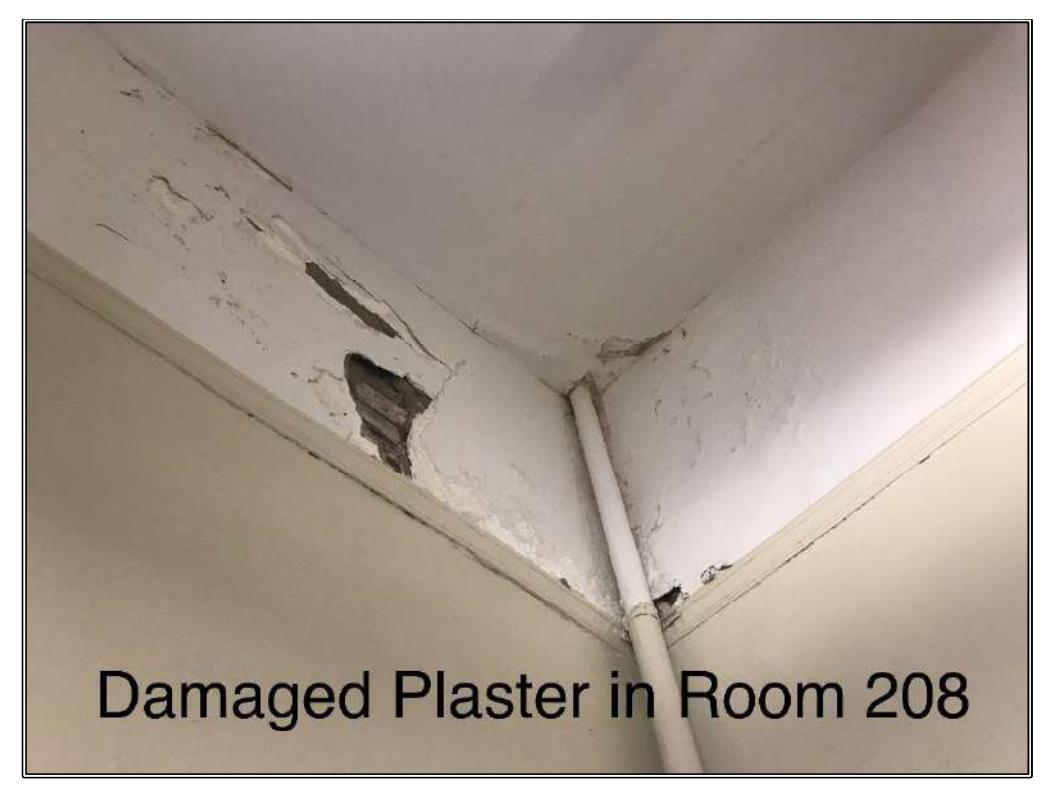
Photo 2: Plaster Damage Prior to Stabilization

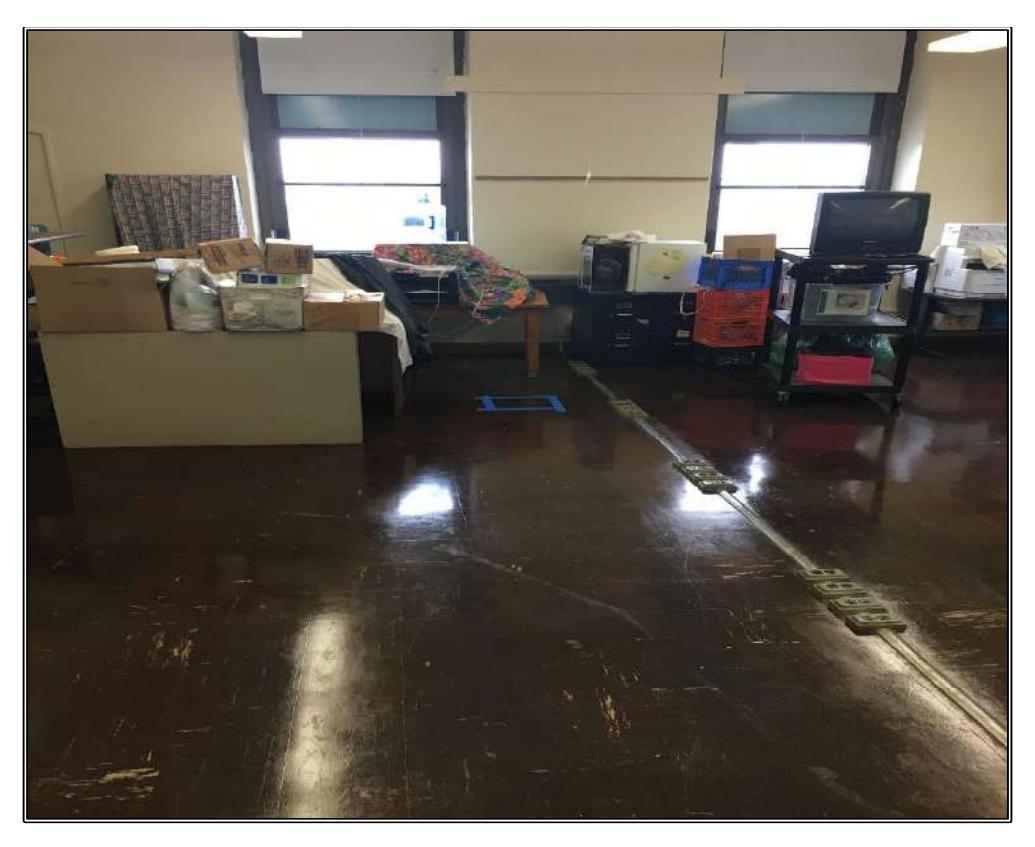
Photo 5: Stabilized Classroom Prior to Testing
