Facility Condition Assessment Summary Report

Longstreth School

School District of Philadelphia
S135001; Longstreth
Final
Site Assessment Report
January 30, 2017

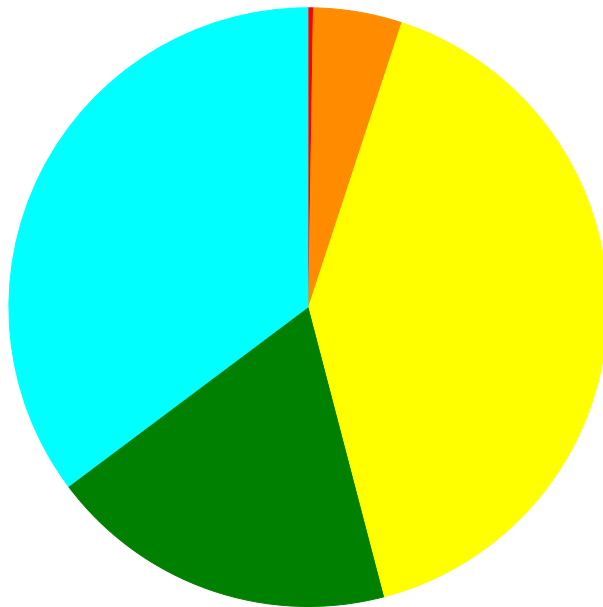
Deficiencies By Priority

- 1 - Response Time (< 2 yr) - \$8,792.10
- 2 - Response Time (2-3 yrs) - \$165,169.56
- 3 - Response Time (3-4 yrs) - \$1,411,408.30
- 4 - Response Time (4-5 yrs) - \$649,996.75
- 5 - Response Time (> 5 yrs) - \$1,215,964.37

Budget Estimate Total: \$3,451,331.08

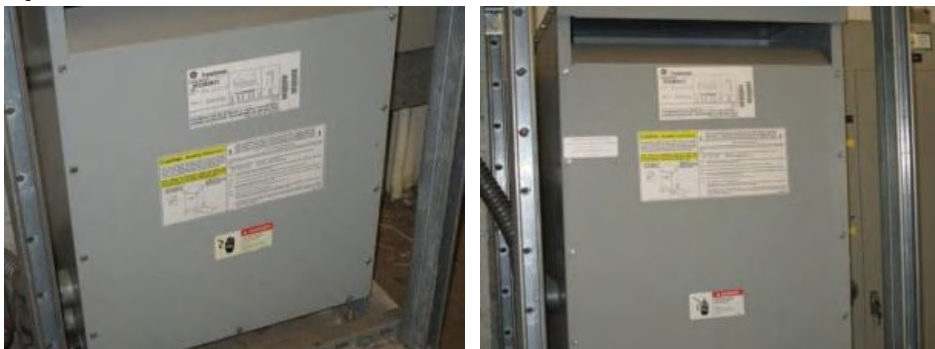
System: D5010 - Electrical Service/Distribution

Note: Step-down transformer 30KVA 480V-120/208V

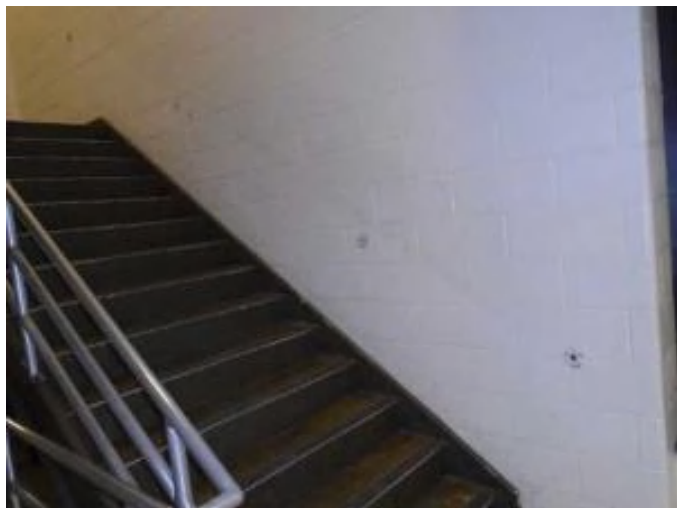
System: C2010 - Stair Construction

Location: Stairs

Distress: Building / MEP Codes

Notes: Replace stair railing to comply with building codes

Correction: Replace inadequate or install proper stair railing
- select appropriate material

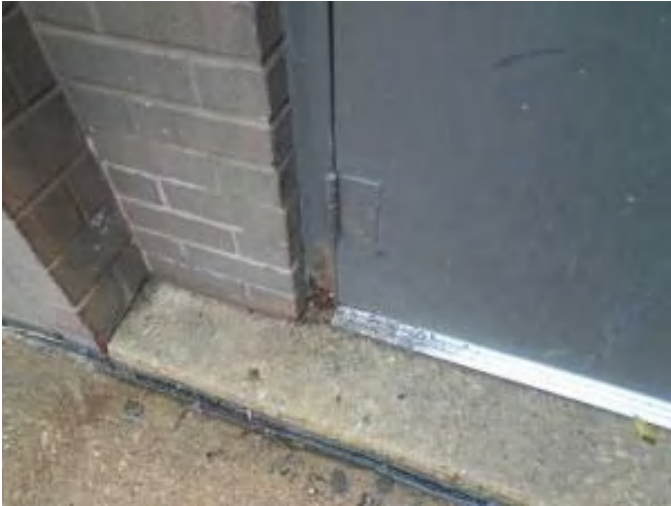
System: B2030 - Exterior Doors

Location: Various entrances

Distress: Failing

Notes: Replace exterior doors – beyond service life, rusted and failing

Correction: Remove and replace exterior doors - per leaf

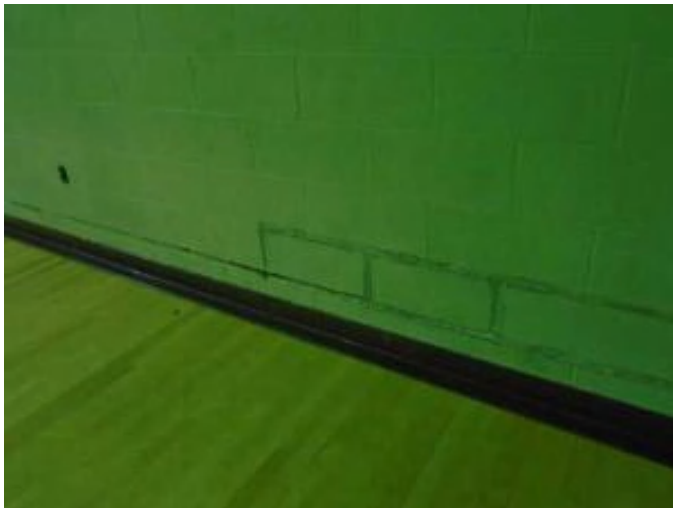
System: C3010230 - Paint & Covering

Location: Various

Distress: Damaged

Notes: Repair CMU partition walls – structural cracks developing

Correction: Repair substrate and repaint interior concrete or CMU walls - SF of wall surface

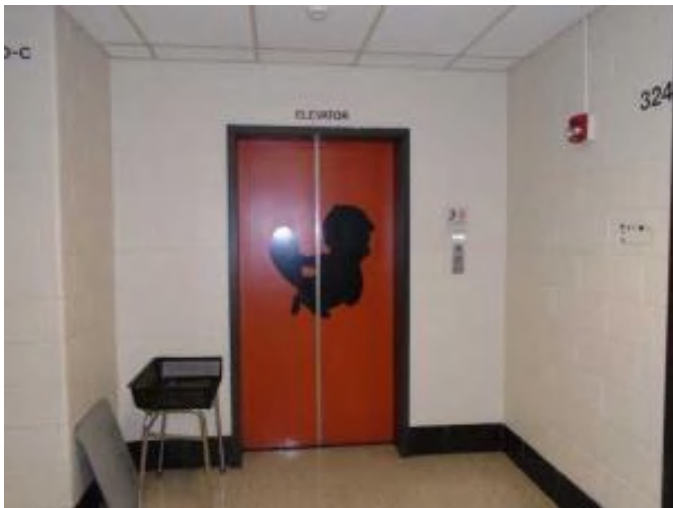
System: D1010 - Elevators and Lifts

Location: Elevator

Distress: Accessibility

Notes: Updated elevator – call buttons and cabin panel not code compliant

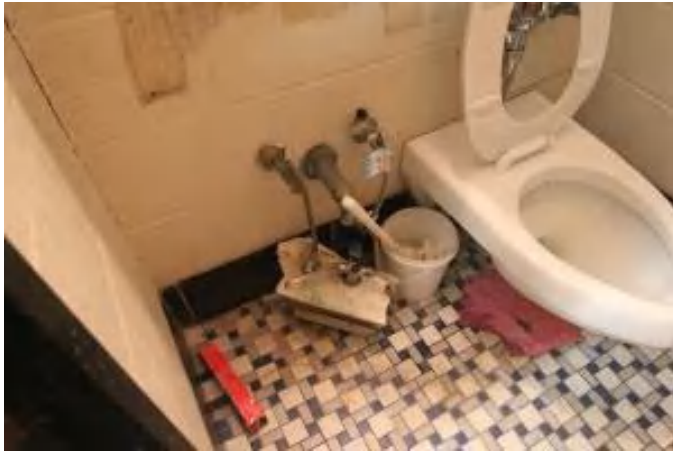
System: D2010 - Plumbing Fixtures

Location: Toilet room

Distress: Damaged

Notes: Replace broken lavatory in engineer's toilet room

Correction: Remove and replace or replace lavatory - quantify accessible if required

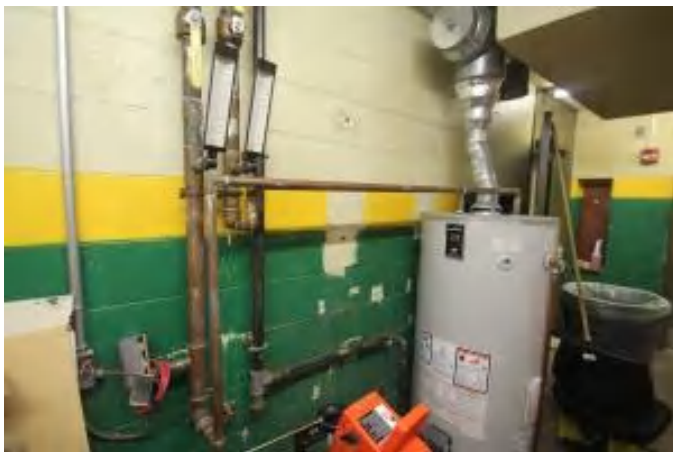
System: D2020 - Domestic Water Distribution

Location: Mechanical room

Distress: Building / MEP Codes

Notes: Install expansion tank and circulation pump for domestic hot water

Correction: Replace domestic water circulation pump (to 1 HP)

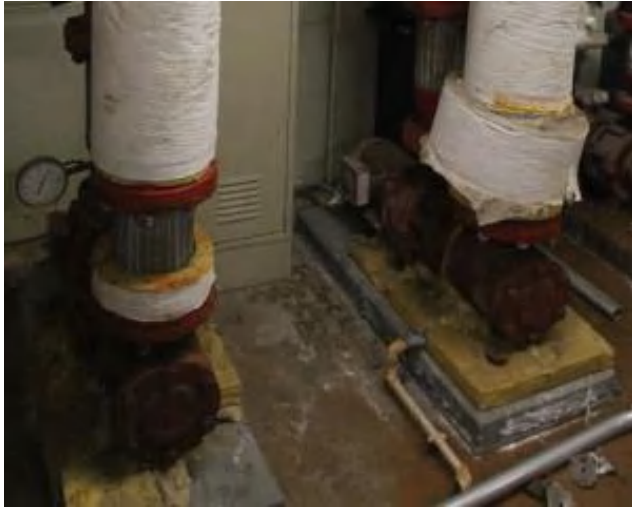
System: D3040 - Distribution Systems

Location: Boiler room
Distress: Maintenance Required
Category: 3 - Operations / Maint.
Priority: 2 - Response Time (2-3 yrs)
Correction: Replace hydronic distribution piping insulation - 100 LF of piping
Qty: 30.00
Unit of Measure: L.F.
Estimate: \$1,047.45
Assessor Name: James Sullivan
Date Created: 12/29/2015

Notes: Repair boiler room chilled water piping insulation, approx. 15 linear ft., to prevent condensation and rust

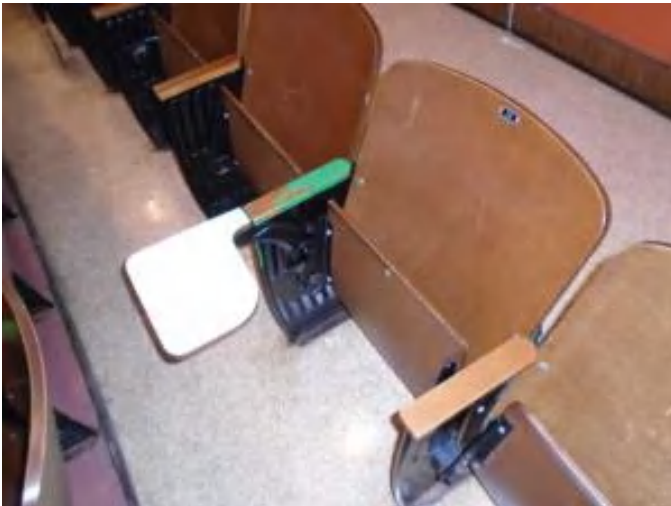
System: E2010 - Fixed Furnishings

Location: Auditorium
Distress: Damaged
Category: 3 - Operations / Maint.
Priority: 2 - Response Time (2-3 yrs)
Correction: Replace auditorium seating - add tablet arms if required. Veneer seating is an option.
Qty: 5.00
Unit of Measure: Ea.
Estimate: \$4,827.31
Assessor Name: James Sullivan
Date Created: 11/10/2015

Notes: Repair or replace auditorium seats – 2% damaged or missing

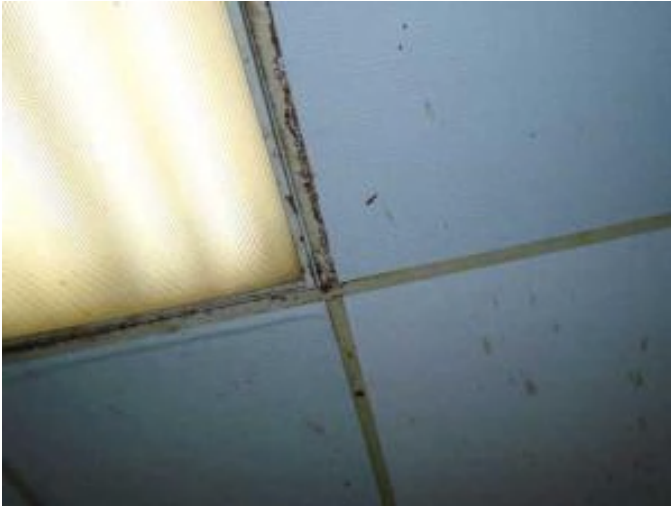
System: C3030 - Ceiling Finishes

Location: Throughout

Distress: Beyond Service Life

Notes: Replace suspended acoustic tile ceiling system – beyond service life (90% of suspended ceiling)

Correction: Remove and replace suspended acoustic ceilings - lighting not included

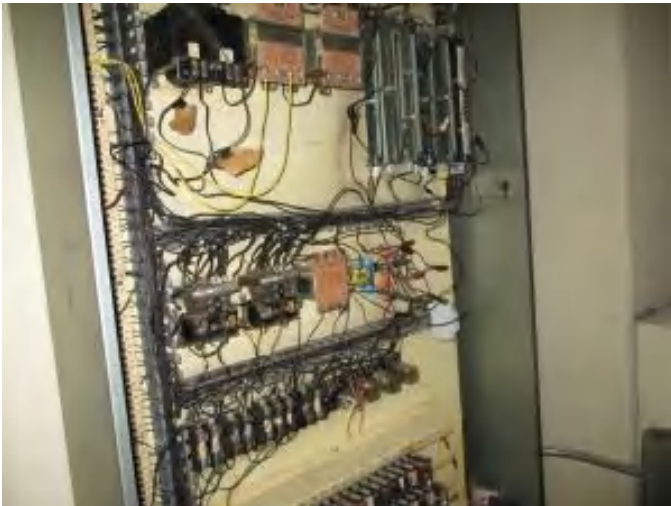
System: D1010 - Elevators and Lifts

Location: Basement Elevator Machine Room

Distress: Obsolete

Notes: Provide a new elevator controller

Correction: Replace elevator motor and controller

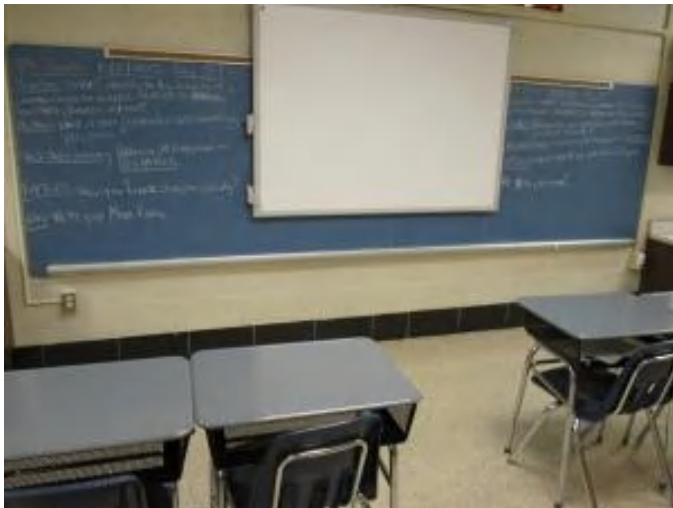
System: D5020 - Lighting and Branch Wiring

Location: Entire Building
Distress: Inadequate
Category: 4 - Capital Improvement
Priority: 3 - Response Time (3-4 yrs)
Correction: Add wiring device
Qty: 96.00
Unit of Measure: Ea.
Estimate: \$35,267.62
Assessor Name: James Sullivan
Date Created: 12/21/2015

Notes: Provide (2)25FT of surface raceways with 24" receptacles on center and two-duplex wall mount receptacles. Approximate 96

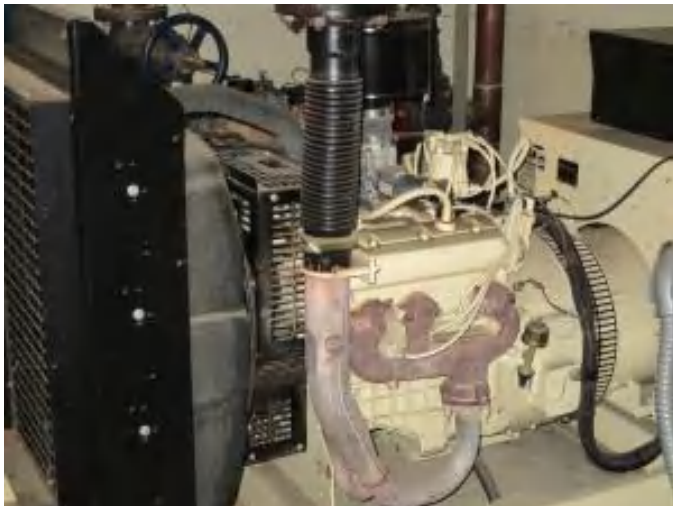
System: D5090 - Other Electrical Systems

Location: Outdoor
Distress: Inadequate
Category: 4 - Capital Improvement
Priority: 3 - Response Time (3-4 yrs)
Correction: Add Standby Generator System
Qty: 1.00
Unit of Measure: Ea.
Estimate: \$202,163.13
Assessor Name: James Sullivan
Date Created: 12/21/2015

Notes: Provide 90KW, outdoor, diesel powered generator.

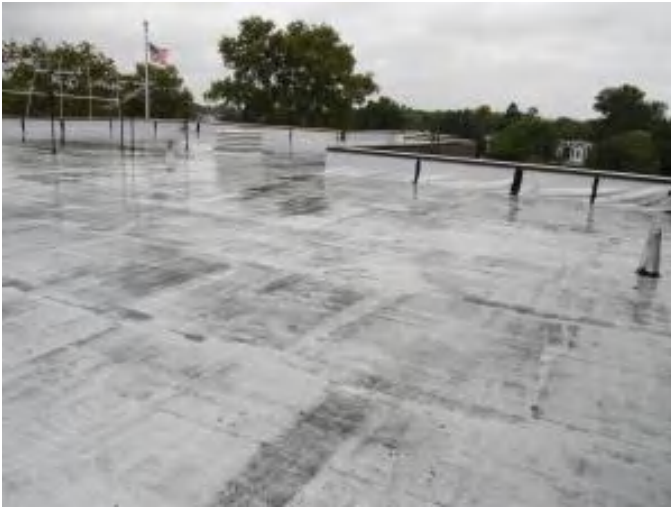
System: D5090 - Other Electrical Systems

Location: Roof
Distress: Building / MEP Codes
Category: 2 - Code Compliance
Priority: 3 - Response Time (3-4 yrs)
Correction: Repair Lightning Protection System
Qty: 1.00
Unit of Measure: Job
Estimate: \$24,249.82
Assessor Name: James Sullivan
Date Created: 12/21/2015

Notes: Prepare a study to determine if the school building requires lightning protection system.

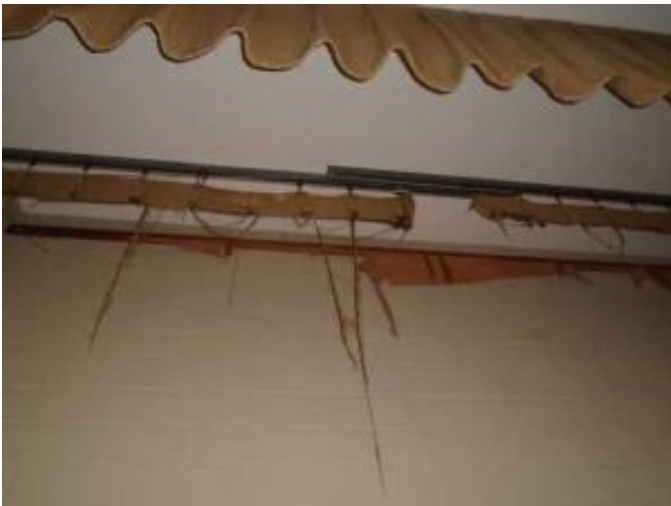
System: E2010 - Fixed Furnishings

Location: Stage
Distress: Damaged
Category: 3 - Operations / Maint.
Priority: 3 - Response Time (3-4 yrs)
Correction: Remove and replace stage curtain - insert the LF of track and SF of curtain
Qty: 1.00
Unit of Measure: Ea.
Estimate: \$11,189.10
Assessor Name: James Sullivan
Date Created: 11/10/2015

Notes: Replace stage curtains – torn/damaged

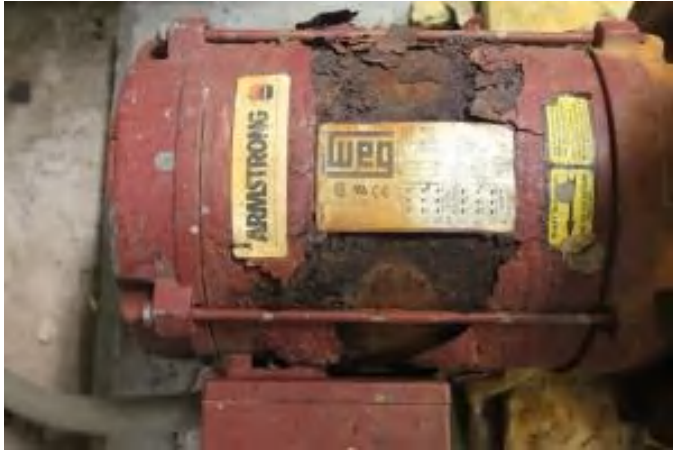
System: D3030 - Cooling Generating Systems

Location: Boiler room

Distress: Failing

Notes: Replace 5 HP chilled water pump motor due to excessive rust on motor case

Correction: Replace base mounted, end suction CHW pump (3" size, 5 HP, to 225 GPM)

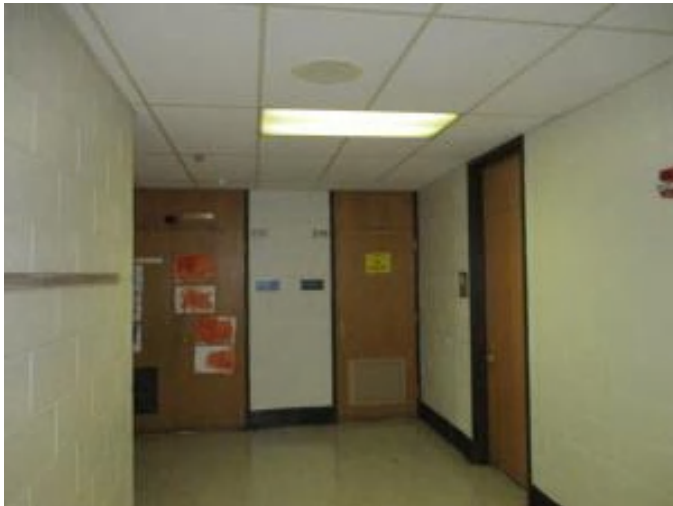
System: D5020 - Lighting and Branch Wiring

Location: Entire Building

Distress: Obsolete

Notes: Replace 30% of the existing lighting fixtures with fluorescent fixtures with T8 lamps. Approximate 340 fixtures

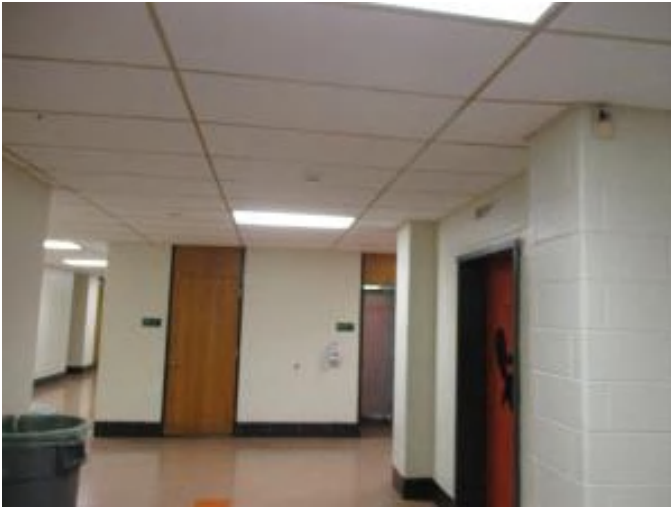
System: D5030 - Communications and Security

Location: Entire Building
Distress: Security Issue
Category: 1 - Health & Safety
Priority: 4 - Response Time (4-5 yrs)
Correction: Add/Replace Video Surveillance System
Qty: 30.00
Unit of Measure: Ea.
Estimate: \$118,216.45
Assessor Name: James Sullivan
Date Created: 12/21/2015

Notes: Provide surveillance CCTV cameras to provide a complete coverage of the school building interior. Approximate 30 surveillance CCTV cameras

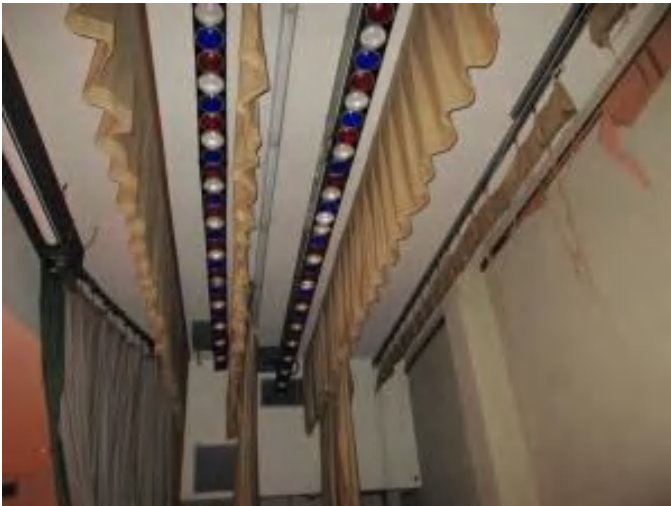
System: E1020 - Institutional Equipment

Location: Auditorium
Distress: Inadequate
Category: 4 - Capital Improvement
Priority: 4 - Response Time (4-5 yrs)
Correction: Add/Replace Stage Theatrical Lighting System
Qty: 1.00
Unit of Measure: Ea.
Estimate: \$293,594.70
Assessor Name: James Sullivan
Date Created: 12/21/2015

Notes: Provide theatrical lighting and dimming system.

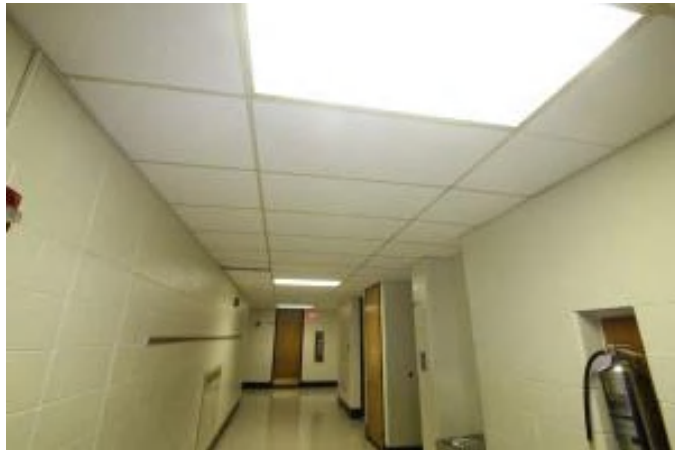
System: D4010 - Sprinklers

Location: Entire building

Distress: Life Safety / NFPA / PFD

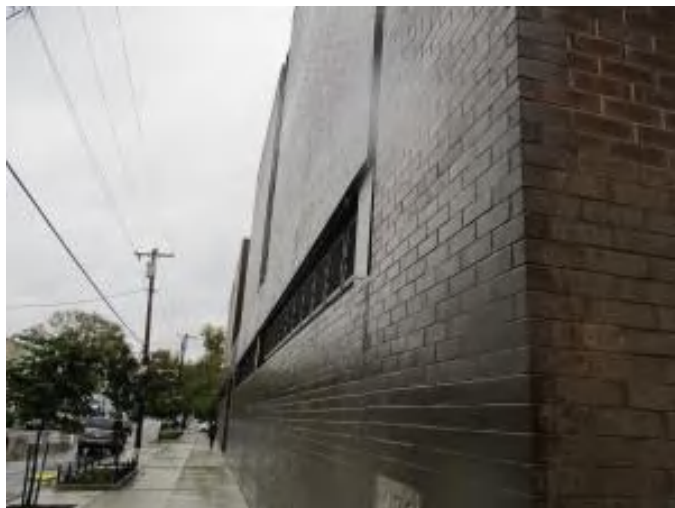
System: G4030 - Site Communications & Security

Location: Building Perimeter

Distress: Security Issue
