# Elkin Elementary School

# Major Mechanical Replacement Project Scope Determination Report

August 27, 2019

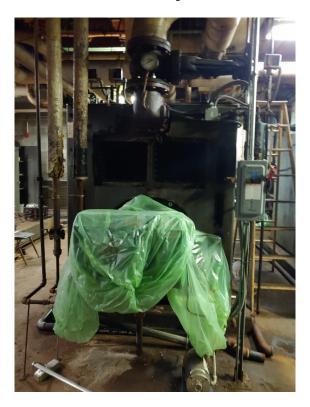
Photo No. 3 – Existing Boiler No. 1

- 4. Two Weil-McLain, cast iron sectional, model 94 with 5,230 MBH (156) HP net capacity. Boilers provide steam for heating the entire building. They are equipped with recently installed Power Flame oil and natural gas burners. When the building is in heating mode the steam is routed to a shell and tube heat exchanger that heats the building water. Combustion air makeup is supplied by louvers equipped with motorized dampers. Cast iron sectional boilers have an anticipated service life of 35 years or more; as these units have been in service 40 years they need to be replaced. The boiler feed tank is installed in the boiler room, It is beyond its useful service life, shows signs of damage from rust, and needs to be replaced. A chemical feed tank is located next to the boiler feed tank and treats the boiler feed water.

- 3. The new basement boiler room upgrade shall consist of the following new mechanical work:
  - a. Furnish and install 2 new (skid mounted, if possible) net 5230 MBTUH condensing boilers (dual fuel capability) with VFD pumps, hydraulic separator, PRV, control panel and all necessary piping appurtenances to properly heat the 3 story 53,200 sf school building.

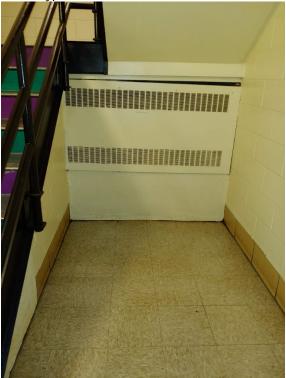
Photo No. 10 – A typical recessed radiator located in the corridor area.

- 11. Unit ventilators and fin tube radiators provide heating and cooling for the majority of classrooms, offices, and indirectly to the hallways. The unit ventilators and radiators are original to the building and beyond their service life.
