Summary of Paint & Plaster Stabilization Activities

**#2590– Nebinger Elementary School
601 Carpenter Street
Philadelphia, PA 19147**

**Criterion Laboratories, Inc.
January 8, 2019**

**Project Number: 180847
Project Dates: April 9, 2018 – July 5, 2018**

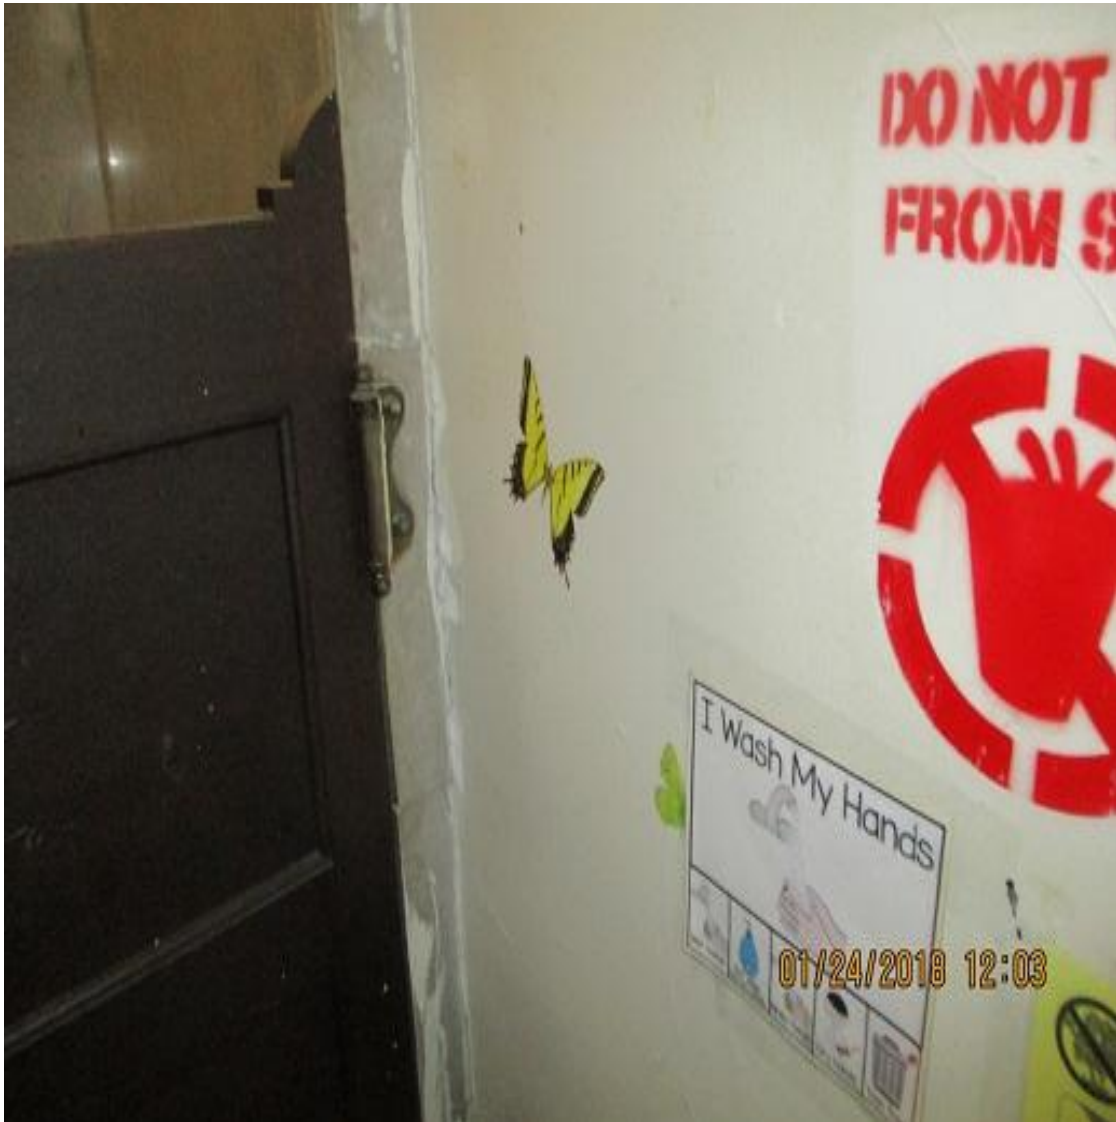
Prior to stabilization.

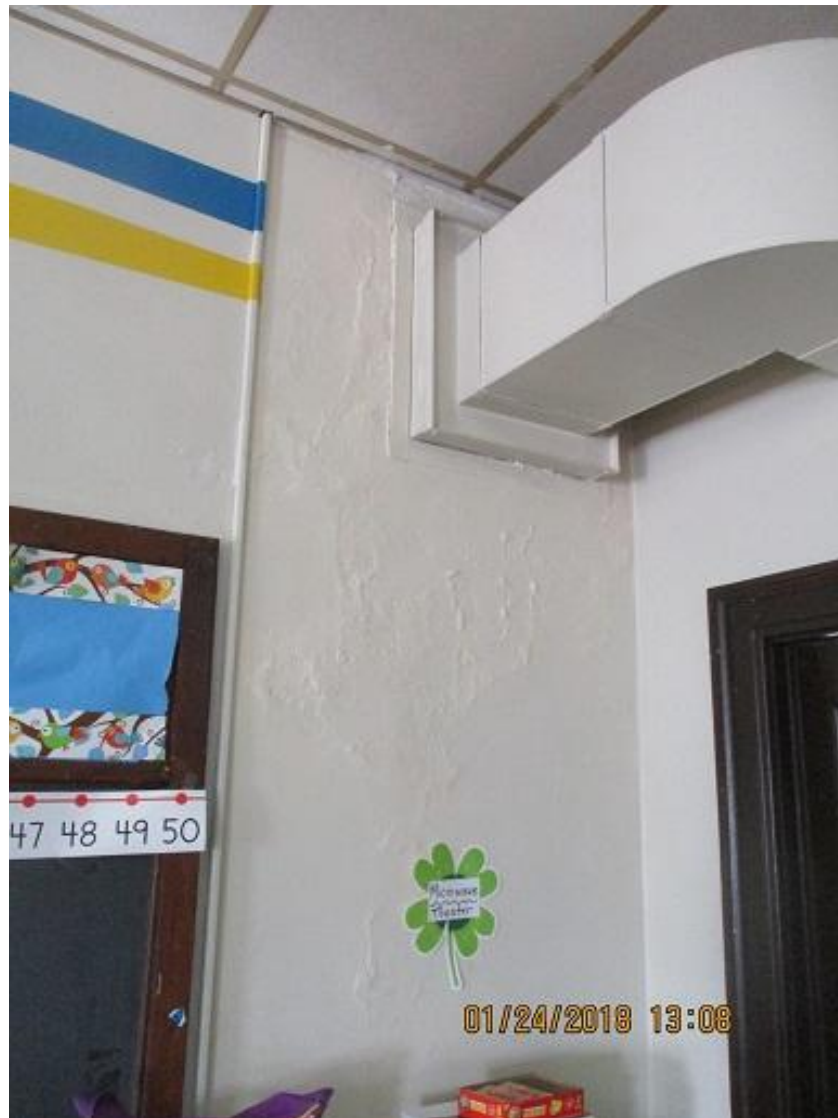
Prior to stabilization.

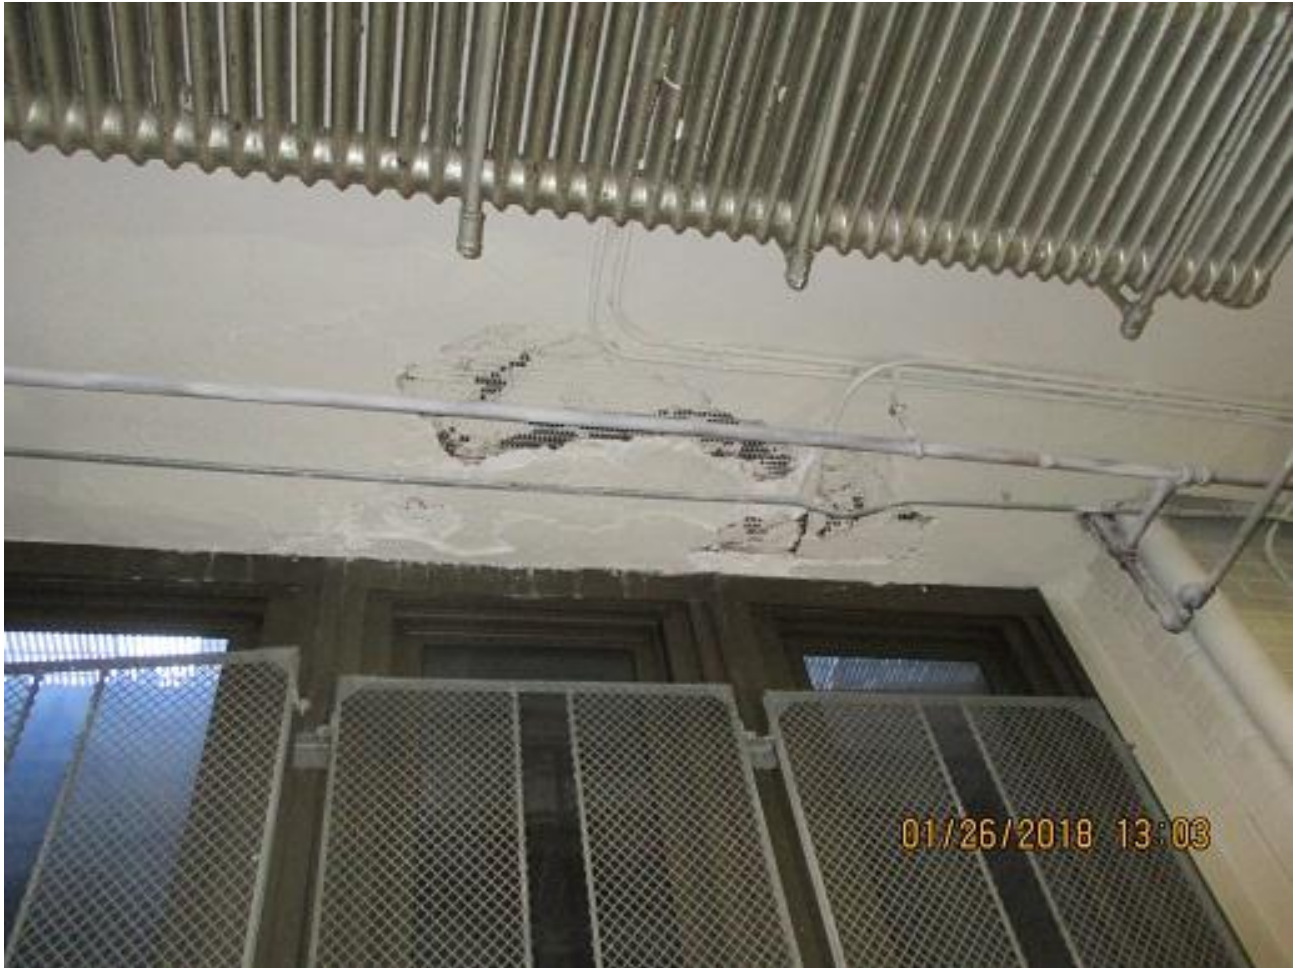
Prior to stabilization.

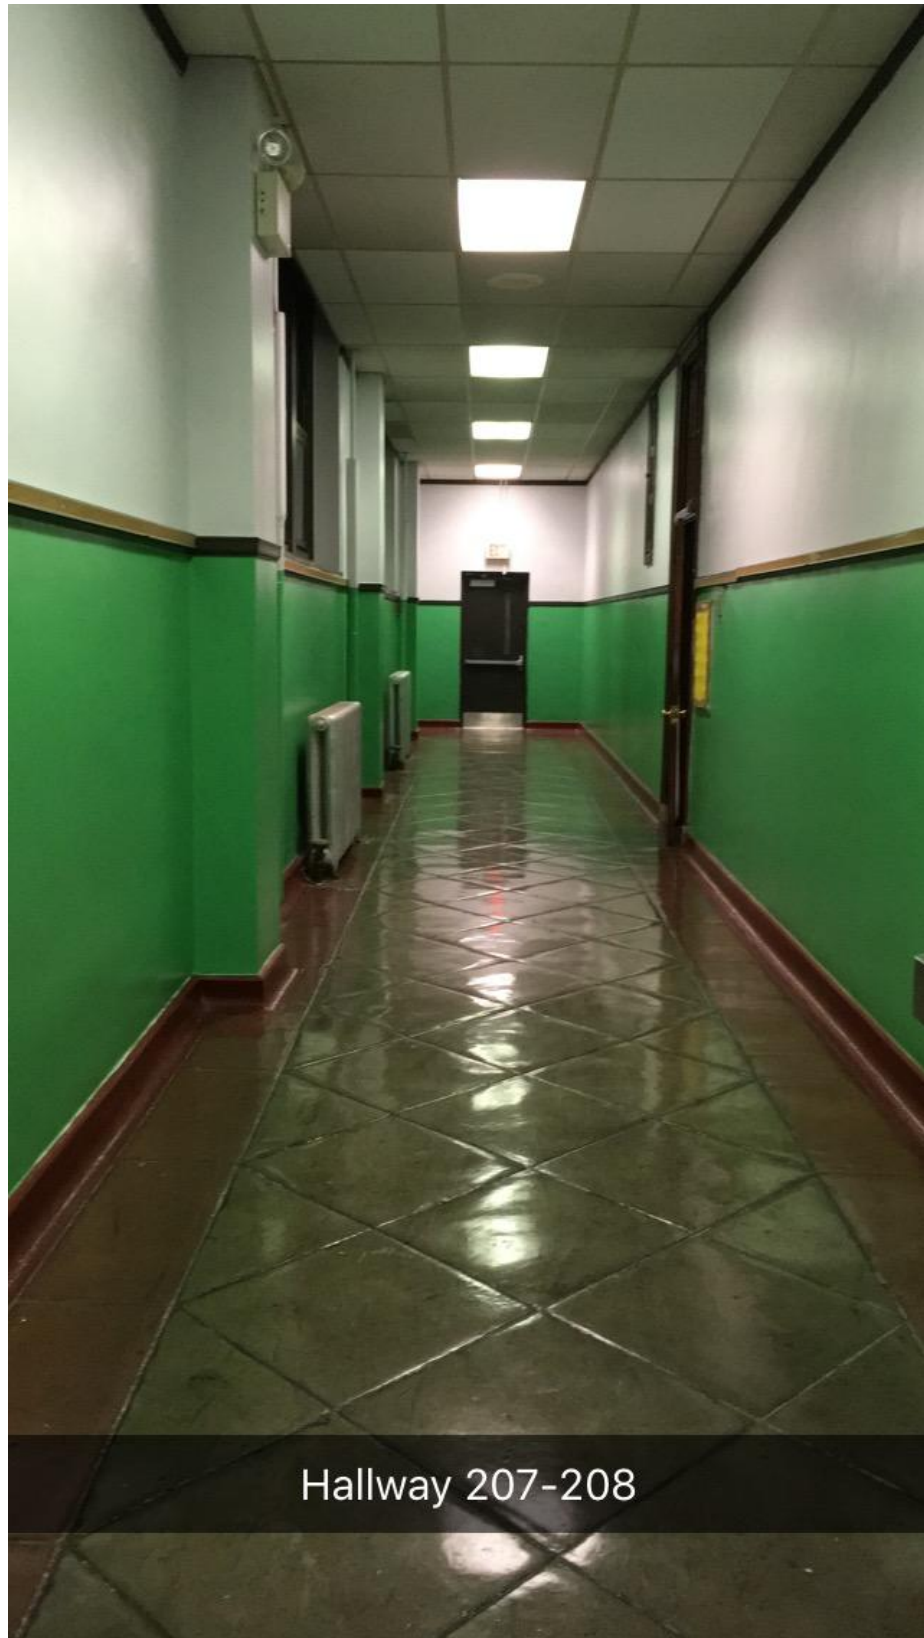
Following stabilization

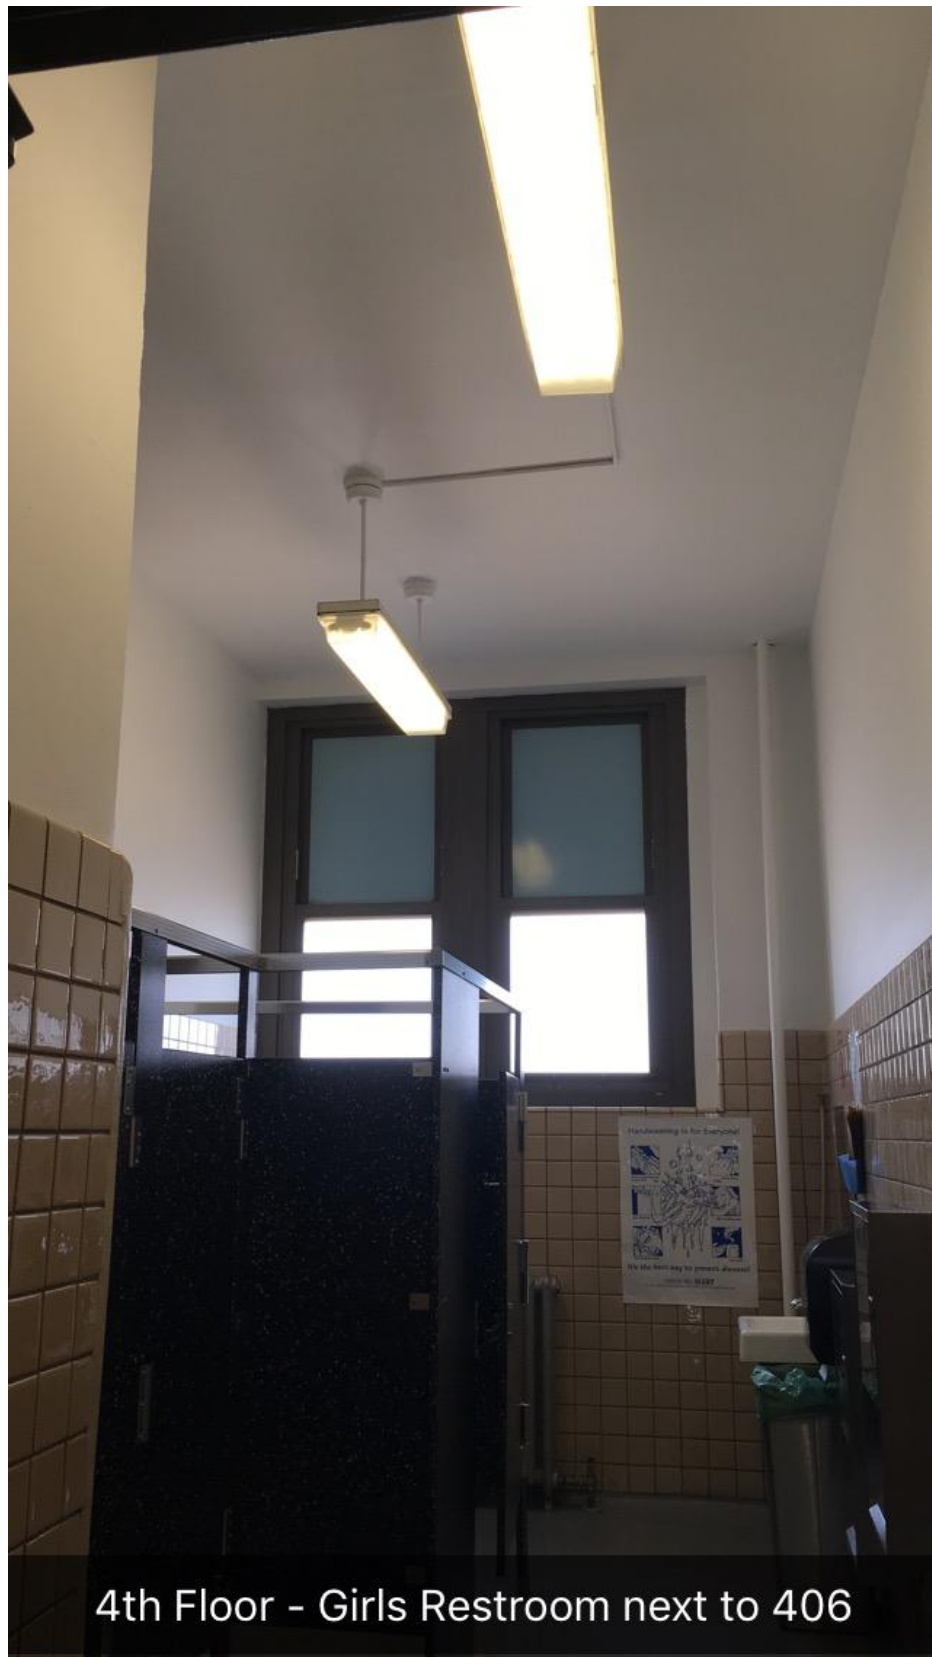
4th Floor - Girls Restroom next to 406

Following stabilization

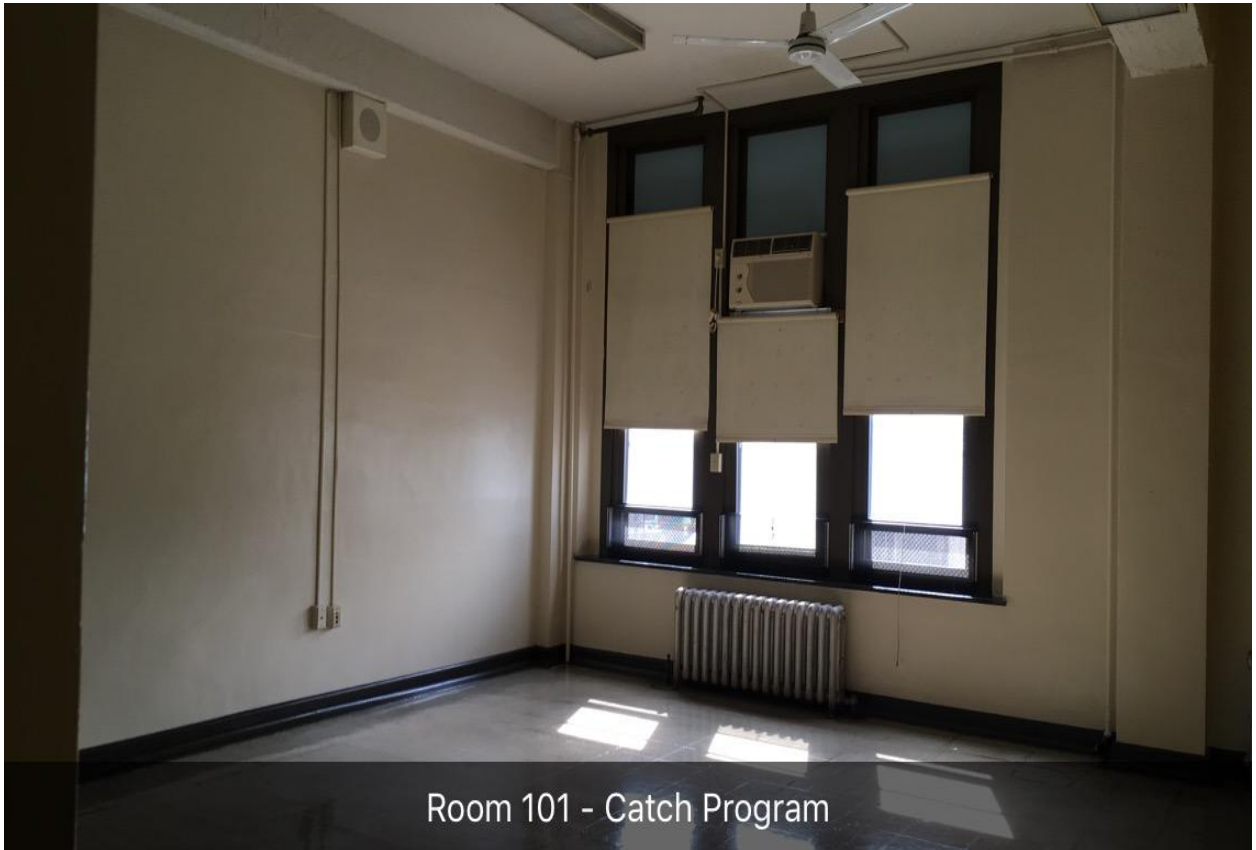
Following stabilization
