# *Summary of Paint & Plaster Stabilization Activities*

**#7270– Finletter Academics Plus School  
6100 N. Front Street  
Philadelphia, PA 19120**

**Criterion Laboratories, Inc.  
January 17, 2019**

**Project Number: 181675  
Project Dates: July 30 – December 8, 2018**

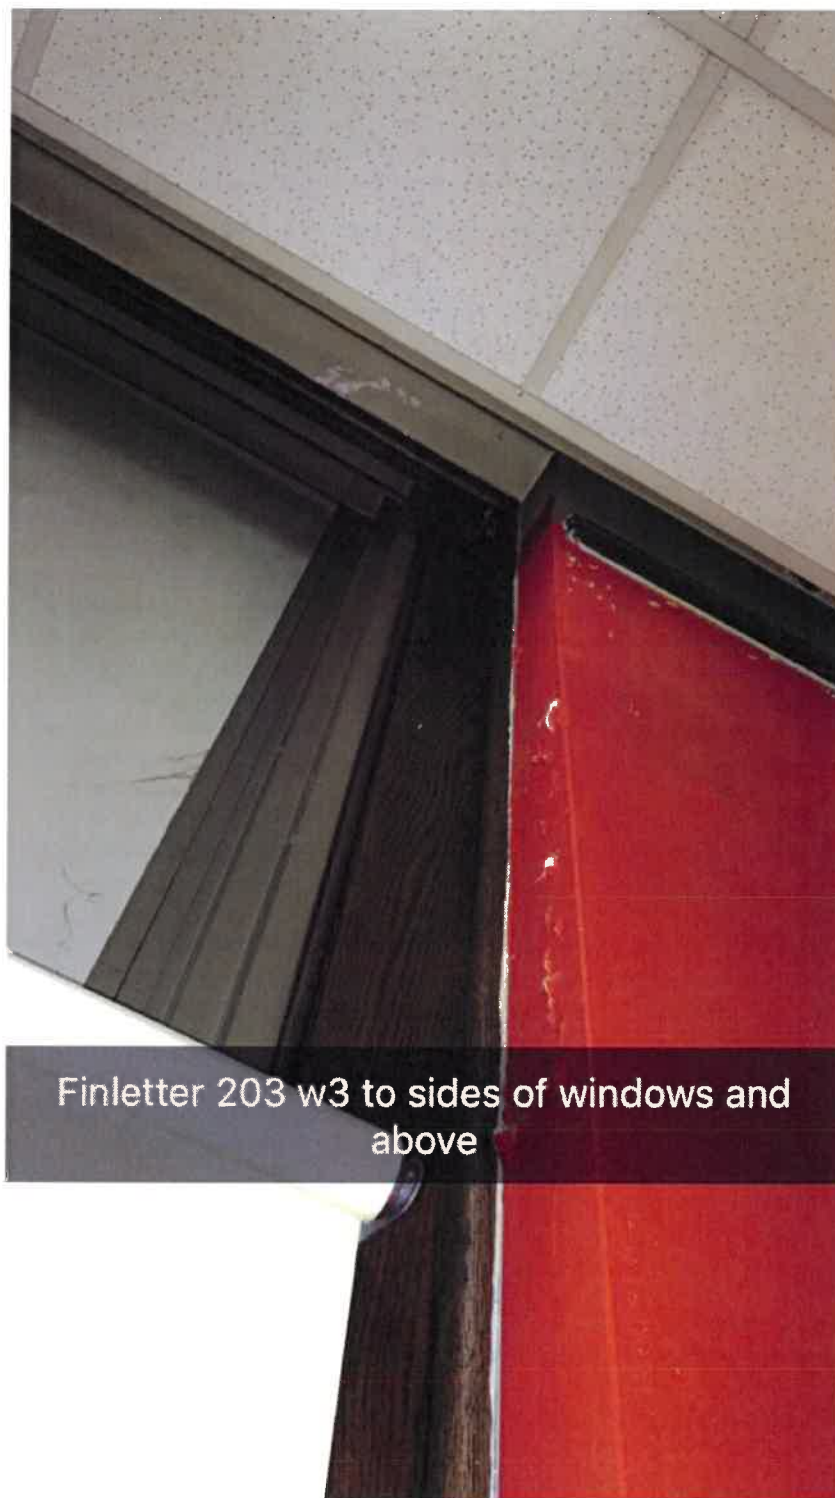
Prior to stabilization.

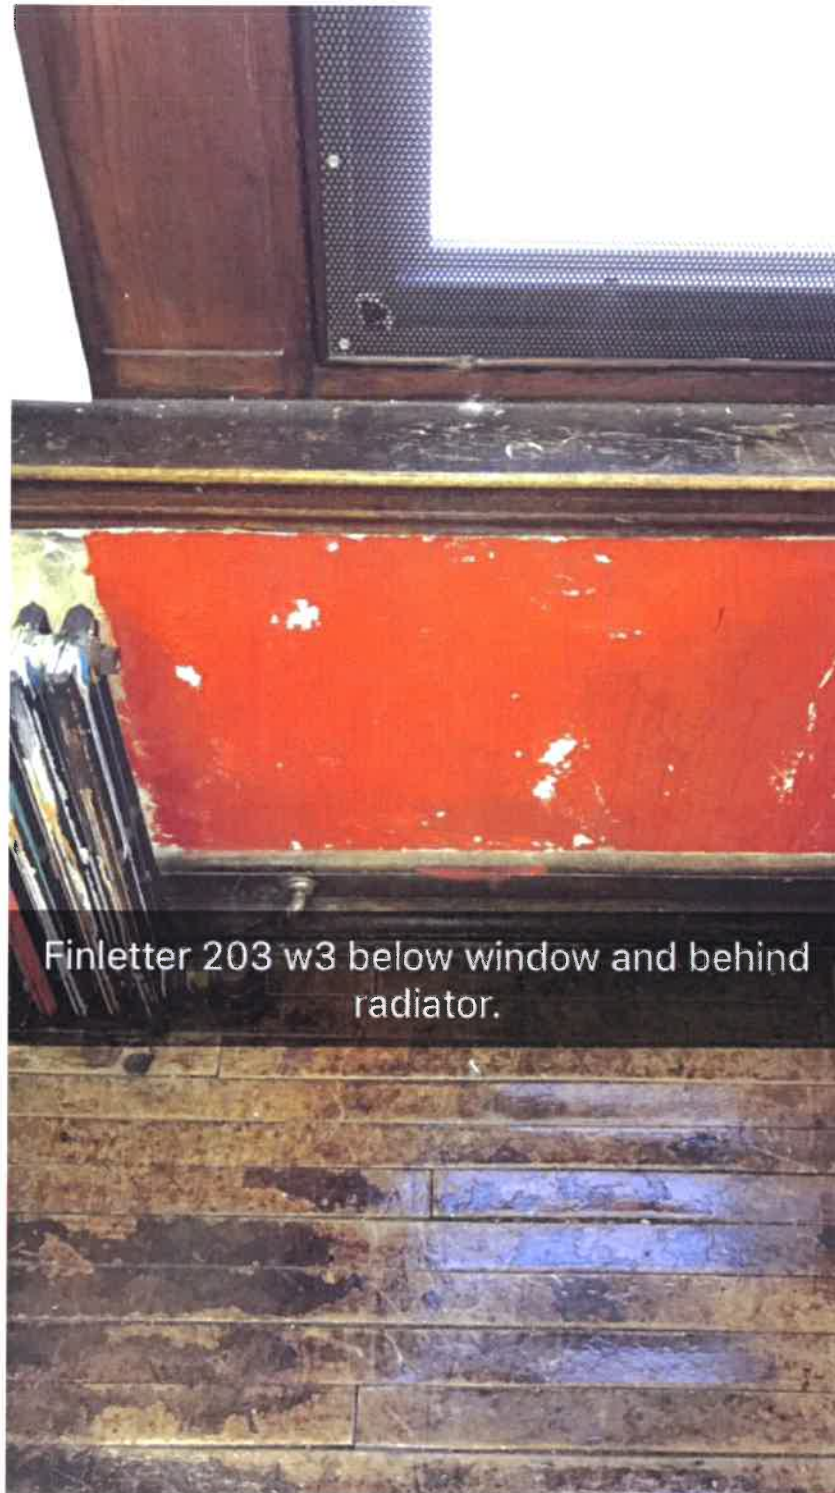
Prior to stabilization.

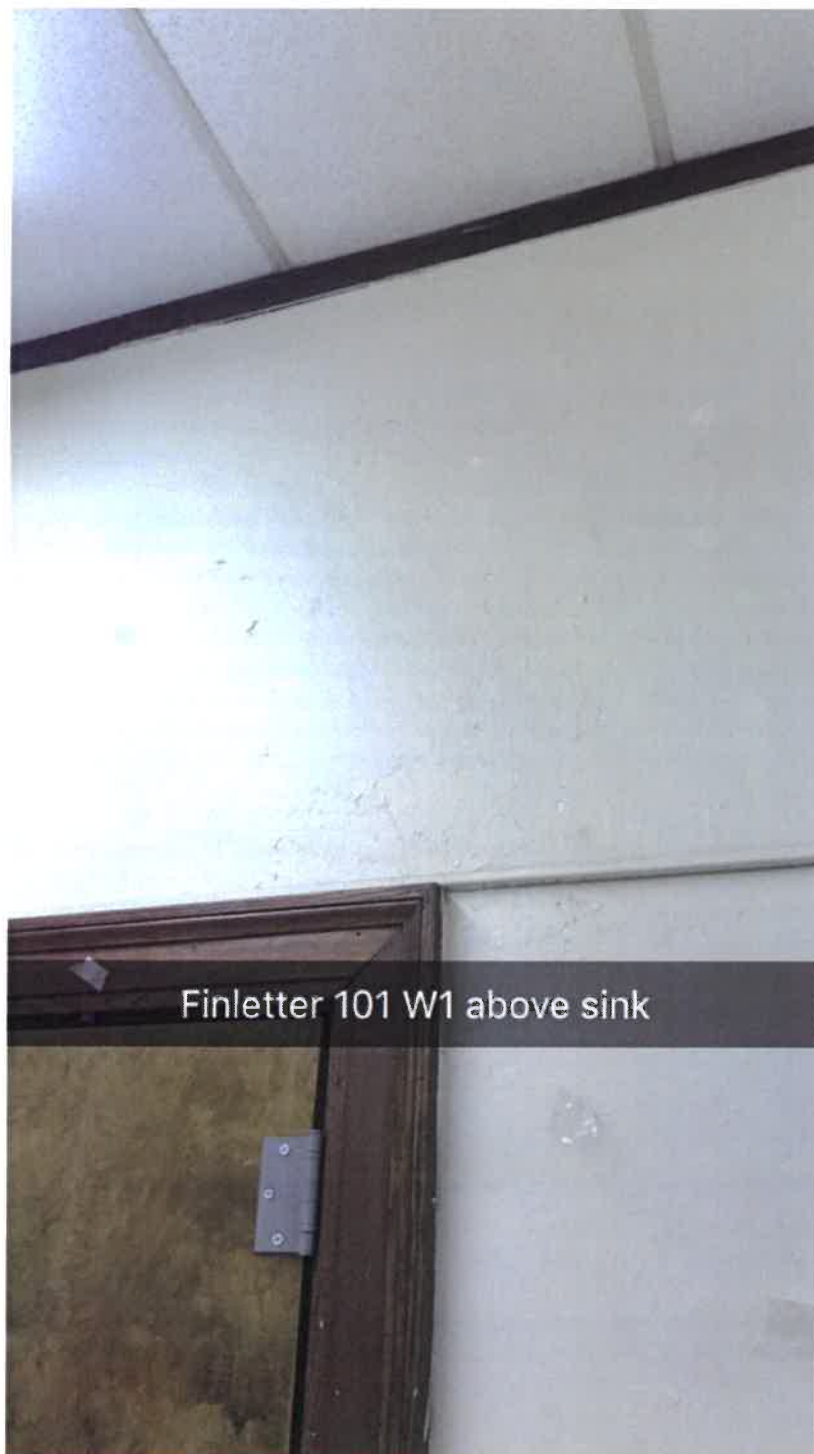
Prior to stabilization.

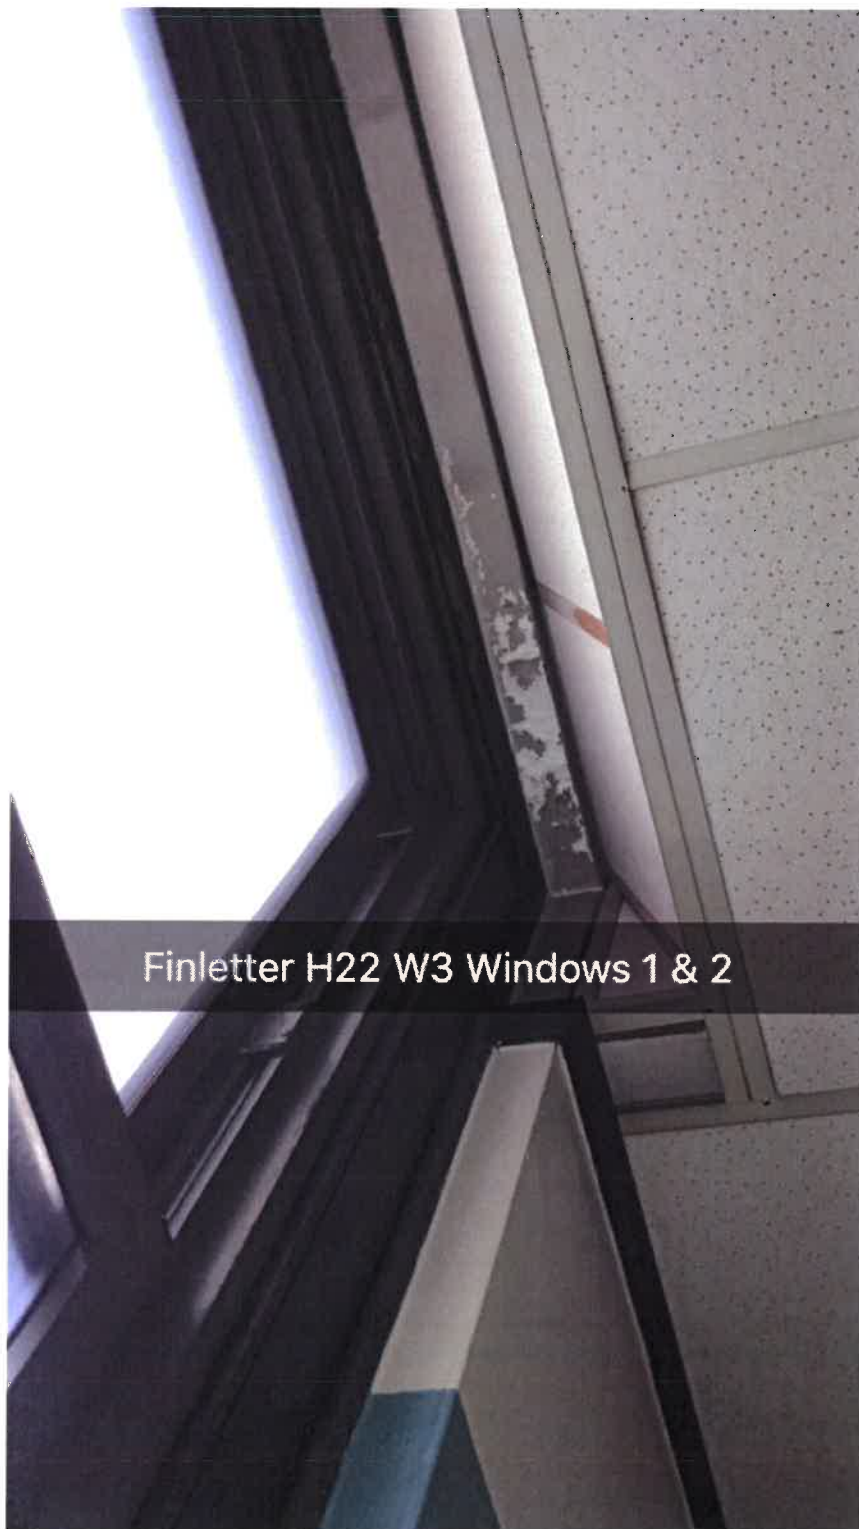
Prior to stabilization.

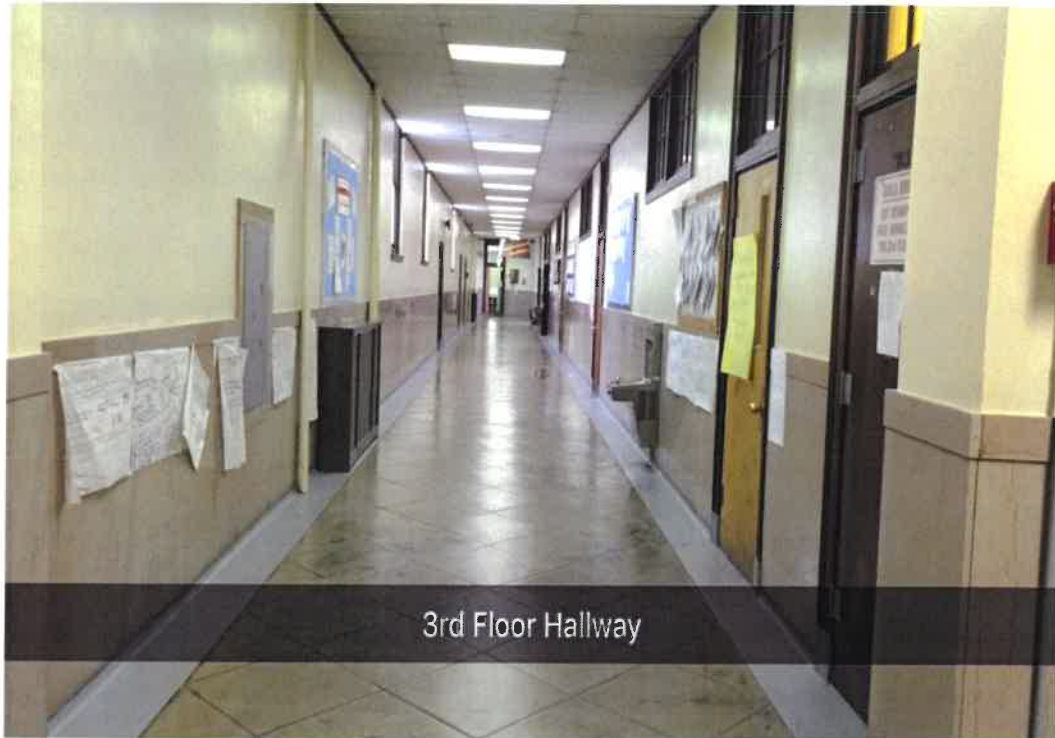
3rd Floor Hallway

Following stabilization

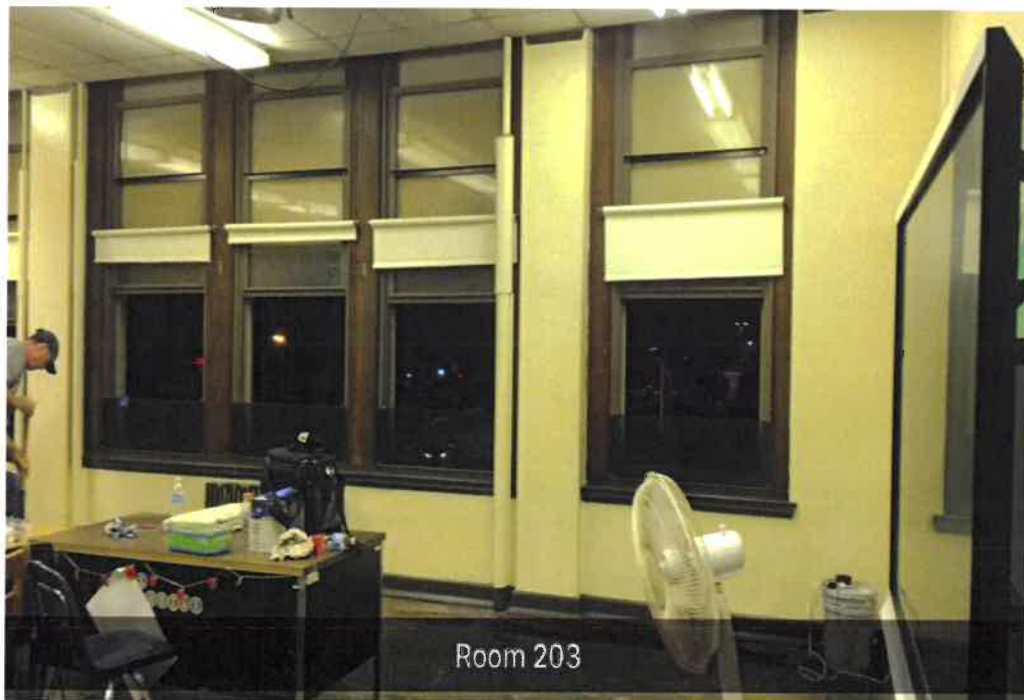
Room 203

Following stabilization

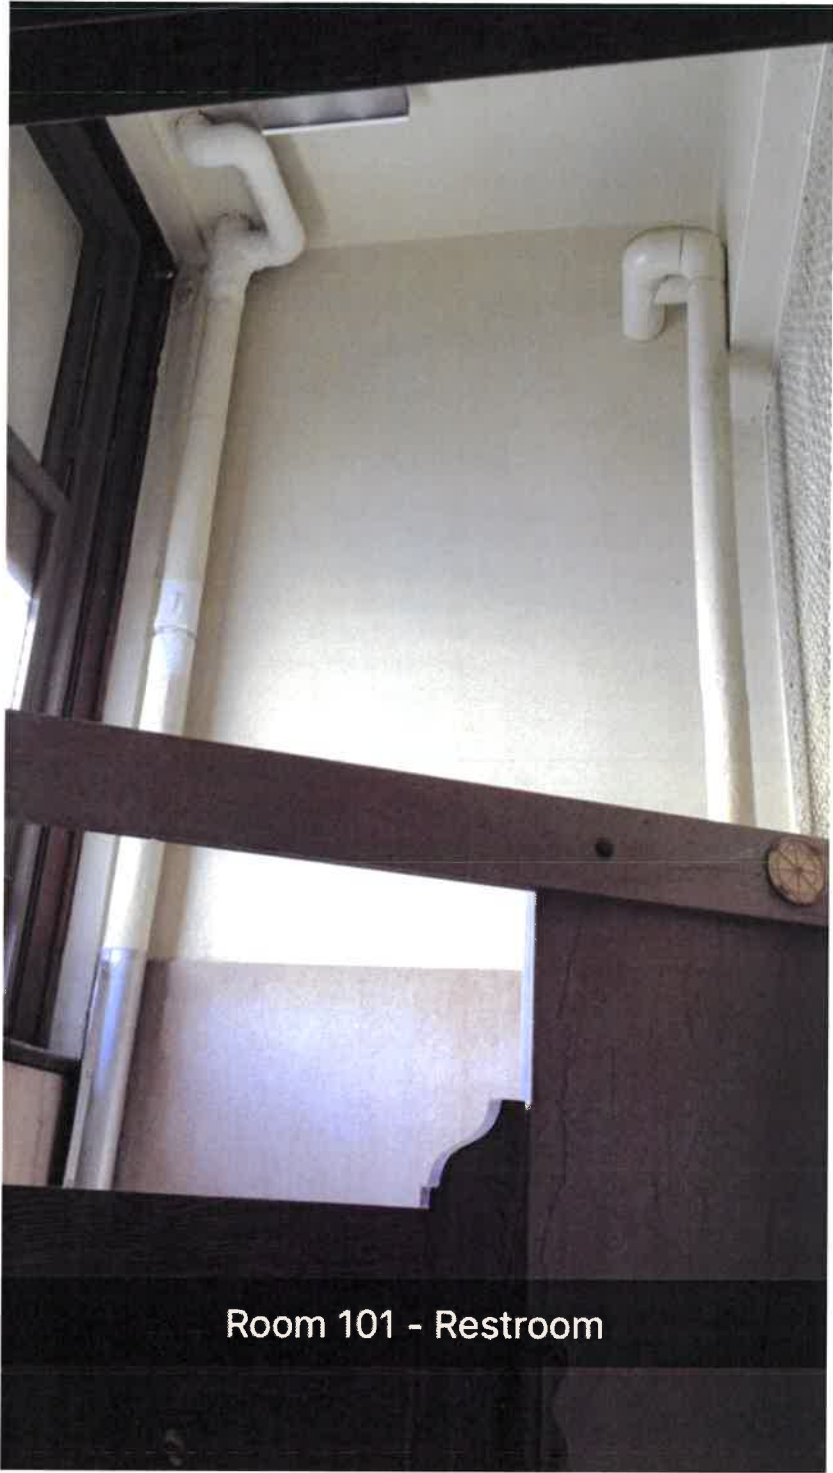
Room 101 - Restroom

Following stabilization
