Facility Condition Assessment Summary Report

MYA (Sulzberger) School

S112001;Sulzberger

Site Assessment Report

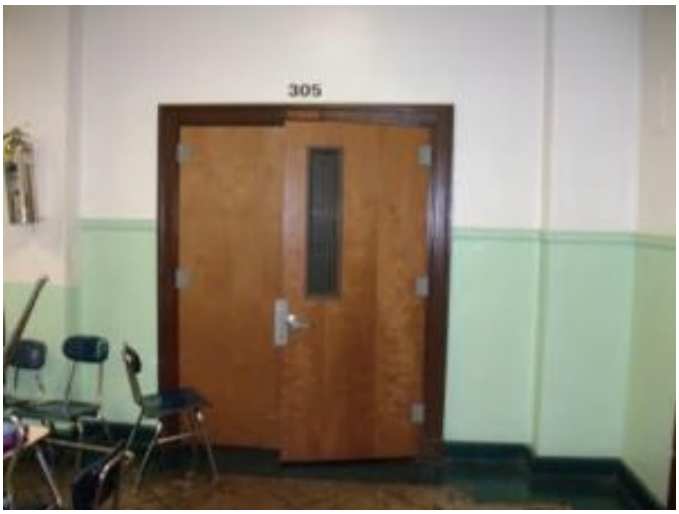
Location: Classrooms

System: C1020 - Interior Doors

Distress: Security Issue

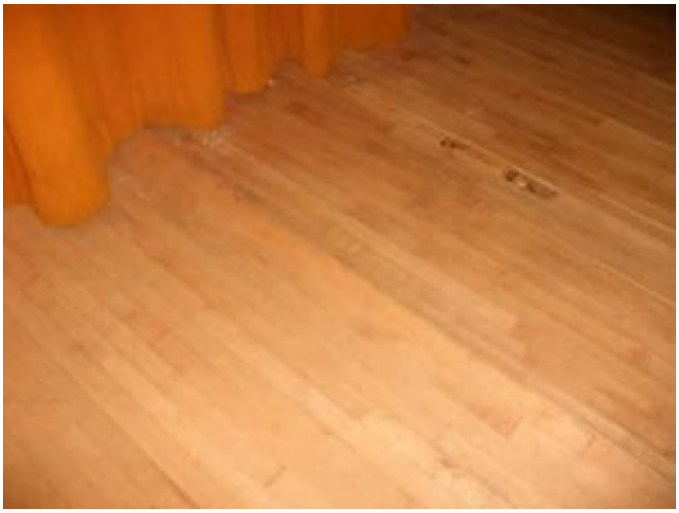
Location: B112001;Sulzberger

System: C3020414 - Wood Flooring

Distress: Damaged

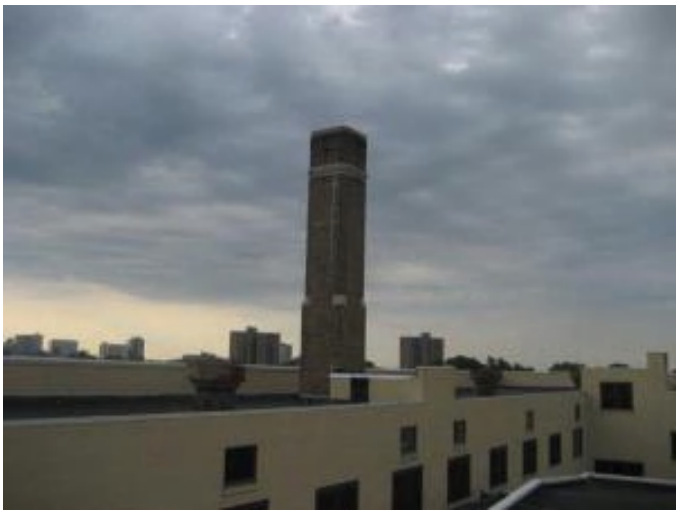
Location: Roof

System: D5090 - Other Electrical Systems

Distress: Building / MEP Codes

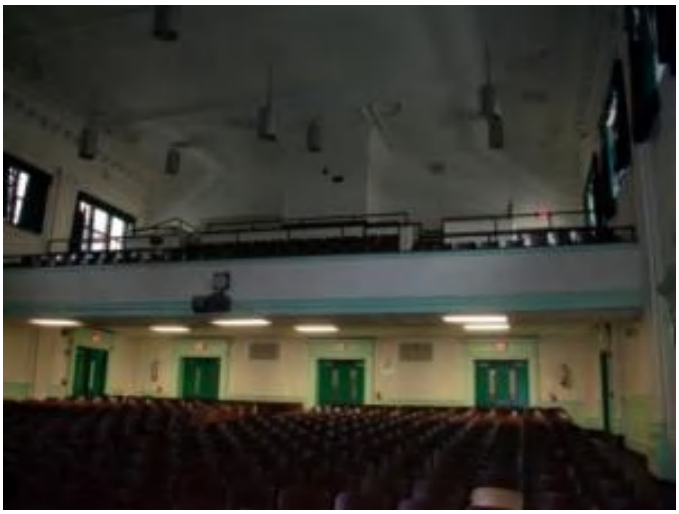
Location: Auditorium

System: E2010 - Fixed Furnishings

Distress: Failing
