Facility Condition Assessment Summary Report

Elkin School

January 30, 2017

Facility Assessment, August 2015

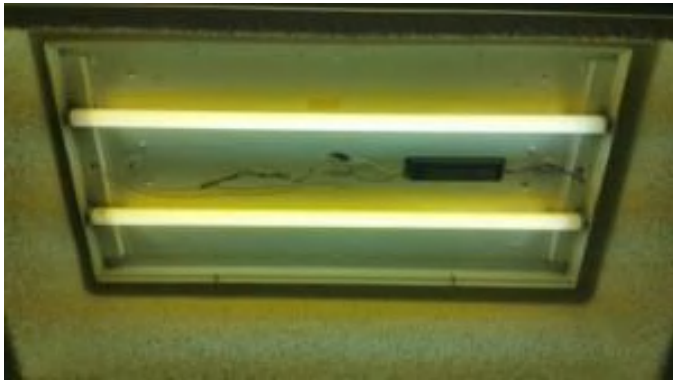
System: D5020 - Lighting and Branch Wiring

Location: throughout the building

Distress: Beyond Service Life

Notes: New lighting system in the entire building

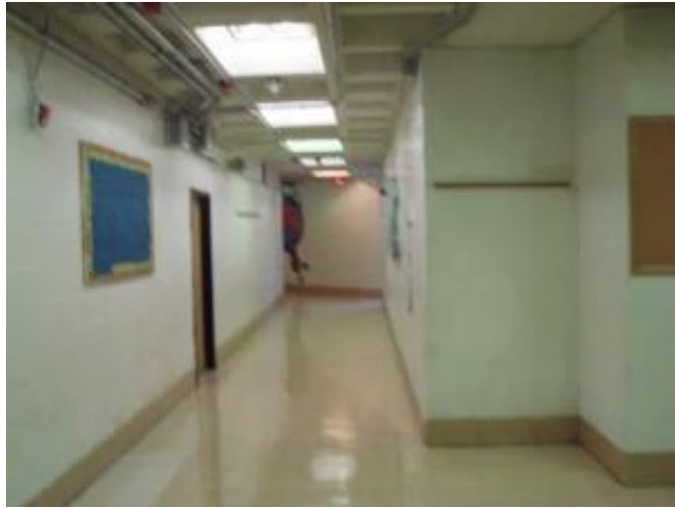
System: D5090 - Other Electrical Systems

Location: throughout the building

Distress: Life Safety / NFPA / PFD

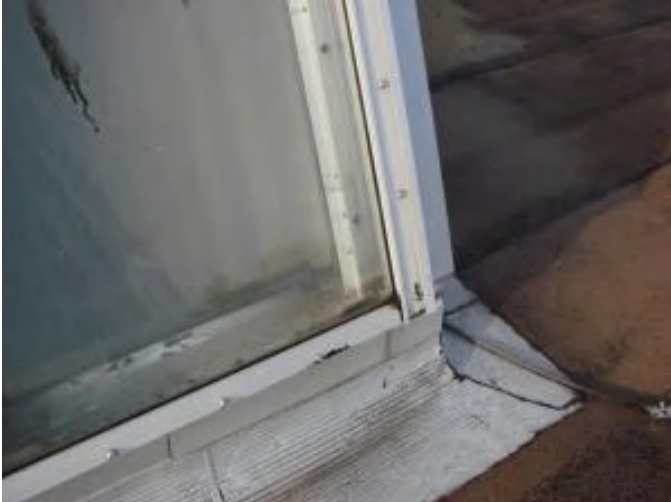
System: B2020 - Exterior Windows

Location: Exterior

Distress: Building Envelope Integrity

Notes: Replace all clerestory curtain wall windows within next 4 to 5 years

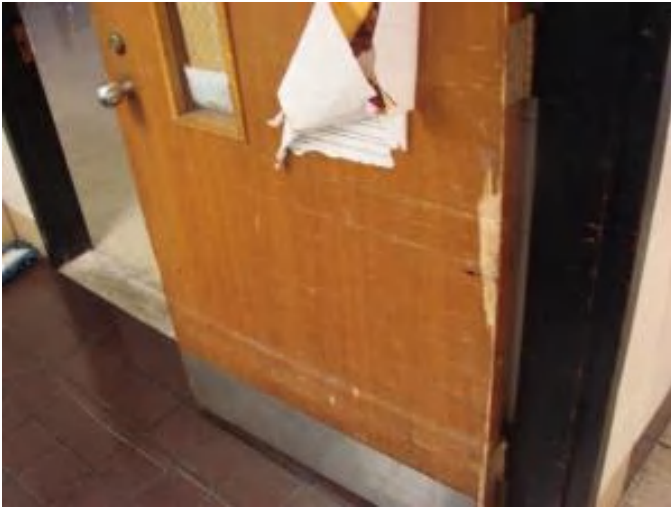
System: C1020 - Interior Doors

Interior doors are generally solid core wood doors, some glazed, with hollow metal frames. Most doors have glazed or solid core wood transoms. Some doors are damaged and missing hardware (20%). The doors leading to exit stairways are hollow metal doors and frames in good condition.

Location: Interior

Distress: Damaged

Notes: Replace damaged interior doors

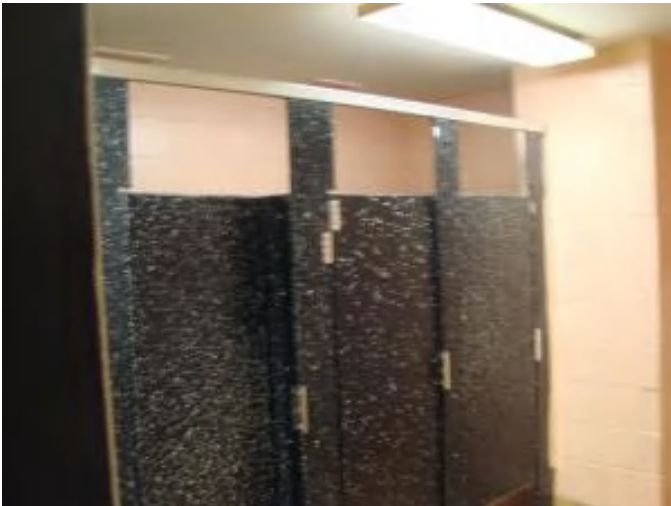
System: C1030 - Fittings

Location: Interior

Distress: Accessibility

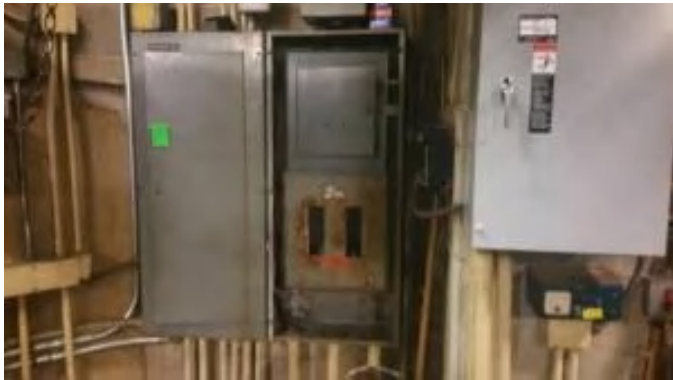
System: D5010 - Electrical Service/Distribution

Location: electrical room

Distress: Beyond Service Life

Notes: New Site electrical service 2000KVA, 480V, 3 Phase to feed the existing loads plus new additional loads for new HVAC System. New Distribution system throughout the building for lighting, receptacles and new MCC for HVAC loads. •

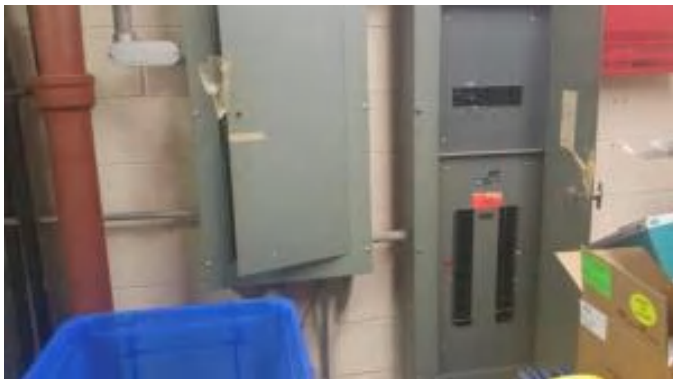
System: D5010 - Electrical Service/Distribution

Distribution system - The electrical distribution is accomplished with a 120V distribution switchboards. Switchboard feeds the 120V panels throughout the building (two on each floor). These panels are in poor condition and need replacements.

Location: throughout the building

Distress: Beyond Service Life

Notes: New panel boards throughout the building for lighting, receptacles..

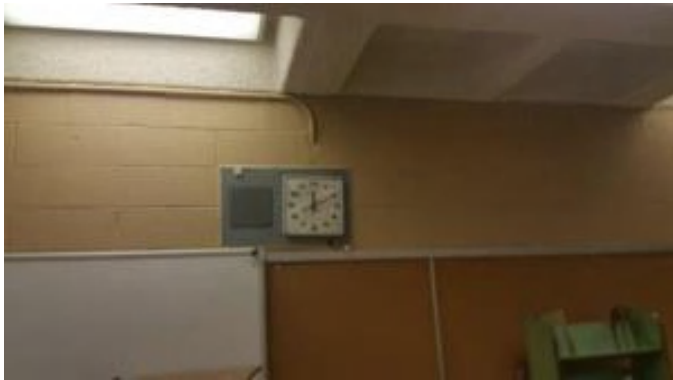
System: D5030 - Communications and Security

Location: throughout the building

Distress: Beyond Service Life

Notes: New Clock System

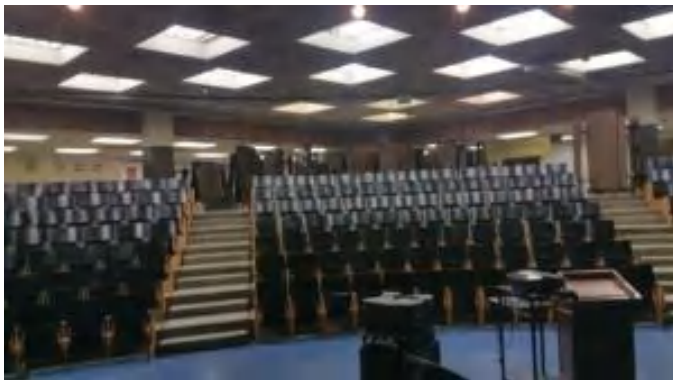
System: E1020 - Institutional Equipment

Location: auditorium

Distress: Beyond Service Life

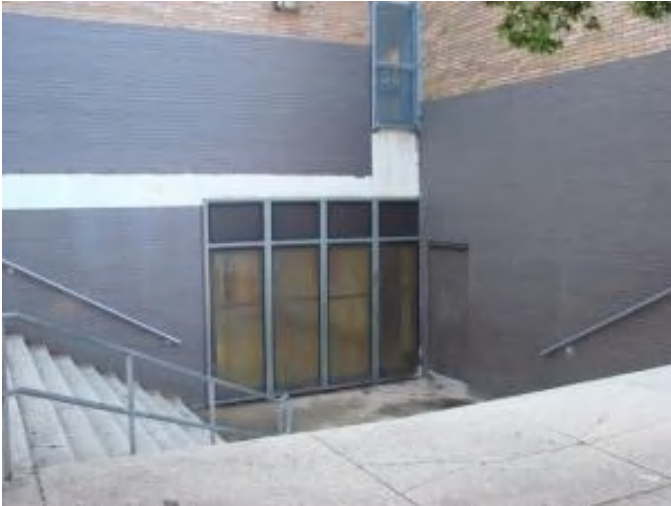
System: B2010 - Exterior Walls

Location: Exterior

Distress: Appearance

Notes: Provide new anti-graffiti coating first floor ext. walls (remove old coating)

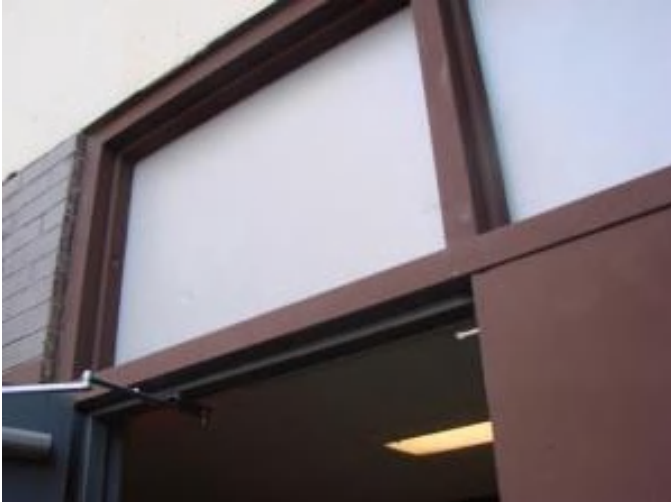
System: B2030 - Exterior Doors

The exterior doors are typically hollow metal doors and frames, painted. The doors are generally in fair condition; some doors have vision glazing with security screens. Service doors are in poor condition.

Location: Exterior

Distress: Beyond Service Life

Notes: Replace exterior doors

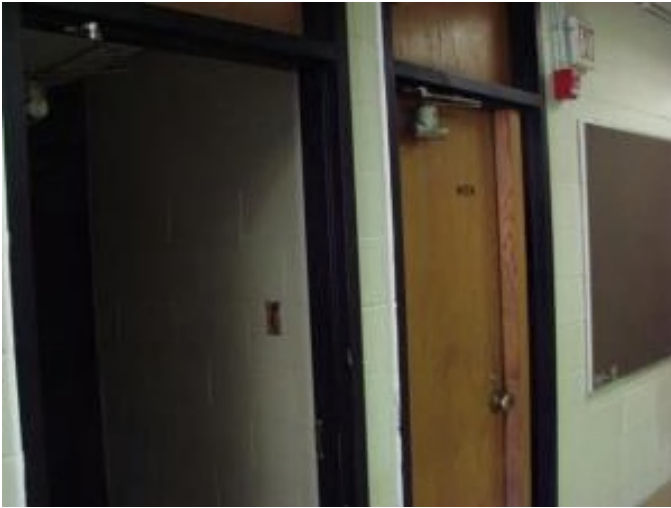
System: C1030 - Fittings

Location: Interior

Distress: Inadequate

Notes: Replace signage throughout the building

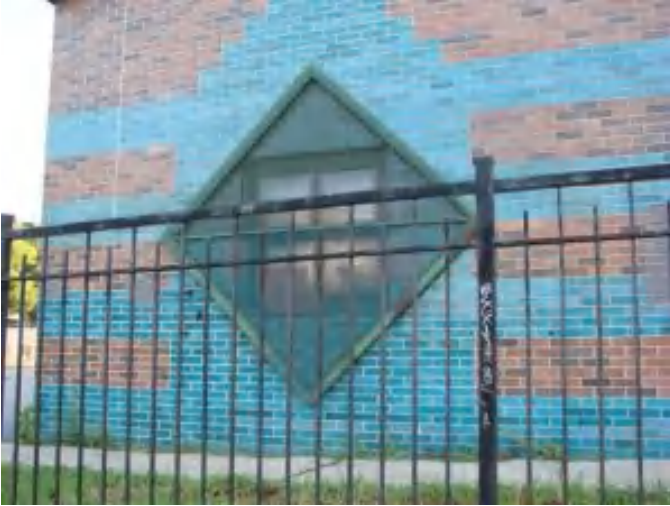
System: B2020 - Exterior Windows

Location: Exterior

Distress: Security Issue

Notes: Replace damaged security screens

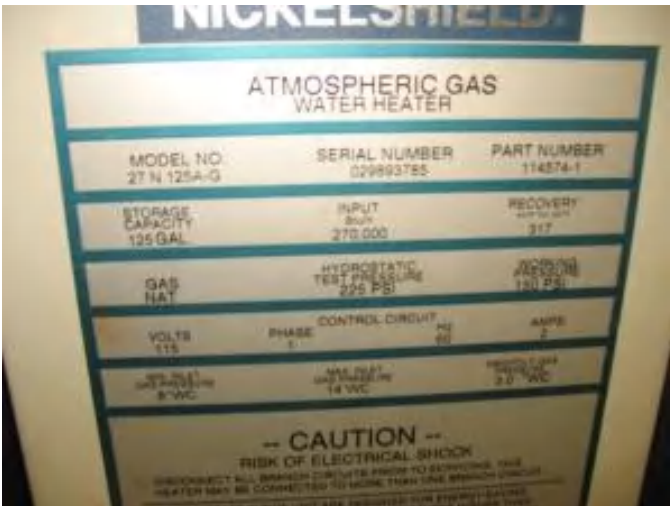
System: D2020 - Domestic Water Distribution

Location: Mechanical room

Distress: Beyond Service Life

Notes: Replace the two 125 gallon vertical gas fired domestic hot water heaters.

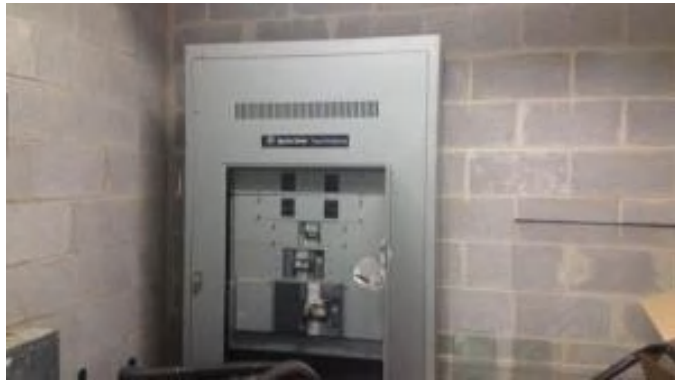
System: D5090 - Other Electrical Systems

Location: electrical room

Distress: Building / MEP Codes

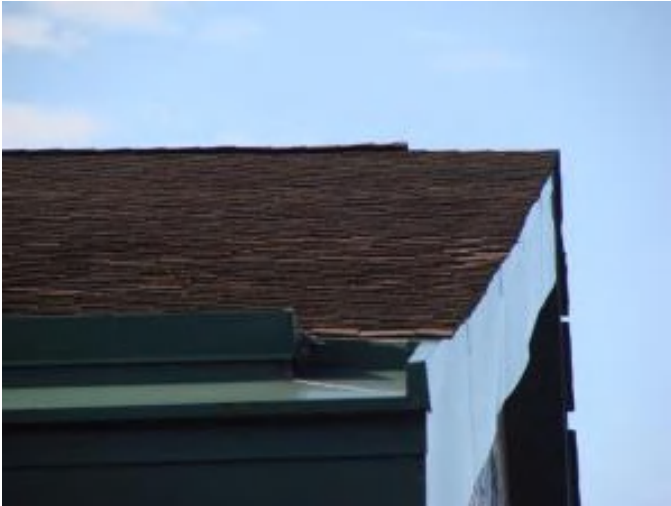
System: B3010140 - Shingle & Tile

Location: Exterior

Distress: Beyond Service Life

Notes: Replace shingle roof system

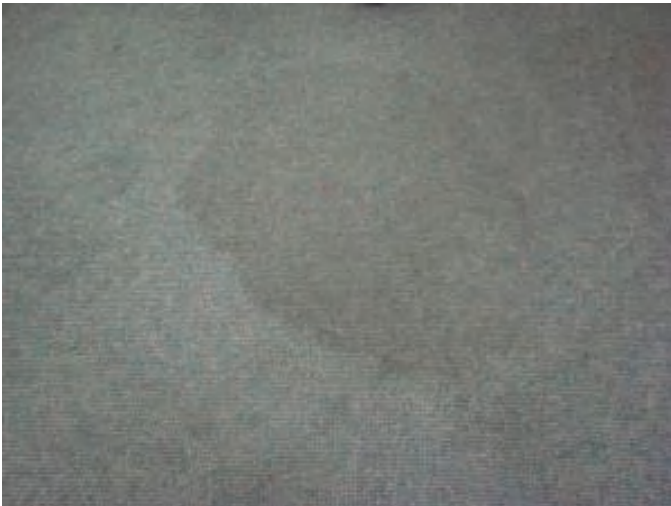
System: C3020411 - Carpet

Location: Interior

Distress: Beyond Service Life

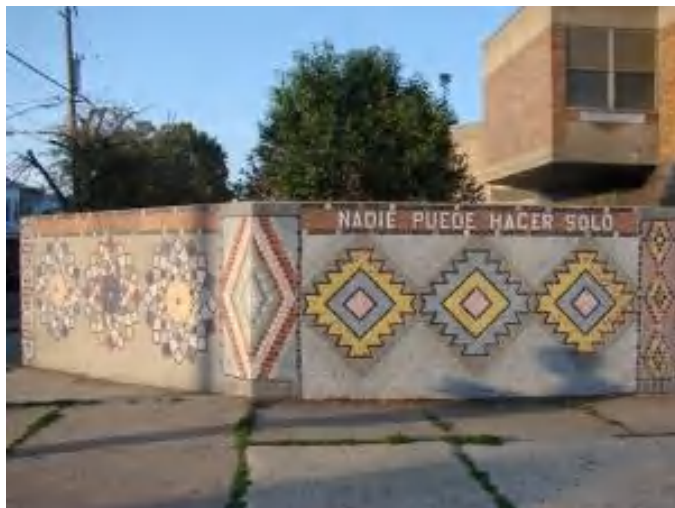
System: G2030 - Pedestrian Paving

Location: Grounds/ site

Distress: Beyond Service Life
