Facility Condition Assessment Summary Report

Bache-Martin School

Martin (Bache-Martin) School

January 31, 2017

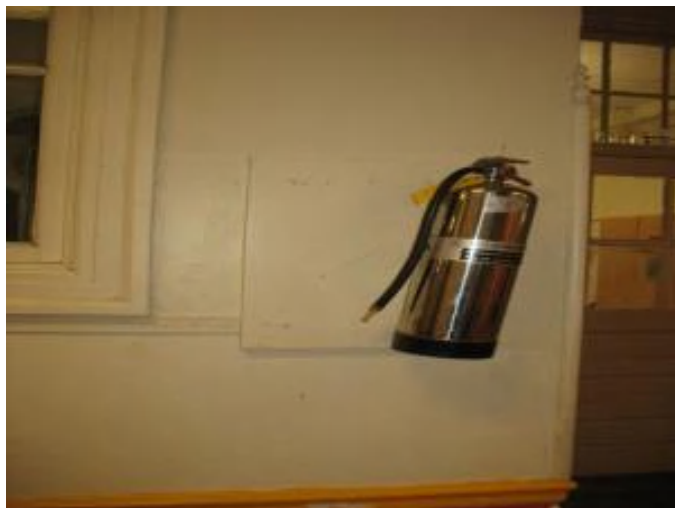
System: D4010 - Sprinklers

Location: Throughout building

Distress: Life Safety / NFPA / PFD

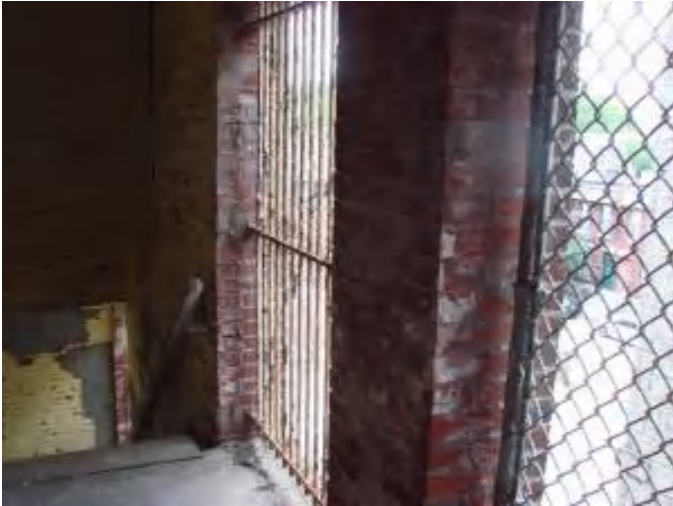
System: B2010 - Exterior Walls

The building envelope is typically granite ashlar facing on elevations facing streets and face brick on the courtyard sides. In general, masonry is in fair to poor condition. The school principal reported water penetration on West wall especially during heavy rains.

Location: Exterior

Distress: Building Envelope Integrity

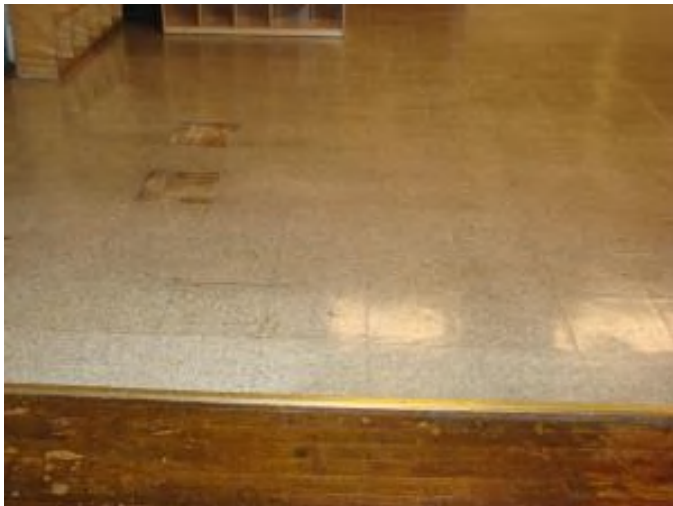
System: C3020413 - Vinyl Flooring

Flooring in classrooms and most corridors is hardwood. Toilet flooring is ceramic tile good condition, installed in early 2000's. VCT is installed in few rooms and in poor condition, some tiles are missing.

Location: Interior

Distress: Beyond Service Life

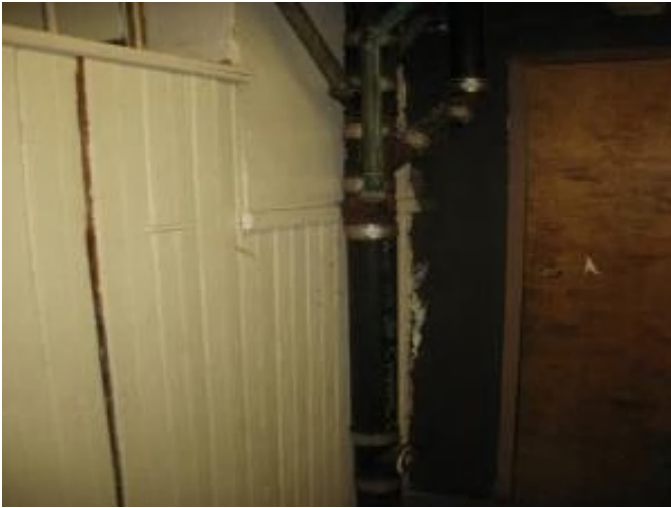
System: D2030 - Sanitary Waste

The maintenance staff reported mostly minor problems with the sanitary waste piping systems. However, the sewer piping has been in service for decades and will require more frequent attention from the maintenance staff as time passes. The District should hire a qualified contractor to examine the sanitary waste piping using video cameras to locate and replace any damaged piping and to further quantify the extent of potential failures.

Location: Throughout building

Distress: Beyond Service Life

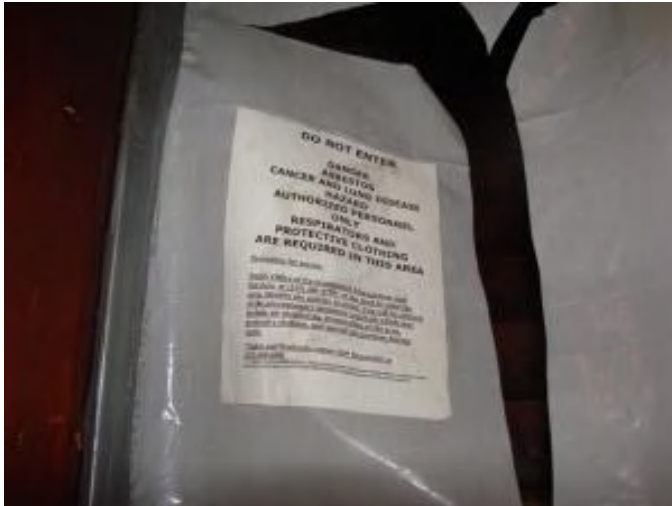
System: D3040 - Distribution Systems

Location: Attic

Distress: Beyond Service Life

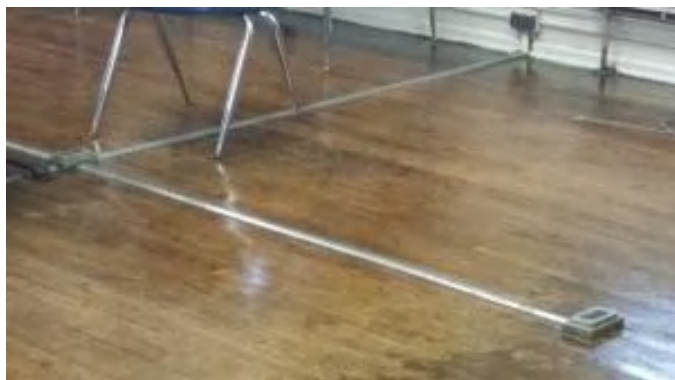
System: D5020 - Lighting and Branch Wiring

Location: Throughout the building

Distress: Beyond Service Life

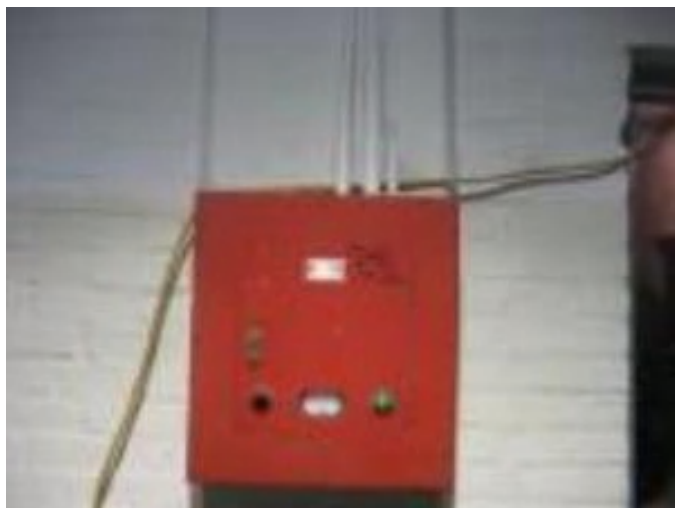
System: D5030 - Communications and Security

Fire Alarm System – The present Fire Alarm system is inadequate and is not addressable. A new Automated Fire Alarm System is needed.

Location: Throughout the building

Distress: Beyond Service Life

Notes: Install a new Automated Fire Alarm System to be located in the new Electrical Room.

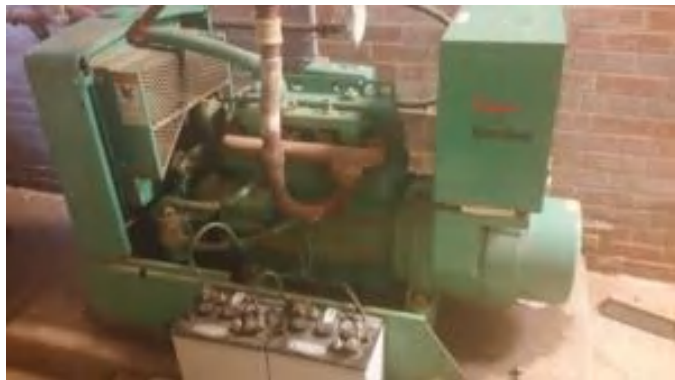
System: D5090 - Other Electrical Systems

Emergency Power System – The present emergency power system is inadequate, old and undersized. A larger emergency power system (30 KVA) is needed.

Location: Electrical room in the basement

Distress: Beyond Service Life

Notes: Install a new emergency power system (100 KVA generator).

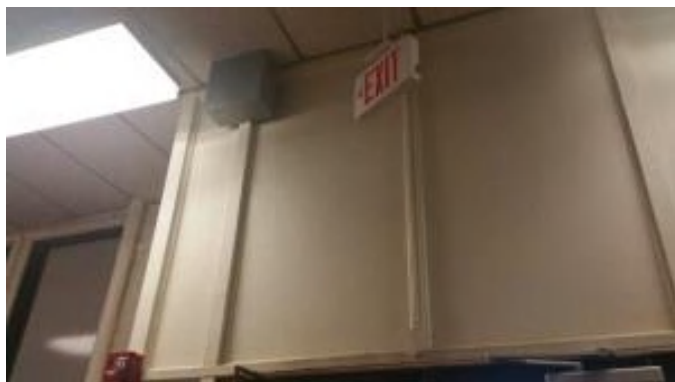
System: D5090 - Other Electrical Systems

Emergency Lighting System / Exit Lighting- The emergency lighting and exit lighting is inadequate throughout each floor and stairways.

Location: Throughout the building

Distress: Life Safety / NFPA / PFD

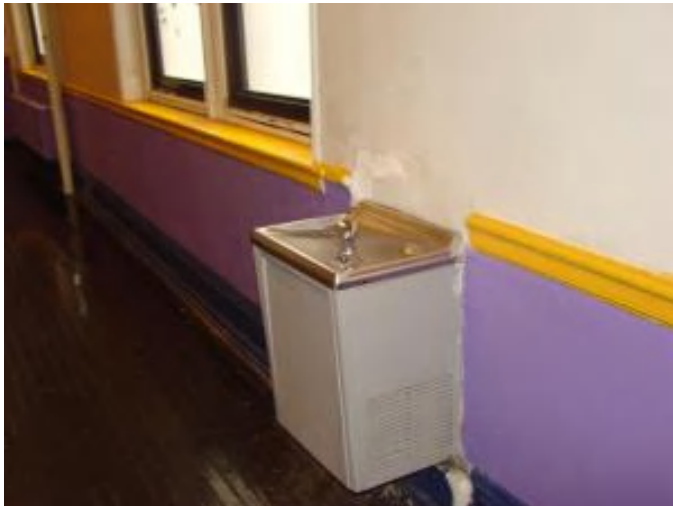
System: C3010230 - Paint & Covering

Location: Interior

Distress: Appearance

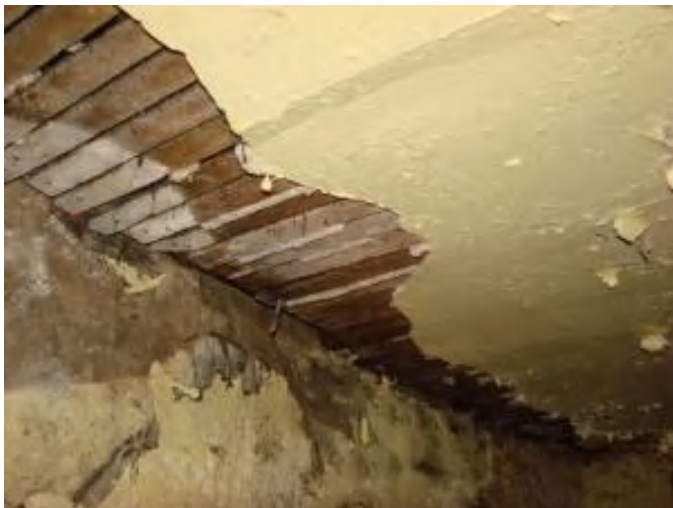
System: C3030 - Ceiling Finishes

Most ceilings are 2x4 suspended acoustical panels. The suspension system and tile are old and approaching the end of their useful life. The balance of ceilings is generally plastered in various stages of deterioration, particularly in basement mechanical spaces.

Location: Interior

Distress: Beyond Service Life

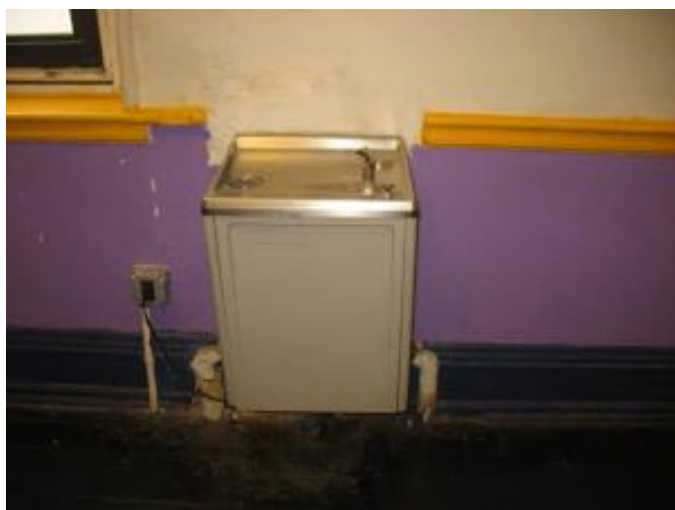
System: D2010 - Plumbing Fixtures

Drinking fountains in the corridors and at the restrooms are wall hung with integral refrigerated coolers. Several fountains are beyond their service life and should be replaced; some are NOT accessible type.

Location: Corridors

Distress: Beyond Service Life

Notes: Replace the wall hung drinking fountains and integral refrigerated coolers in the corridors and at the restrooms. Some of these units are well beyond their service life and many are NOT accessible type.

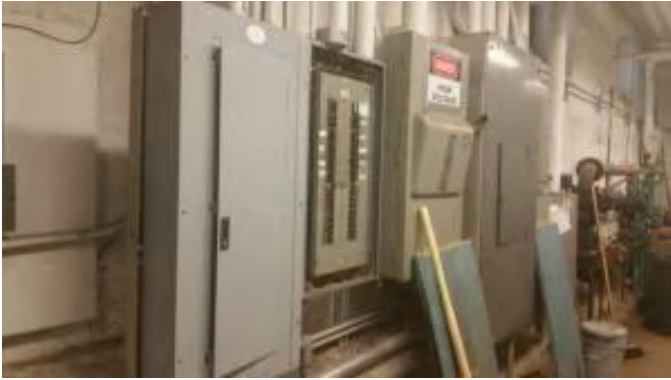
System: D5010 - Electrical Service/Distribution

Location: Electrical Room in the basement

Distress: Beyond Service Life

Notes: Upgrade the existing electrical service with a new service. Install a new 1000 KVA dry-type Transformer, 13.2KV to 480V/277V, 3Ph, with a new 1200A, 480V, 3 phase Switchboard. The new Main switchboard shall be sized to handle the existing loads plus any new HVAC loads. Install a new step down transformer from 480V to 120V/208V, and a main 120V/208V Panel Board for all the lighting/receptacle loads. •

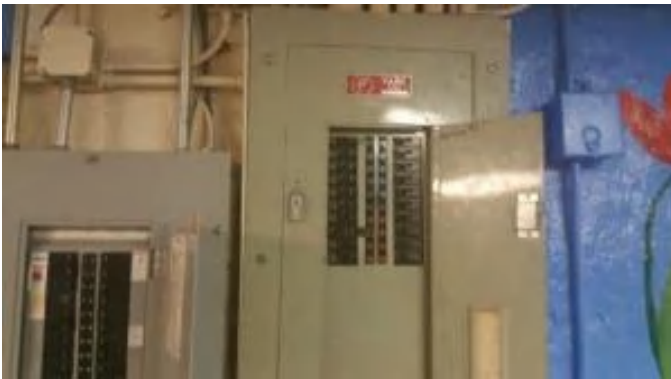
System: D5010 - Electrical Service/Distribution

Location: Throughout the building

Distress: Beyond Service Life

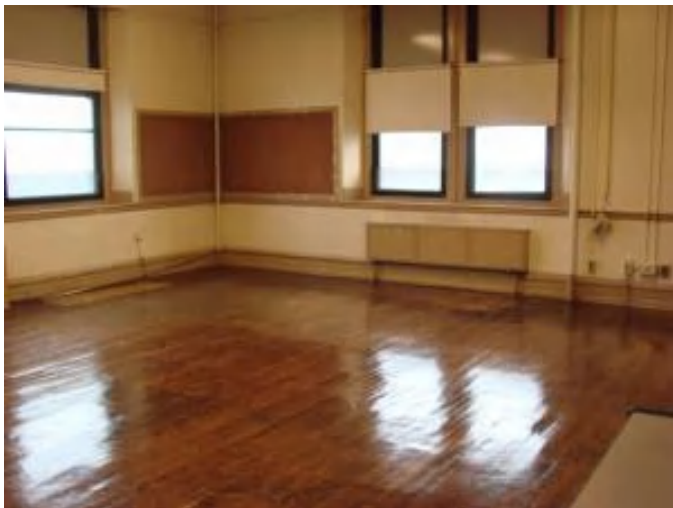
System: C1030 - Fittings

Fittings include original chalk boards, generally in poor condition.

Location: Interior

Distress: Beyond Service Life

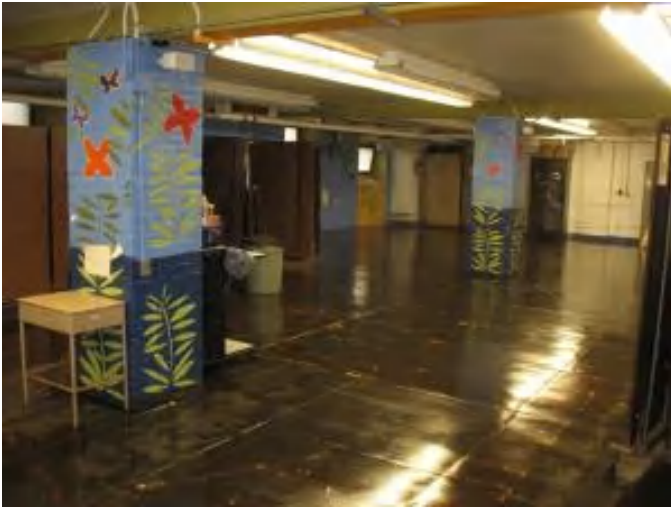
System: D3040 - Distribution Systems

Location: Cafeteria

Distress: Building / MEP Codes

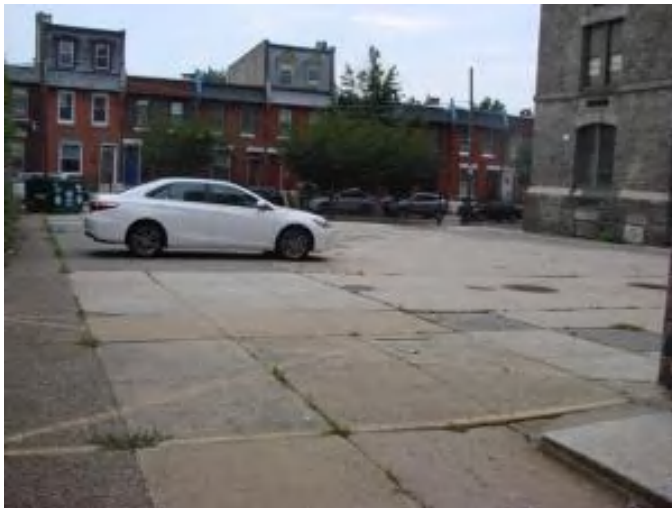
System: G4020 - Site Lighting

Location: Grounds/Site

Distress: Accessibility

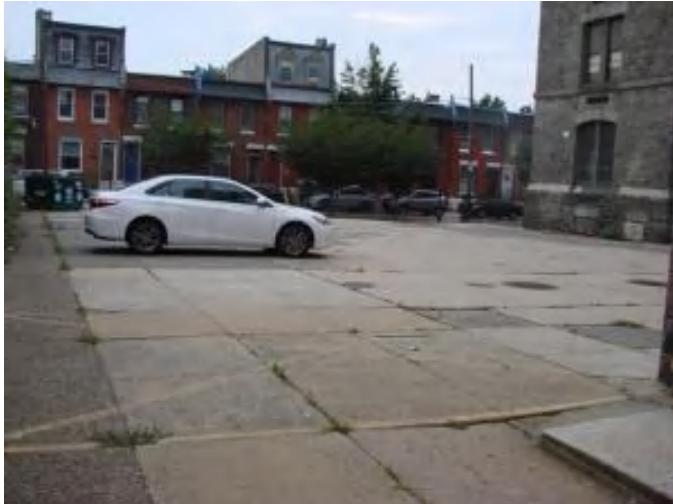
System: G2030 - Pedestrian Paving

Location: Grounds/ site

Distress: Beyond Service Life

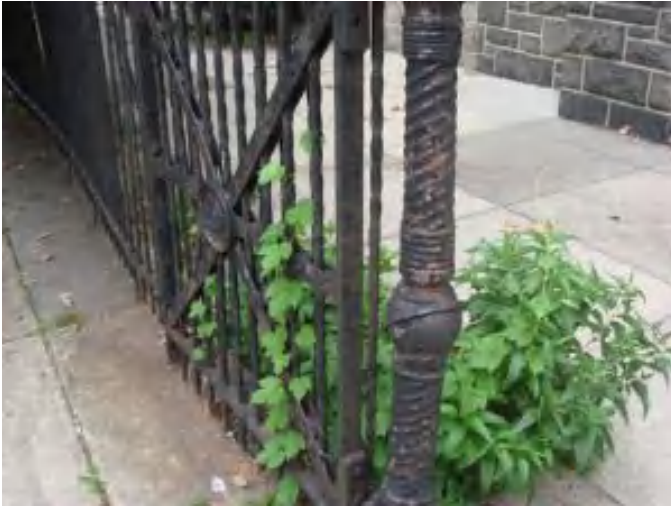
System: G2040 - Site Development

Playground adjacent to the building is in poor condition, paving is cracked and deteriorated; playground equipment is in poor condition. Original perimeter fences are generally in poor condition and rusting; chain link fence along North property line is rusting. There is no landscaping.

Location: Grounds/ site

Distress: Beyond Service Life

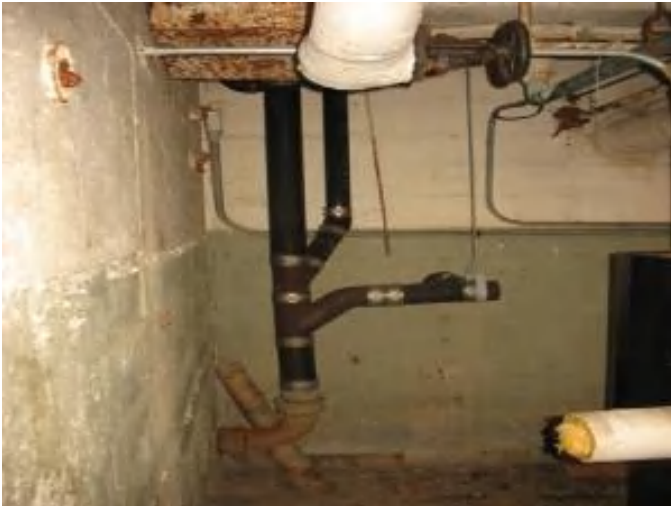
System: D2030 - Sanitary Waste

Location: Throughout building

Distress: Health Hazard / Risk

Correction: Inspect sanitary waste piping and replace damaged sections. (+50KSF)

Notes: Hire a qualified contractor to perform a detailed examination of the sanitary waste piping using visual inspection and video cameras to locate and replace any damaged piping and to further quantify the extent of potential failures.

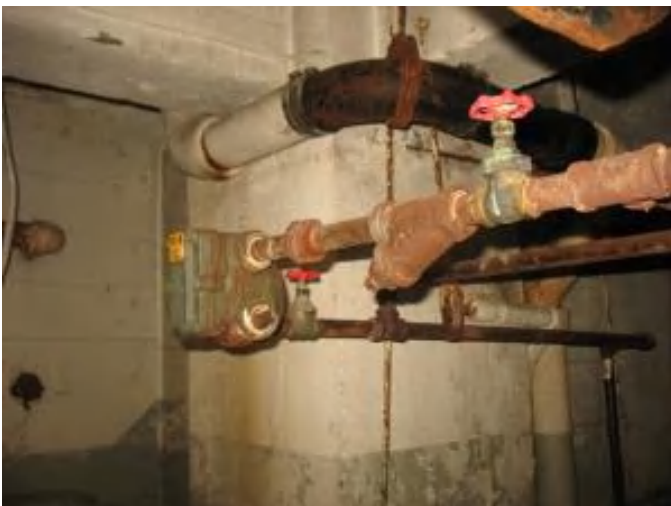
System: D3040 - Distribution Systems

Location: Throughout building

Distress: Beyond Service Life

Correction: Conduct a steam trap survey and replace failed units.

Notes: Conduct a steam trap survey to identify and replace failed traps passing live steam into the condensate piping system.

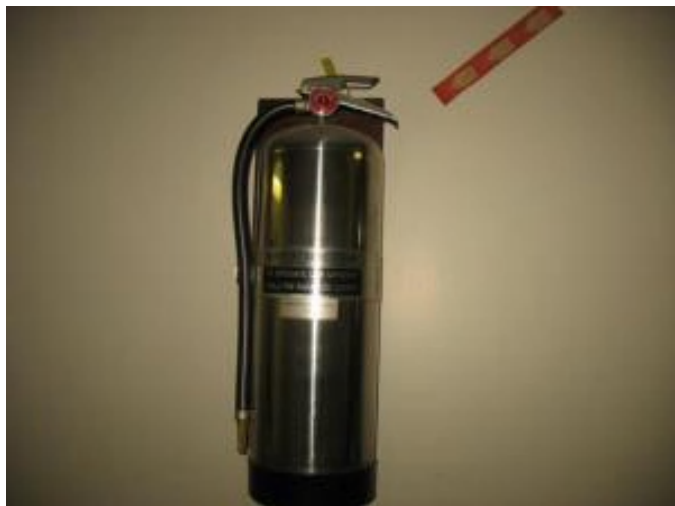
System: D4010 - Sprinklers

Location: Throughout building

Distress: Life Safety / NFPA / PFD

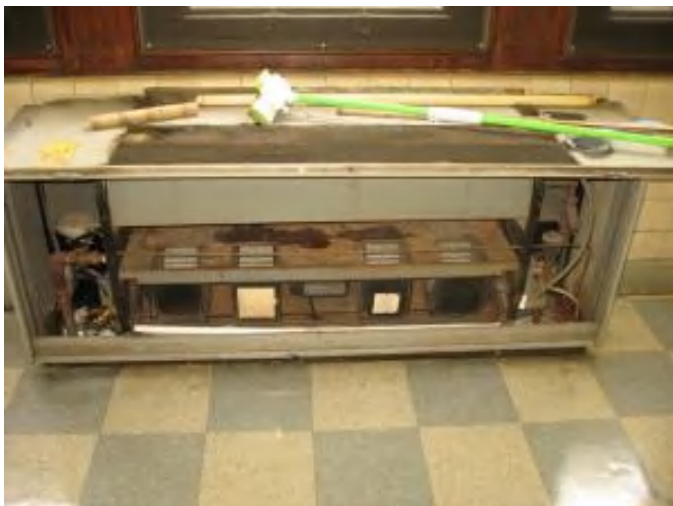
System: D3040 - Distribution Systems

Location: Throughout building

Distress: Beyond Service Life

Correction: Replace the existing unit ventilators with new units designed to provide adequate ventilation per ASHRAE Std 62 - insert the SF of bldg. in the qty.

Notes: Remove the existing unit ventilators and install units with hot and chilled water coils and integral heat exchangers to introduce outdoor air to the building.

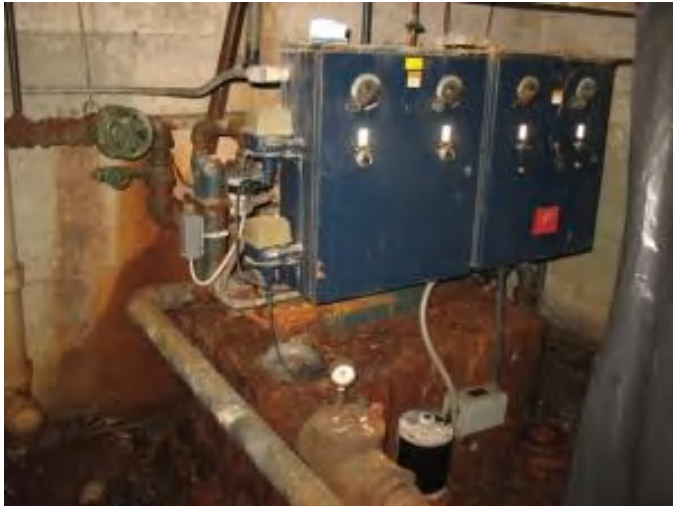
System: D3040 - Distribution Systems

Location: Mechanical room

Distress: Damaged

Correction: Replace vacuum condensate pump set (duplex)

Notes: Replace the condensate receiver in the basement mechanical room.

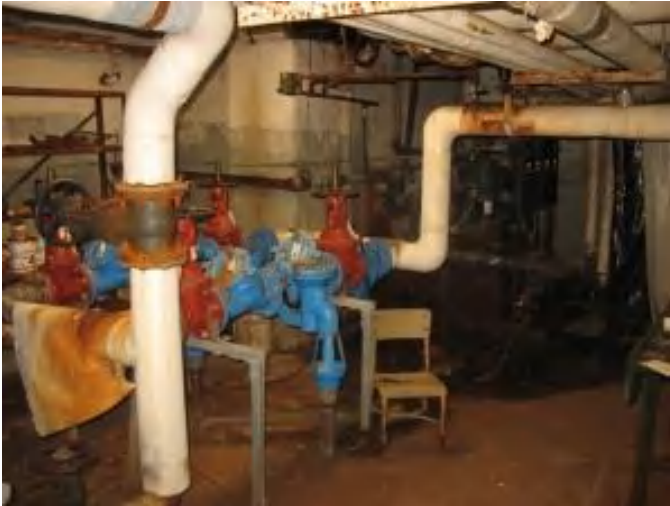
System: D3040 - Distribution Systems

Location: Throughout building

Distress: Beyond Service Life

Correction: Perform testing to identify and replace damaged steam and condensate piping.

Notes: Hire a qualified contractor to examine the steam and condensate piping and perform additional testing to locate and replace any damaged piping and to further quantify the extent of potential failures.

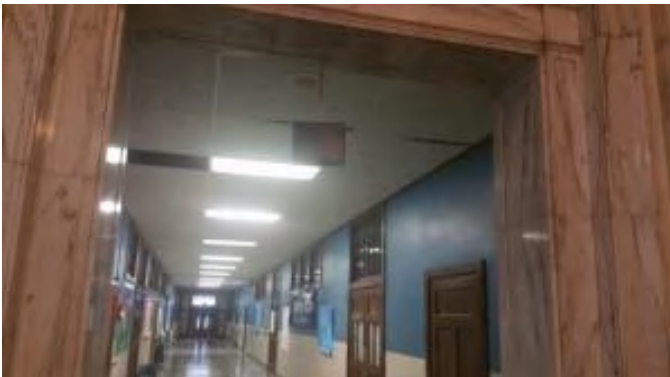
System: D5020 - Lighting and Branch Wiring

Location: Throughout the building

Distress: Beyond Service Life

Correction: Replace Lighting Fixtures (SF)

Notes: Install new lighting fixtures for all the class rooms, and other rooms. New fluorescent lighting (T-5) will be adequate, however, using the state-of-the-art LED lighting will improve the energy usage.

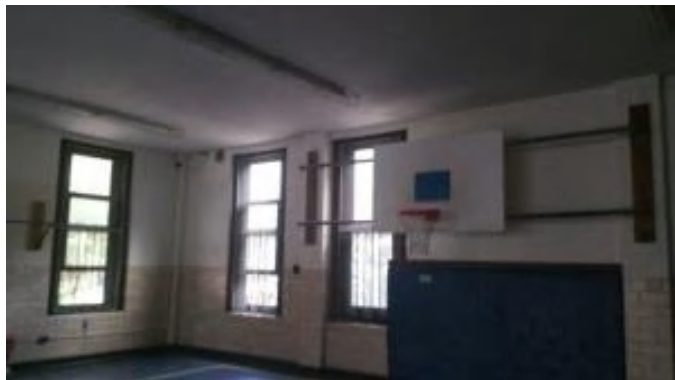
System: D5020 - Lighting and Branch Wiring

Location: Throughout the building

Distress: Beyond Service Life

Correction: Replace Wiring Devices (SF) - surface mounted conduit and boxes

Notes: Install two receptacles in all of class rooms and other purpose rooms. Add a wire-mold system with receptacles on every 3' for the computer room.

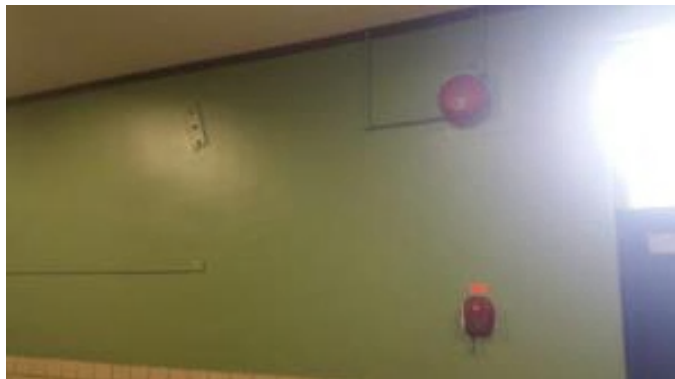
System: D5030 - Communications and Security

Location: Throughout the building

Distress: Beyond Service Life

Correction: Replace fire alarm system

Notes: Install a new Automated Fire Alarm System to be located in the new Electrical Room.

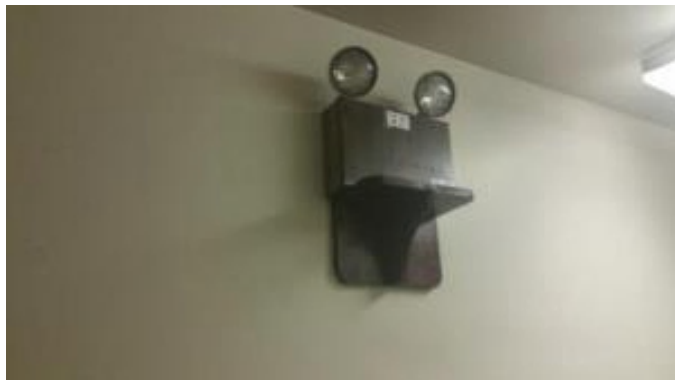
System: D5090 - Other Electrical Systems

Location: Throughout the building

Distress: Life Safety / NFPA / PFD

Notes: Install new battery packed emergency lights and exit lights in all the hallways, stairways, and in each class room or other purpose rooms.

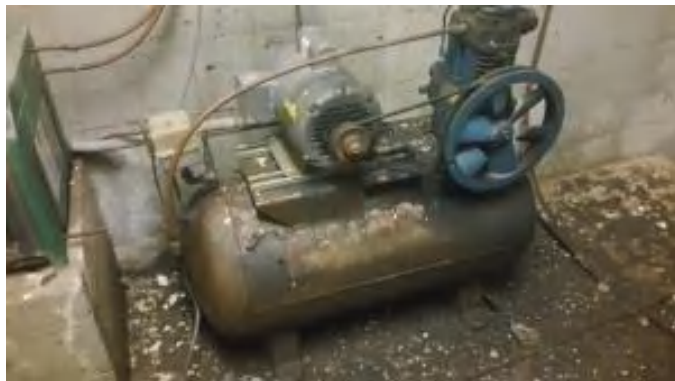
System: D5090 - Other Electrical Systems

Location: Electrical room in the basement

Distress: Beyond Service Life

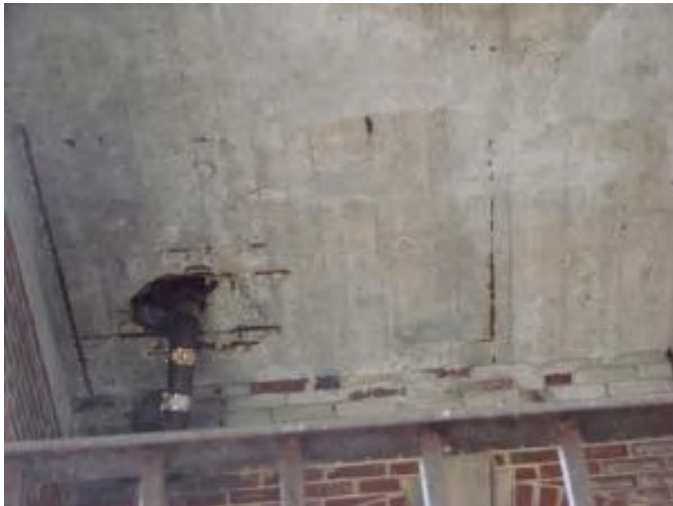
System: B1010 - Floor Construction

Location: Exterior/ Interior

Distress: Damaged

Correction: Repair rebar and epoxy grout exposed rebar on the underside of floors and floor beams

Notes: Repair damaged structural slabs and supporting members

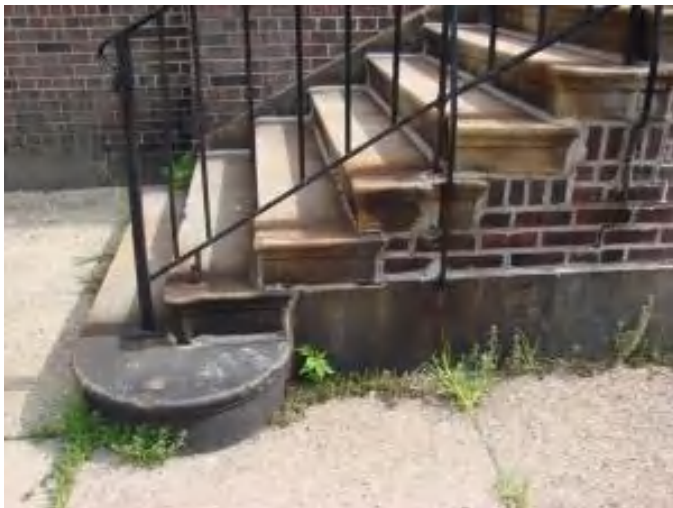
System: B2010 - Exterior Walls

Location: Exterior

Distress: Building Envelope Integrity

Correction: Repair cracks in masonry - replace missing mortar and repoint - SF of wall area

Notes: Repair cracks and tuck-point stone and brick masonry (entire building)

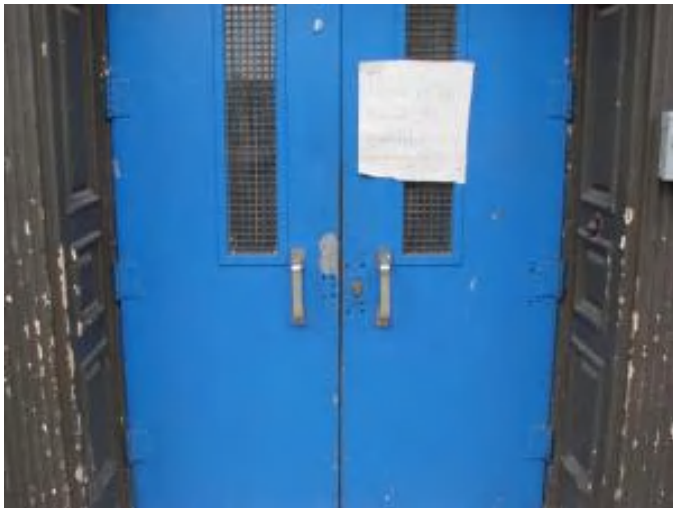
System: B2030 - Exterior Doors

Location: Exterior

Distress: Beyond Service Life

Correction: Remove and replace exterior doors - per leaf

Notes: Replace all exterior doors

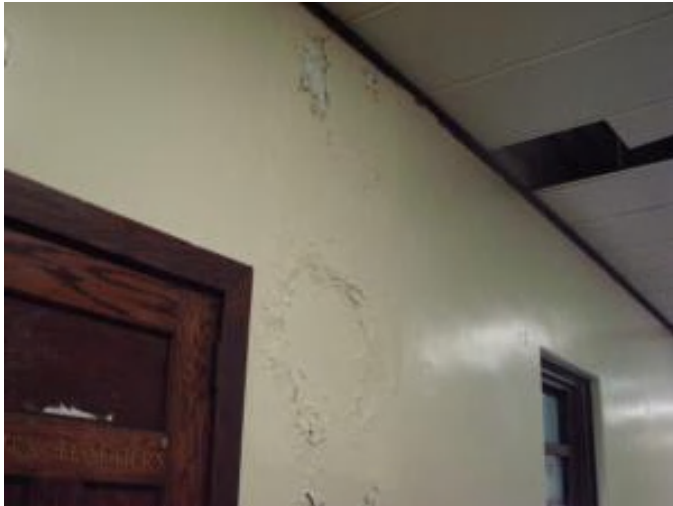
System: C3010230 - Paint & Covering

Location: Interior

Distress: Damaged

Correction: Repair and repaint all interior walls - SF of wall surface

Notes: Repair (10%) and repaint all interior walls

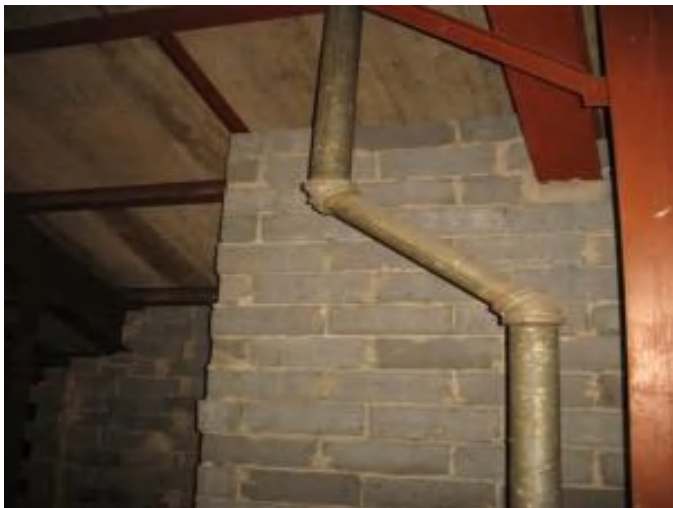
System: D2040 - Rain Water Drainage

Location: Throughout building

Distress: Beyond Service Life

Correction: Replace roof drains - per drain including piping

Notes: Hire a qualified contractor to perform a detailed examination of the rain water drainage piping using visual inspection and video cameras to locate and replace any damaged piping and to further quantify the extent of potential failures.

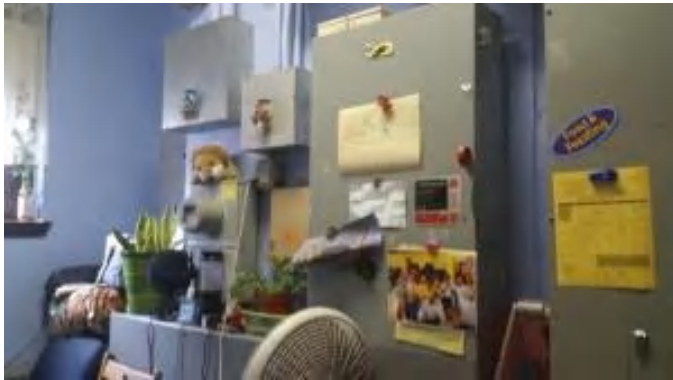
System: D5010 - Electrical Service/Distribution

Location: Electrical room in the basement

Distress: Beyond Service Life

Correction: Replace Electrical DIstribution System (U1)

Notes: Install a new electrical service. Upgrade the existing electrical service to a new service with a new 1000 KVA dry-type Transformer, 13.2KV to 480V/277V, 3Ph. Install a new 1200A, 480V, 3 Ph. Switchboard. The new Main switchboard shall be sized to handle the existing loads plus any new HVAC loads. Install a new step down transformer from 480V to 120V/208V, and a main 120V/208V Panel Board for all the lighting/receptacle loads. Install two 120V/208V panels in each floor to replace the existing panels. Also replace the power feeders, conduits, wire to the four panels from the new 120V/208V three phase main Panel Board.

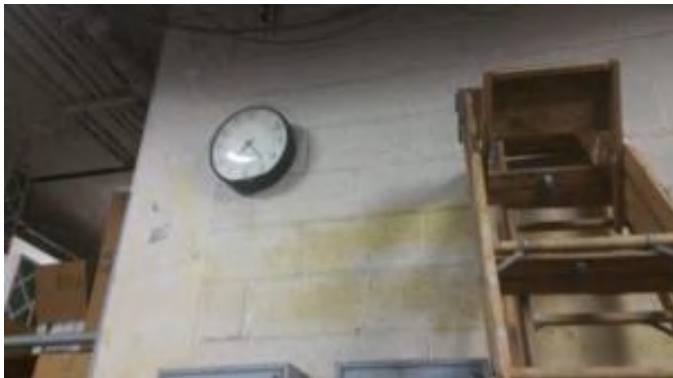
System: D5030 - Communications and Security

Location: Throughout the building

Distress: Beyond Service Life

Correction: Add/Replace Clock System or Components

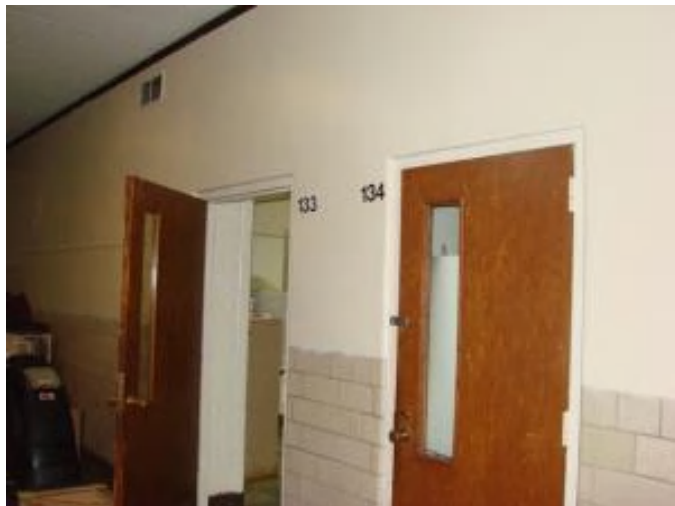
System: C1020 - Interior Doors

Location: Interior

Distress: Damaged

Correction: Remove and replace interior doors - wood doors with hollow metal frames - per leaf

Notes: Replace damaged classroom doors

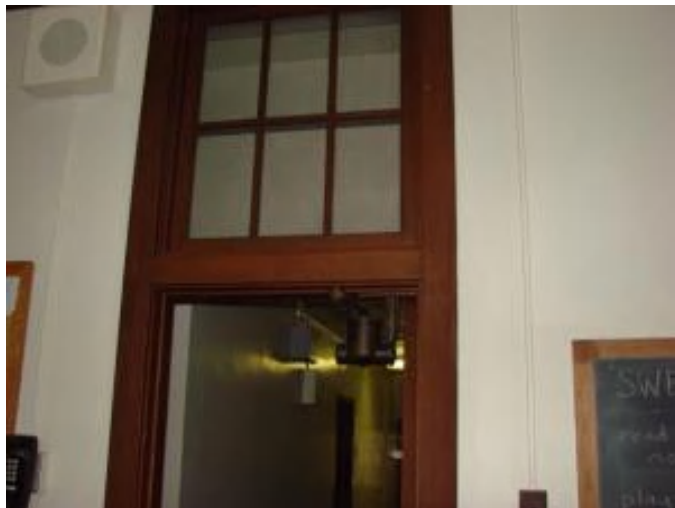
System: C1020 - Interior Doors

Location: Interior

Distress: Appearance

Notes: Refinish original doors and transoms

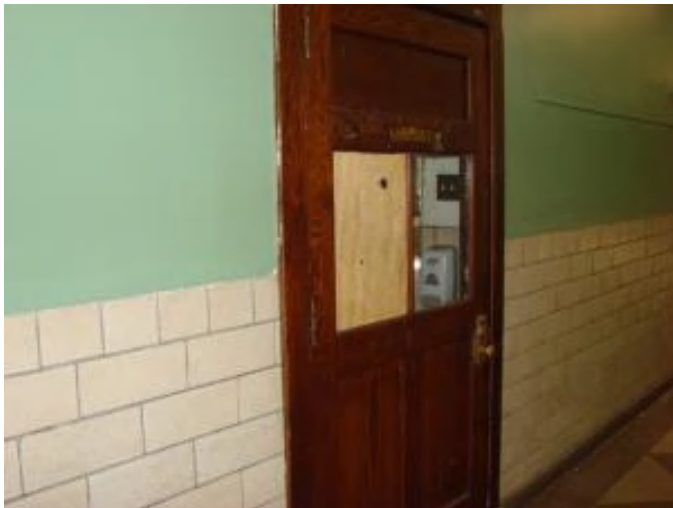
System: C1020 - Interior Doors

Location: Interior

Distress: Building / MEP Codes

Correction: Replace door knobs with compliant lever type

Notes: Replace door knobs with ADA compliant handles

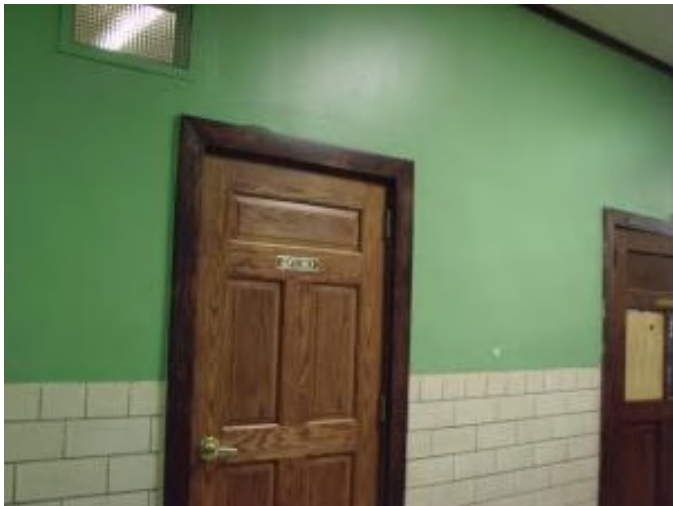
System: C1030 - Fittings

Location: Interior

Distress: Inadequate

Correction: Replace missing or damaged signage - insert the number of rooms

Notes: Install new signage throughout

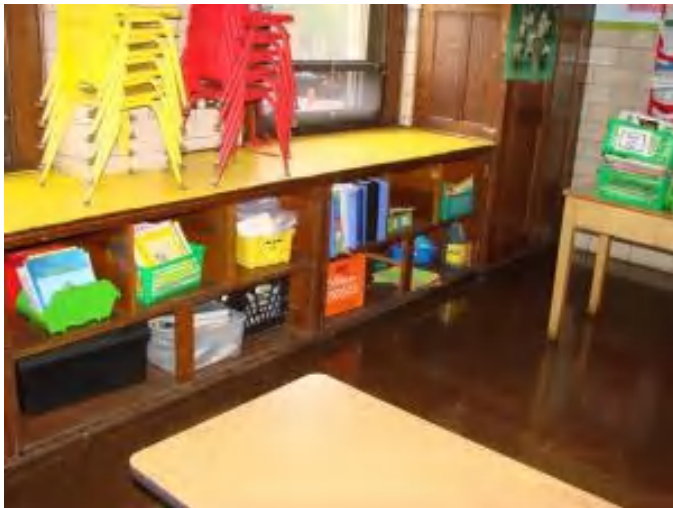
System: C3020414 - Wood Flooring

Location: Interior

Distress: Beyond Service Life

Notes: Repair refinish hardwood flooring

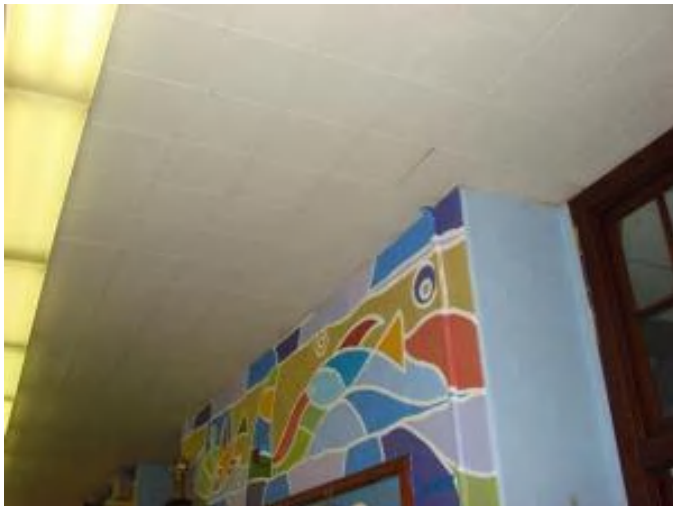
System: C3030 - Ceiling Finishes

Location: Interior

Distress: Damaged

Correction: Remove and replace suspended acoustic ceilings - lighting not included

Notes: Replace all suspended acoustical ceilings

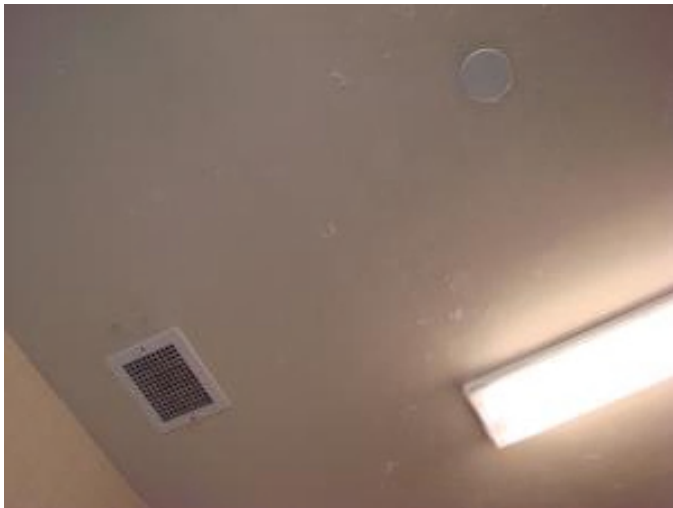
System: C3030 - Ceiling Finishes

Location: Interior

Distress: Beyond Service Life

Correction: Repair and resurface plaster ceilings - 2 coats plaster

Notes: Repair (15%) and repaint plaster ceilings

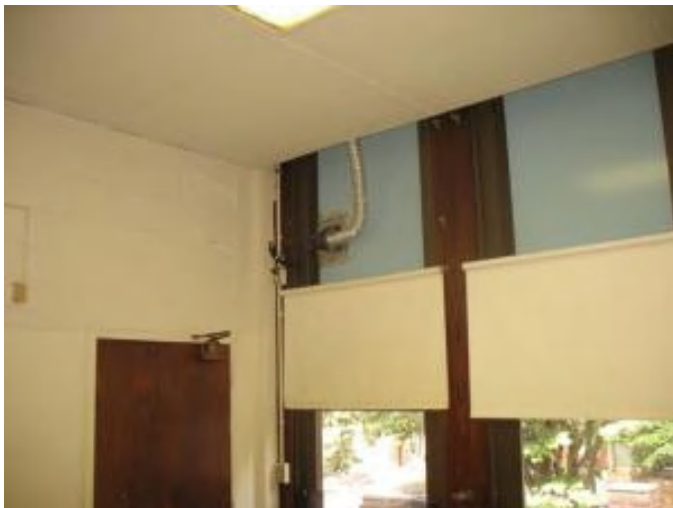
System: D3030 - Cooling Generating Systems

Location: Throughout building

Distress: Inadequate

Notes: Remove the window air conditioning units and install a 170 ton air-cooled chiller with chilled water distribution piping and pumps located in a mechanical room to supply more reliable air conditioning for the building with a much longer service life.

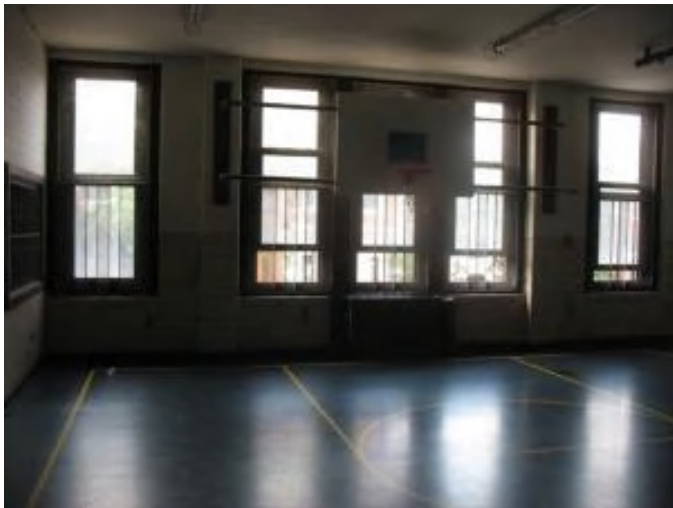
System: D3040 - Distribution Systems

Location: Gymnasium

Distress: Building / MEP Codes

Notes: Provide ventilation for the Gymnasium by installing a fan coil air handling unit hung from the structure with outdoor air ducted to the unit from louvers in the window openings.

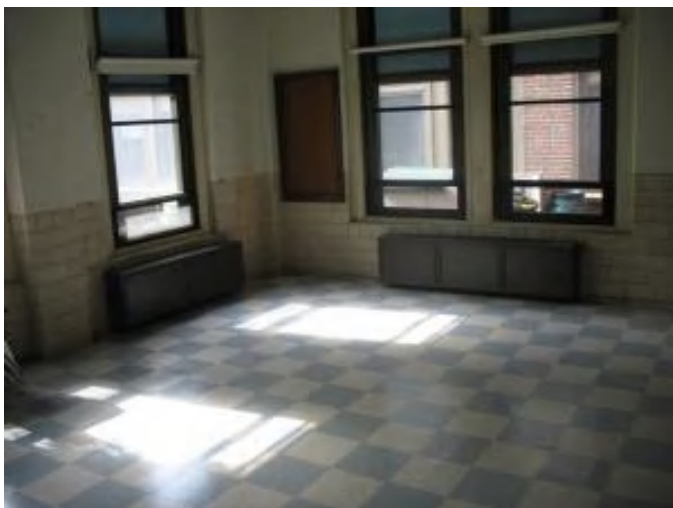
System: D3040 - Distribution Systems

Location: Cafeteria

Distress: Building / MEP Codes

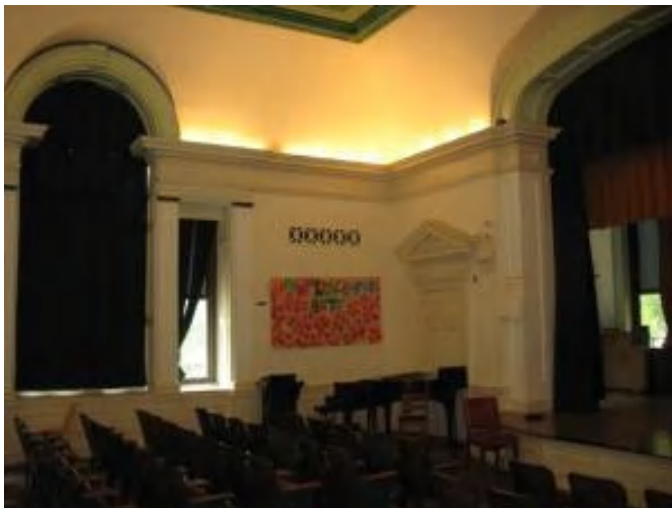
System: D3040 - Distribution Systems

Location: Auditorium

Distress: Building / MEP Codes

Correction: Install / replace HVAC unit for Auditorium (800 seat).

Notes: Provide ventilation for the Auditorium by installing a fan coil air handling unit hung from the structure with outdoor air ducted to the unit from louvers in window openings.

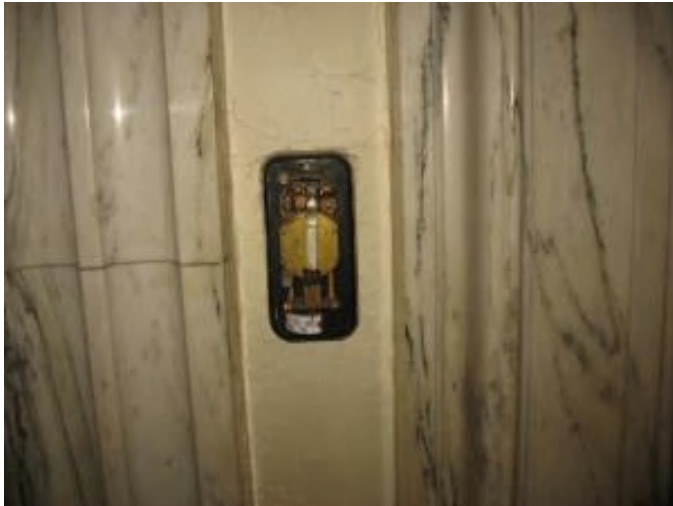
System: D3060 - Controls & Instrumentation

Location: Throughout building

Distress: Inadequate

Correction: Replace pneumatic controls with DDC (75KSF)

Notes: Replace the pneumatic controls for the HVAC systems with modern DDC modules, valves and actuators to improve reliability and energy efficiency. Provide a new building automation system (BAS) with communication interface to the preferred system in use throughout the District.

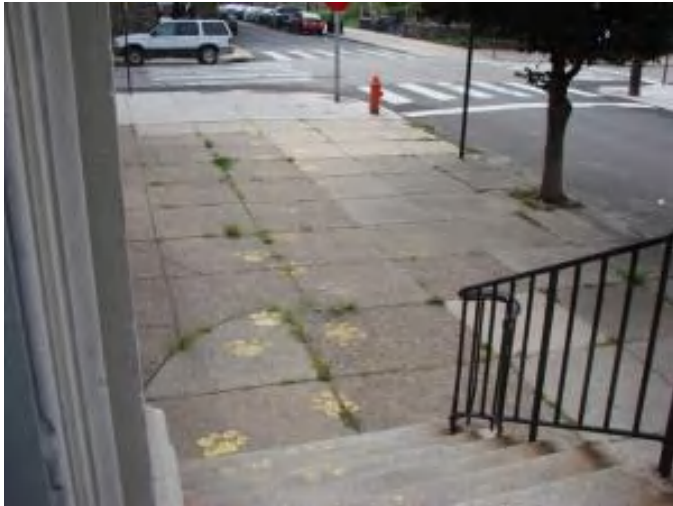
Location: Grounds/ site

System: G2030 - Pedestrian Paving

Distress: Beyond Service Life

Correction: Remove and replace concrete sidewalk or concrete paving - 4" concrete thickness
