Facility Condition Assessment Summary Report

Barton School

School District of Philadelphia
S720001; Barton
Final
Site Assessment Report

January 31, 2017

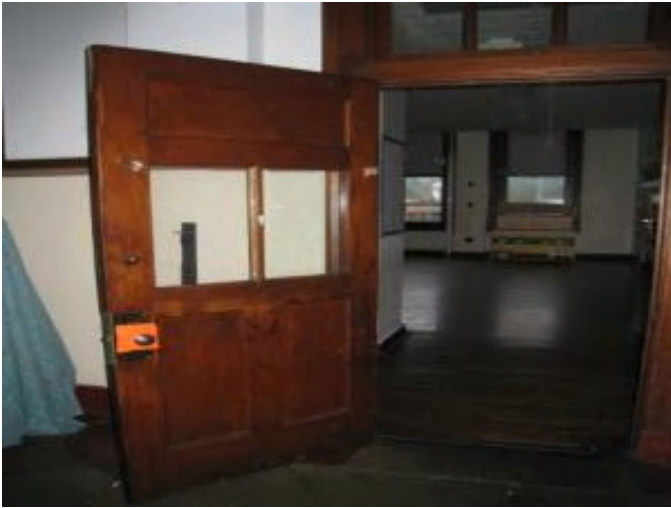
Location: classroom and office doors

System: C1020 - Interior Doors

Distress: Life Safety / NFPA / PFD

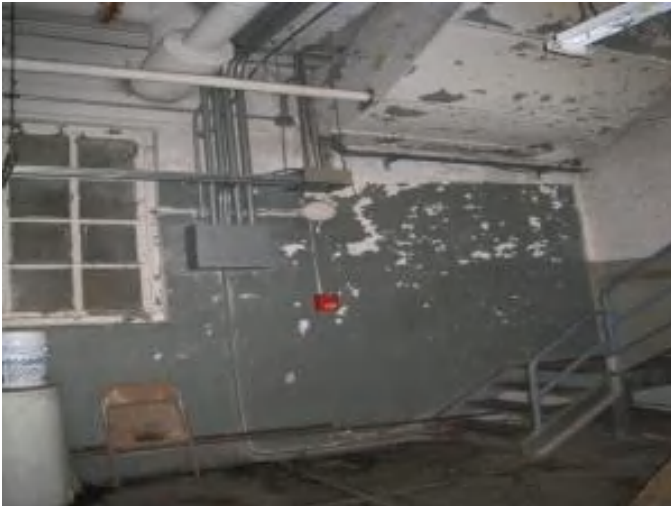
Location: boiler and mechanical rooms

System: C3010230 - Paint & Covering

Distress: Appearance

Notes: Strip and repaint concrete foundation (basement) walls in mechanical rooms

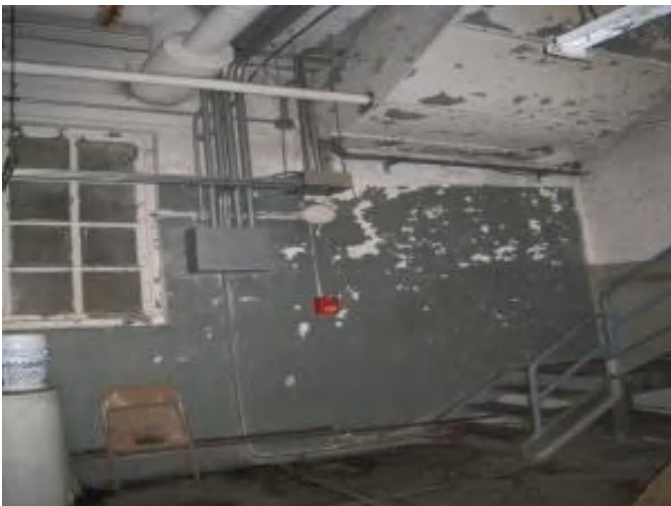
Location: ceilings

System: C3010230 - Paint & Covering

Distress: Appearance

Notes: Repaint plaster ceilings where damaged in the building

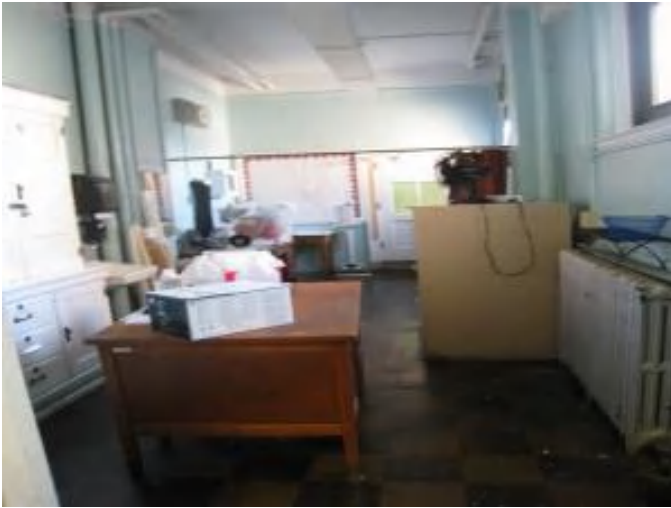
Location: offices

System: C3020413 - Vinyl Flooring

Distress: Life Safety / NFPA / PFD

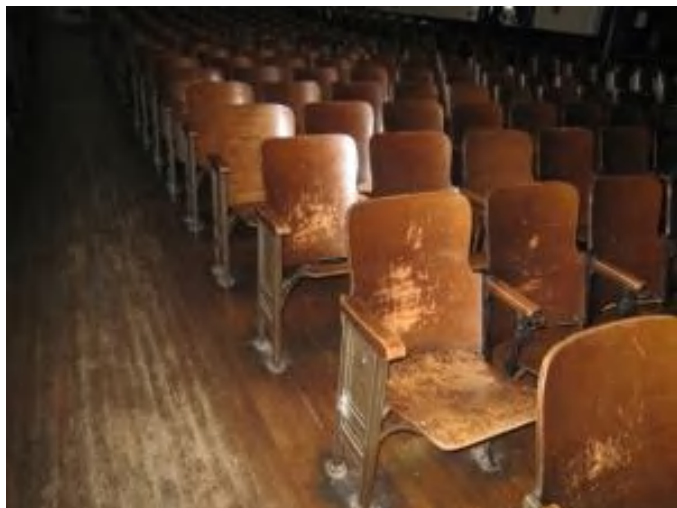
Location: auditorium

Furnishings include the original folding wood seating in the auditorium is still in use; however many seats need to be repaired to operate properly and many are scratched. With the unavailability of parts for repair and the worn condition of the seating, full replacement is required. Wood wainscot in the auditorium is generally in good condition and can be repaired and refinished. Casework in classrooms and the office is damaged, worn, and needs replacement. Few classrooms have smartboards.

System: E2010 - Fixed Furnishings

Distress: Beyond Service Life

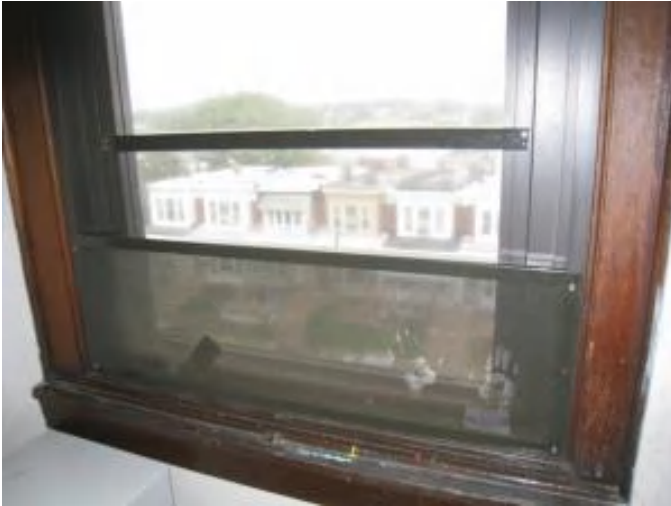
Location: exterior walls

Exterior windows were replaced in the 1990's with bronze anodized aluminum frame operable single hung units with single thickness clear plexiglass acrylic vision panel glazing. Windows are in poor condition with oxidized frames and severely scratched single-pane plexiglass vision panels. Operable units are difficult to operate up and down or do not stay open due to broken internal counterbalance weights, accidentally slamming closed in some cases – a potential safety hazard. Single pane plexiglass units do not meet today's energy code requirements and are large sources of heat loss. All wood trim around windows needs refinishing. Replacement of all windows is recommended.

System: B2020 - Exterior Windows

Distress: Beyond Service Life

Notes: Replace all exterior windows with insulated single hung units

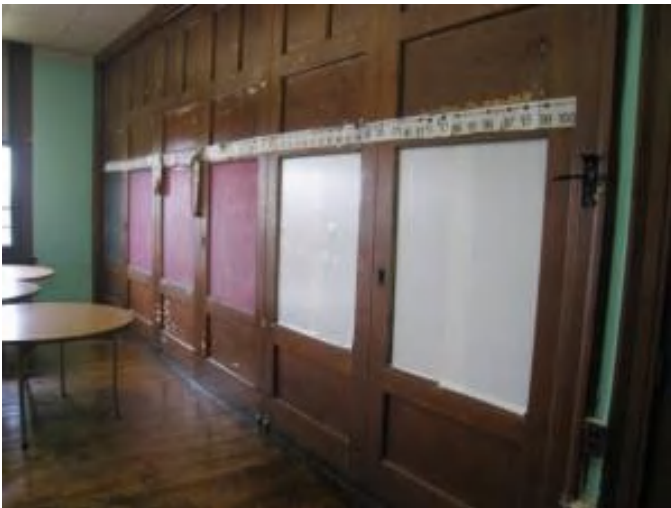
Location: classrooms

System: C1010 - Partitions

Distress: Beyond Service Life

Notes: Remove folding wood partitions; replace with gypsum board and metal stud walls

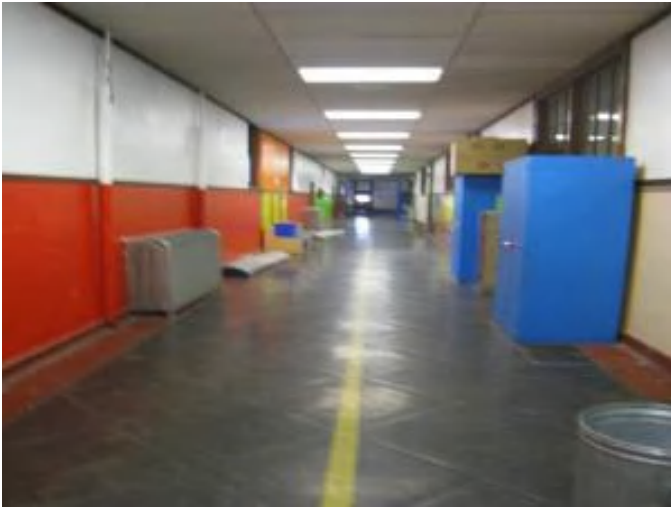
Location: corridors

System: C1010 - Partitions

Distress: Life Safety / NFPA / PFD

Notes: Remove non-rated glass panels between classrooms and corridors; fill with fire rated gyp bd sys.

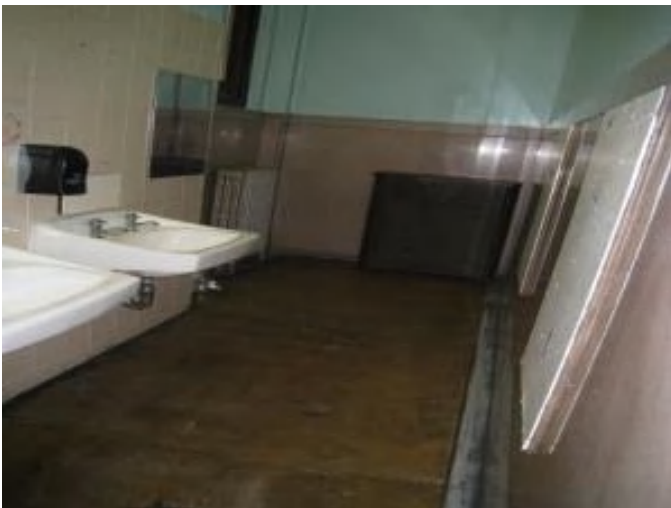
Location: toilet rooms

System: C1030 - Fittings

Distress: Beyond Service Life

Notes: Provide toilet room accessories and partitions (old bathrooms not yet renovated)

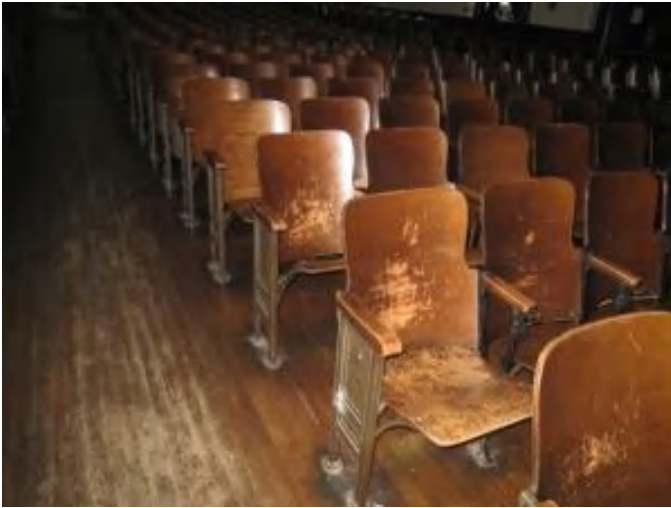
Location: classrooms, auditoriums

Floor finishes in the original building consist of mostly dark stained oak floors in classrooms and the auditorium. Most are in good enough condition to be stripped, sanded, and refinished. There are some classrooms and other rooms such as the main office, faculty lounge, and gymnasium (also serving as the cafeteria) finished with 12"x12" vinyl composition tile (VCT) over the old wood floors. Two small storage rooms in "Element 2" have 9"x9" tile floors that appear to be vinyl asbestos tiles (VAT). All wood floors need to be stripped and refinished to remove years of wax and dirt buildup; few need to be removed and replaced due to excessive warpage of the boards. All 12"x12" VCT floors need to be removed and replaced. Nine by nine inch tile floors may have asbestos and need to be addressed as possible asbestos containing materials. They should be removed using proper asbestos abatement procedures if they are found to contain asbestos. Corridor floors are finished with 4'x4' (nominal size) concrete tiles which appear to be a monolithic system and highly durable. Edges along the walls form a coved base and are painted. These slabs have not been stripped and cleaned for years and have dirt sealed into the surface and corners, causing their color to be very dark and dingy. There is an especially large build-up of dirt at all corners. Stairs walking surfaces are finished in exposed concrete that has years of dirt ground into the surfaces. These floor finishes should be stripped, cleaned and resealed.

System: C3020414 - Wood Flooring

Distress: Appearance

Notes: Strip, sand, repair and refinish all wood floors in classrooms and auditorium

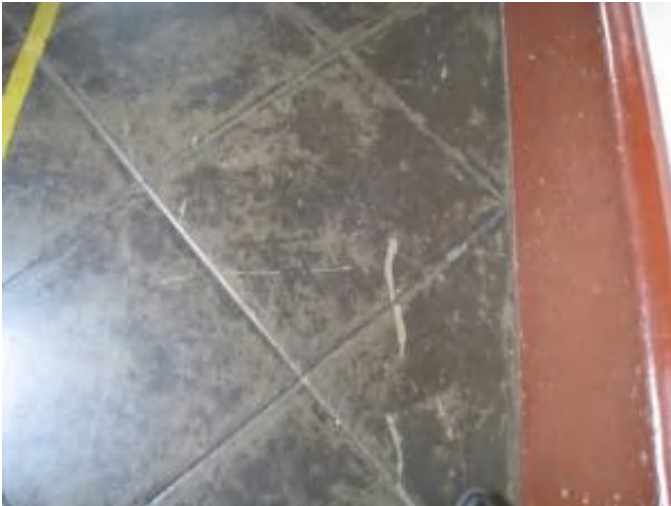
Location: interiors - corridors

System: C3020415 - Concrete Floor Finishes

Distress: Appearance

Notes: Clean and reseal concrete floors in hallways and stairways

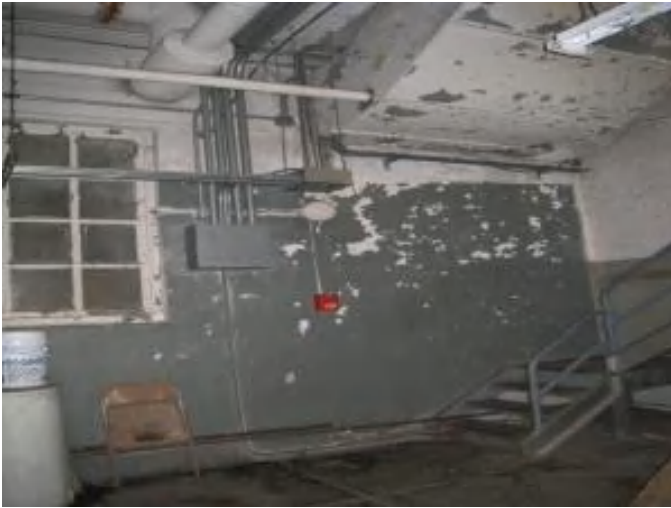
Location: boiler room floor

System: C3020415 - Concrete Floor Finishes

Distress: Appearance

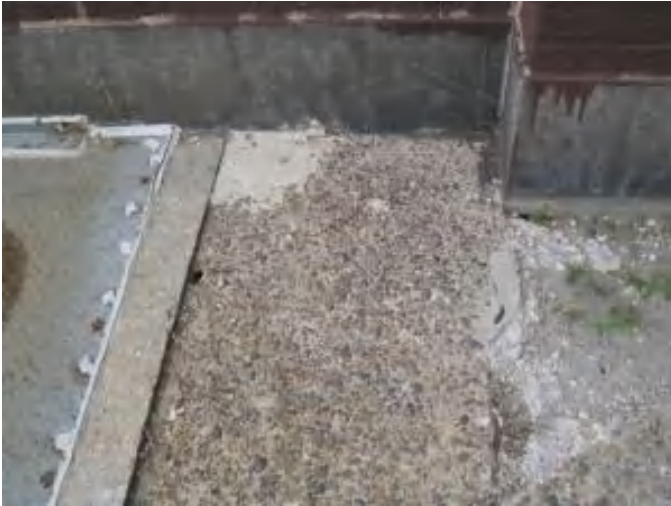
Location: exterior walls

Exterior walls are generally in good condition, however there are lintels above most basement windows, some upper windows, and some doors which are rusted with brick joint cracks extending from the lintels into the brick joints in the walls. On the roof, there are gaps along the caulk joint where the reglets meet parapet walls which could be sources for water to enter the wall, forming leaks inside. A more detailed inspection of masonry is required to repair all failing joints and ensure a watertight envelope. Brick is stained with dirt and mildew and should be cleaned.

System: B2010 - Exterior Walls

Distress: Appearance

Notes: Powerwash front and sides of building

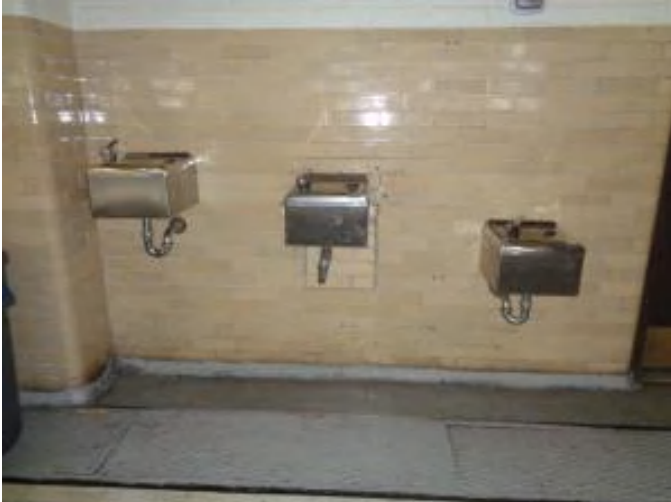
Location: corridors

Drinking fountains in the corridors and outside the restrooms are wall hung with integral refrigerated coolers. Most appear to be beyond their service life. Replacement of all drinking fountains is recommended.

System: D2010 - Plumbing Fixtures

Distress: Beyond Service Life

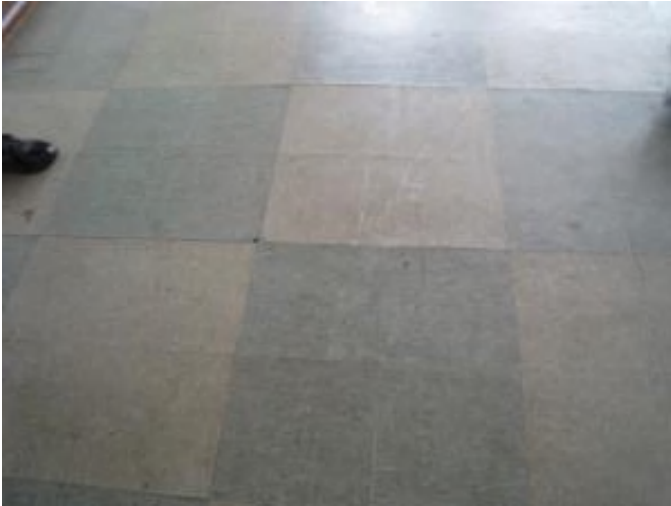
Location: gymnasium, classrooms

System: C3020413 - Vinyl Flooring

Distress: Beyond Service Life

Notes: Remove and replace all 12"x12" VCT floors in classrooms and gym

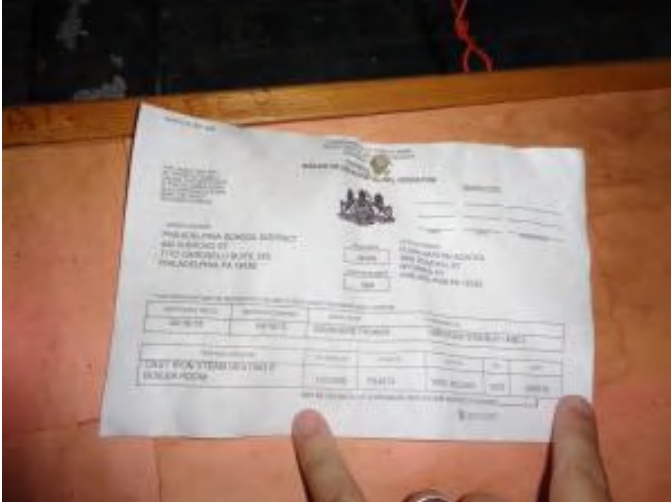
Location: boiler room

The boilers have Webster oil burners. The boilers and burners appear to be at the end of their serviceable life and should be replaced within the next 5 years.

System: D3020 - Heat Generating Systems

Distress: Beyond Service Life

Notes: The steam boilers appear to be at the end of their serviceable life and should be replaced within the next 5 years with hot water boilers..

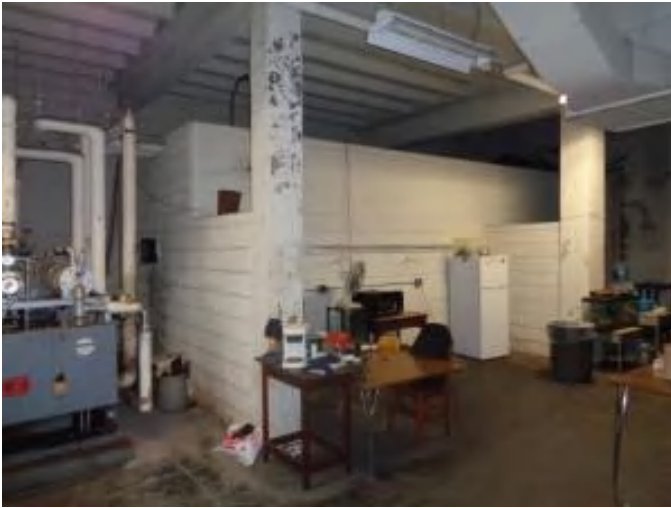
Location: outside building, location to be determined

System: D3020 - Heat Generating Systems

Distress: Life Safety / NFPA / PFD

Notes: Replace concrete fuel tank

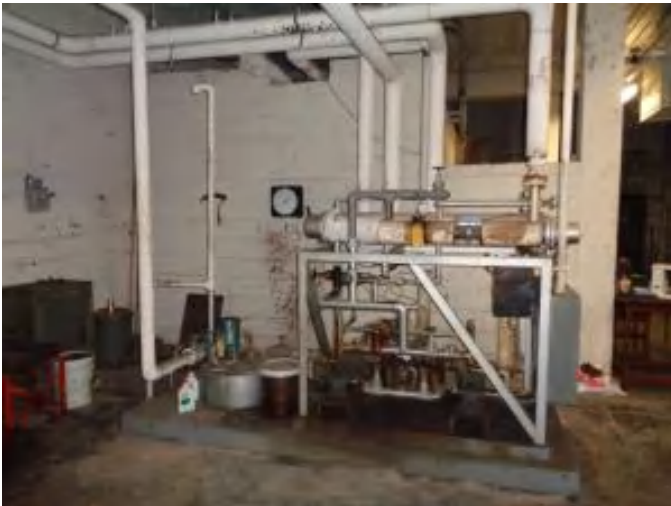
Location: boiler room

System: D3020 - Heat Generating Systems

Distress: Beyond Service Life

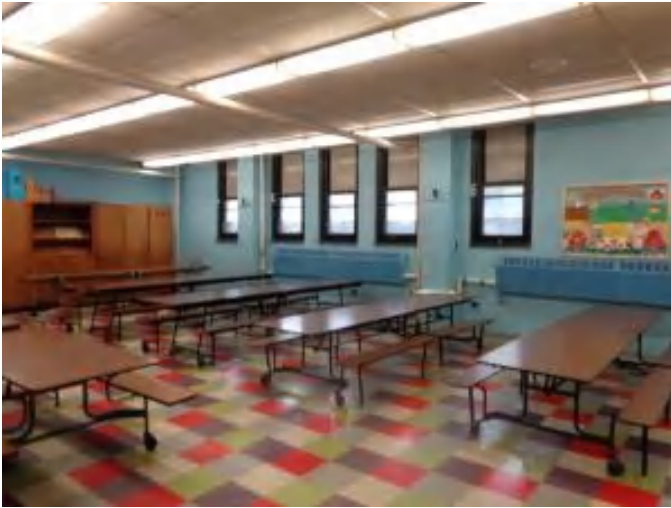
Location: cafeteria

System: D3040 - Distribution Systems

Distress: Inadequate

Notes: Install AHU to condition the cafeteria

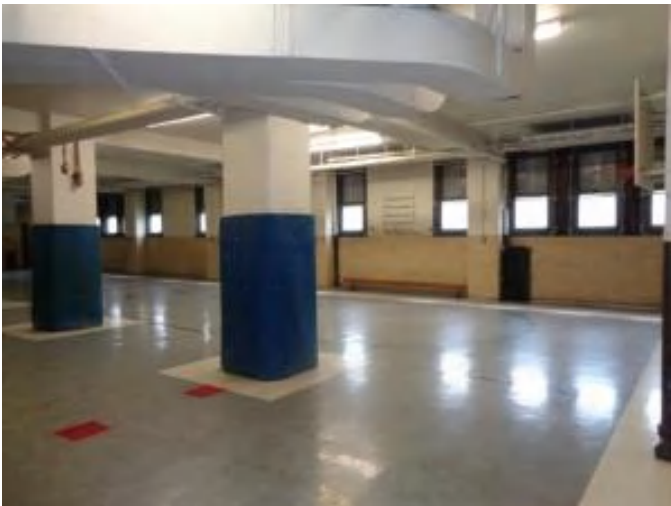
Location: gym

System: D3040 - Distribution Systems

Distress: Inadequate

Notes: Install AHU to condition the gymnasium

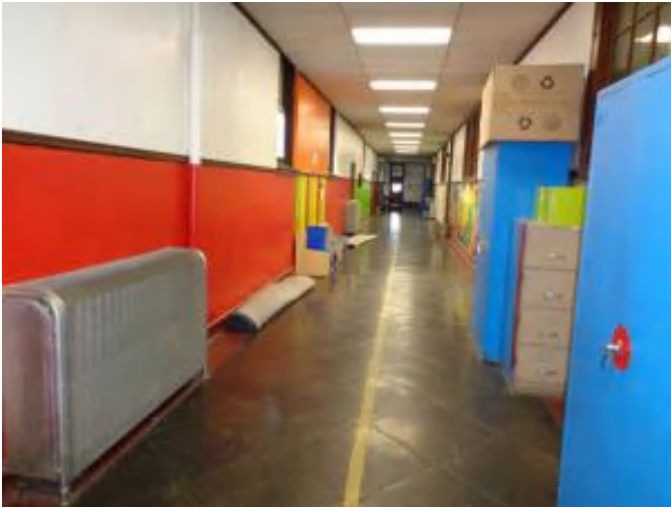
Location: entire building

System: D4010 - Sprinklers

Distress: Life Safety / NFPA / PFD

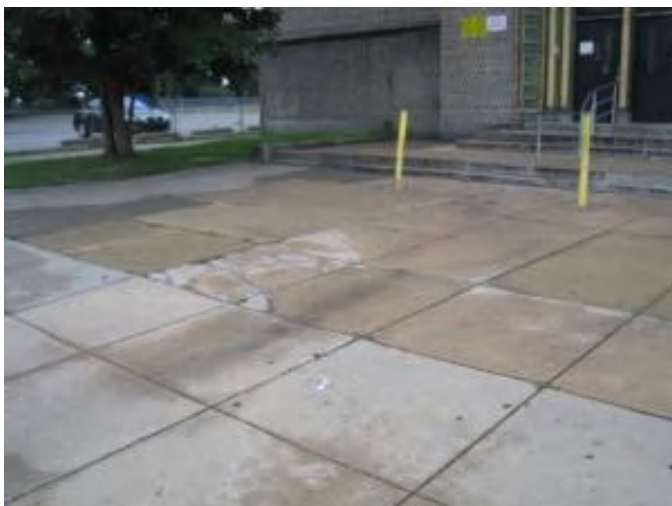
Location: concrete play area

System: G2030 - Pedestrian Paving

Distress: Failing

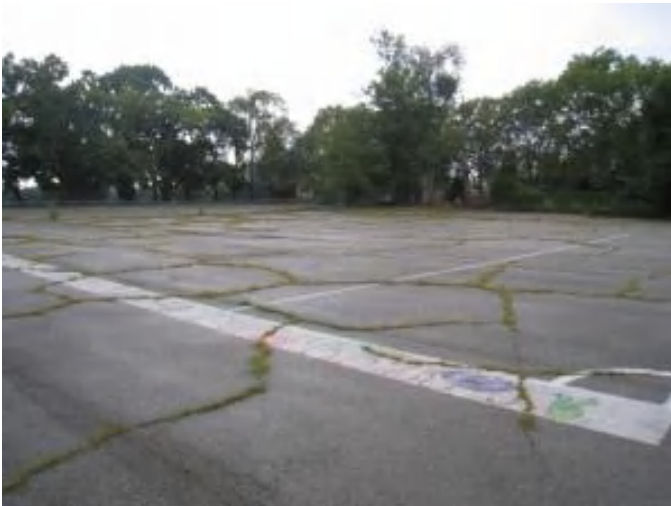
Location: parking lot

Paving and parking is constructed of asphalt and in need of repaving. Asphalt areas serve as parking and playground areas, separated by fences. Stairways into the building are limestone blocks (tread/riser) with grouted joints between blocks; all stairs need regrouting. Parking and play area striping is worn and almost invisible. Clear separation of play area and parking is not evident. The number of required parking spaces for school staff is unknown.

System: G2020 - Parking Lots

Distress: Beyond Service Life

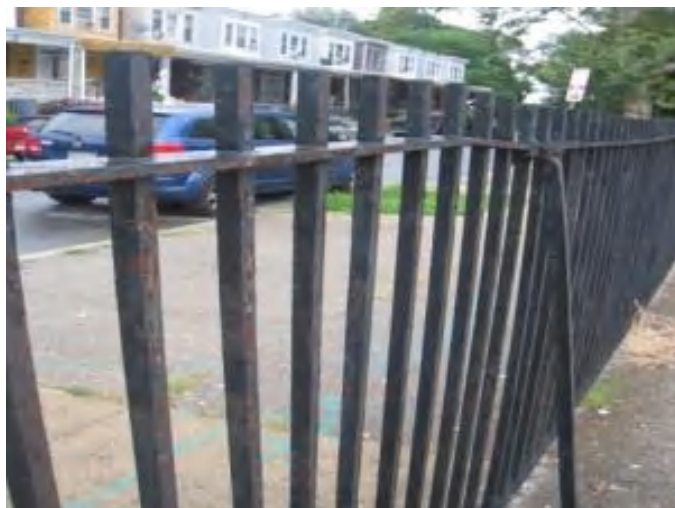
Location: edge of property

System: G2040 - Site Development

Distress: Beyond Service Life
