## Facility Condition Assessment Summary Report

### Beeber Middle School

School District of Philadelphia  
**S410001;Beeber**  
Final  
**Site Assessment Report**

January 30, 2017

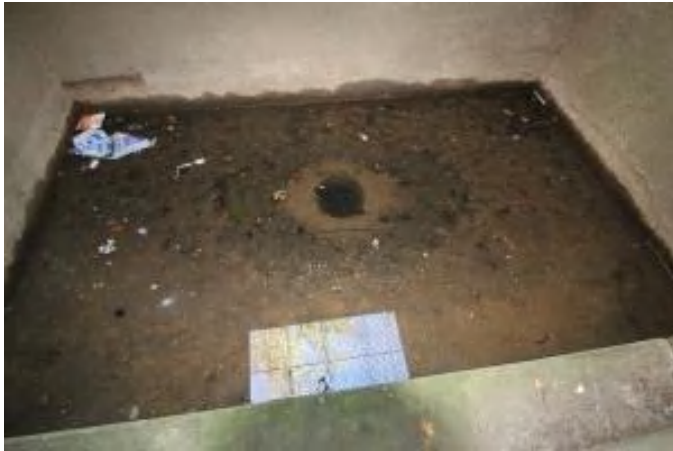
**System: D2040 - Rain Water Drainage**

Rain water drain pipes are threaded galvanized steel fed from cast iron roof drains. Drain pipes run inside the building. There are no overflow drains on the roof. Roof drains appear to have been recently replaced, likely in 2005 when the roof was last replaced. The pipe appears older than 10 years. There are drainage problems throughout the building and especially at basement level stairwells where there is ponding. The rain water drain system should be inspected in detail and repaired where needed.

**Location:** Entire building

**Distress:** Failing

- Repair or replace inoperative hot water circulation pump
- Inspect and repair sanitary drain system due to age and appearance
- Inspect and repair rain water drain system due to ponding and age

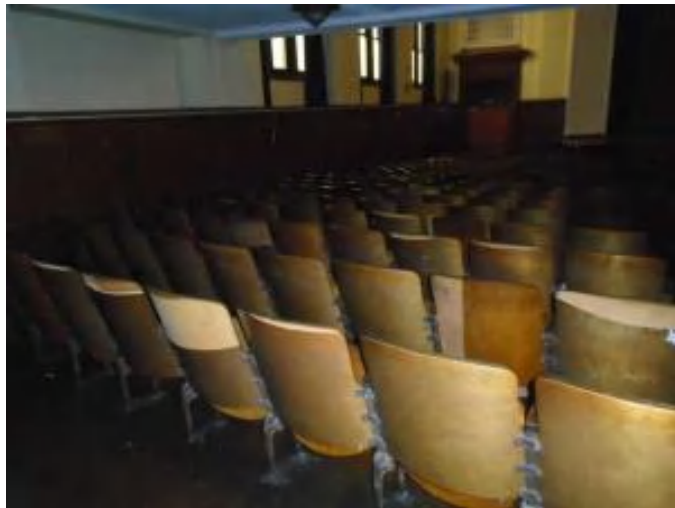
**System: E2010 - Fixed Furnishings**

Fixed furnishings include: fixed casework in classrooms, corridors and library, generally in fair to good condition; window shades/blinds, generally in fair condition; and fixed auditorium seating generally in poor condition with some damaged and missing seats and failing veneer.

**Location:** Auditorium/balcony

**Distress:** Beyond Service Life

- Replace auditorium seats – beyond service life and failing veneer
- Replace concrete paving – spalling and cracking (10% of concrete paving area)
- Replace site fencing rusted, damaged, and failing

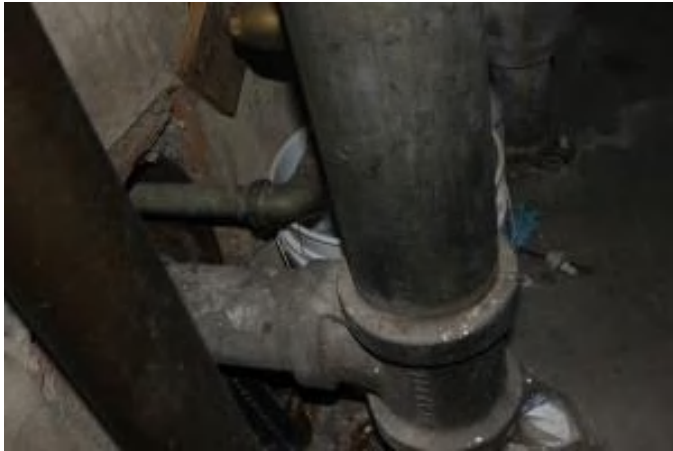
**System: D2030 - Sanitary Waste**

Sanitary drain piping is threaded galvanized steel pipe. Precise age is unknown, but it has certainly surpassed its expected lifespan and flows poorly. The sanitary drain pipes should be inspected in detail and repaired or replaced as needed. The building has a sewage ejector located in a sump in the basement mechanical room at the front of the building. The sump is flooded with water and appears to have an electric submerged sump pump to prevent overflow. The sewage ejector appears to be pneumatically operated and there is one air pump in the sump room and a second

**Location:** Entire building

**Distress:** Beyond Service Life

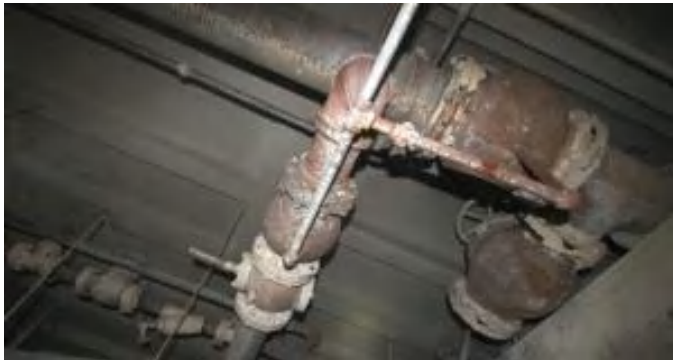
**System: D3040 - Distribution Systems**

**Location:** Entire building

**Distress:** Failing

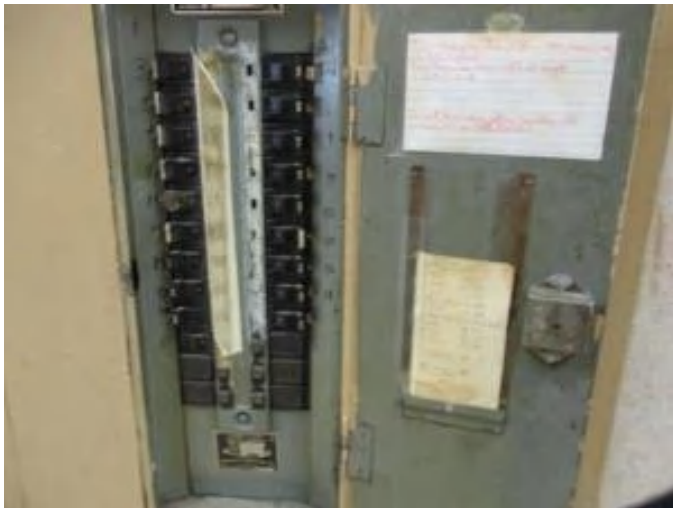
**System: D5010 - Electrical Service/Distribution**

There are 120/240V panel-boards in each floor for lighting and receptacles. These panelboards and associated wiring have exceeded the end of their useful life and are undersized to absorb new loads. The entire distribution system needs to be replaced with new 208/120 volt, 3 phase panelboards and new wiring. The raceway is mainly conduits run above the ceiling.

**Location:** Entire Building

**Distress:** Inadequate

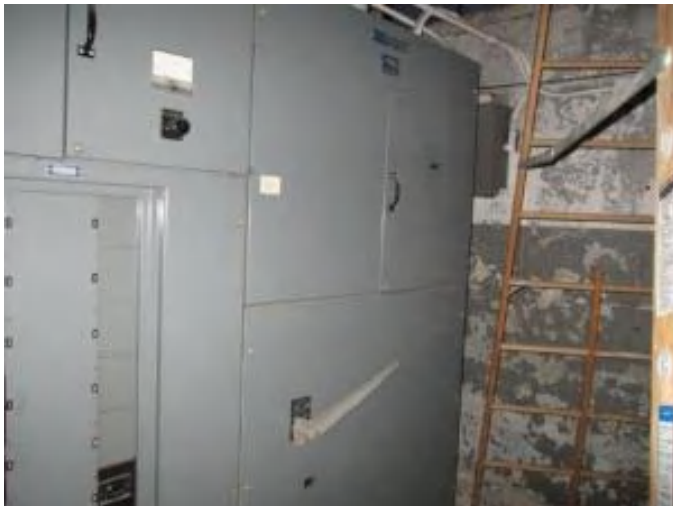
**System: D5010 - Electrical Service/Distribution**

**Location:** Basement

**Distress:** Inadequate

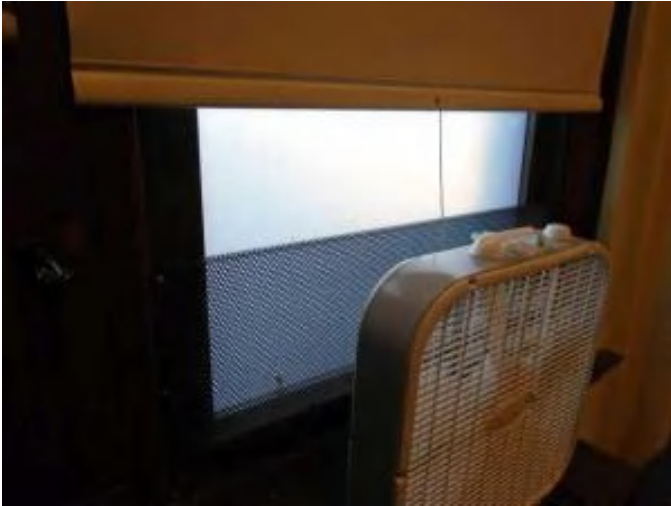
**System: B2020 - Exterior Windows**

**Location:** Throughout

**Distress:** Energy Efficiency

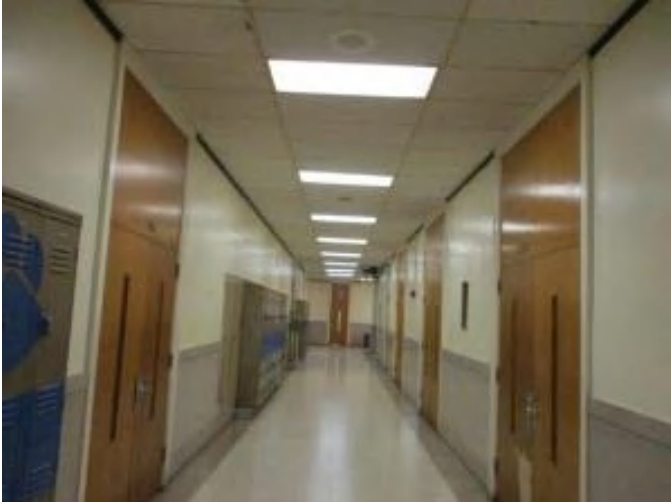
**System: D5030 - Communications and Security**

**Location:** Entire Building

**Distress:** Security Issue

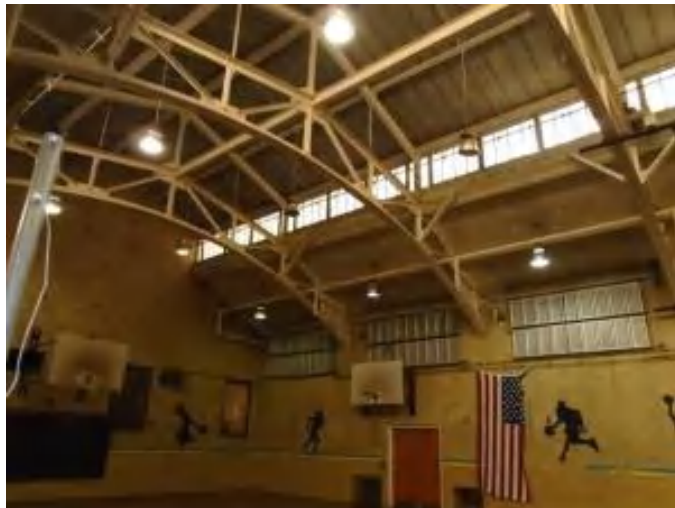
**System: E1020 - Institutional Equipment**

Commercial and institutional equipment includes: stage equipment, generally in fair condition and gym equipment in poor condition and beyond service life. Other equipment includes food preparation and food service equipment in good

**Location:** Gyms

**Distress:** Beyond Service Life

- Replace suspended acoustic ceiling system – rusted & beyond service life (90% of suspended ceiling area)
- Replace gymnasium equipment – damaged and beyond service life

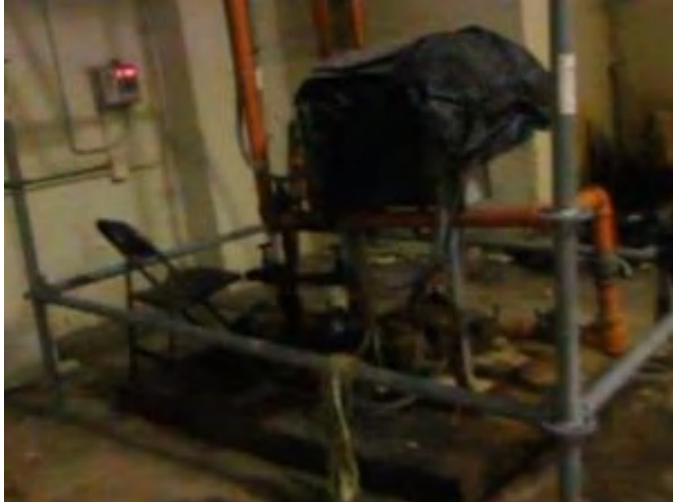
**System: D3020 - Heat Generating Systems**

Three Smith brand, model 6500A-S-19, 7,691 MBH (230 HP) cast iron steam boilers are in the boiler room. Two of them were not operational at the time of the inspection. Boilers should be replaced due to age and chronic repair needs. Power Flame oil fueled burners were manufactured in 2005. The 12,000 oil tank is behind the building. The two oil circulation pumps do not run well, and should be replaced. Boiler feedwater tank has three pumps for the three boilers and a fourth spare pump. Feed pumps are 1 HP. There is a condensate vacuum system with two 5 HP pumps located above the feedwater tank. The boiler chemical injection tank and pump are located next to the feedwater tank. There is a water softener for boiler makeup water. Combustion make up air enters through ceiling level automatic louvers. Boiler exhausts have draft fans. The building has a 1 inch natural gas supply line for the boiler pilot lights, water heater, and kitchen appliance. It enters the building from 59<sup>th</sup> Street in the basement north east mechanical room.

**Location:** Boiler room

**Distress:** Failing

- Replace boilers due to age and chronic repair needs
- Replace failing oil pumps
- Survey and repair steam traps
- Install 350 ton cooling system
- Replace original AHUs due to age and lack of cooling

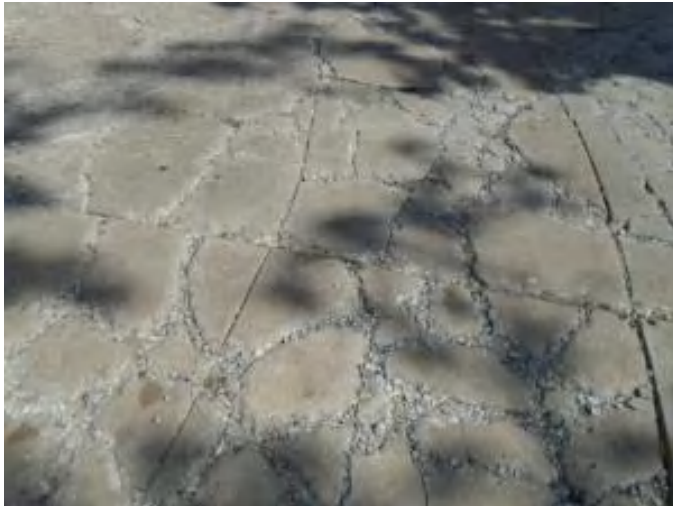
#### System: G2030 - Pedestrian Paving

**Location:** Yard

**Distress:** Damaged

**Notes:** Replace concrete paving – spalling and cracking (10% of concrete paving area)

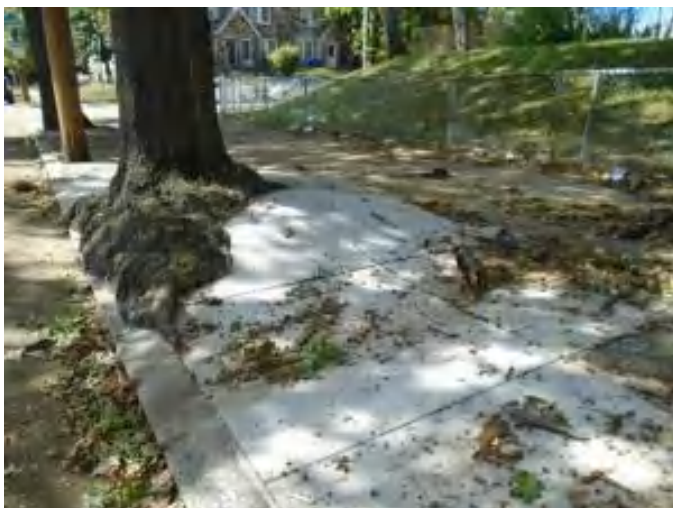
#### System: G2030 - Pedestrian Paving

**Location:** Sidewalks

**Distress:** Damaged

- Repair perimeter wall – SW corner failing
- Replace concrete sidewalks – damaged by trees and roots
- Replace all floor standing urinals, 38
- Replace 25% of water closets, 15

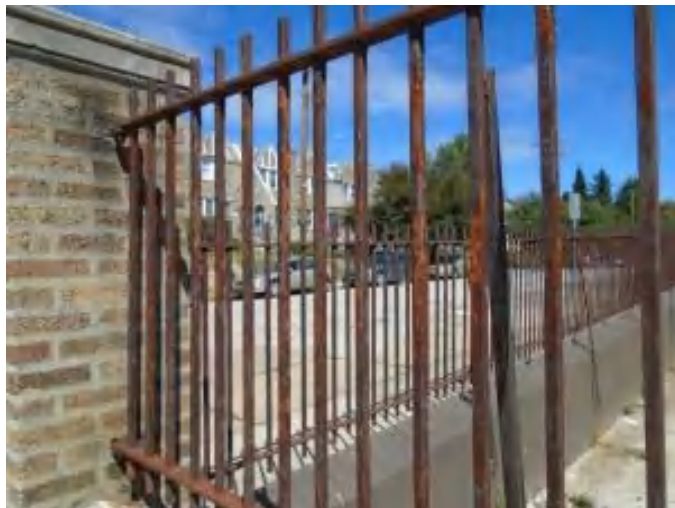
**System: G2040 - Site Development**

**Location:** Site

**Distress:** Failing
