Facility Condition Assessment Summary Report

Blaine School

School District of Philadelphia
S422001;Blaine
Final
Site Assessment Report

January 30, 2017

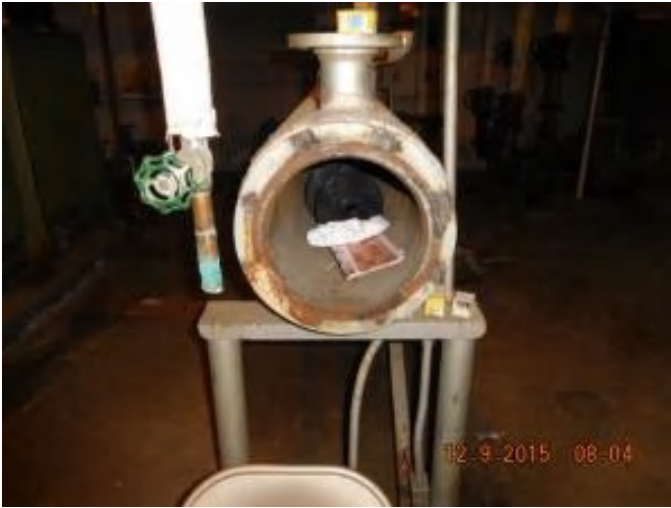
System: D2020 - Domestic Water Distribution

Location: entire building

Distress: Beyond Service Life

Notes: Replace domestic hot and cold water piping including valves, fittings, hangars and insulation.

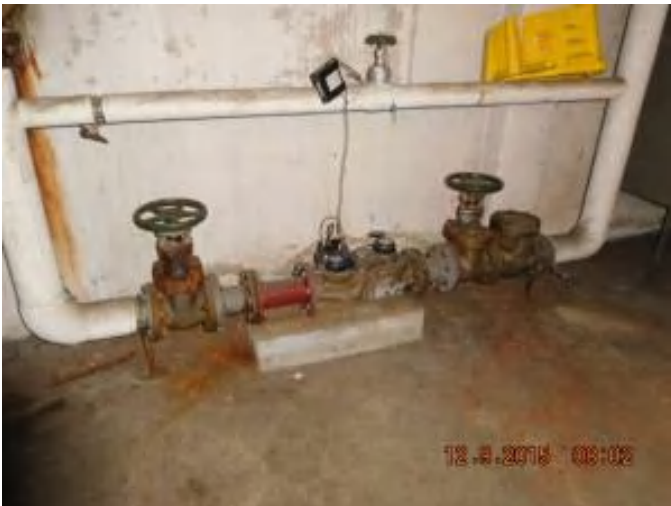
System: D2020 - Domestic Water Distribution

Location: mechanical room

Distress: Building / MEP Codes

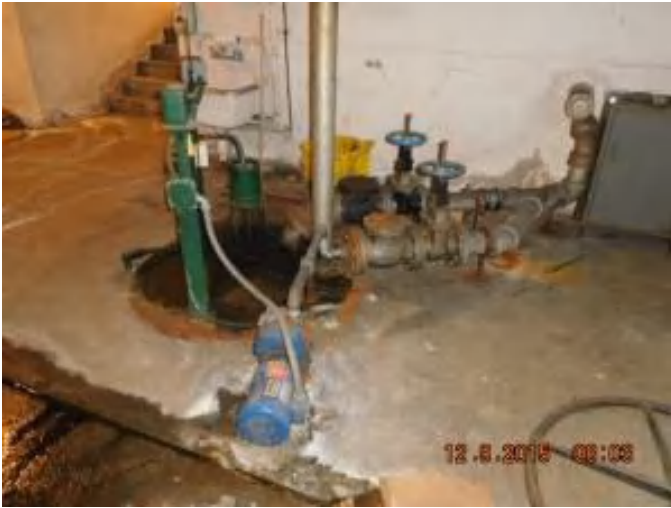
System: D2030 - Sanitary Waste

Location: mechanical room

Distress: Beyond Service Life

Notes: Replace existing duplex sump pump in mechanical room.

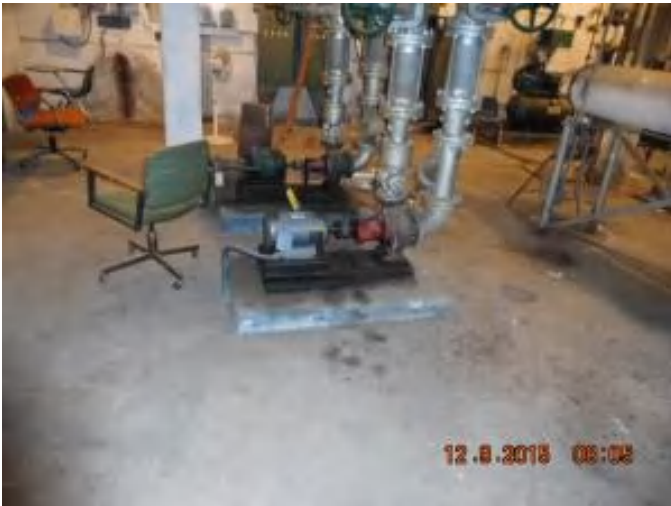
System: D3020 - Heat Generating Systems

Location: mechanical room

Distress: Beyond Service Life

Notes: Replace two existing hot water pumps. Include electrical connections.

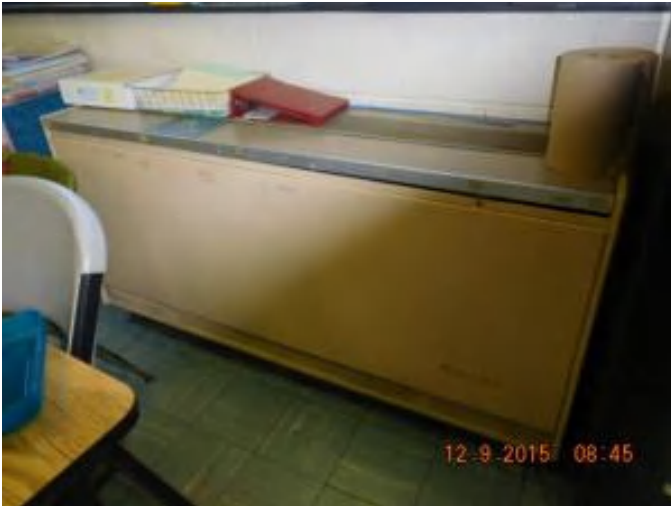
System: D3040 - Distribution Systems

Location: classrooms

Distress: Building / MEP Codes

Notes: Replace the existing unit ventilators with new units designed for quiet operation and equipped with hot water and chilled water coils, hydronic control valves with digital controls and integral heat exchangers to provide code required fresh air quantities. Connect to new chilled and hot water piping systems and building automation control system.

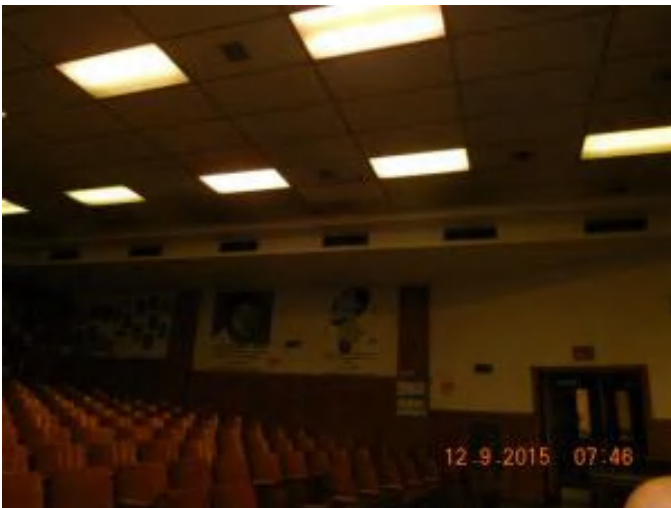
System: D3040 - Distribution Systems

Location: auditorium

Distress: Building / MEP Codes

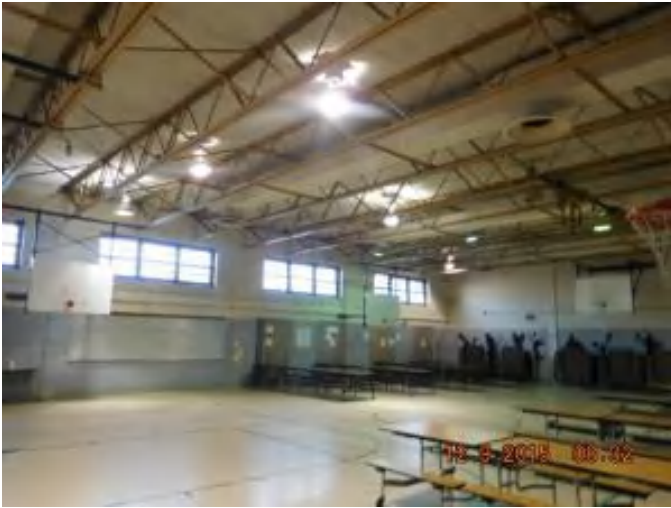
System: D4010 - Sprinklers

Location: entire building

Distress: Life Safety / NFPA / PFD

Notes: Install complete NFPA wet pipe automatic sprinkler system and standpipes. If required provide fire pump and jockey pump with controller.

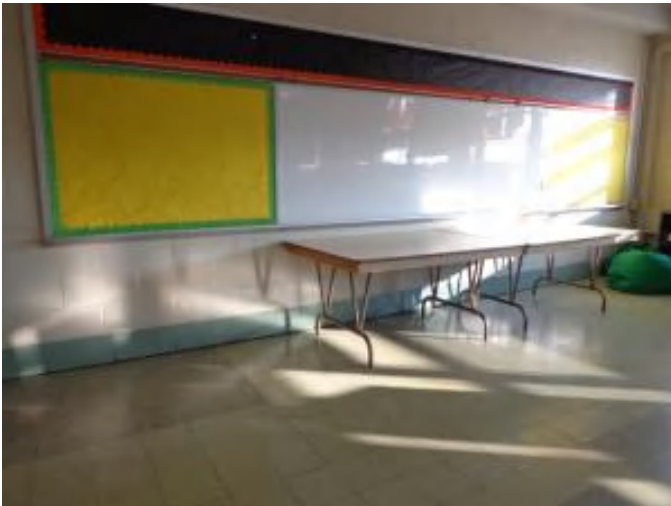
System: D5020 - Lighting and Branch Wiring

Location: Classrooms

Distress: Inadequate

Notes: Provide surface metal raceway system with 6 to 8 duplex receptacles in each of 32 classrooms.

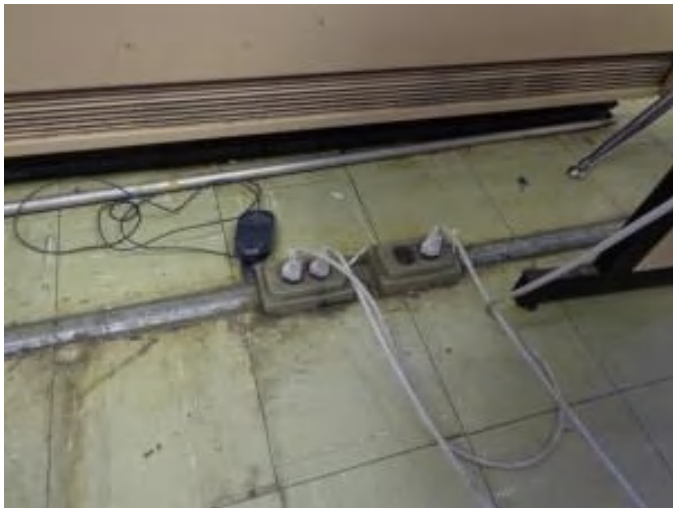
System: D5020 - Lighting and Branch Wiring

Location: Computer Room 311

Distress: Beyond Service Life

Notes: Replace floor mounted raceway system and (24) duplex receptacles in Computer Room 311.

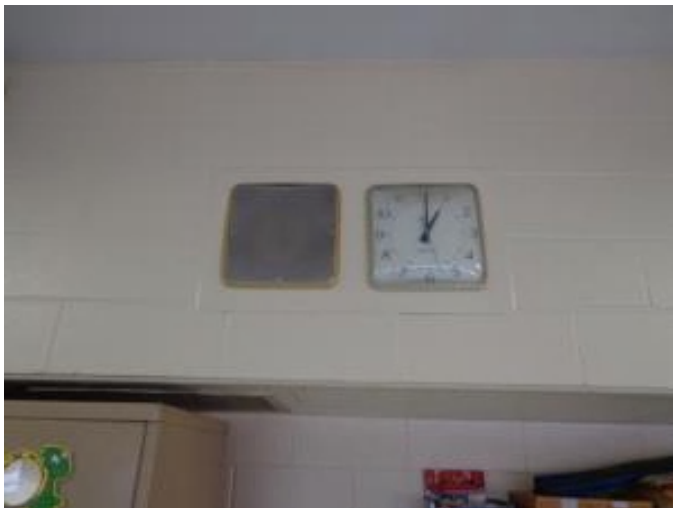
System: D5030 - Communications and Security

Location: Building wide

Distress: Failing

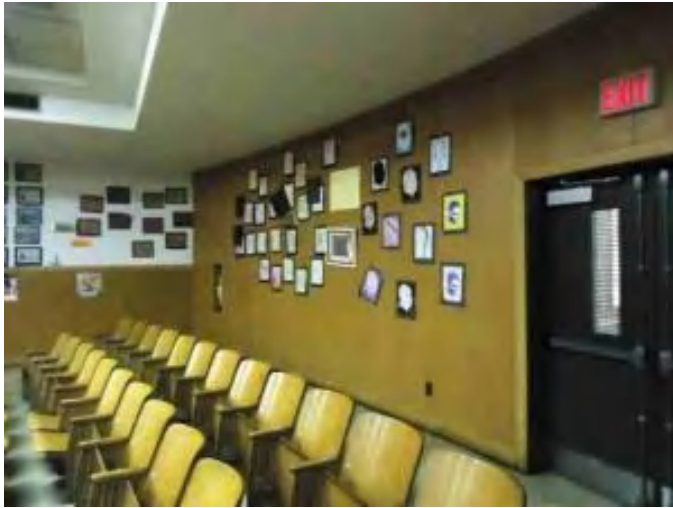
System: E2010 - Fixed Furnishings

Location: Auditorium

Distress: Damaged

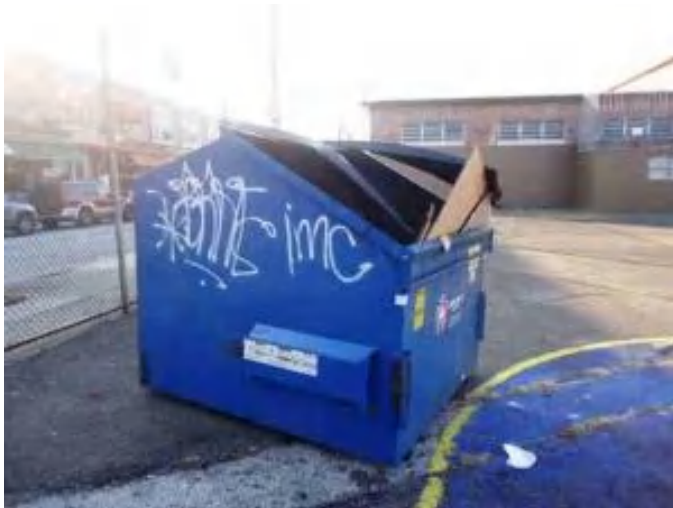
System: G2040 - Site Development

Location: Site

Distress: Health Hazard / Risk

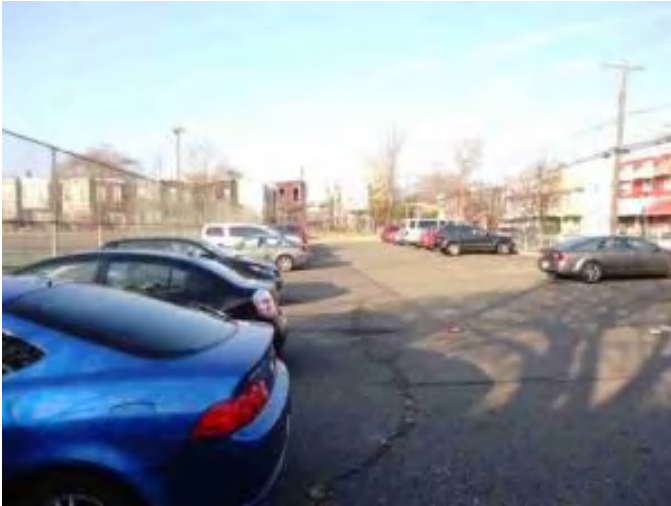
System: G2030 - Pedestrian Paving

Location: Site

Distress: Damaged

Notes: The parking play area has no assigned parking and limited markers for approved activity areas. No curb cuts for access to the sidewalks that lead to the ADA main entrance. The parking play lot is in fair condition, the harsh environmental conditions associated with snow removal have taken its toll on the asphalt surface. Also, there is no marked path of ingress to the main entrance. This project provides a budgetary consideration for a play, parking lot renewal program that includes all aspects of the current ADA legislation. Asphalt removal and replacement is recommended.

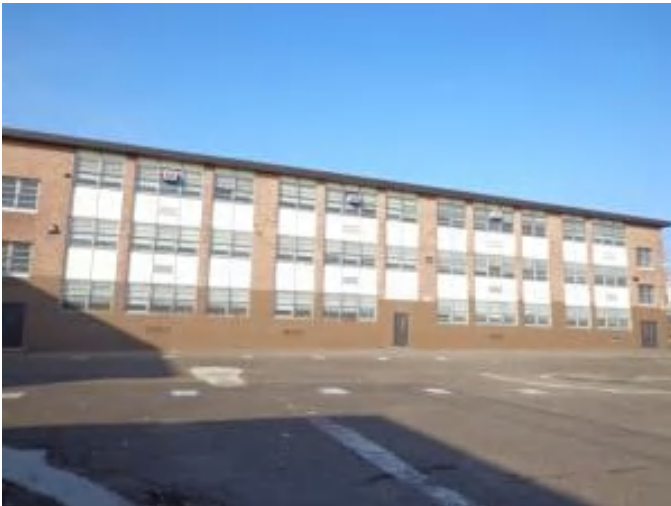
System: G4030 - Site Communications & Security

Location: Site

Distress: Beyond Service Life

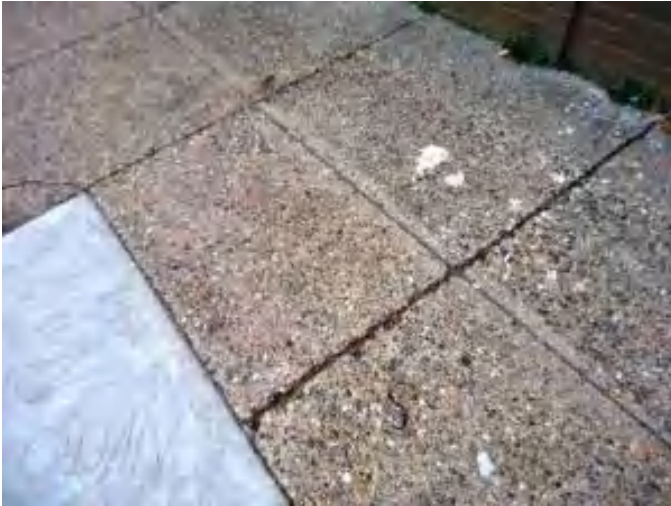
System: G2030 - Pedestrian Paving

Location: Site

Distress: Damaged
