Facility Condition Assessment Summary Report

CAPA School

S202001;CAPA

Site Assessment Report

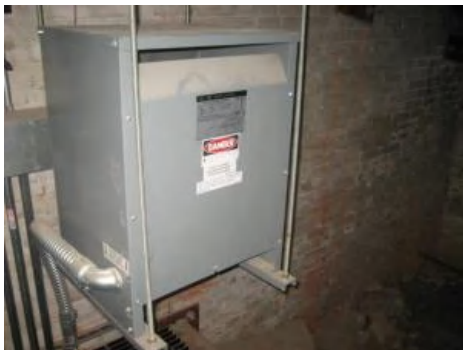
System: D5010 - Electrical Service/Distribution

Note: Step down transformers 480V-120/208V
(1) 500KVA
(1) 225KVA
(2) 150KVA
(1) 112.5KVA
(2) 75KVA
(1) 30KVA
(1) 45KVA power conditioner
